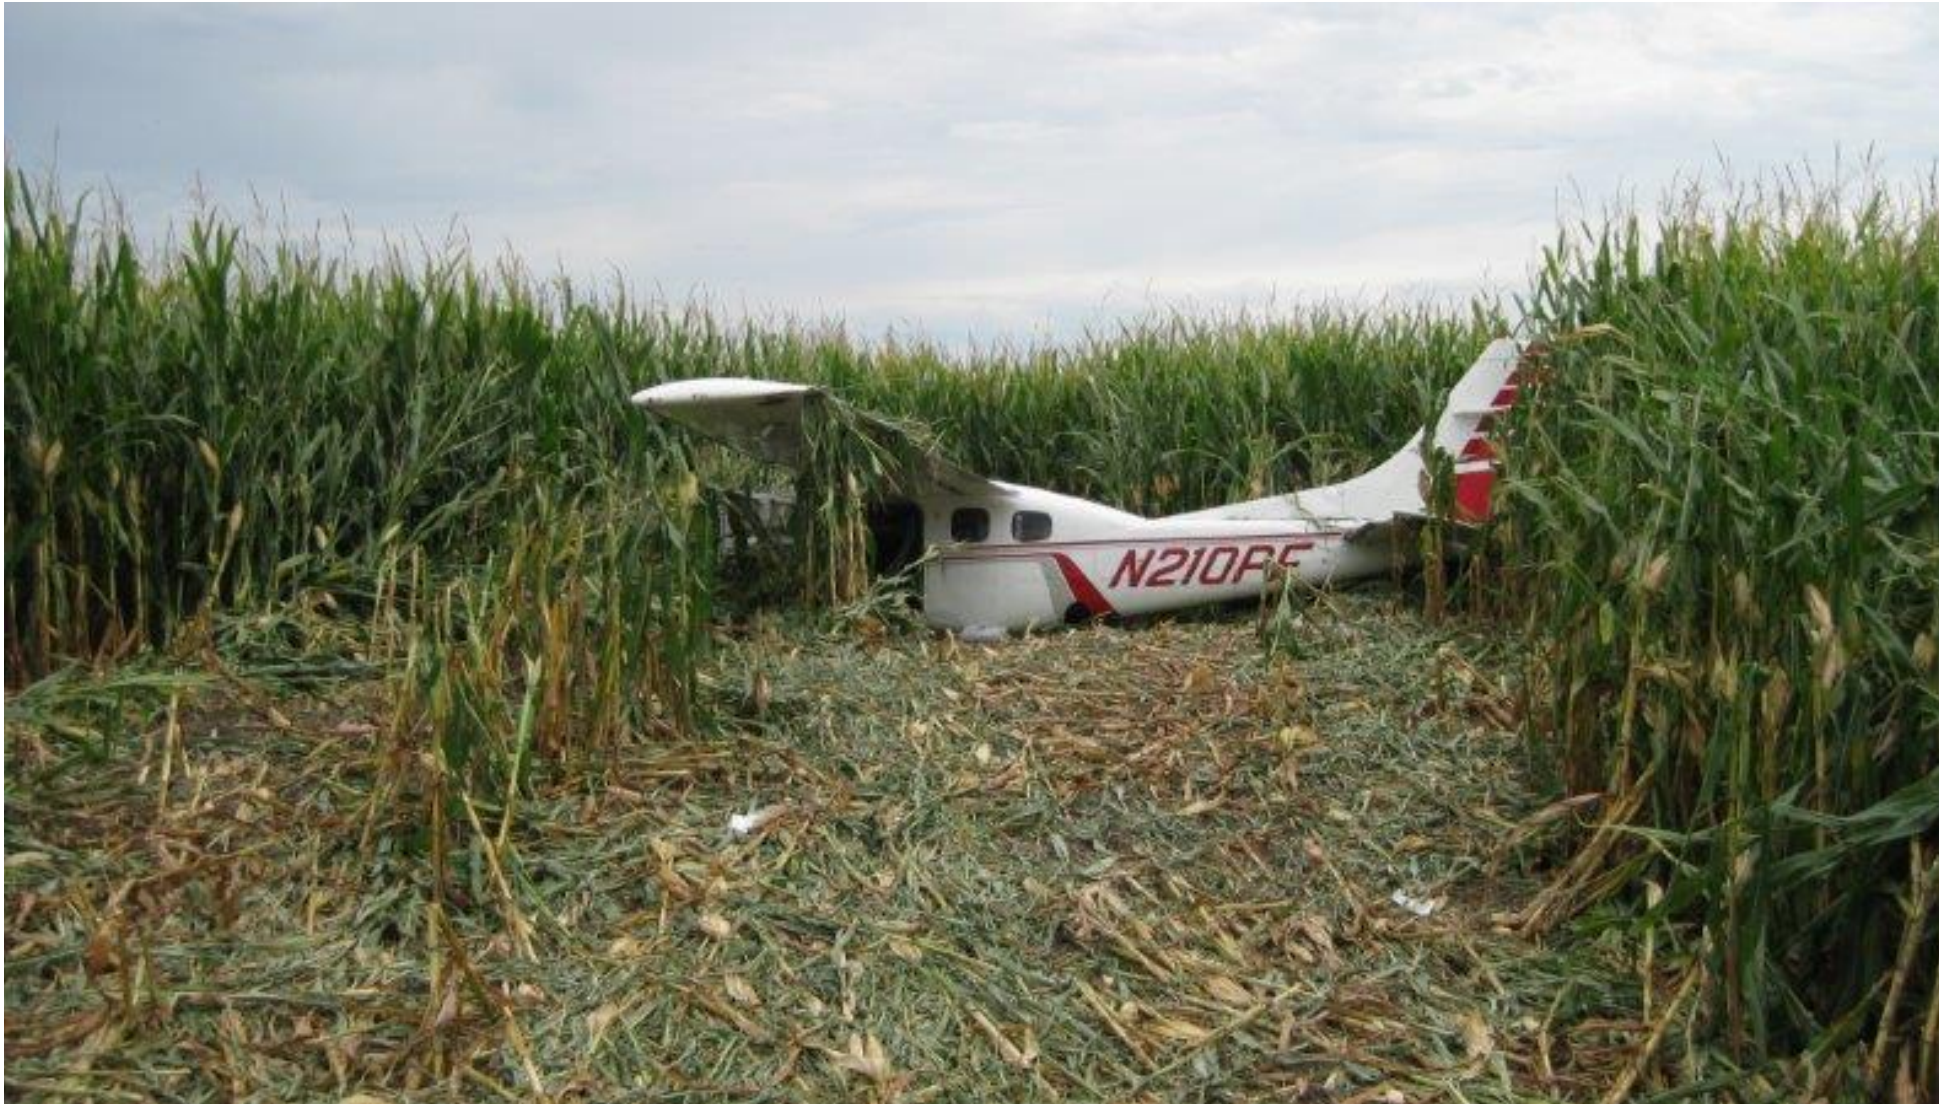
**Photo 1 – View of the left side of the wreckage in a cornfield (FAA Photo)**

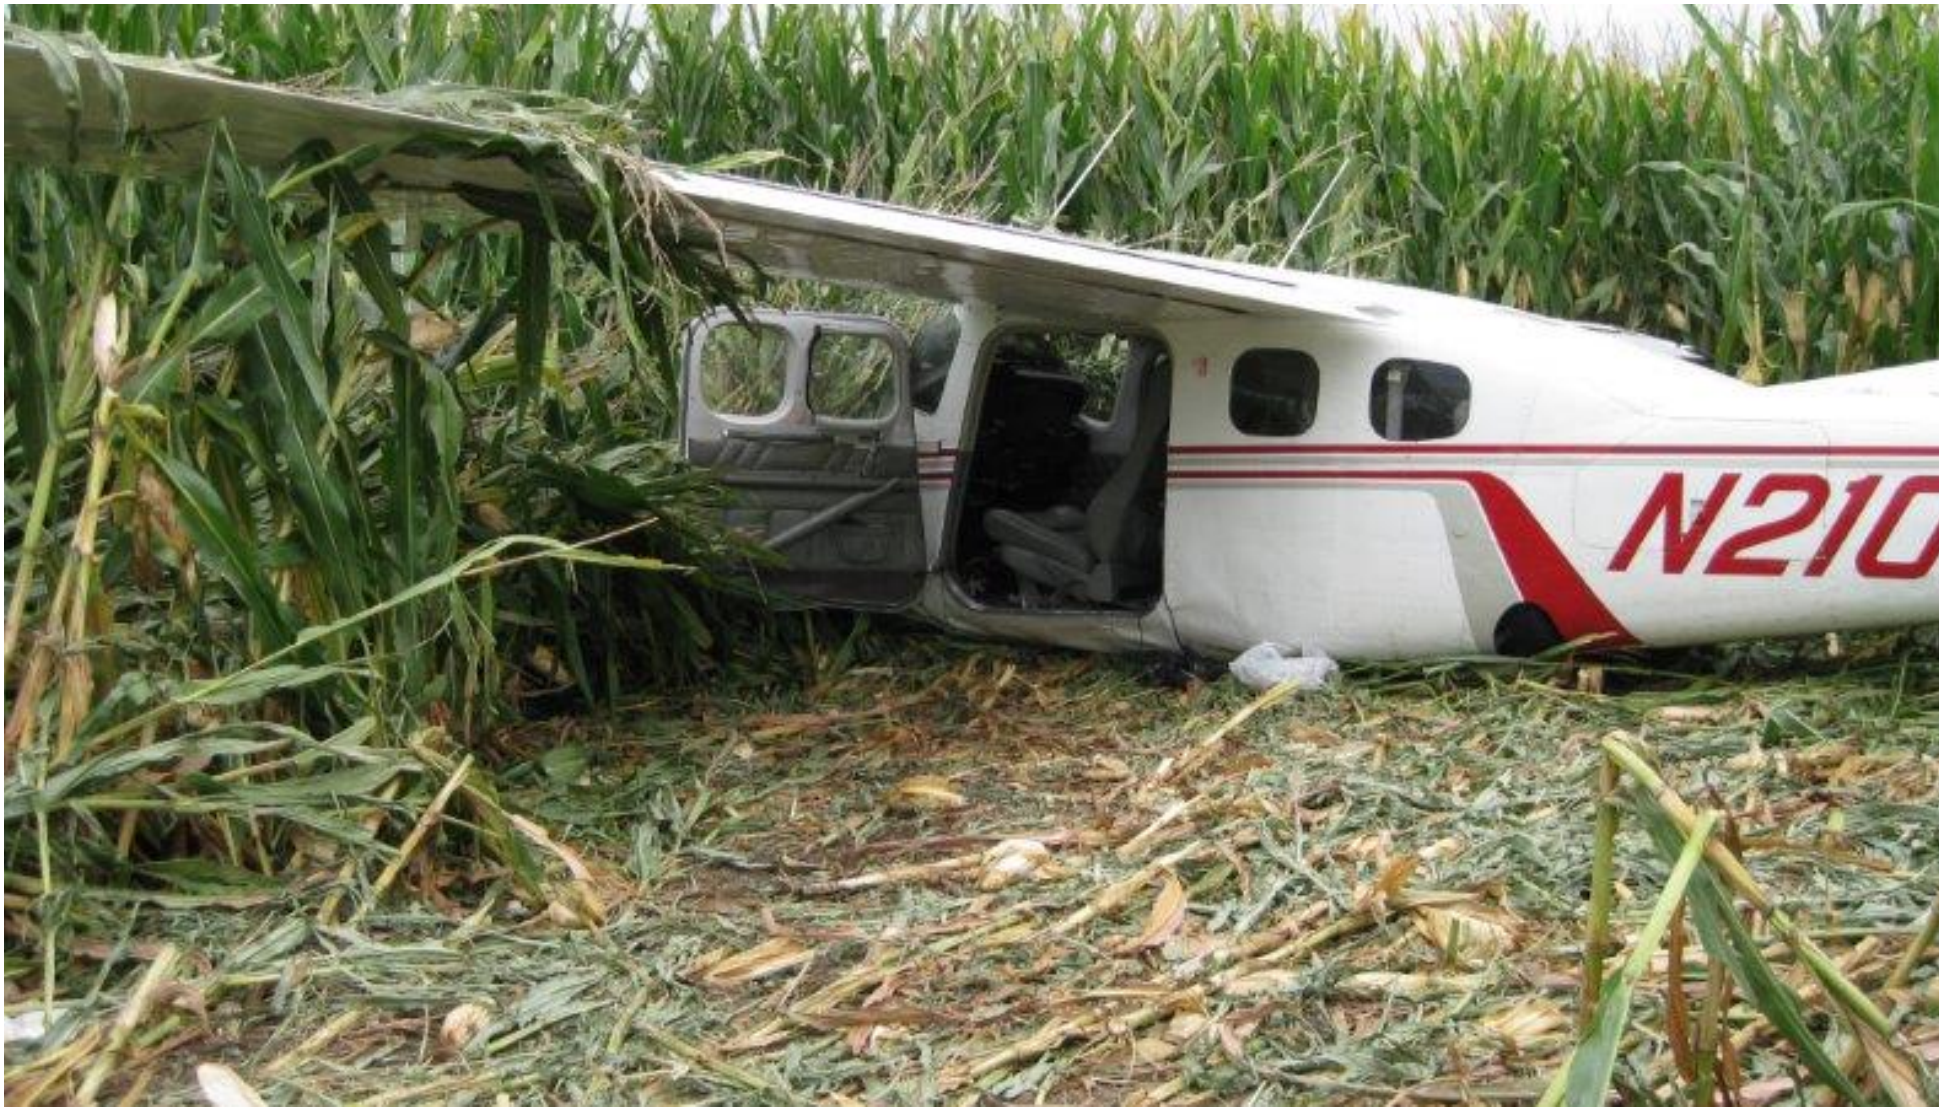
**Photo 2 – View of wreckage in the cornfield (FAA Photo)**

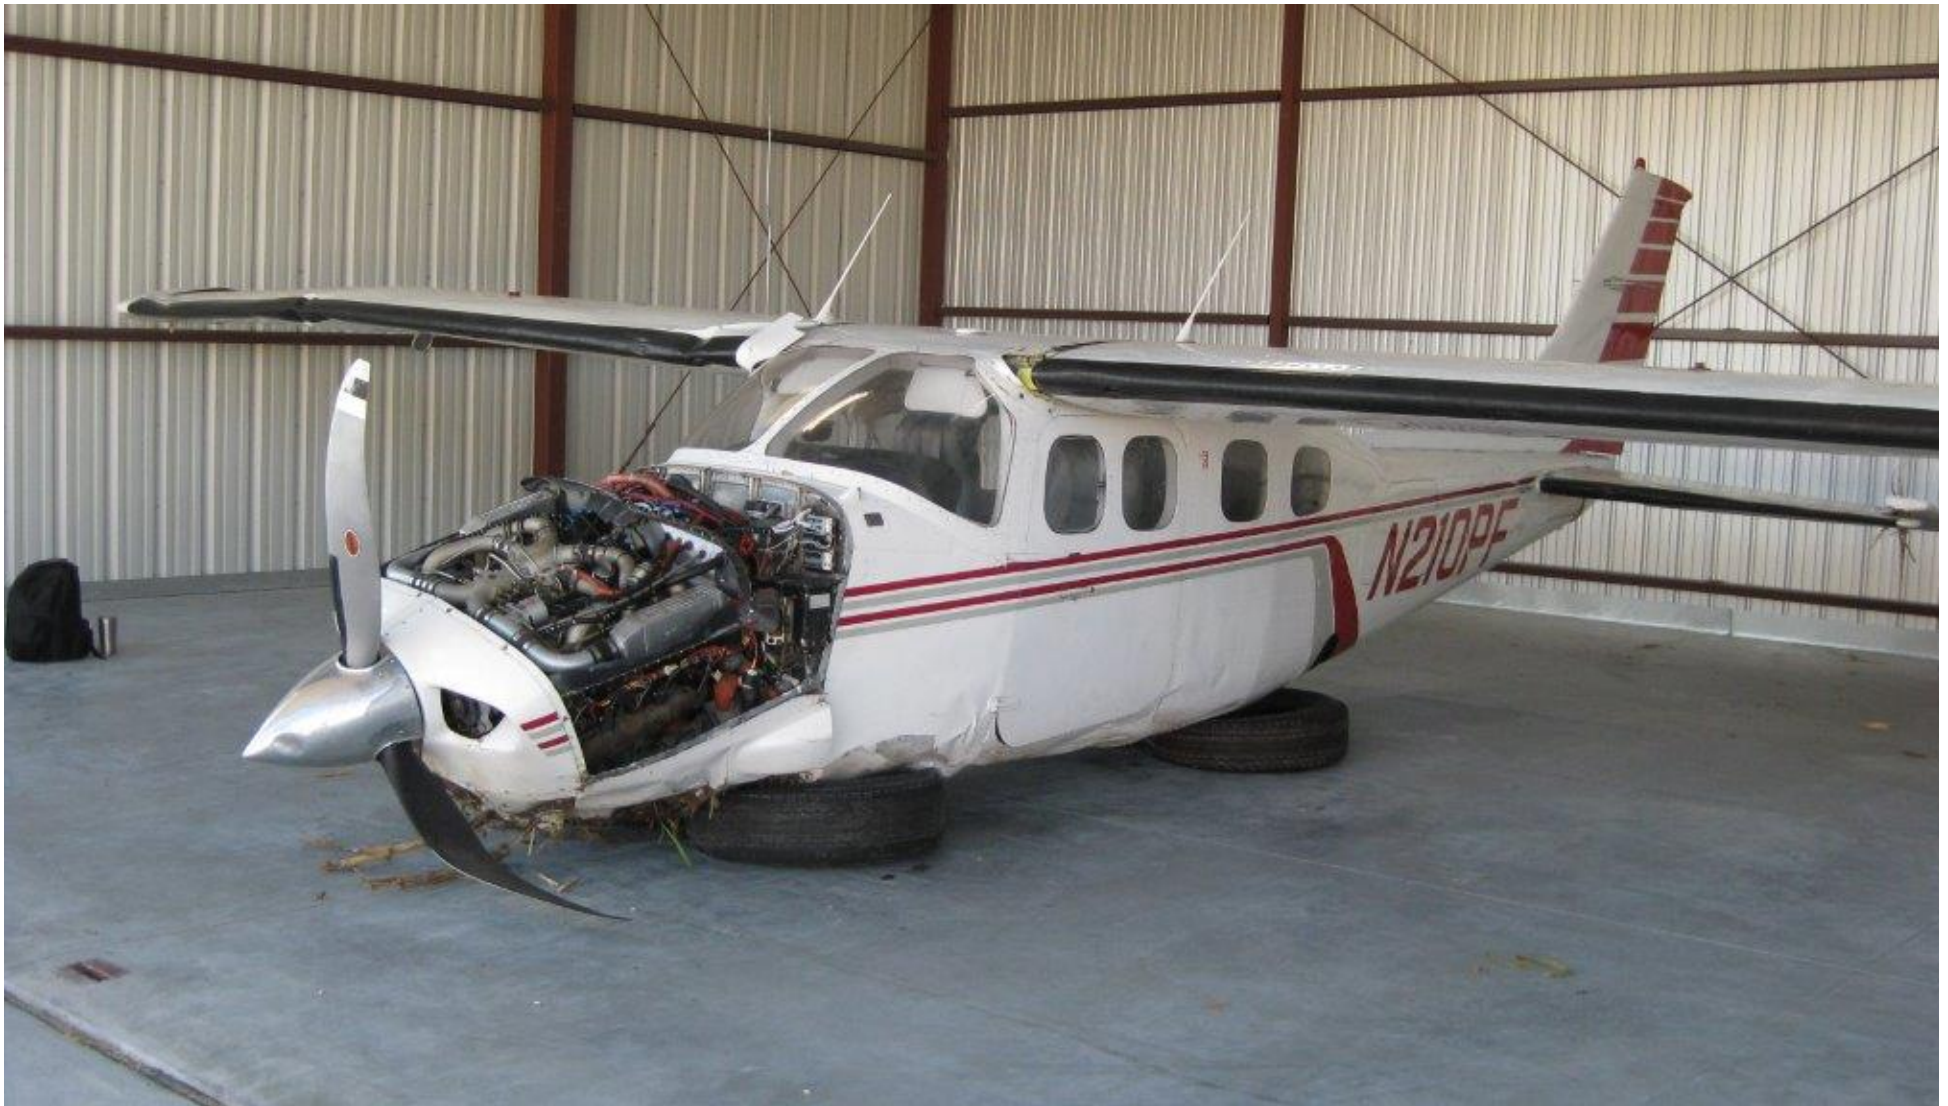
**Photo 3 – View of wreckage in a hangar (FAA Photo)**

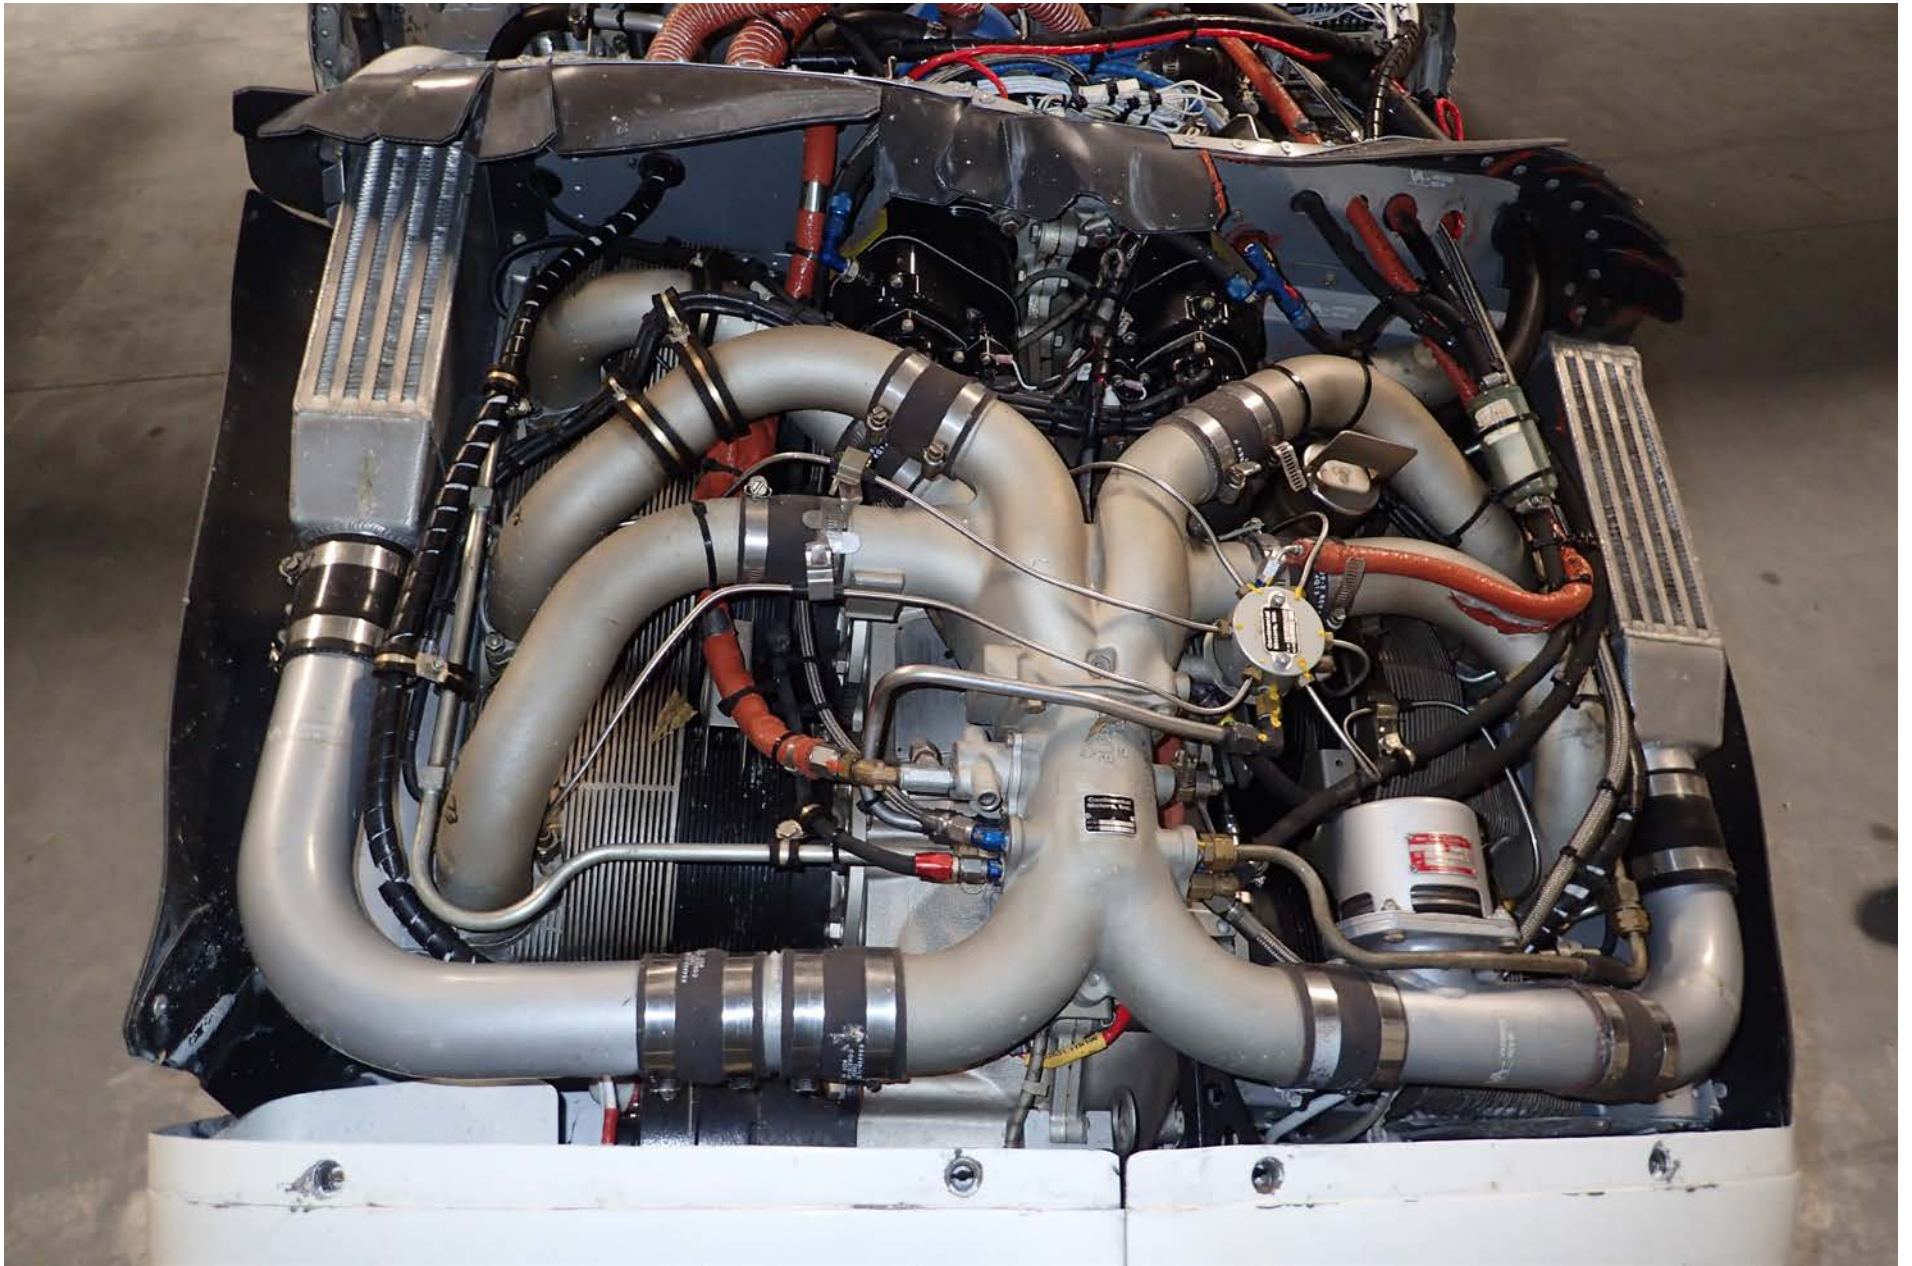
**Photo 4 – View of the top of the engine (CM Photo)**

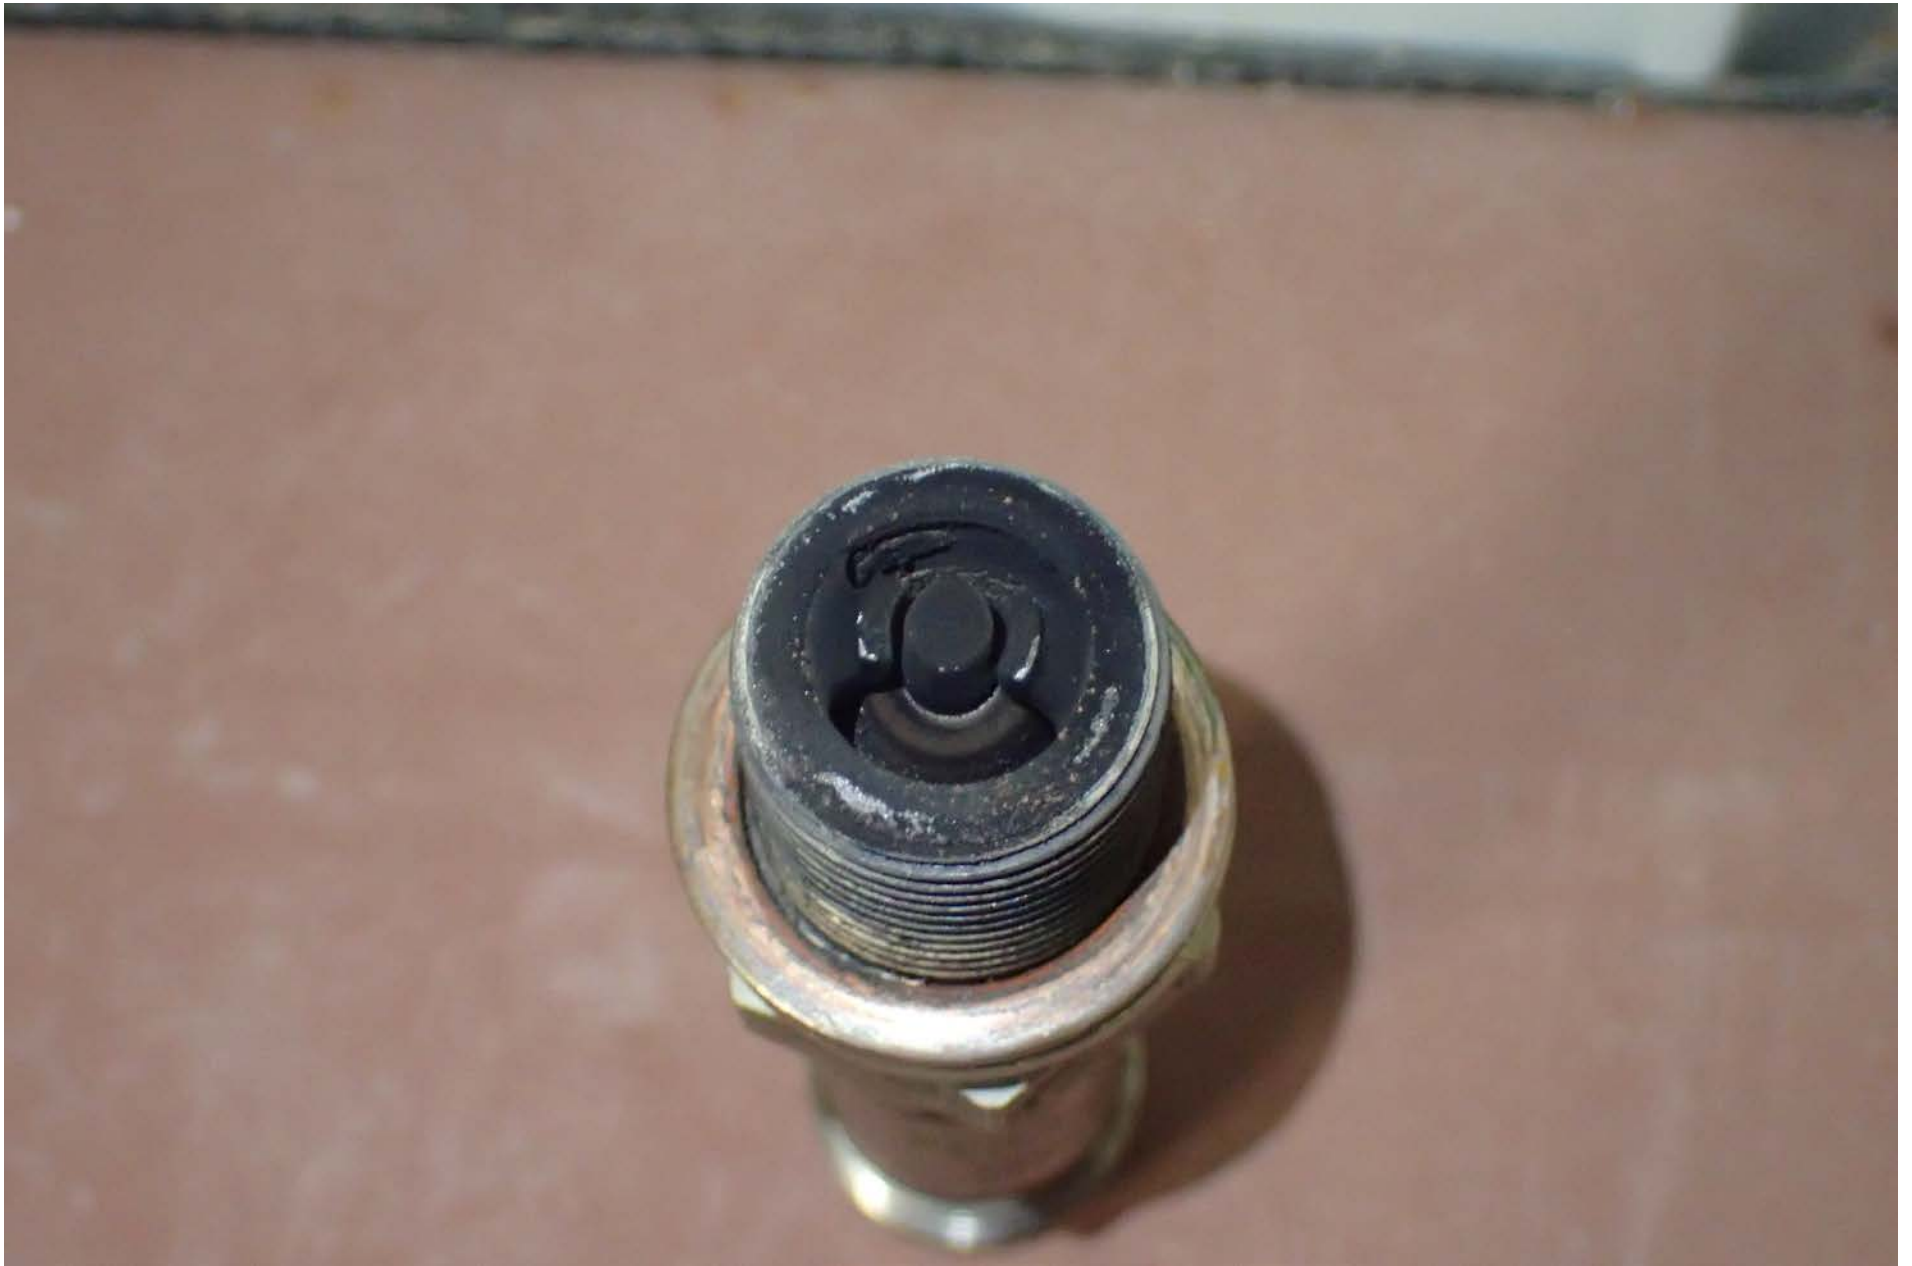
**Photo 5 – View of carbon build-up on 1B sparkplug (CM Photo)**

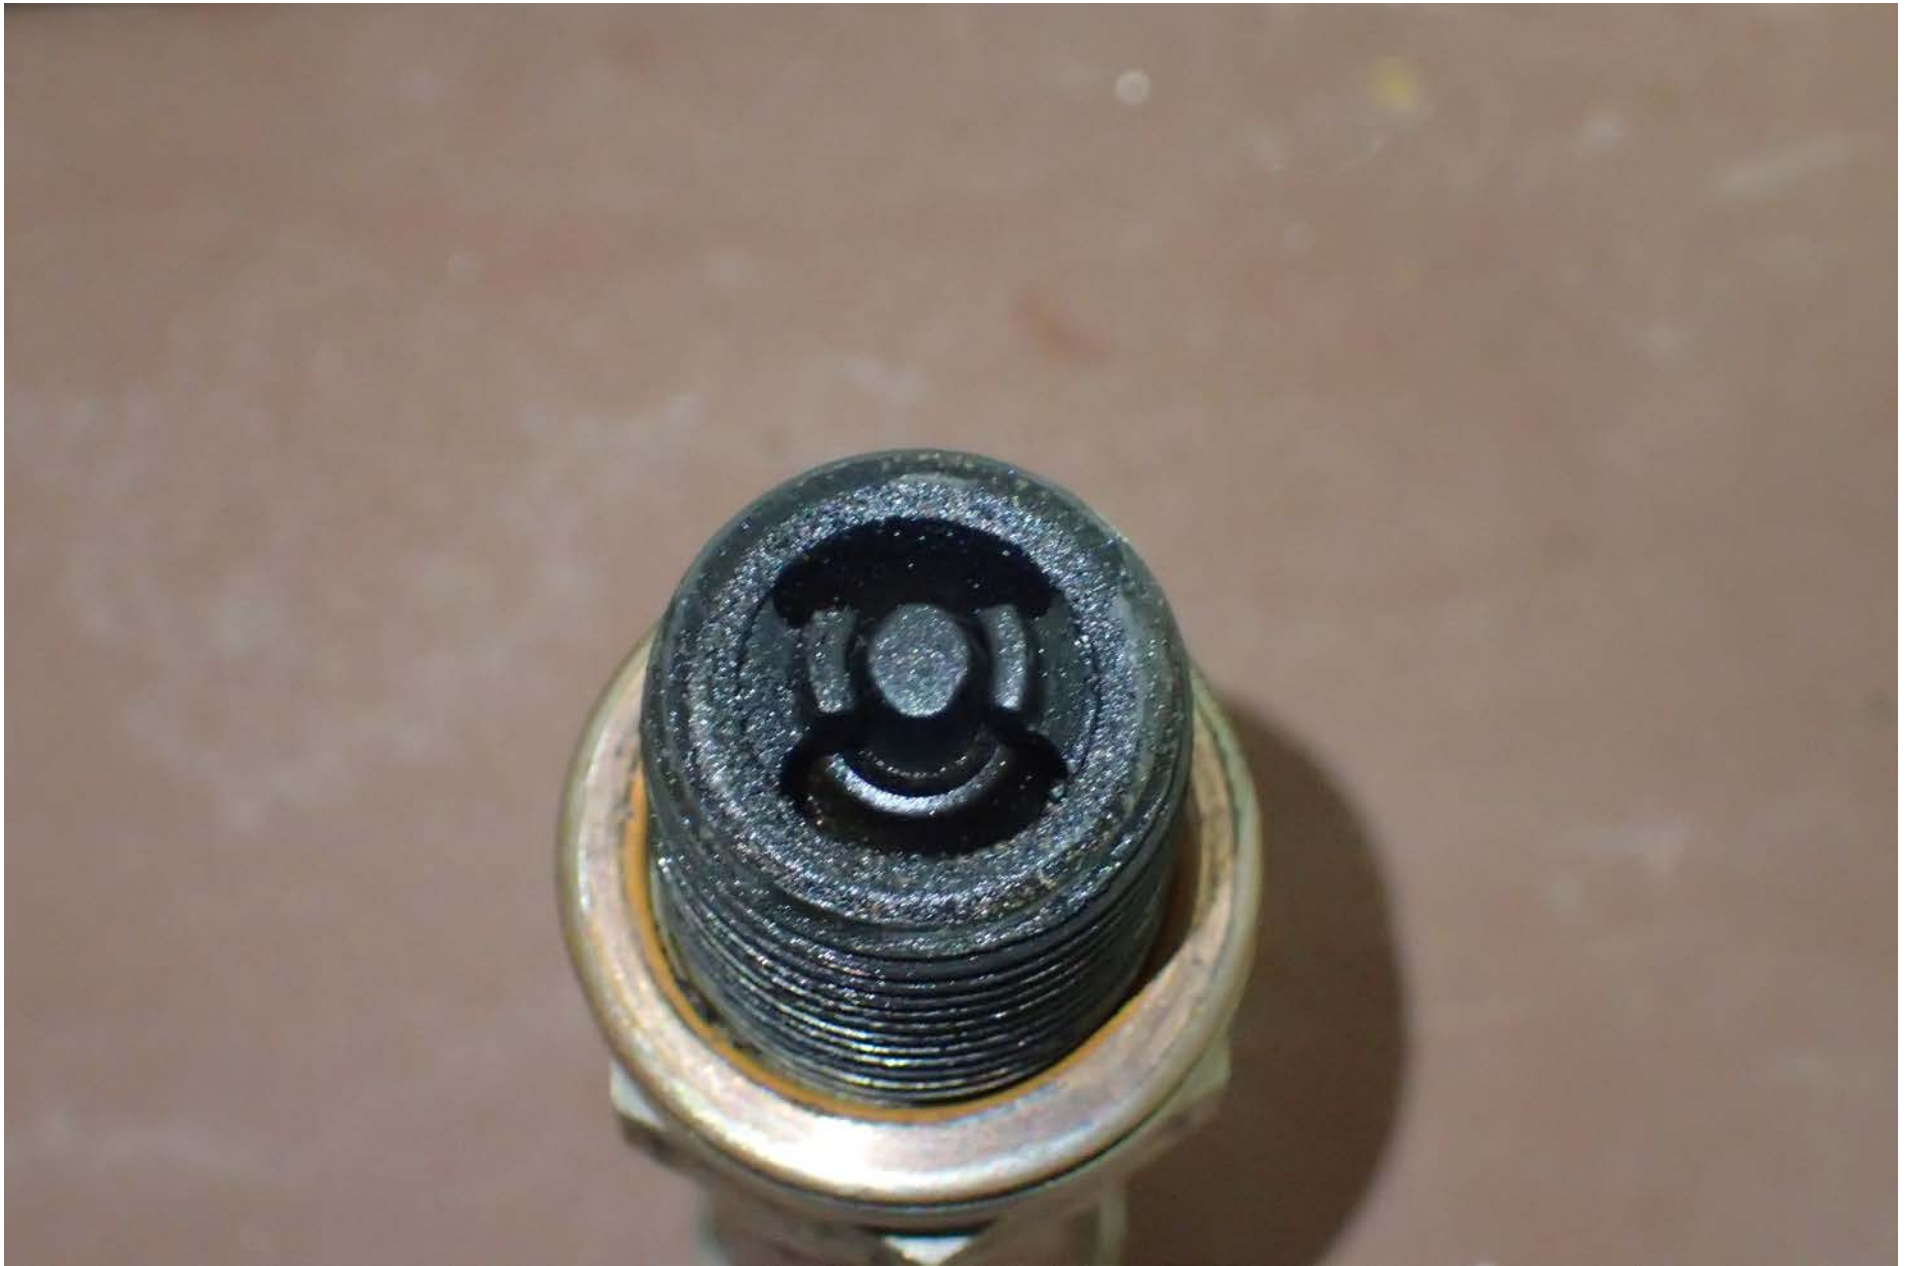
**Photo 6 – View of carbon build-up on 3B sparkplug (CM Photo)**

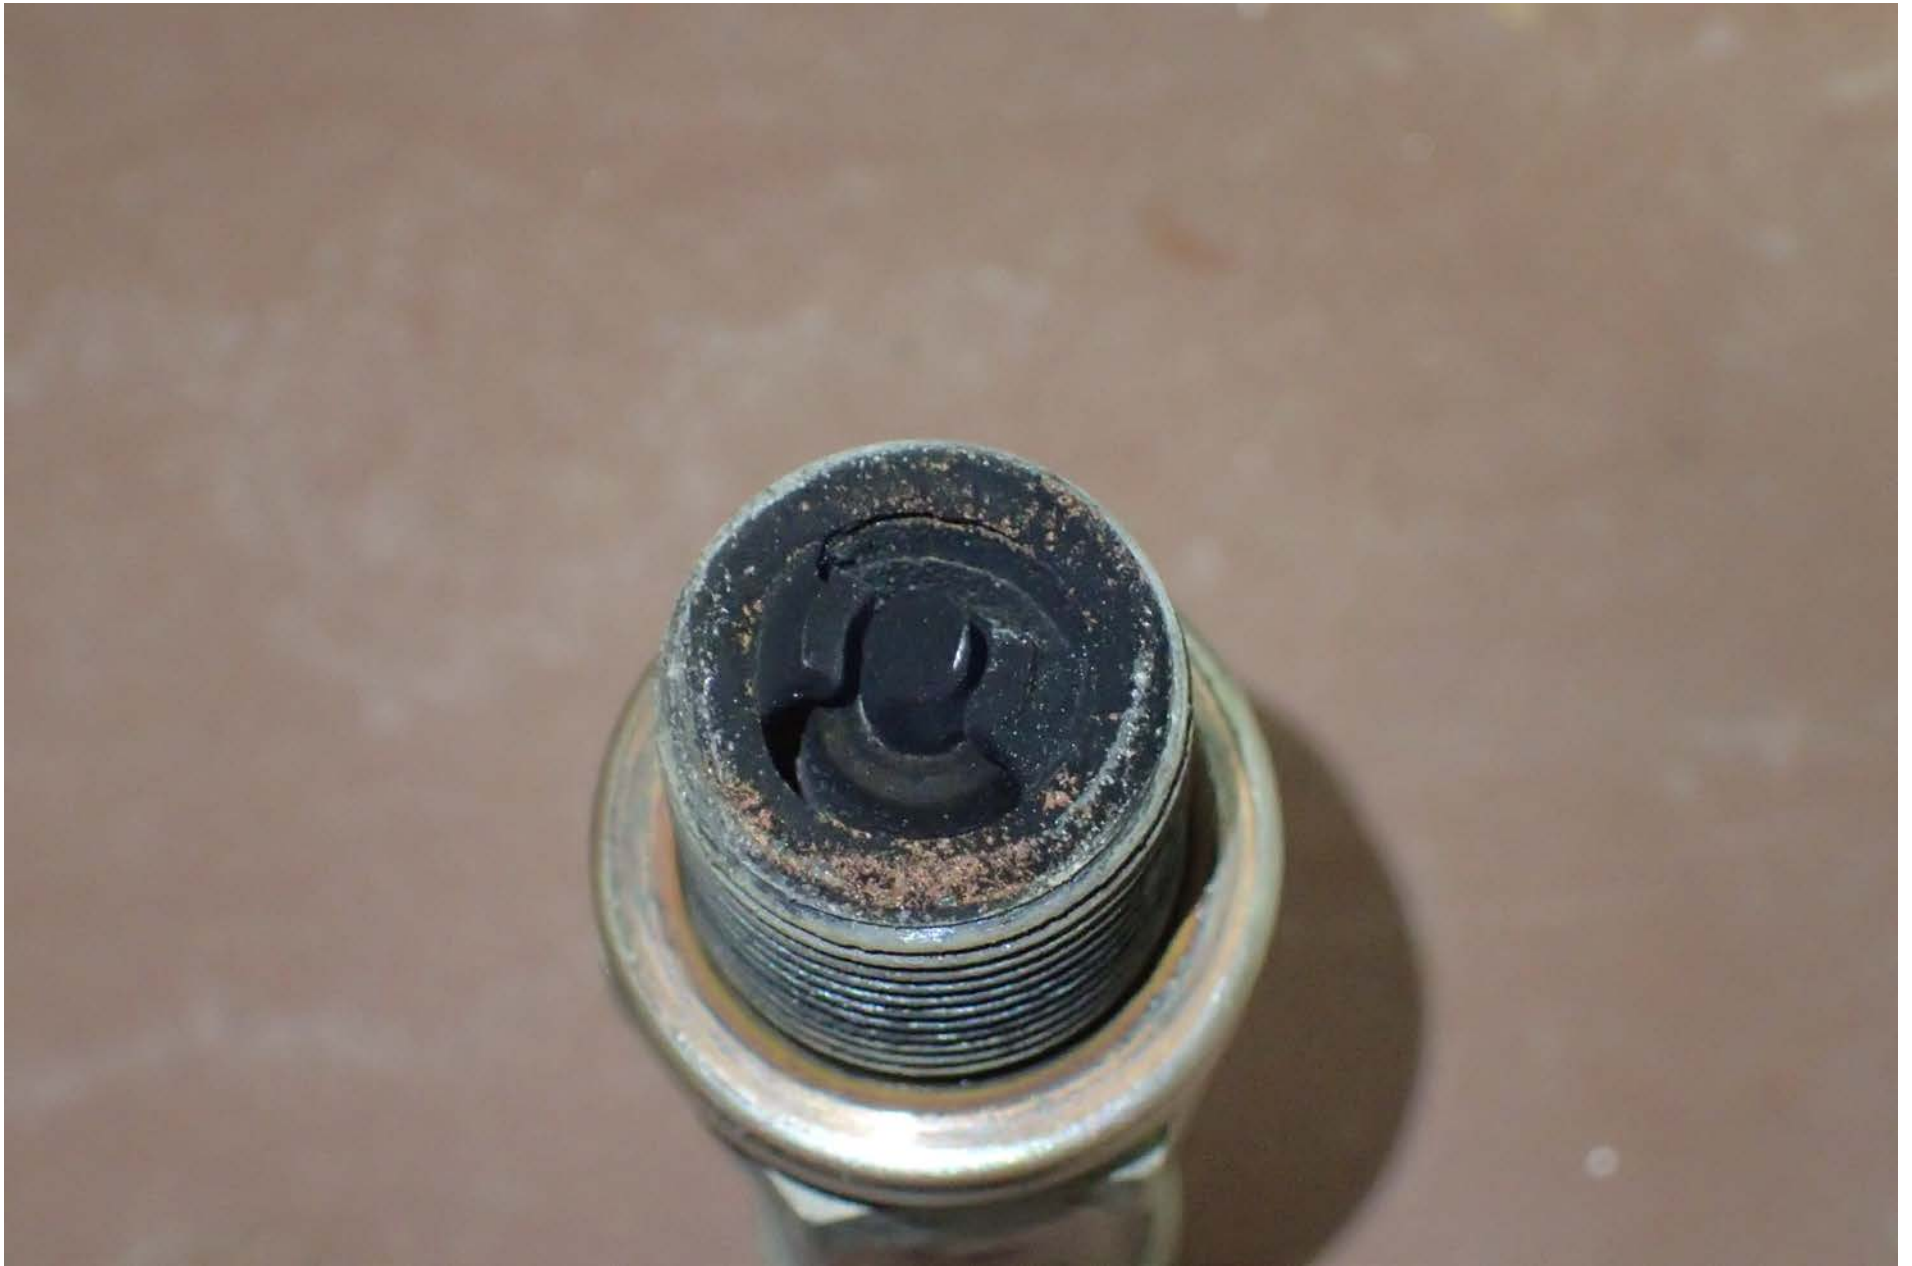
**Photo 7 - View of carbon build-up on 5B sparkplug (CM Photo)**

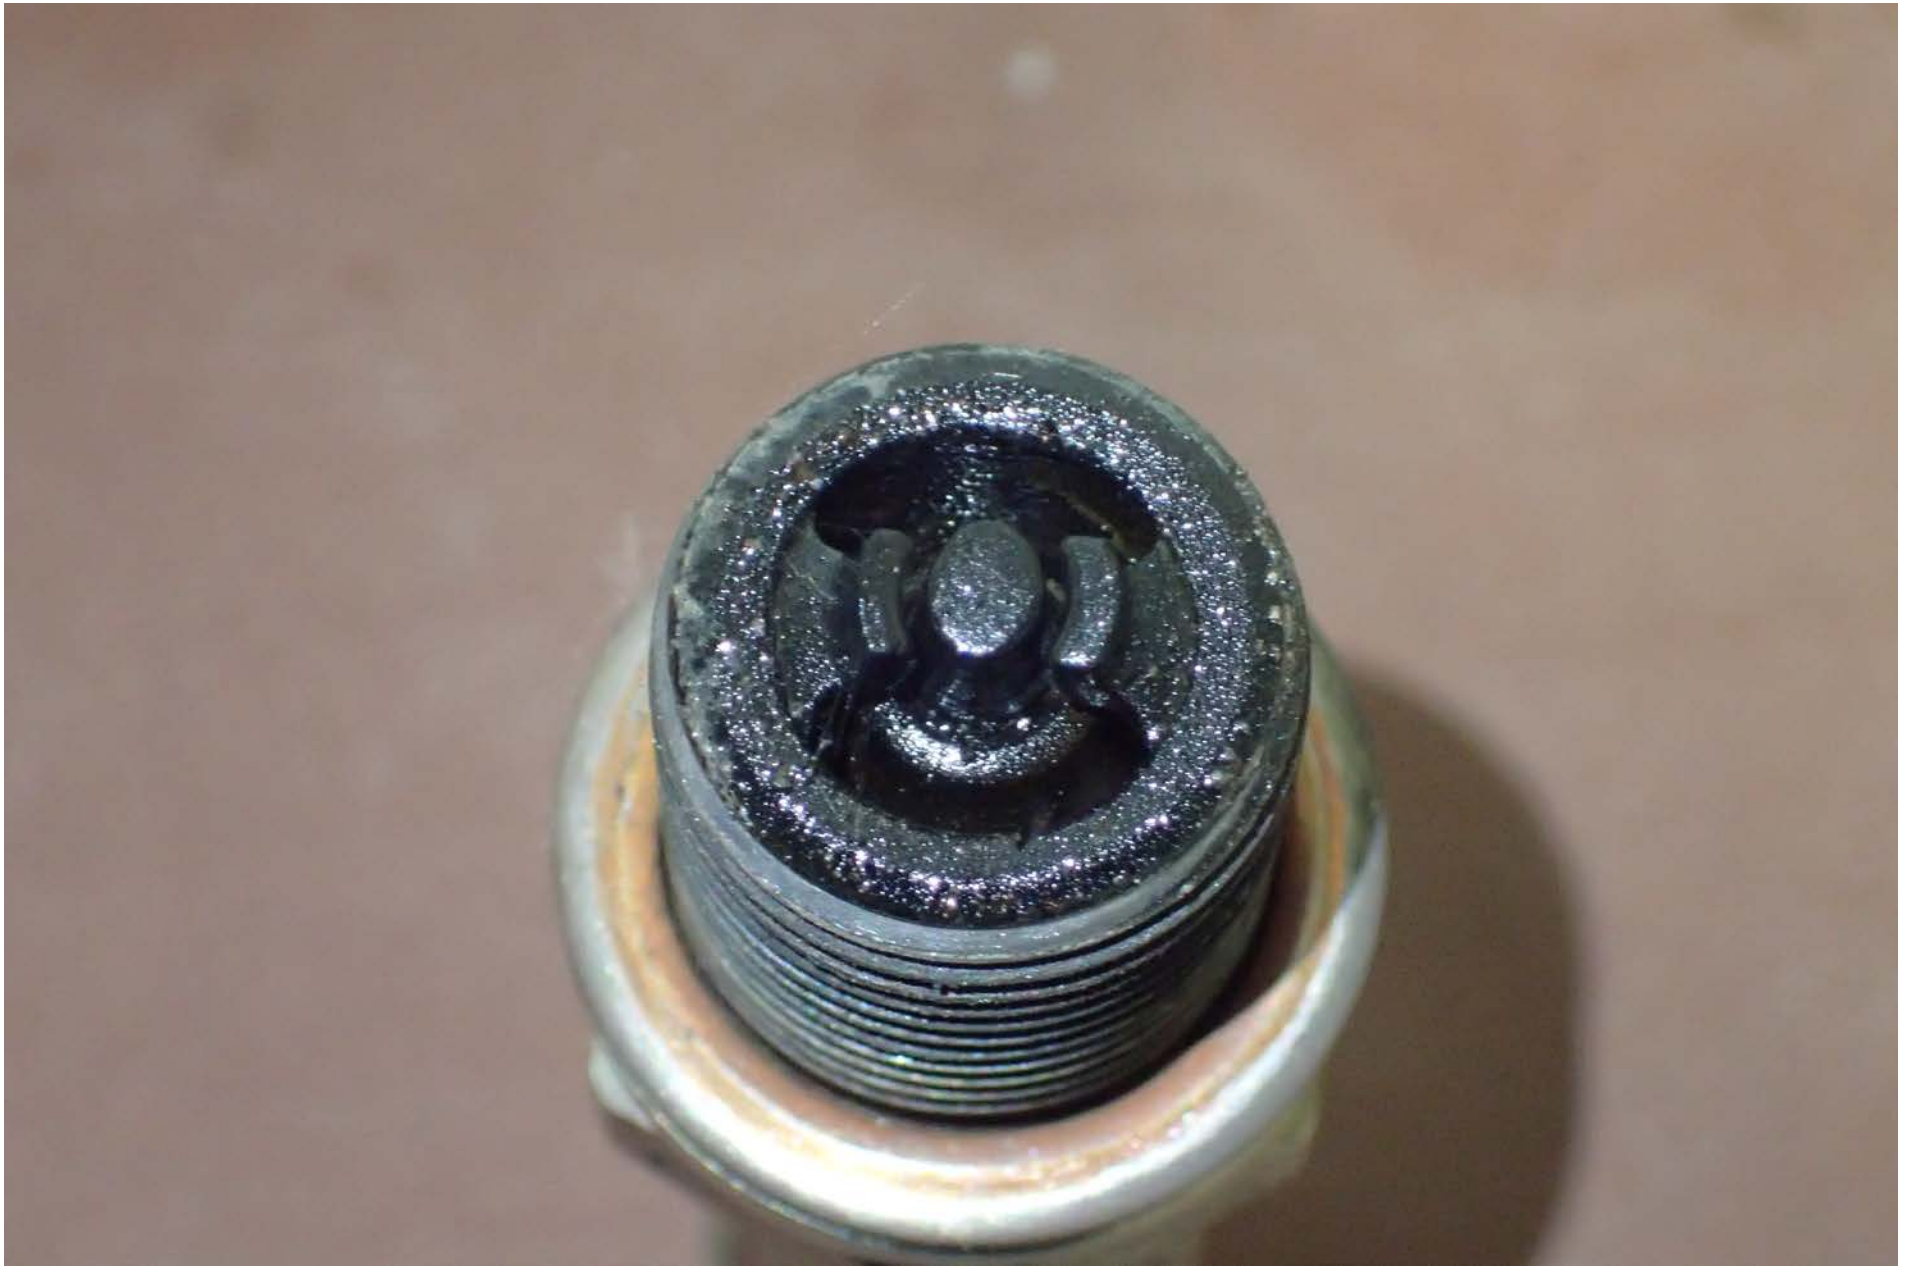
**Photo 8 - View of carbon build-up on 2B sparkplug (CM Photo)**

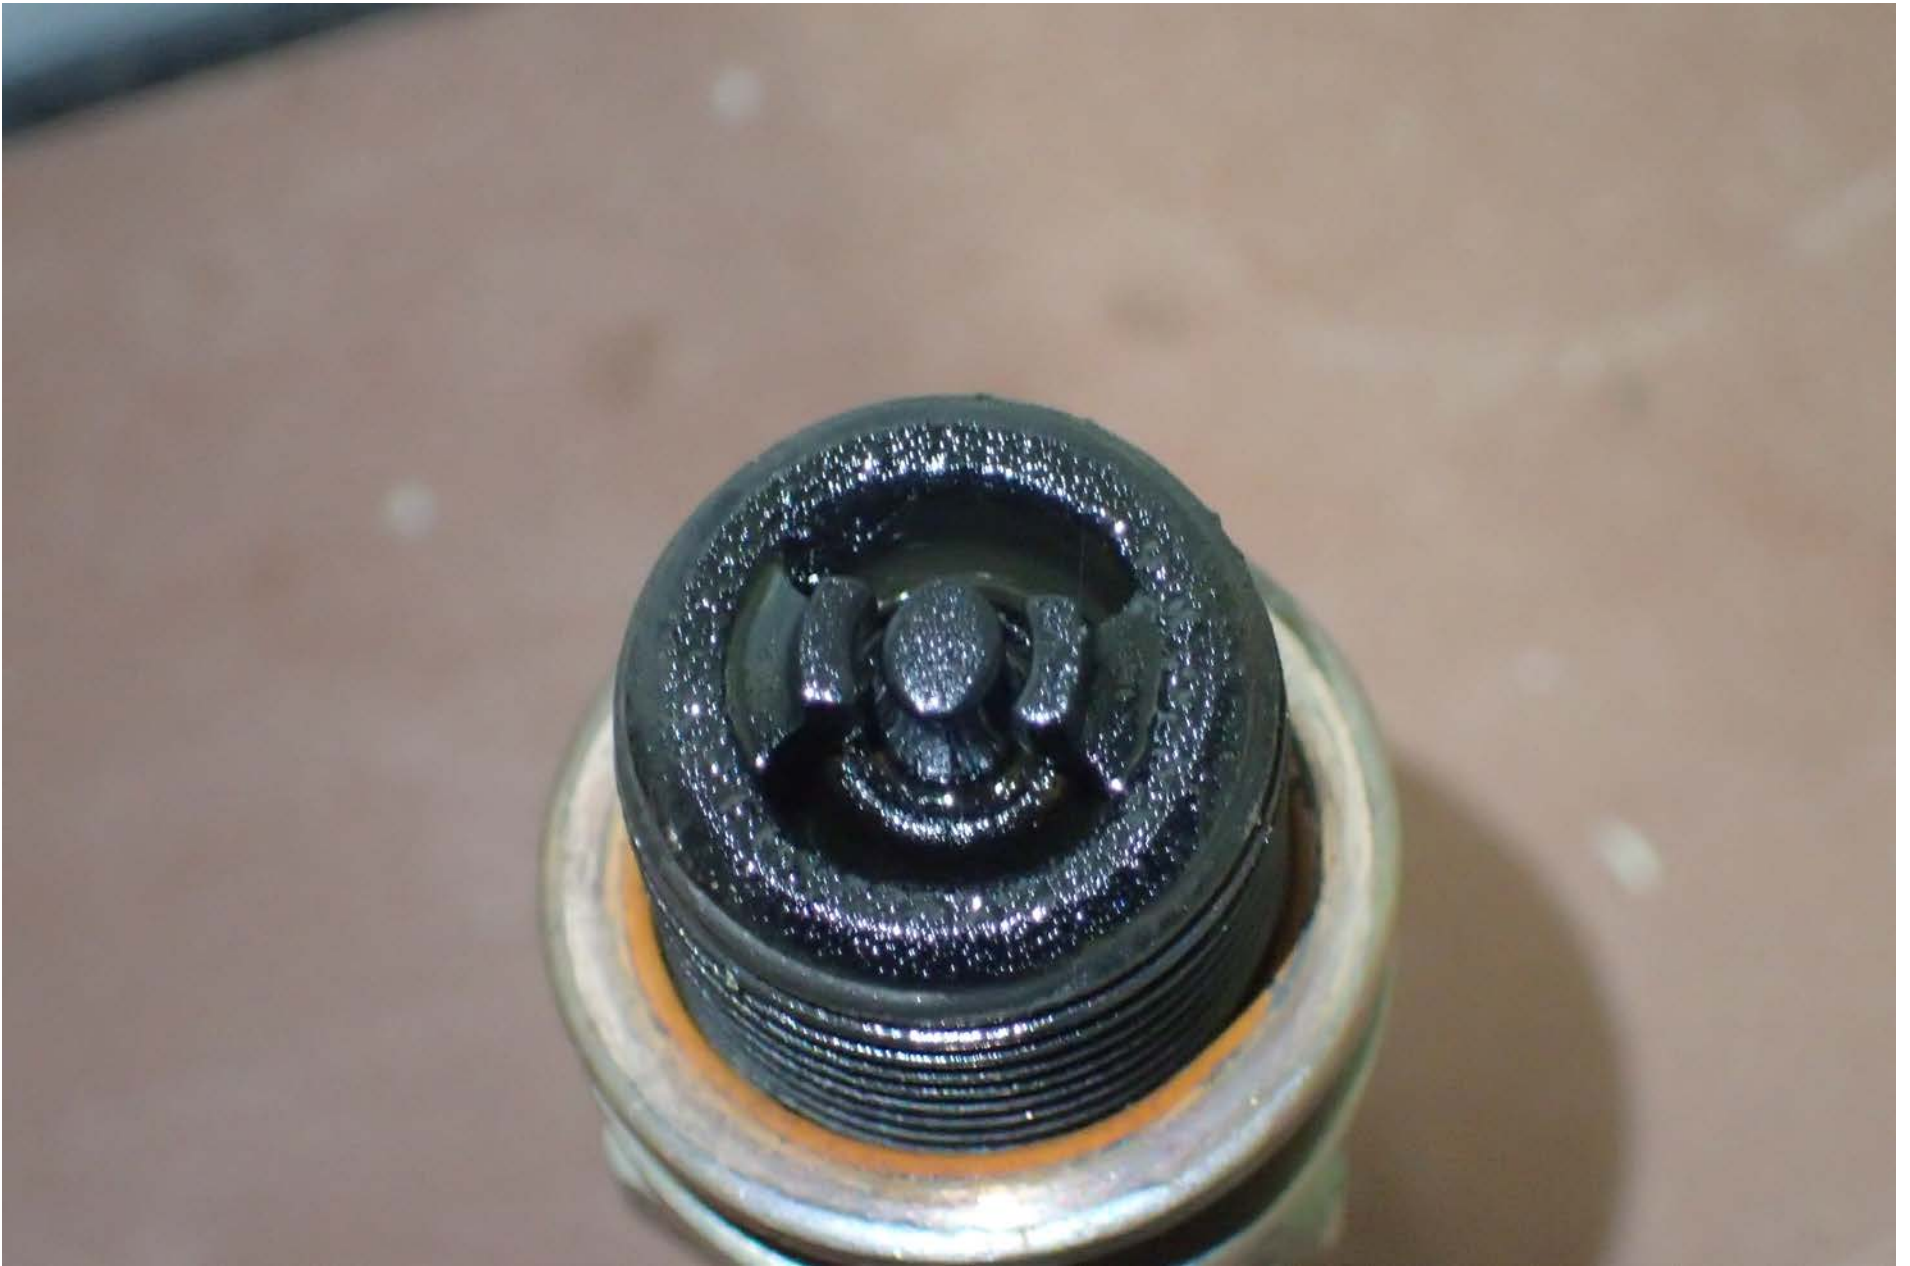
**Photo 9 - View of carbon build-up on 4B sparkplug (CM Photo)**
