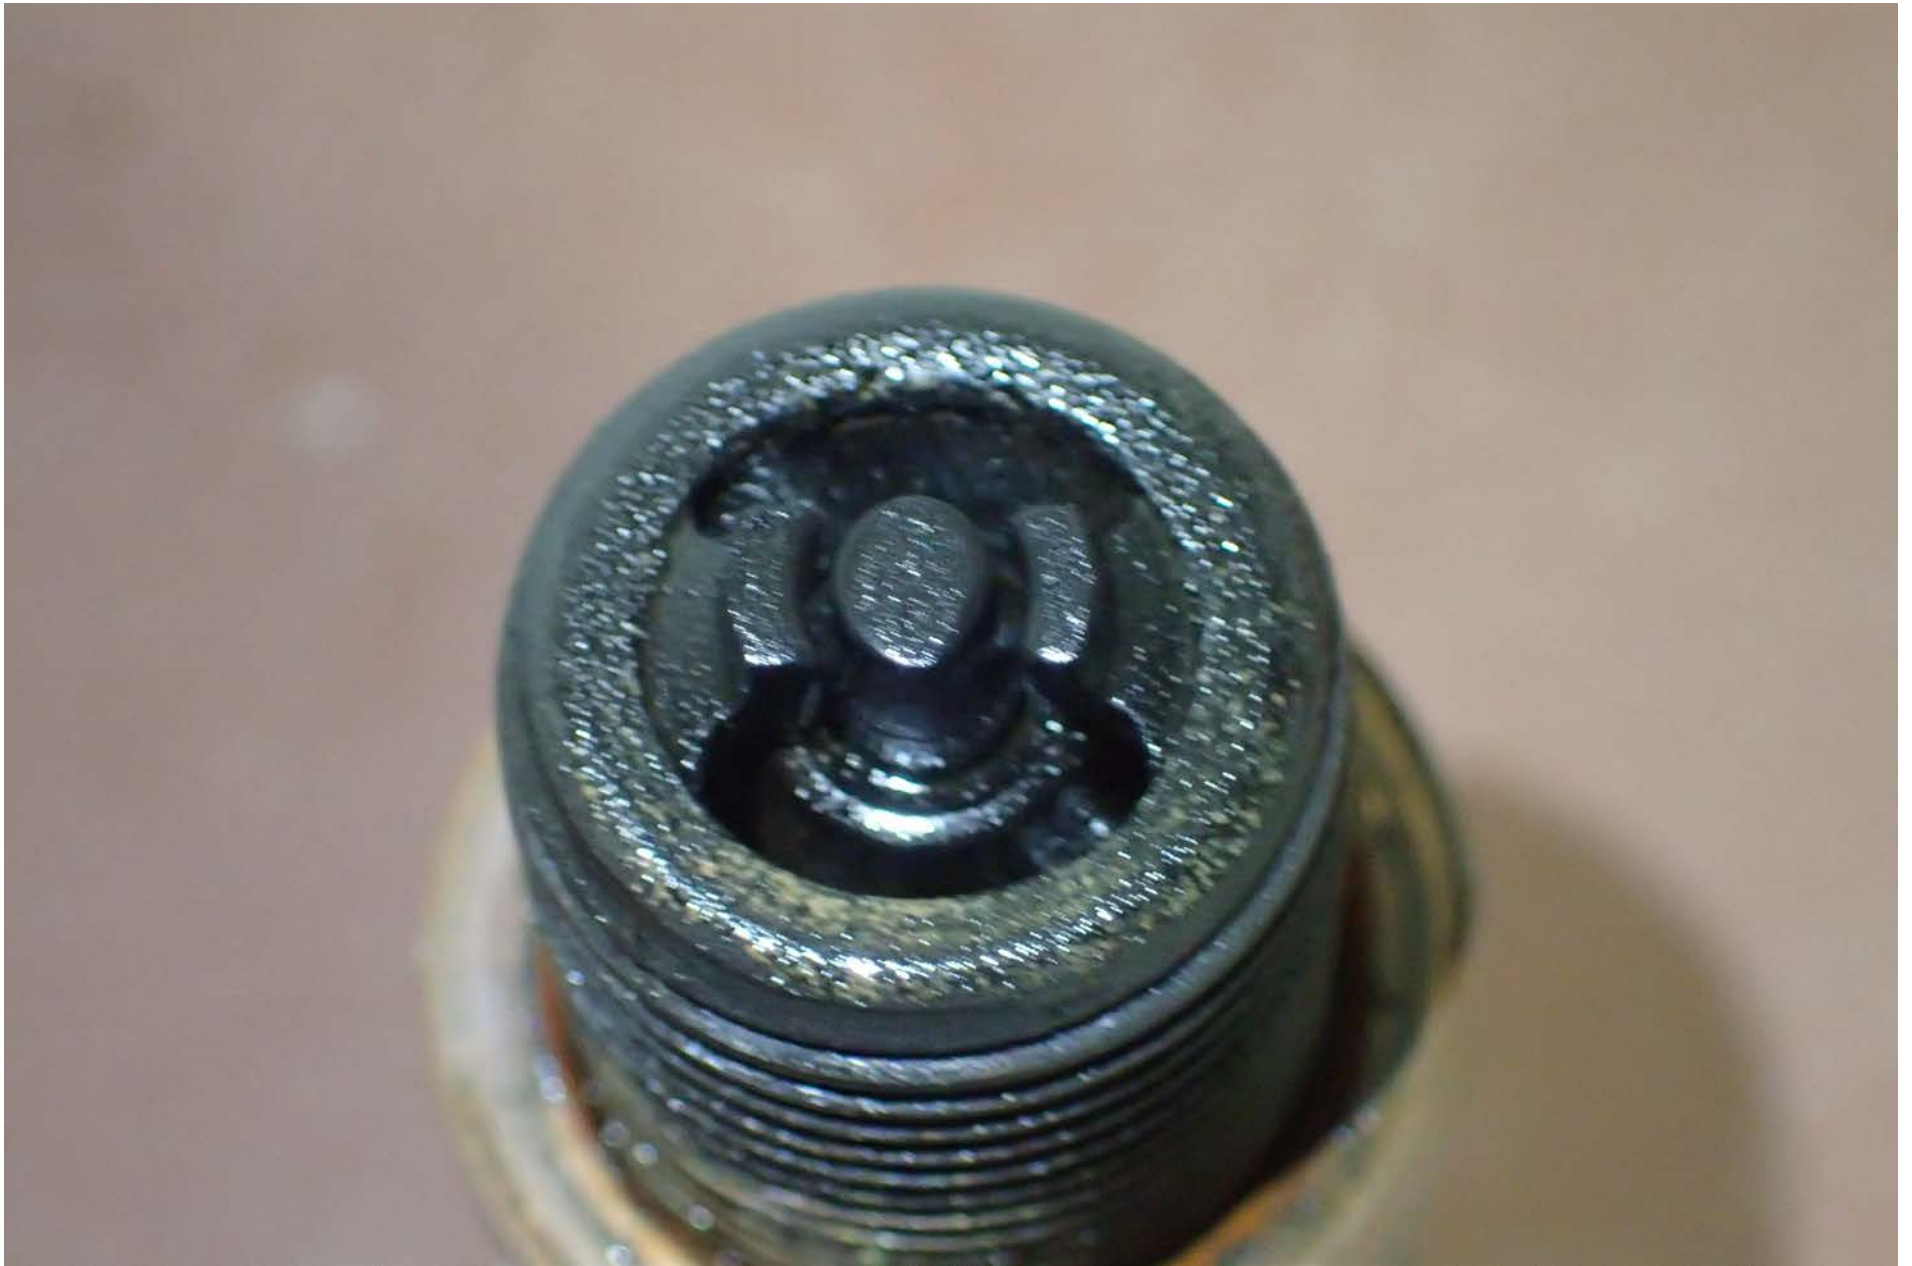
**Photo 10 - View of carbon build-up on 6B sparkplug (CM Photo)**
