## **NATIONAL TRANSPORTATION SAFETY BOARD**

### **Specialist Factual Report**

# **METEOROLOGY**

CEN19FA004

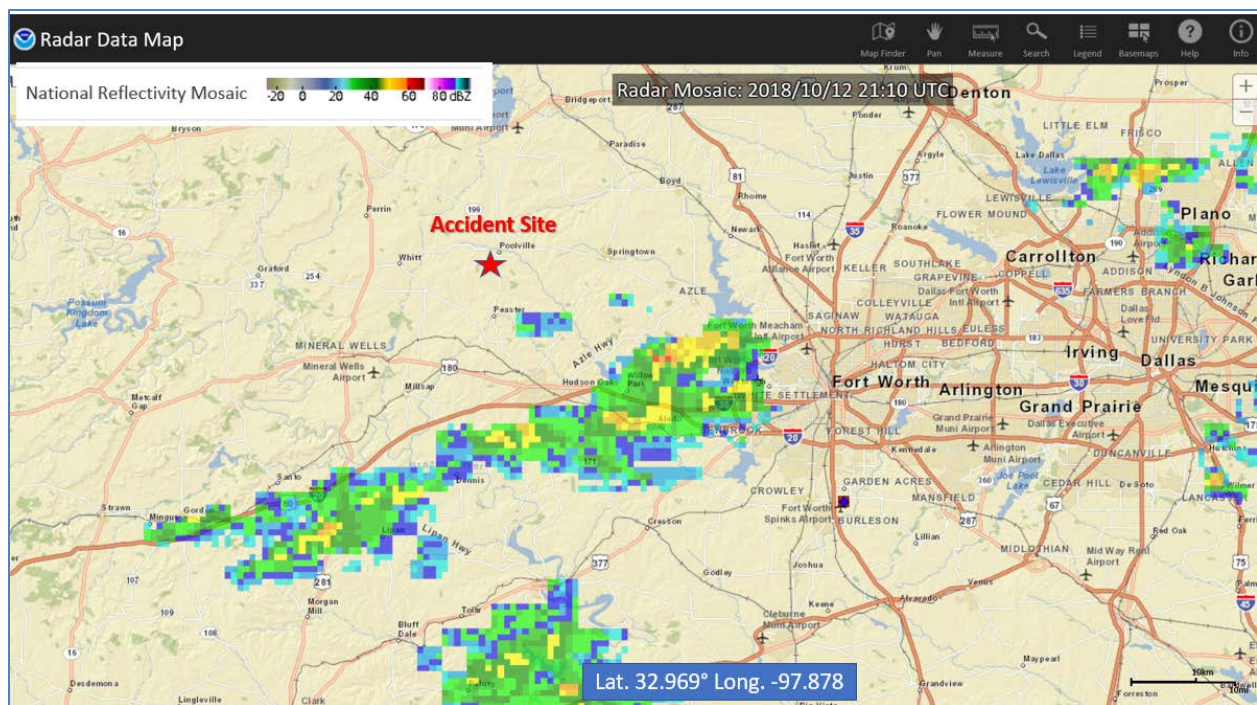
**Figure 2 - Southcentral section of the NWS National Composite Radar Reflectivity image for 1610 CDT**

A screen shot of the NWS NCEI National Composite Reflectivity image for 1610 CDT over the region is included as figure 2, with the approximate accident site marked. The chart depicted a band of echoes extending from immediately west of Fort Worth west-southwestward to Gordon, Texas, to the south of the accident site with several other small areas of scattered echoes across the region. A small area of echoes associated with light rain was located approximately 6 miles south-southeast of the accident site with no echoes over the accident site.

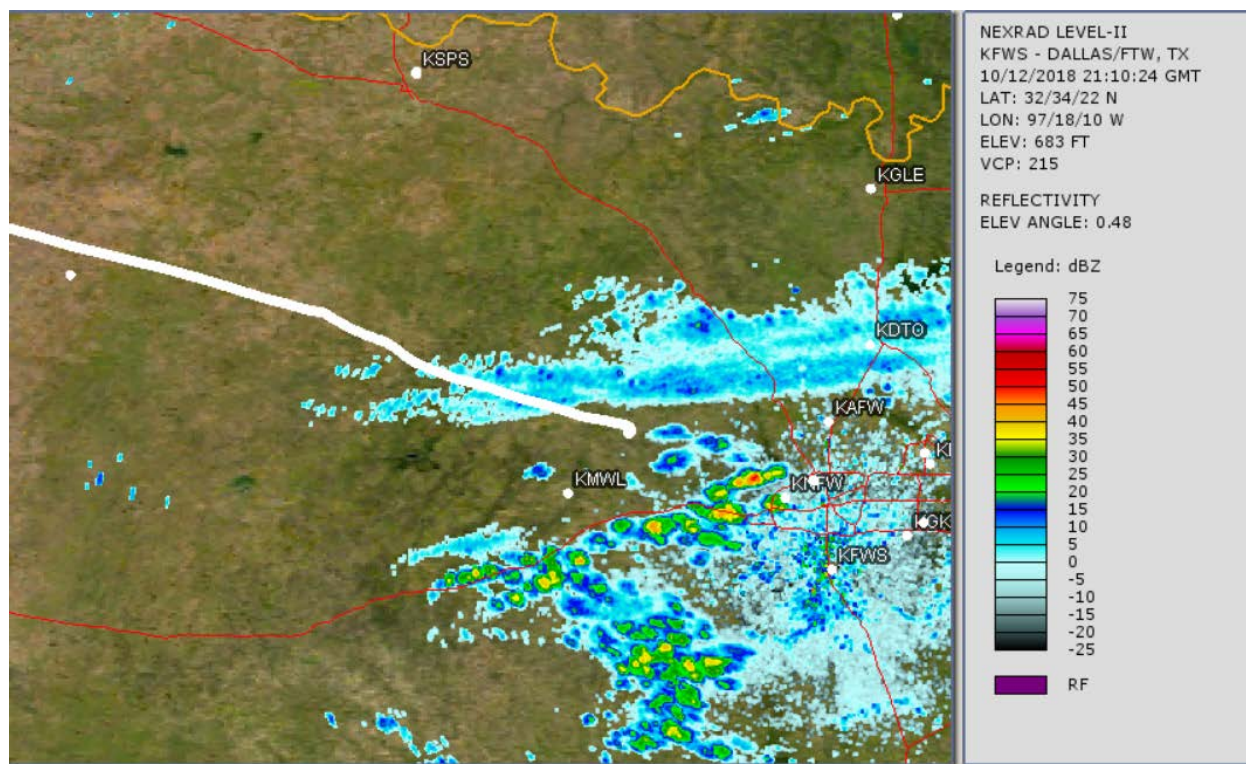
Figure 12 – NWS KFWS WSR-88D 0.5° base reflectivity image at 1610 CDT

Figure 12 is the NWS KFWS WSR-88D 0.5° base reflectivity image at 1610 CDT with the flight track of N221MC overlaid<sup>11</sup>. The image depicts a thin line of echoes in the range of -5 to 15 dBZ or very light intensity echoes along the flight track extending east-to-west north of KAFW, with no echoes over the accident site. Several small cells of echoes near 20 to 25 dBZ were located about 8 miles east and southeast of the accident site. Figure 13 is a closeup of the flight track and echoes in the vicinity of the accident site.

<sup>11</sup> Based on the KFWS antenna height of 776 ft, distance of 37 miles, and assuming normal refraction of the beam, the 0.5° elevation scan beam was centered at about 3,650 ft with the base of the beam at 1,780 ft and the top at 5,510 ft. The flight track of N221MC indicated the accident reached its lowest altitude of 4,000 ft at this time.
