## ENGINE RUN REPORT

| ENGINE MODEL | IO550F13B |
| AIRCRAFT MAKE & MODEL | Cessna 182P |
| FILE NUMBER | 18-245 |

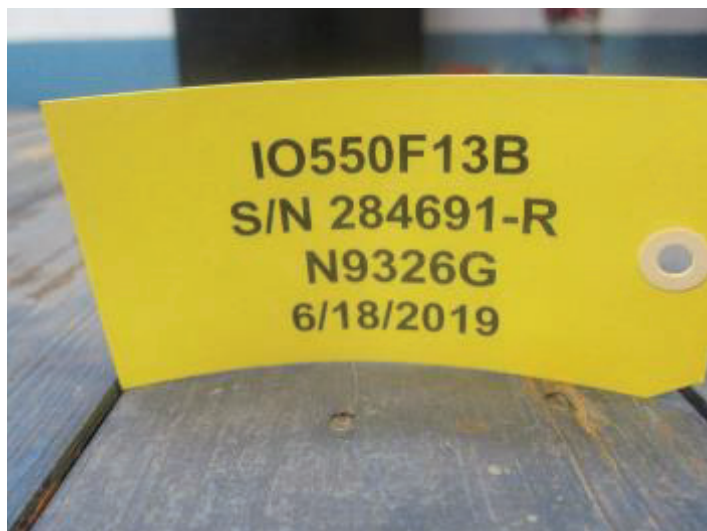
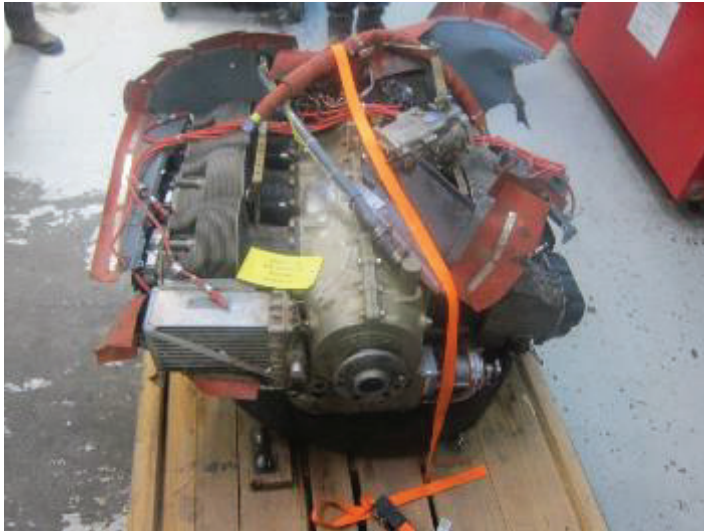
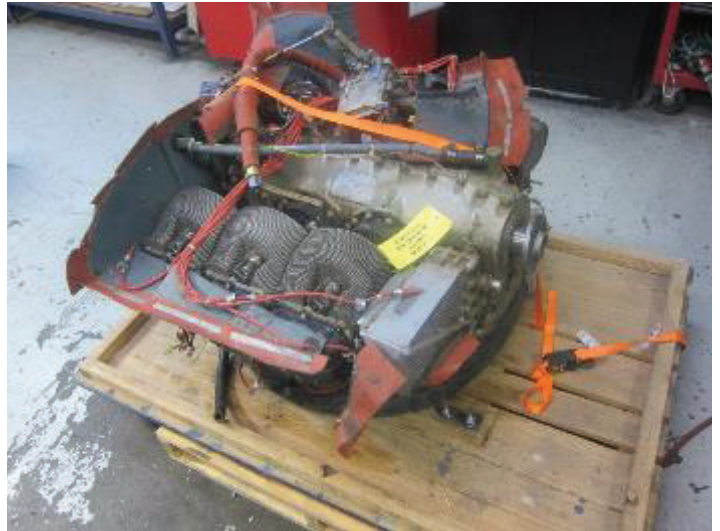
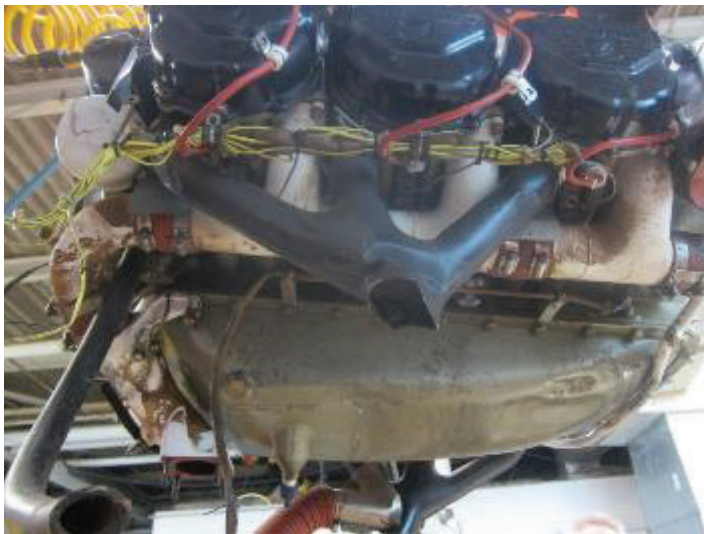
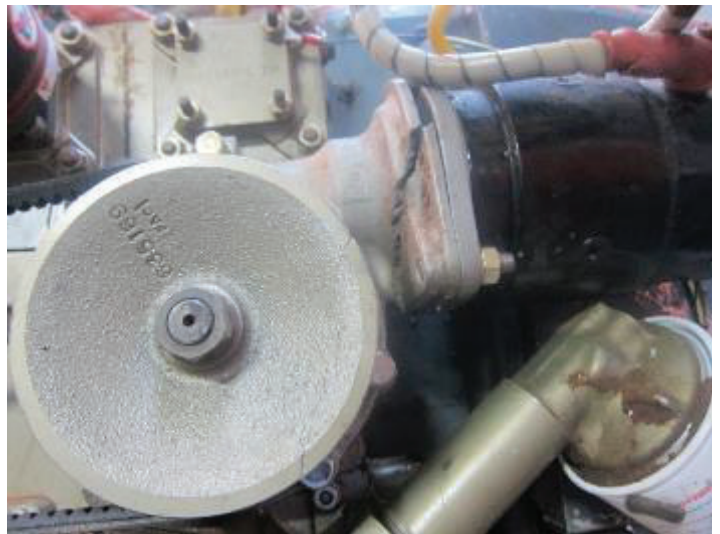
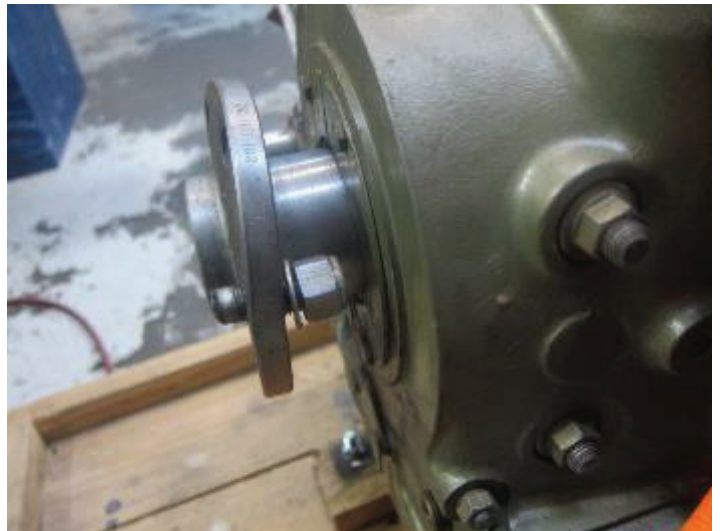
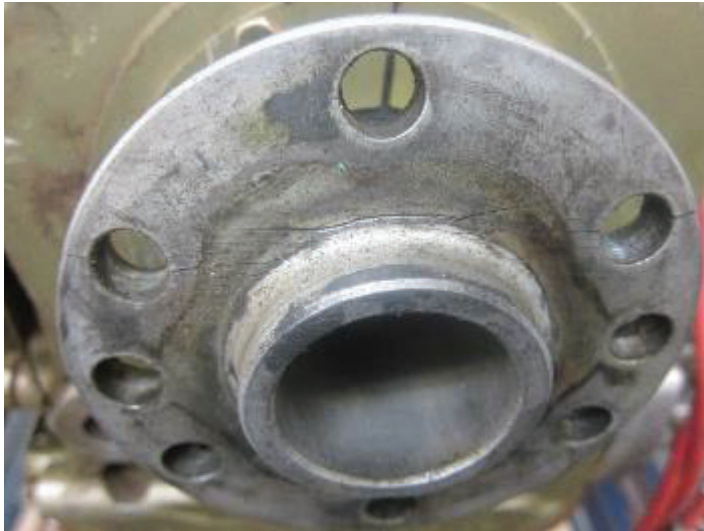
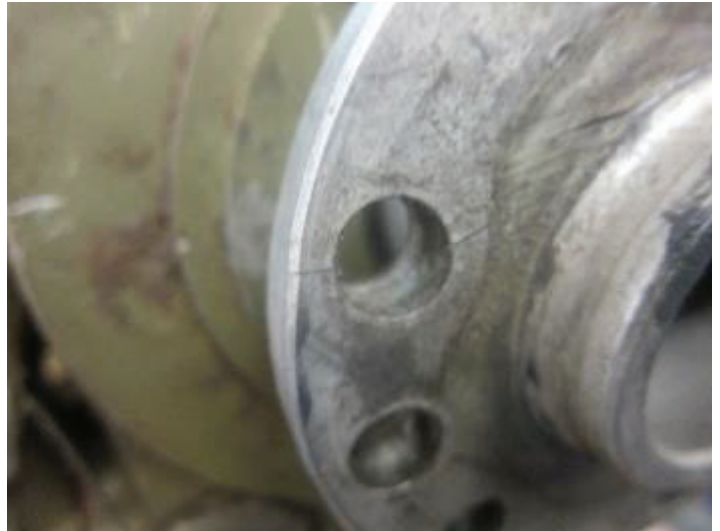
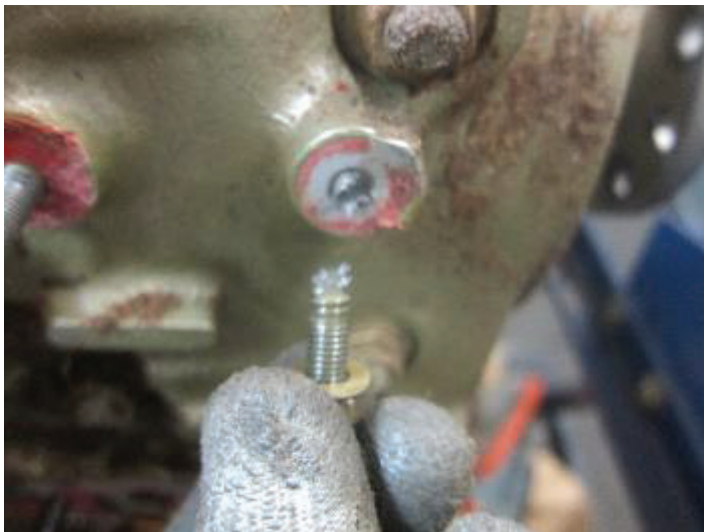
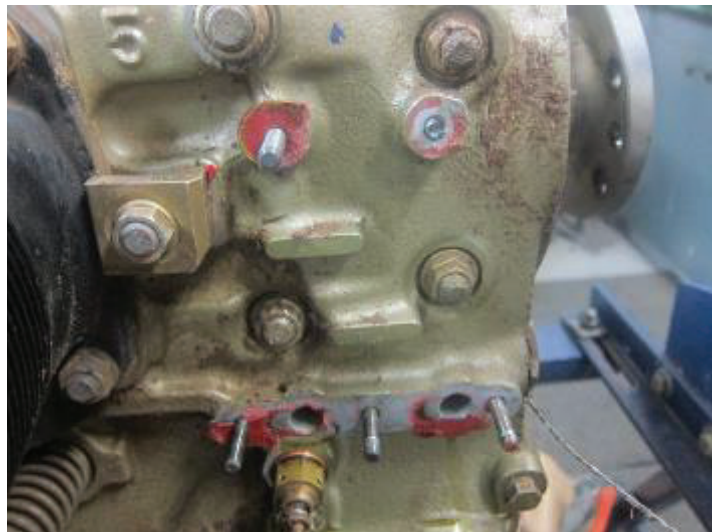
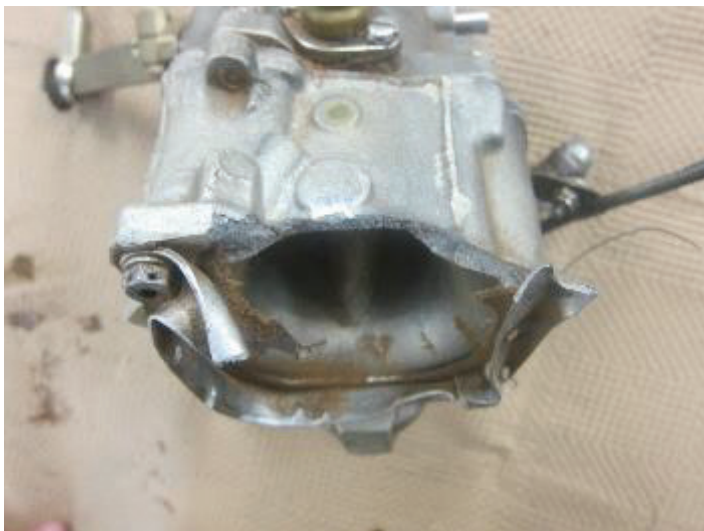
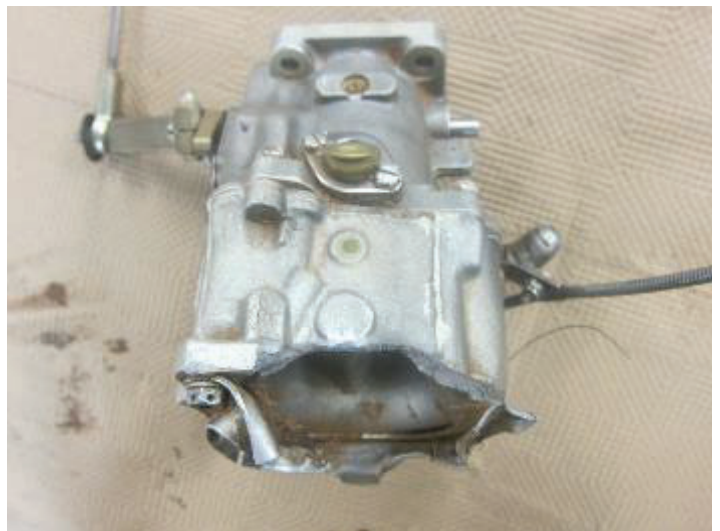
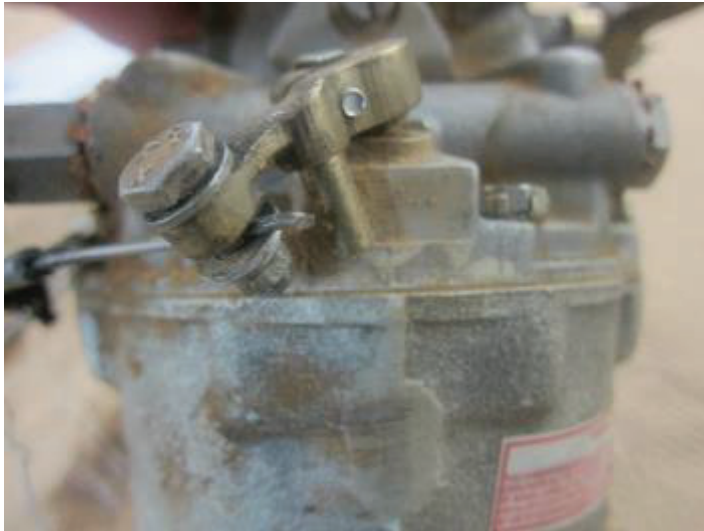
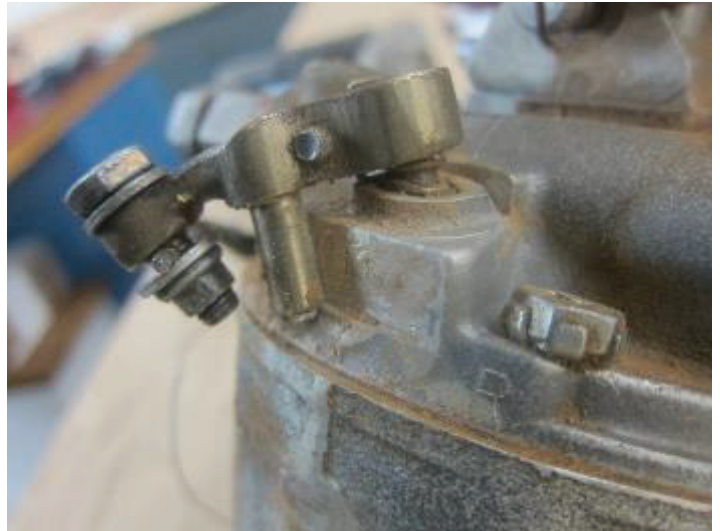
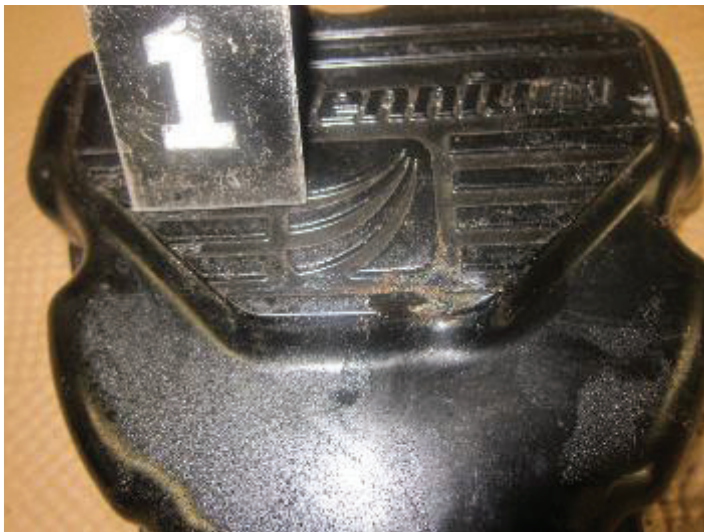
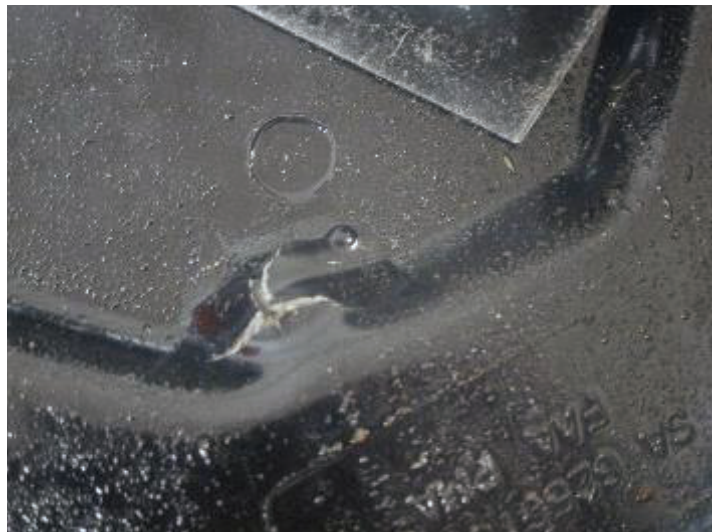
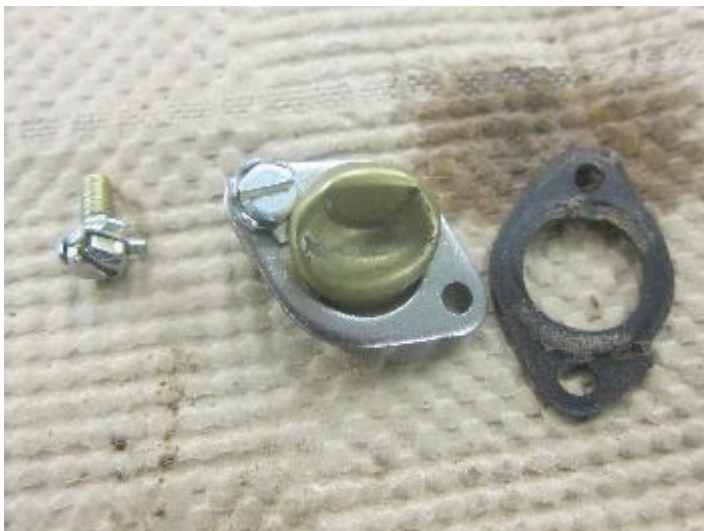
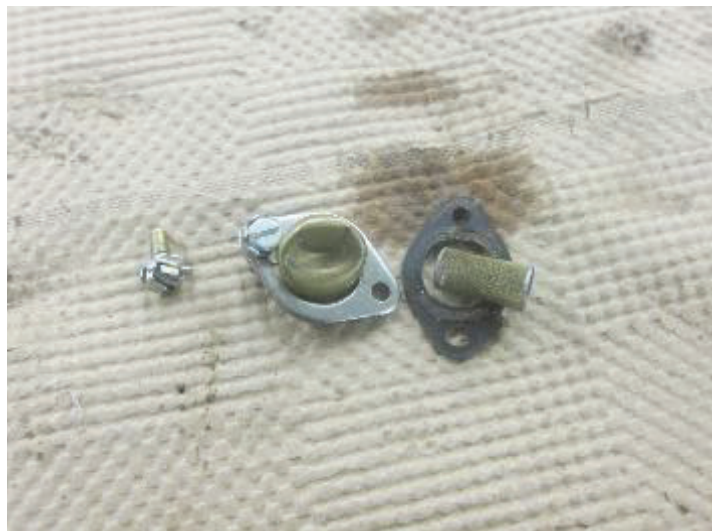
**EXTERNAL INSPECTION OF ENGINE**

The engine was removed from the shipping container and installed on the assembly stand. The oil sump was impact damaged but was able to be used for the test run. Number one rocker box cover was impact damaged. The oil cooler plate had a broken mount stud that was replaced for the engine run. All four mount legs were broken and replaced. The started adapter flange was fractured, a slave starter adapter was used for the test run. The crankshaft flange was bent and cracked. A replacement flange was welded on the end of the crankshaft for the test. The balance tube was impact damaged and replaced. The carburetor was impact damaged and the lower flange fractured. The air screen housing was impact damaged and replaced. The original fuel injection system was removed, and a carburetor was installed per an STC.
