# NATIONAL TRANSPORTATION SAFETY BOARD

## Portable Electronic Devices

### Specialist's Factual Report By Sean Payne

Location: Odanah, WI  
Date: October 29, 2018  
Aircraft: Eurocopter AS350  
Registration: N910S  
Operator: Enbridge Energy Co Inc  
NTSB Number: CEN19FA018

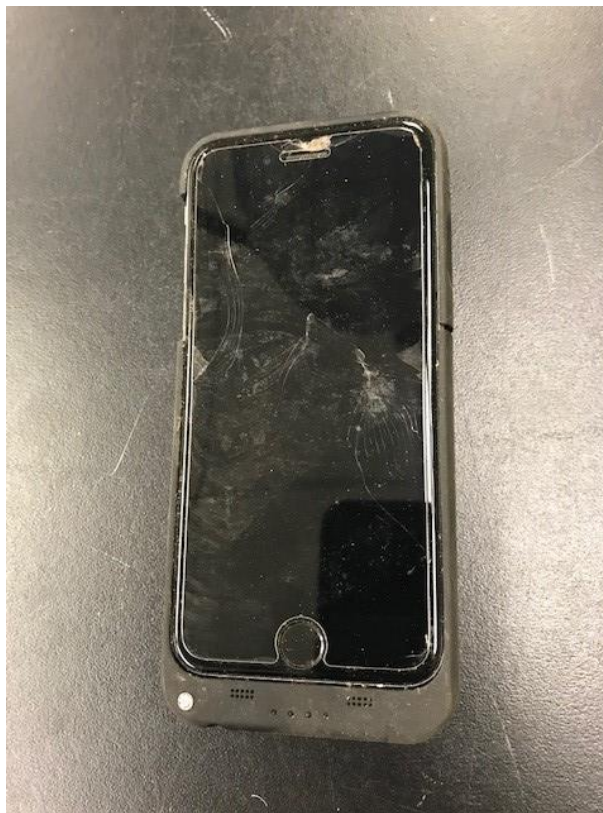
The iPhone 6s showed signs of impact damage. The device was bent and the screen was cracked, however, the device powered normally. The device was managed by the pilot's employer and a remote unlock signal was sent to unlock the phone. The device functioned normally and a data extraction was performed using forensic software. Figure 1 is a photo of the device.

**Figure 1. Photo of damaged iPhone 6s.**

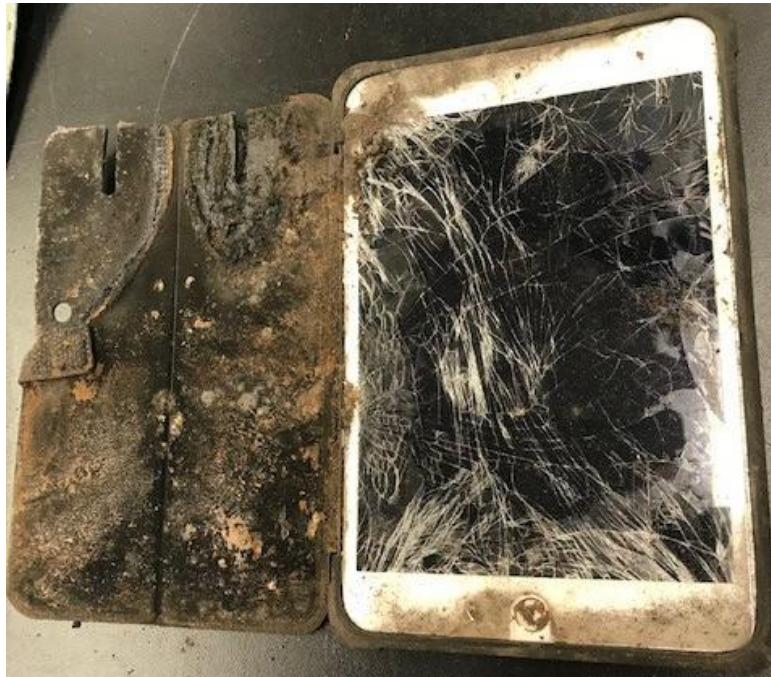
The iPad Mini 4 showed signs of impact damage. The device was non-functional. The arrival state of the device is shown in figure 2. The device was cleaned and the memory board was extracted. The memory board was placed in a surrogate device and the surrogate device was unable to power. Repairs were made to the main board, and the

device became functional in a surrogate. Upon powering, the device was locked with a passcode. The passcode was unable to be determined and no data was recovered.

**Figure 2. Photo of damaged iPad Mini 4.**

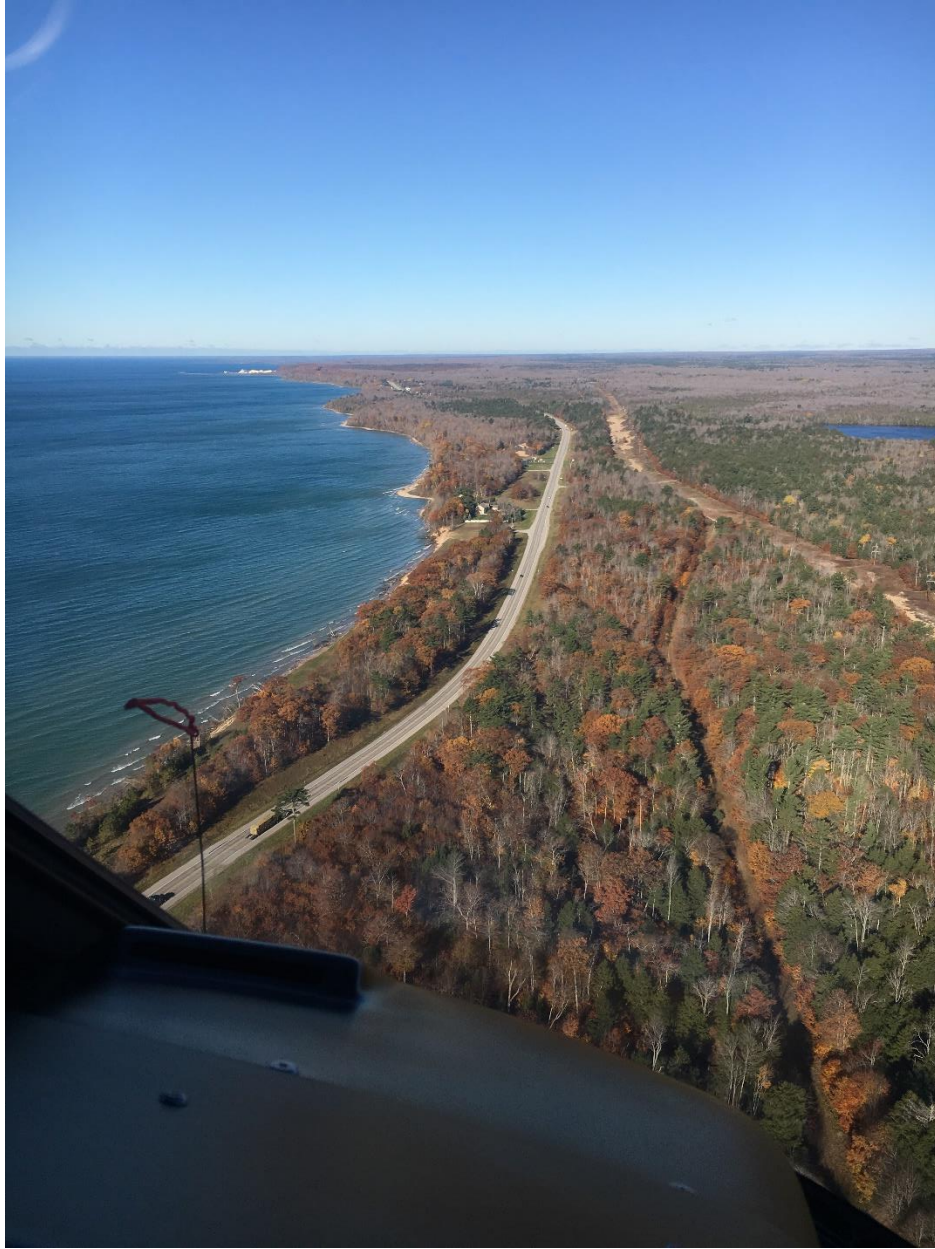
**Figure 11. IMG\_7469.JPG**

In an conversation with an unknown individual on the day of the accident at 11:20 local time, the accident pilot sent IMG\_7469.JPG. The individual responded, "Ahhh very nice" then stated that he missed a call from the accident pilot at 11:28 local time. The unknown individual said via text that he would call back the accident pilot.
