# NATIONAL TRANSPORTATION SAFETY BOARD

### Specialist's Factual Report

#### 1. EVENT SUMMARY

Location: Broomfield, Colorado  
Date: November 2, 2018  
Aircraft: MUSTANG II  
Registration: N287BM  
Operator: Private  
NTSB Number: CEN19FA022

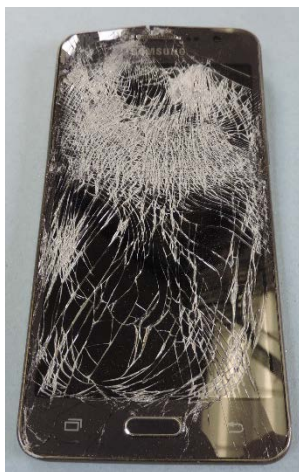
Upon arrival at the Vehicle Recorder Division, an exterior examination revealed the unit had sustained impact damage, as shown in Figure 1. The device was unable to power on normally and the main board was removed and installed in a surrogate device. The device's content was reviewed and it was determined that there were no data pertinent to the accident investigation.

**Figure 1. Photo of damaged Samsung Galaxy Prime as received.**

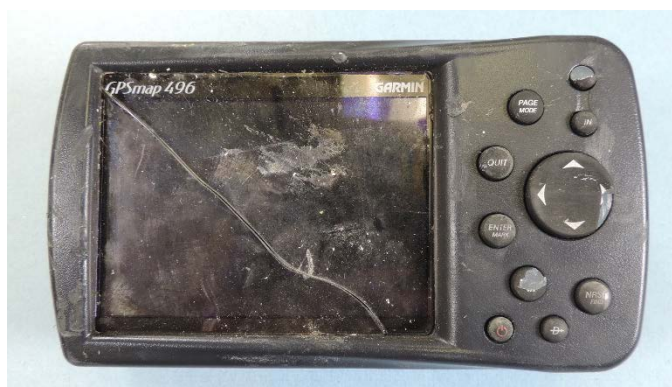
Upon arrival at the Vehicle Recorder Laboratory, an exterior examination revealed the unit has sustained impact damage, as shown in Figure 2. The device did not power on normally. The non-volatile memory chip was removed and data were downloaded and converted to engineering units using laboratory equipment.

Figure 2. Photo of damaged Garmin GPSMAP 496 as received.

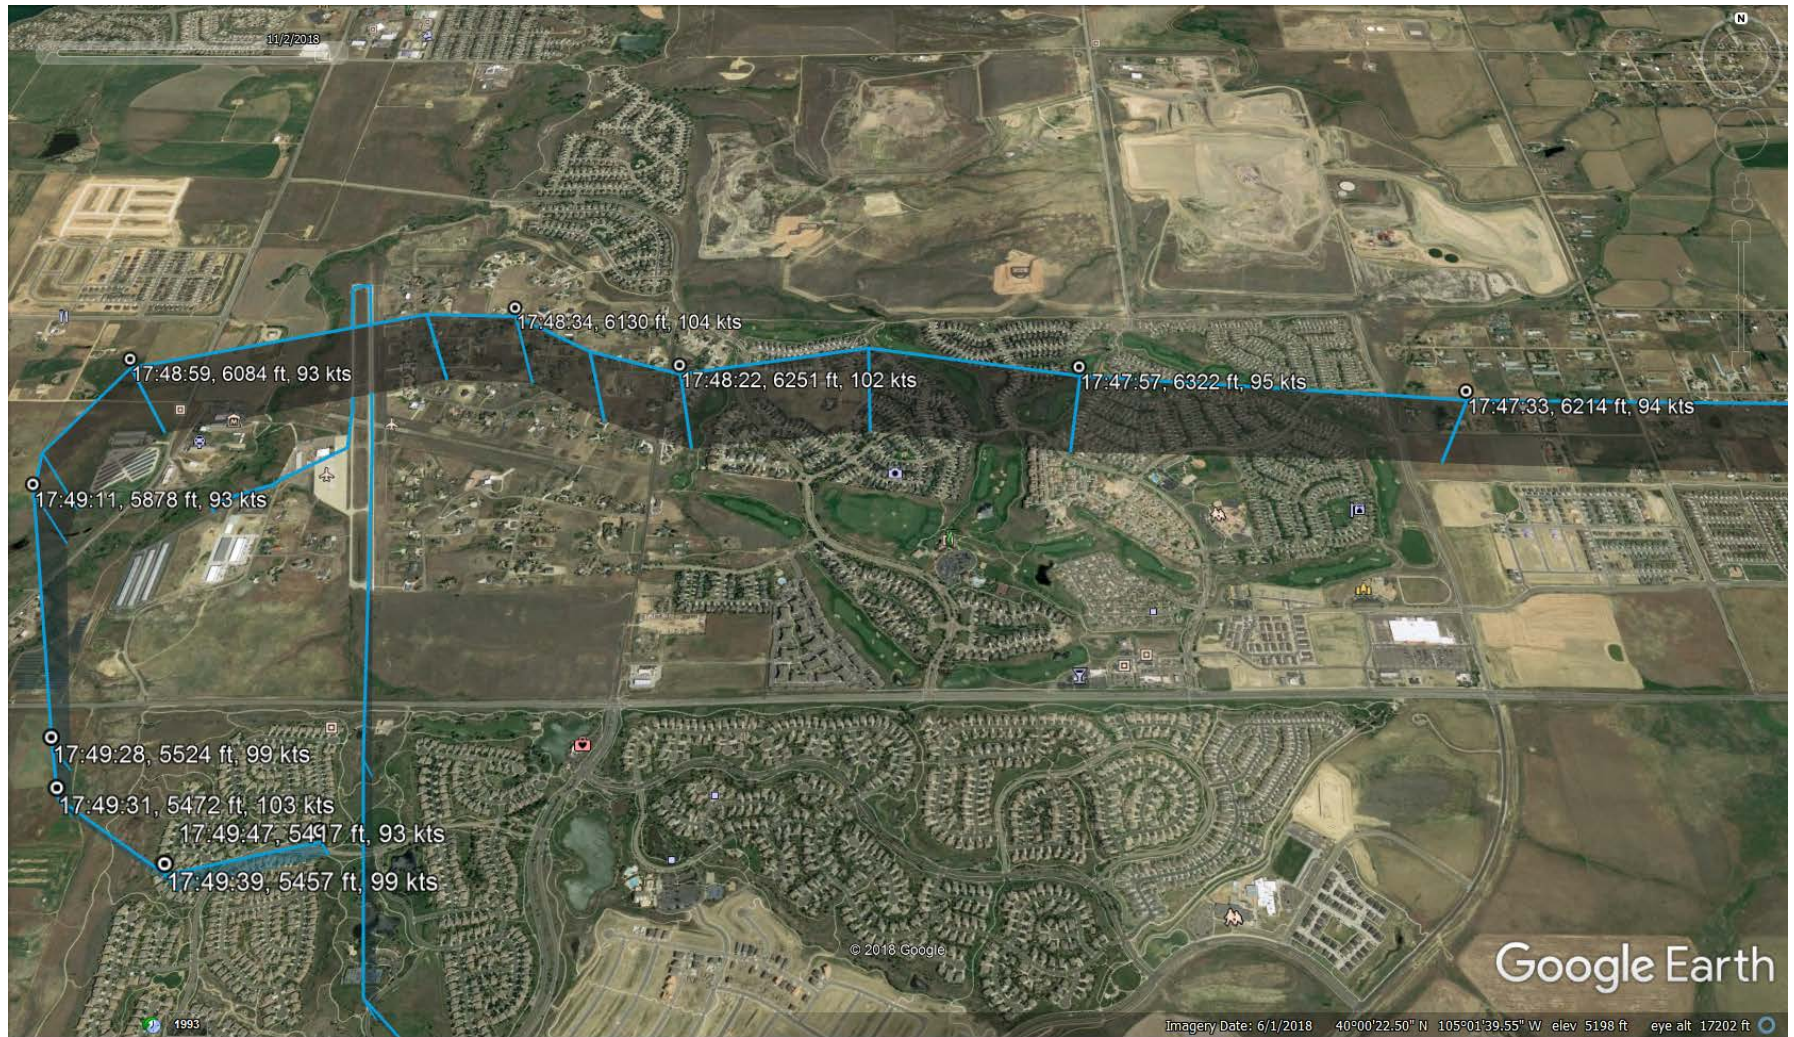
Figure 4 is a graphical overlay generated using Google Earth at the end of the accident flight.

Figure 4. Google Earth overlay at the end of the accident flight.

Tabular data used to generate figures 3 and 4 are included as attachment 1 to this report in electronic comma-delimited (.CSV) format.
