# NATIONAL TRANSPORTATION SAFETY BOARD

## Personal Electronic Devices (PED)

Specialist's Factual Report

| Aircraft: | Cessna 441, N441CX |

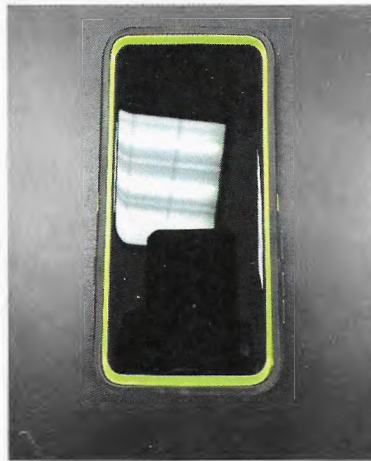
The phone was not immediately available to the NTSB post-accident. Instead, a family member of the deceased had the PED in their custody. The phone was damaged in the accident. The NTSB did not have custody of the phone and was unable to document the damage of the phone. The family member paid a third-party company to have the phone repaired. The NTSB received the phone on April 22, 2019. The family member was able to provide the passcode and the PED was unlocked and was able to be forensically examined.

**Figure 1. The Samsung Galaxy S9 as received by the NTSB**

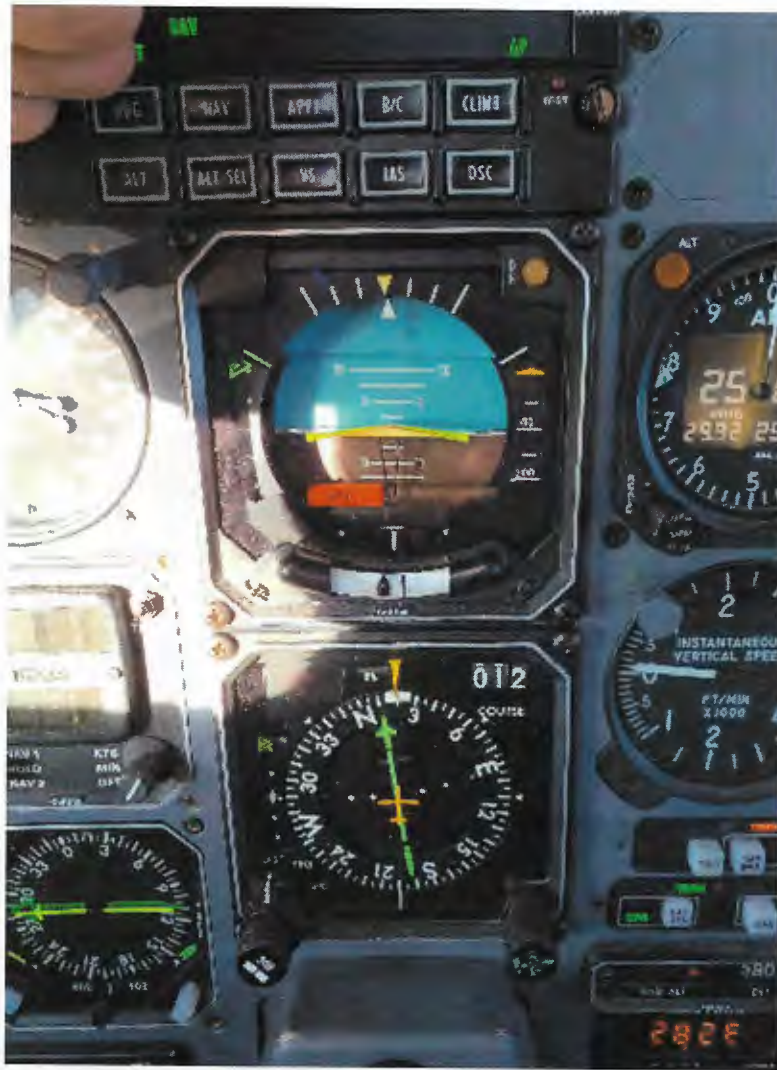
In referencing a flight on the accident airplane on November 12, 2018 from MOT [Minot International Airport, Minot, ND] to APA [Centennial Airport, Denver, CO] "Med crew just notified me that there will be at least an hour at the hospital. Also HSI processed [preprocessed] 25 degrees from Minot to Denver and auto pilot started the jerking again!" The DOBAM then asked, "did you go into free mode". The pilot responded, "had to".

Figure 2. A photo taken on November 12, 2018 at 6:16:37 PM CST.

Three photos were discovered on the accident pilot's PED taken on the same day (November 12, 2018) that seemed to correlate with the conversation displayed above. These photos are presented as figures 2, 3 and 4 and are found at the end of this report.

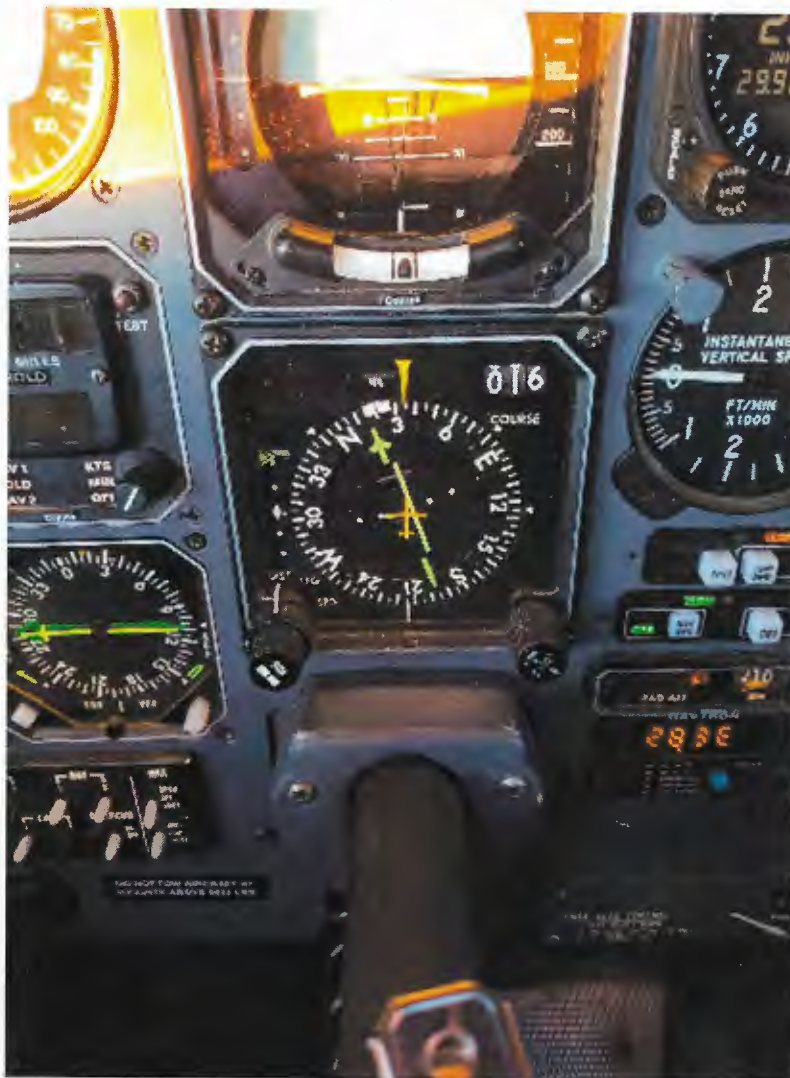
Figure 3. A photo taken on November 12, 2018 at 6:44:44 PM CST.

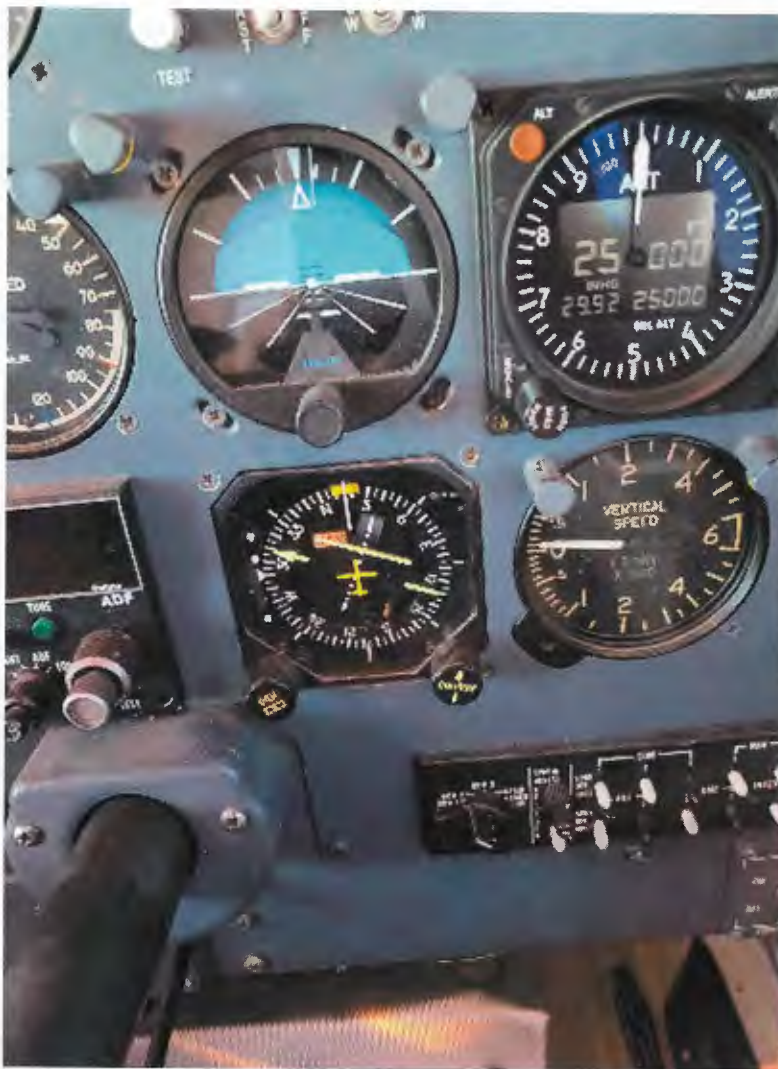
Figure 4. A photo taken on November 12, 2018 at 6:44:50 PM CST.
