## **NATIONAL TRANSPORTATION SAFETY BOARD**

### **Weather Study**

# **METEOROLOGY**

CEN19FA030

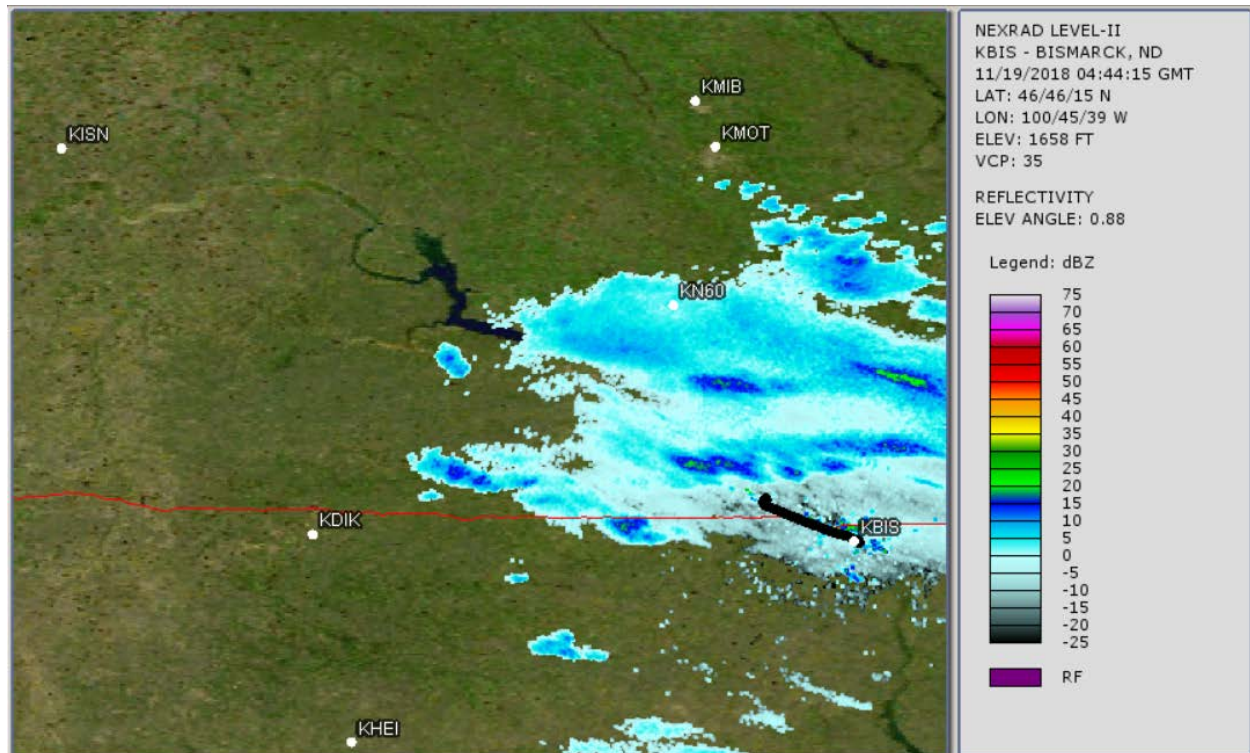
Figure 14 - KBIS WSR-88D for 2244 CST with flight track overlaid

Figure 14 is the NWS KBIS WSR-88D base reflectivity image at 2244 CST which depicted a large area of very light intensity echoes between 0 and 20 dBZ extending northwest through northeast of KBIS. The echoes were consistent with those of light snow. The flight track of N441CX is included in black.

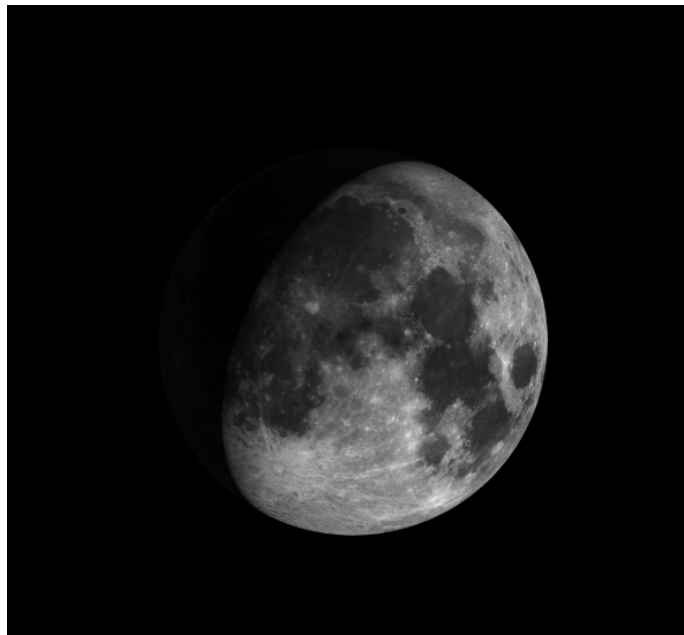
**Figure 18 - Moon phase on November 18, 2018**

On November 18, the Moon phase was a waxing gibbous as illustrated in figure 18, and at the time of the accident the Moon was about 38° above the horizon at an azimuth of 205° and was 82% illuminated above the overcast cloud layer.
