**NATIONAL TRANSPORTATION SAFETY BOARD**  
Vehicle Recorder Division  
Washington, D.C. 20594

## **Engine Data Monitor (EDM)**

**Specialist's Factual Report**  
**By Gerald Kawamoto**

Location: Kerrville, Texas  
Date: April 22, 2019  
Aircraft: Beech 58  
Registration: N501CE  
Operator: Private  
NTSB Number: CEN19FA124

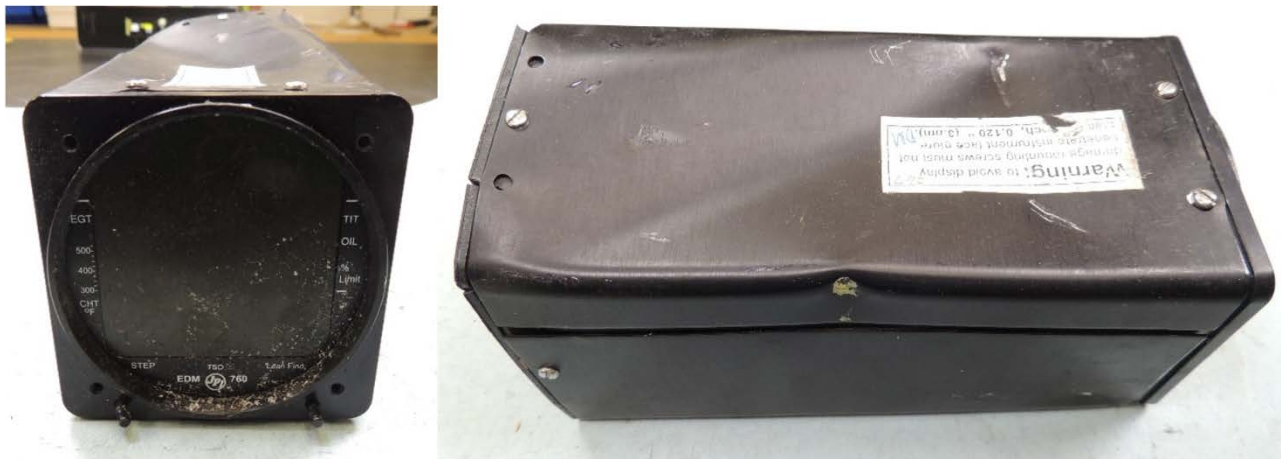
Upon arrival at the Vehicle Recorder Division, an exterior examination revealed the unit had sustained impact damage, as shown in Figure 1. The non-volatile memory chips, as shown in Figure 2, were removed and a binary image was created using laboratory tools.

Figure 1. JPI EDM-760 as received.

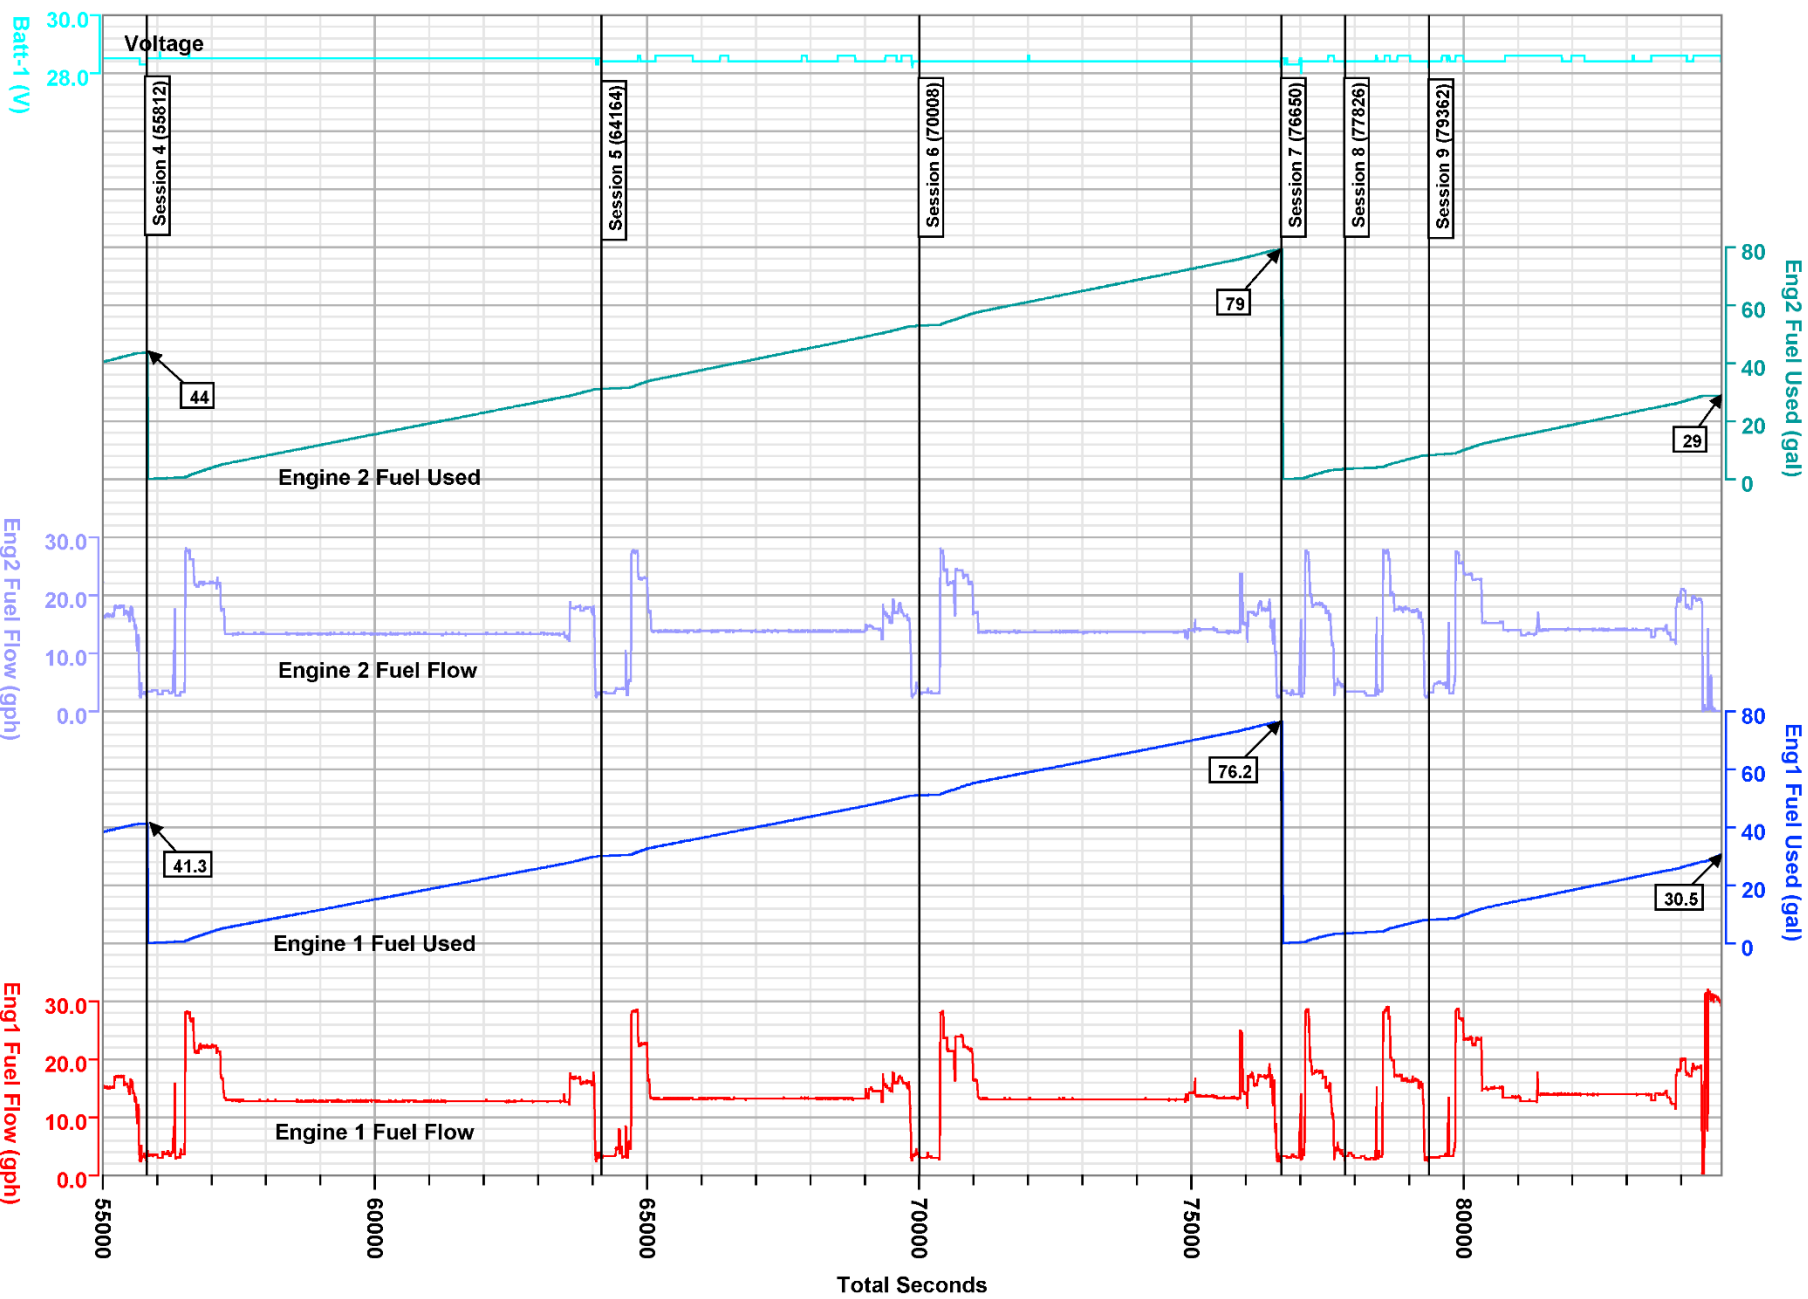
Figure 7 is a plot of Engine 1 and Engine 2 fuel parameters for the last six sessions recorded. The x-axis depicts the total seconds elapsed from the first session recorded to the JPI EDM-760's non-volatile memory. The dates and times of the sessions are summarized in Table 2.

Figure 7. Plot of Engine 1 and Engine 2 fuel parameters for the last 6 sessions recorded.

The tabular data associated with Figures 3 through 6 from the accident flight recorded by the JPI EDM-760 device is included as Attachment 1. The tabular data associated with Figure 7 is included as Attachment 2. These attachments are provided in electronic comma-delimited (.csv) format.
