# NATIONAL TRANSPORTATION SAFETY BOARD

## Electronic Devices

### Specialist's Factual Report

Location: Eagle Lake, Texas  
Date: May 11, 2019  
Aircraft: Air Tractor AT-502A  
Registration: N713LA  
Operator: ANF Air Service, Inc  
NTSB Number: CEN19FA140

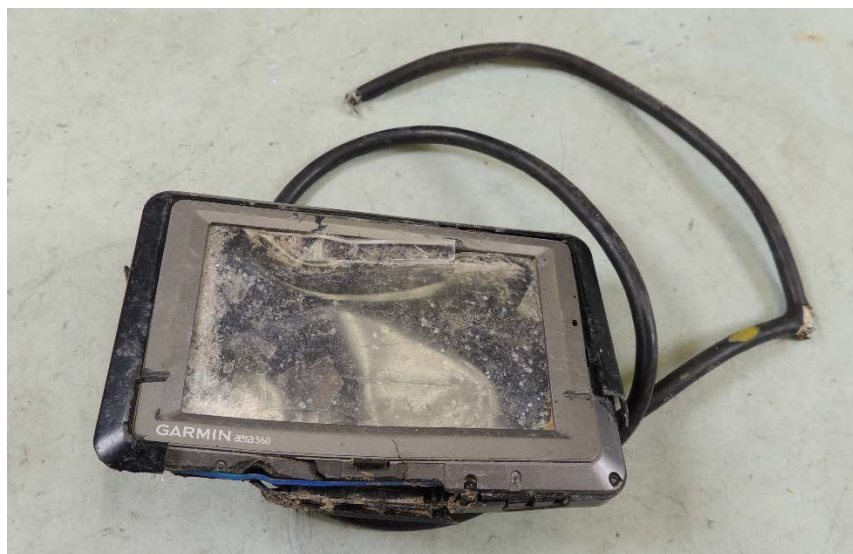
Upon arrival at the Vehicle Recorder Laboratory, an exterior examination revealed the unit had sustained impact damage, as shown in Figure 1, resulting in the device becoming inoperable. The NVM chip was removed, read out, and converted to engineering units using laboratory equipment.

**Figure 1. Garmin Aera 560 as received.**

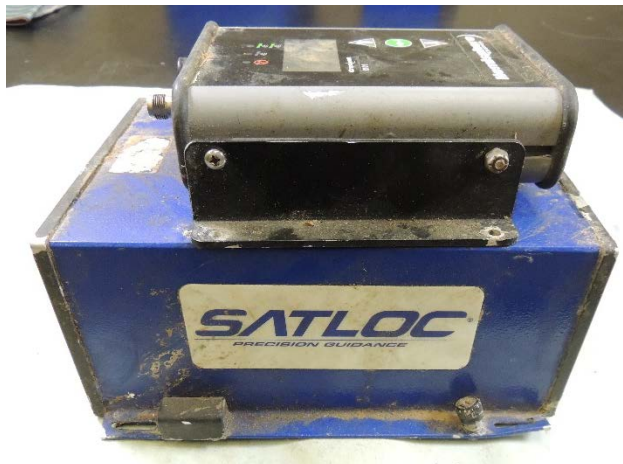
Upon arrival at the Vehicle Recorder Laboratory, an exterior examination revealed the devices had sustained minor impact damage as shown in Figures 2 and 3. The internally mounted CF card, as shown in Figure 3, was removed from the SATLOC and data was extracted normally using laboratory tools.

**Figure 2. SATLOC M3 and Hemisphere GPS R101 as received.**

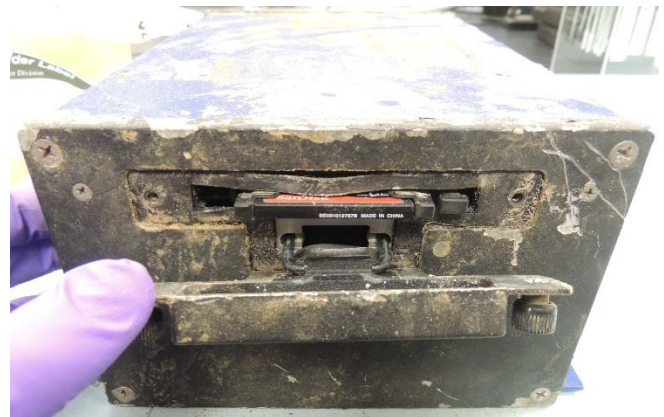
**Figure 3. CF card mounted in SATLOC M3.**

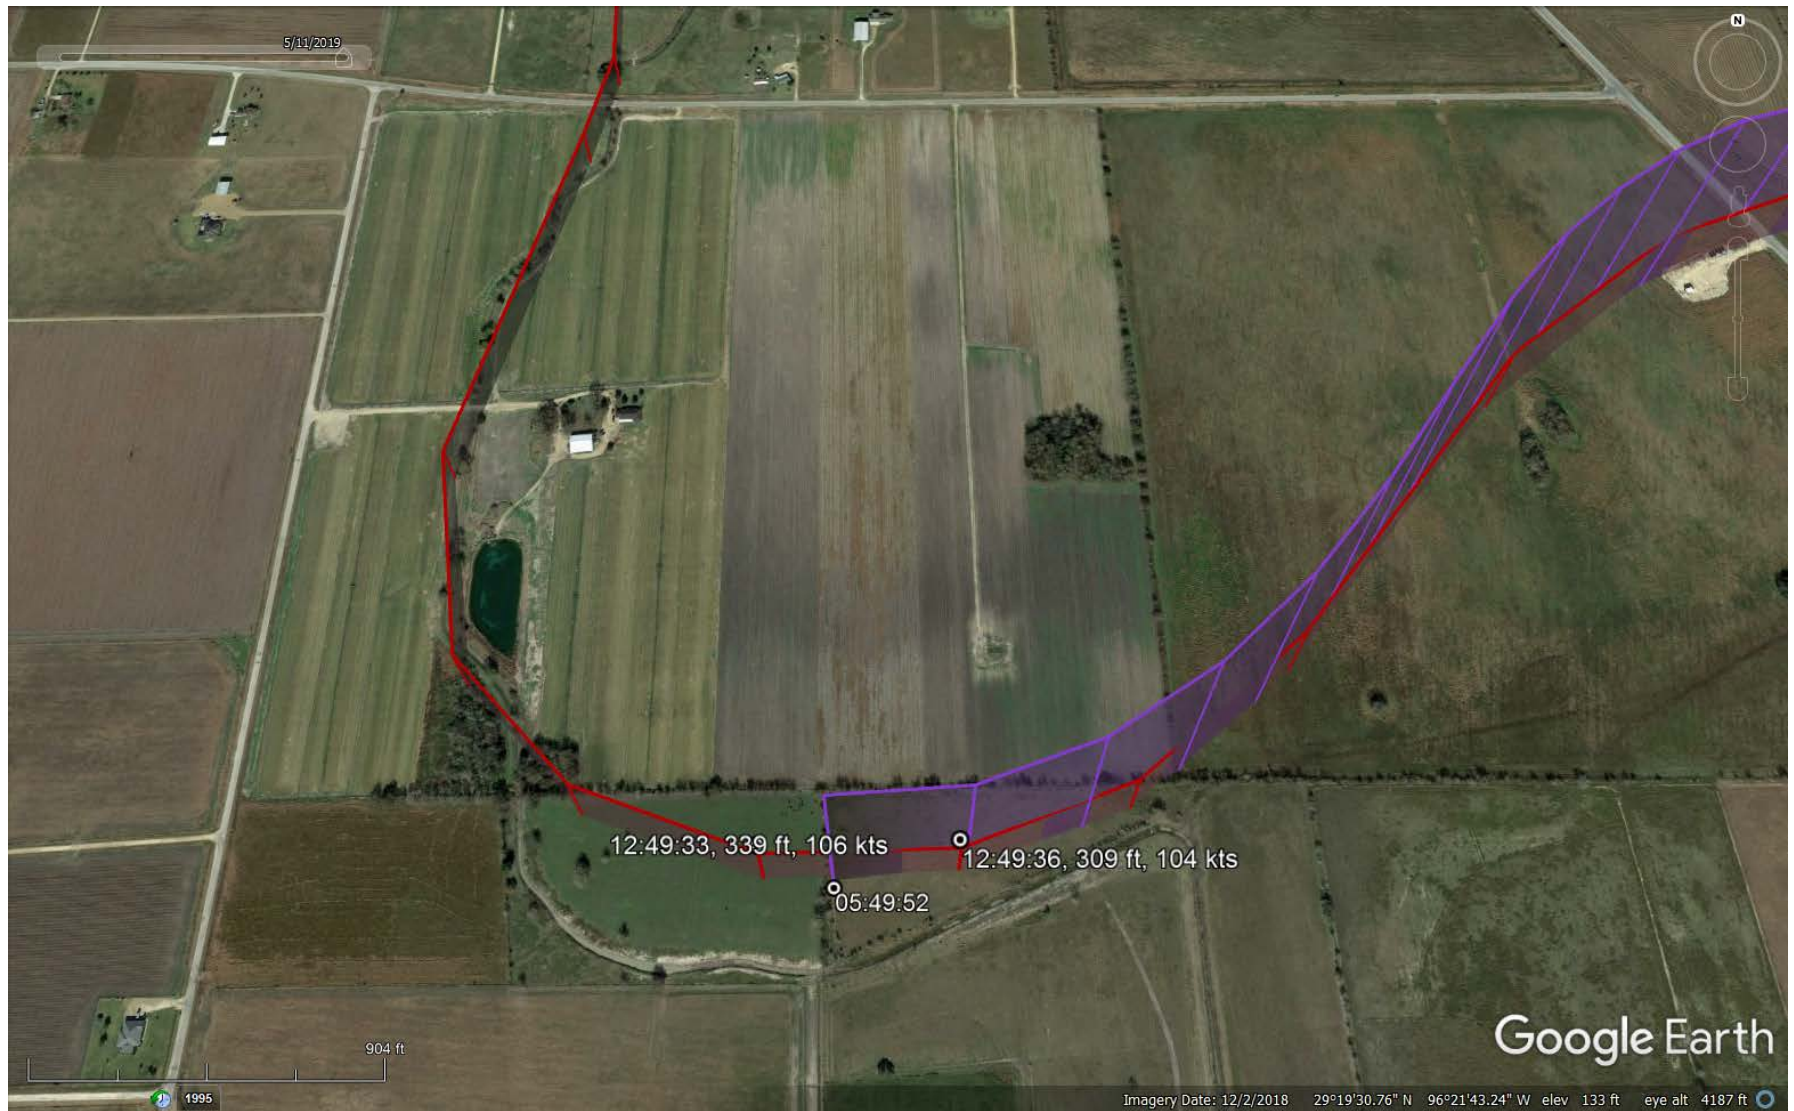
Figure 5 is a graphical overlay generated using Google Earth showing the beginning of the SATLOC recording and the time correlation between the flight tracks.

Figure 5. Google Earth overlay showing the start of the SATLOC recording.

Tabular data used to generate figures 4 through 8 are included as Attachments 1 and 2 in electronic comma-delimited (.CSV) format.

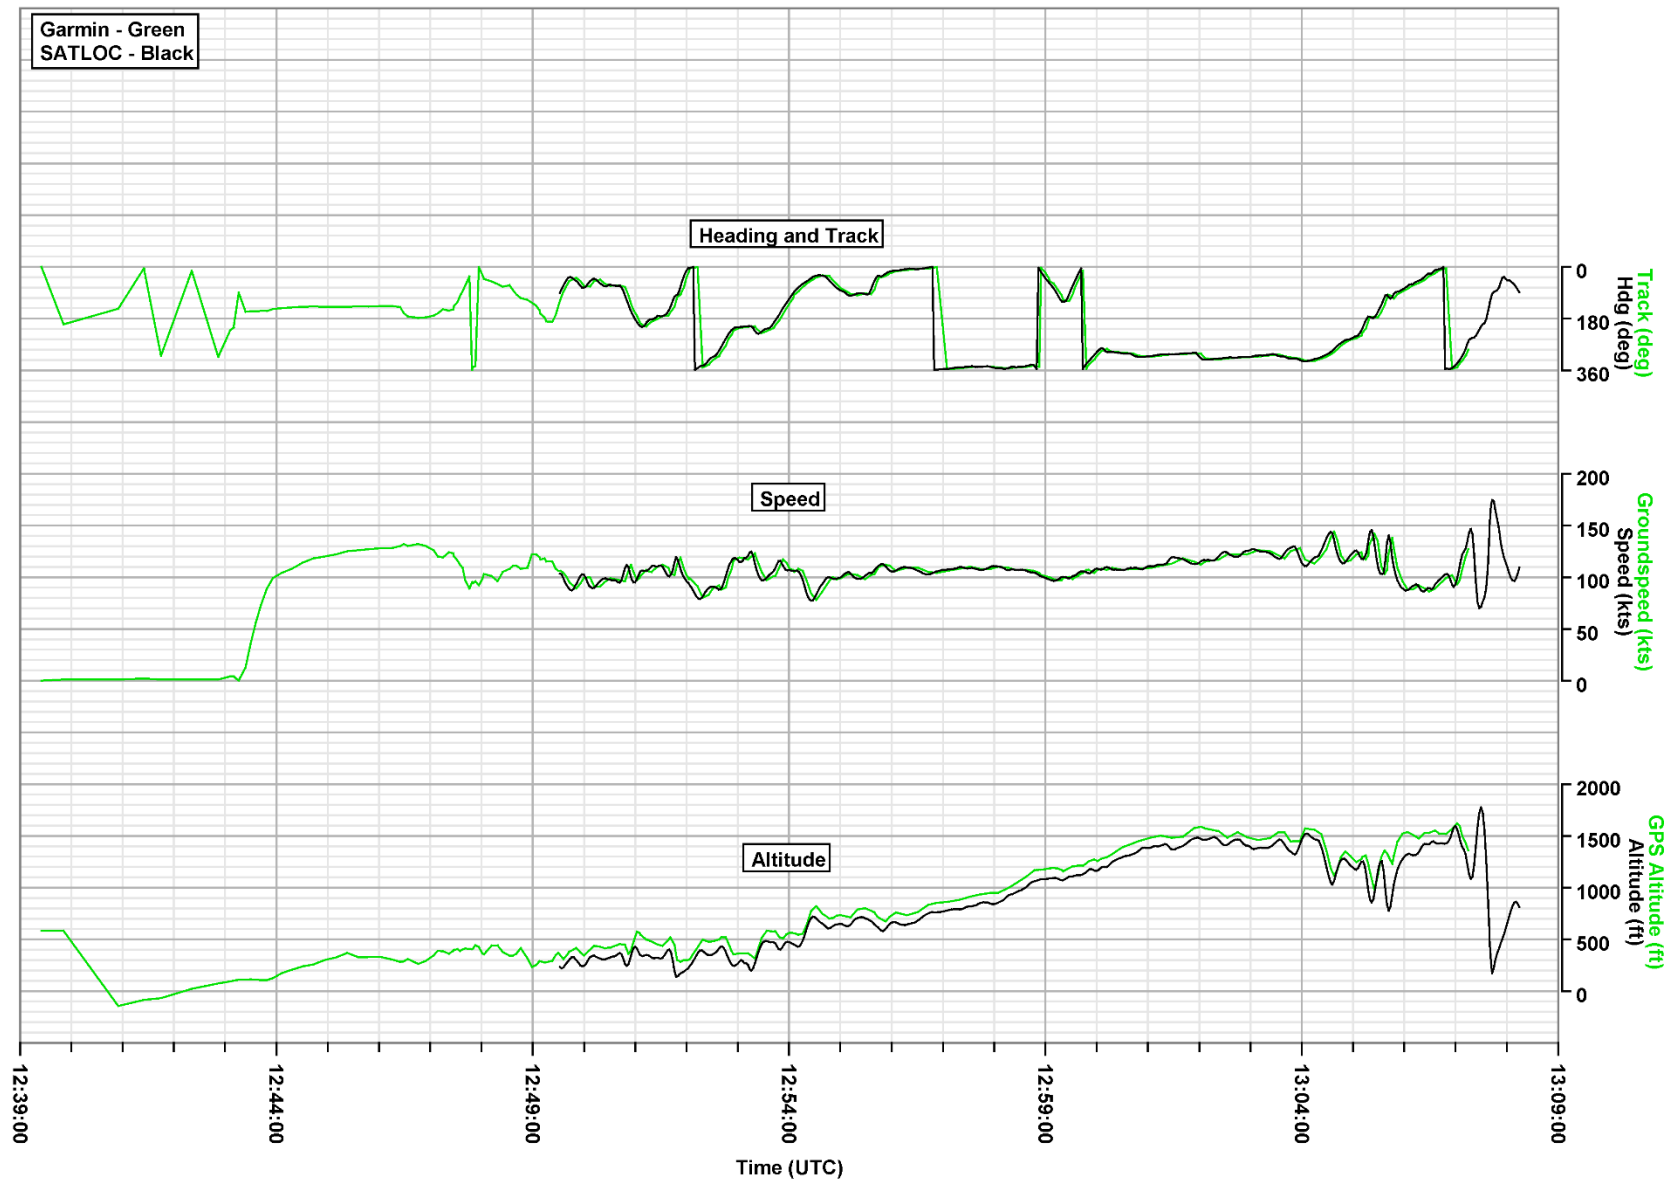
Figure 7 is a plot of parameters for the entire flight recordings from both the Garmin and the SATLOC. The Garmin is shown in green and the SATLOC is shown in black. The time interval shown is 12:39:00 UTC to 13:09:00 UTC.

Figure 7. Plot of parameters of the entire flight recordings.

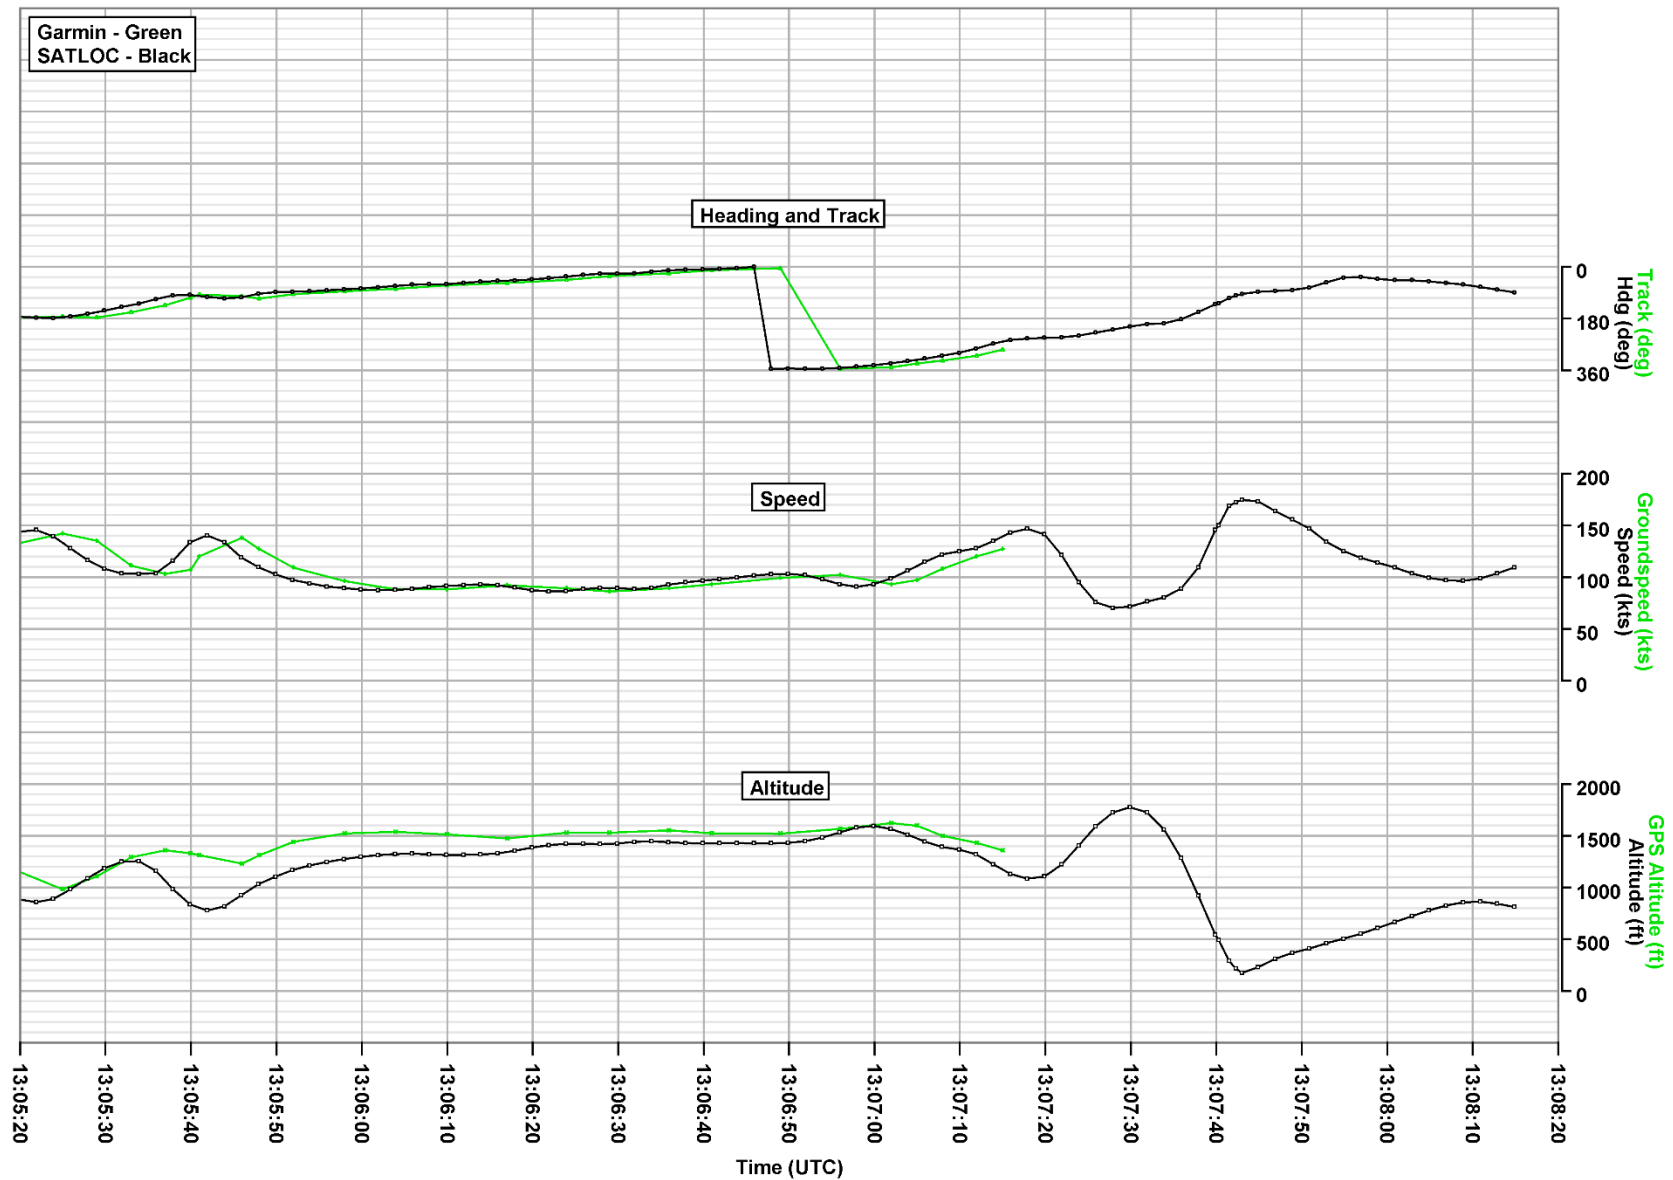
Figure 8 is a plot of parameters at the end of the flight recordings from both the Garmin and the SATLOC. The time interval shown is 13:05:20 UTC to 13:08:20 UTC.

Figure 8. Plot of parameters from the end of the flight recordings.
