**Photo 1 – Airplane at Accident Site After Fire was Extinguished (Courtesy of Owner/Operator)**

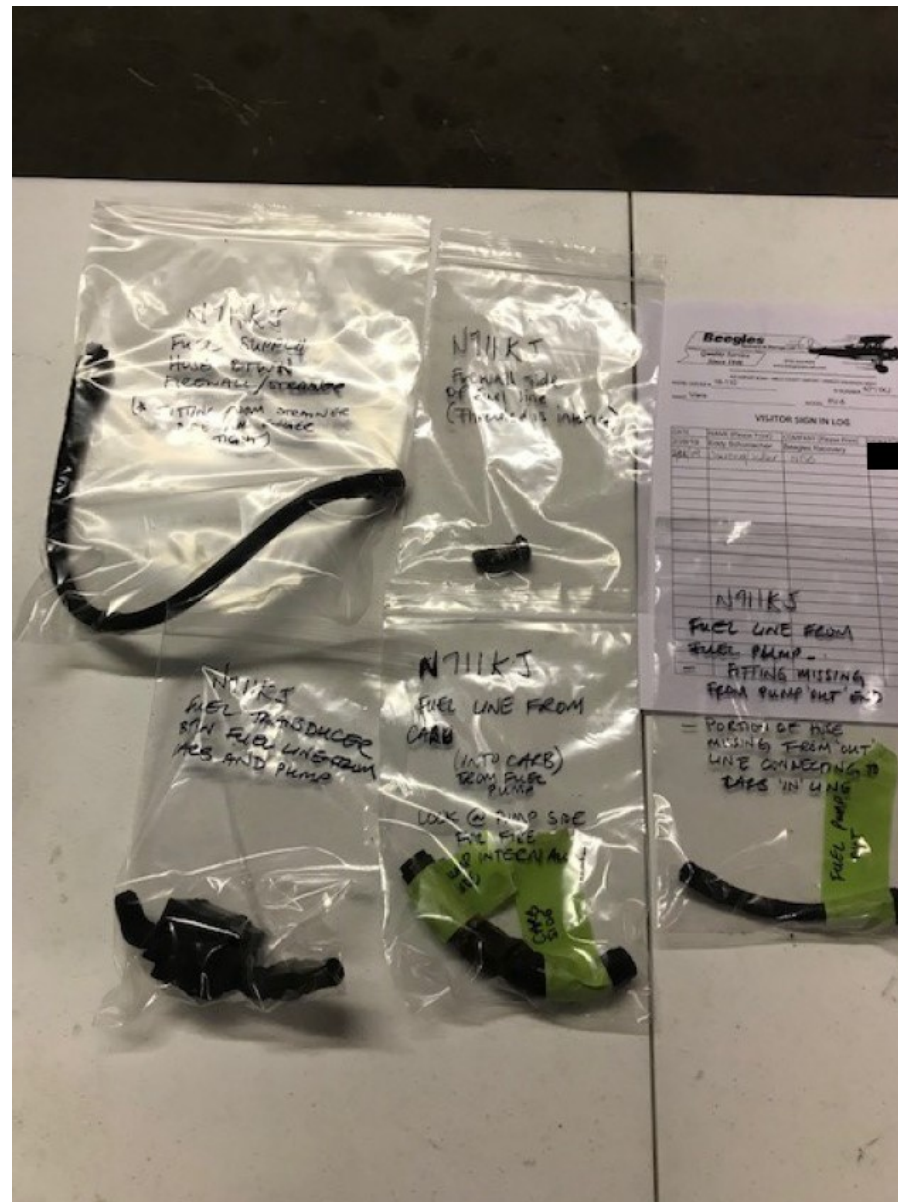
Photo 3 – Fuel Line Components collected from Accident Airplane (Courtesy of NTSB)

19-24 Nov 2018, Tach Time 994.3, Total Time 1475.3,  
Drained oil, removed filter, installed new Champion  
48110-1 Filter and 7 qts. Aeroshell 15W50 oil. Replaced all  
fuel and oil hoses with new hoses fabricated by Aviall  
Hose Shop, KAPA. Cleaned and oiled air filter.  
Replaced broken alternator output ring terminal,  
fabricated and installed alternator air blast tube. James  
Taylor A&P [REDACTED] [REDACTED]
