# NATIONAL TRANSPORTATION SAFETY BOARD

## Flight Display Factual Report

Location: Sioux Falls, South Dakota  
Date: December 25, 2018  
Aircraft: Hawker Beechcraft 58  
Registration: N6745V  
Operator: Private  
NTSB Number: CEN19LA049

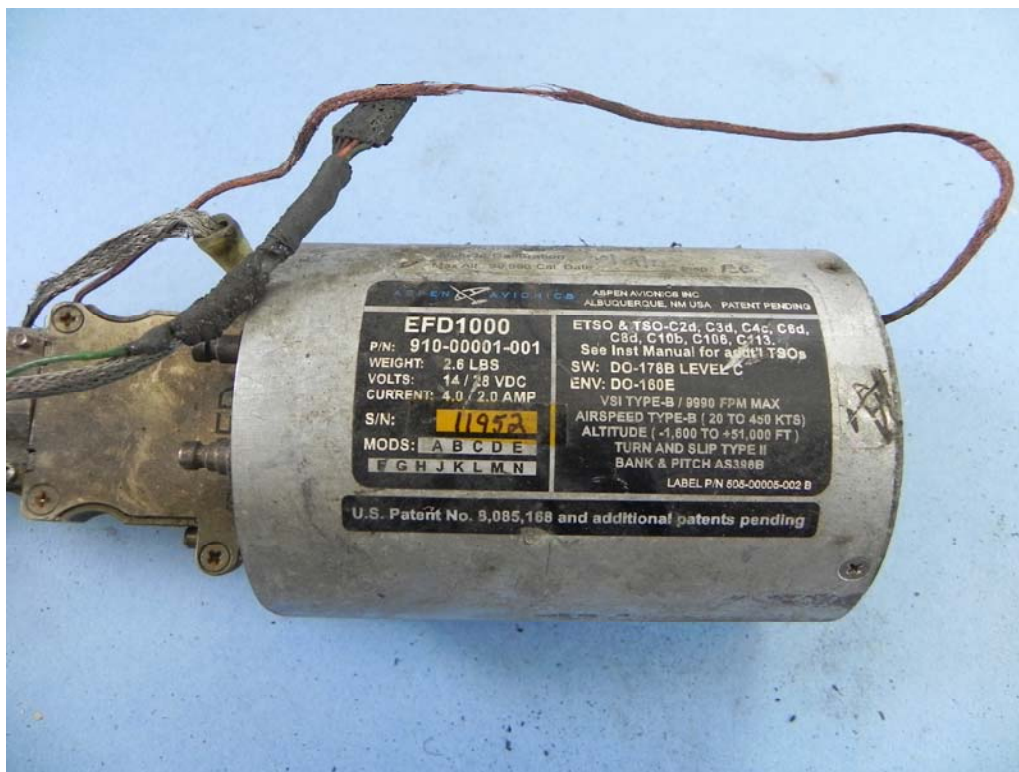
Upon arrival at the Vehicle Recorder Laboratory, an examination revealed the both devices had sustained extensive fire and impact damage. The condition of the EFD1000 Pro is shown in Figure 1 and the condition of the EFD500 is shown in Figure 2.

Figure 1. Photo of damaged EFD1000 Pro

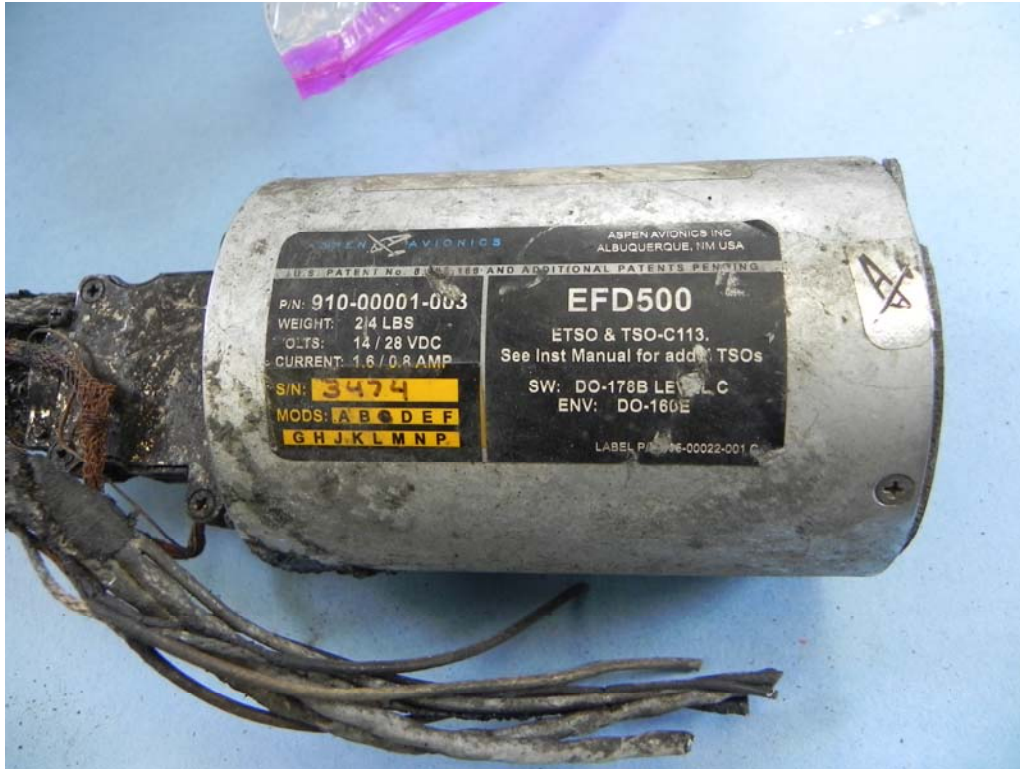
**Figure 2.** Photo of damaged EFD500
