# SERVICE LETTER

No. 910

Piper Aircraft Corporation

Engine Oil Quick Drain Valve

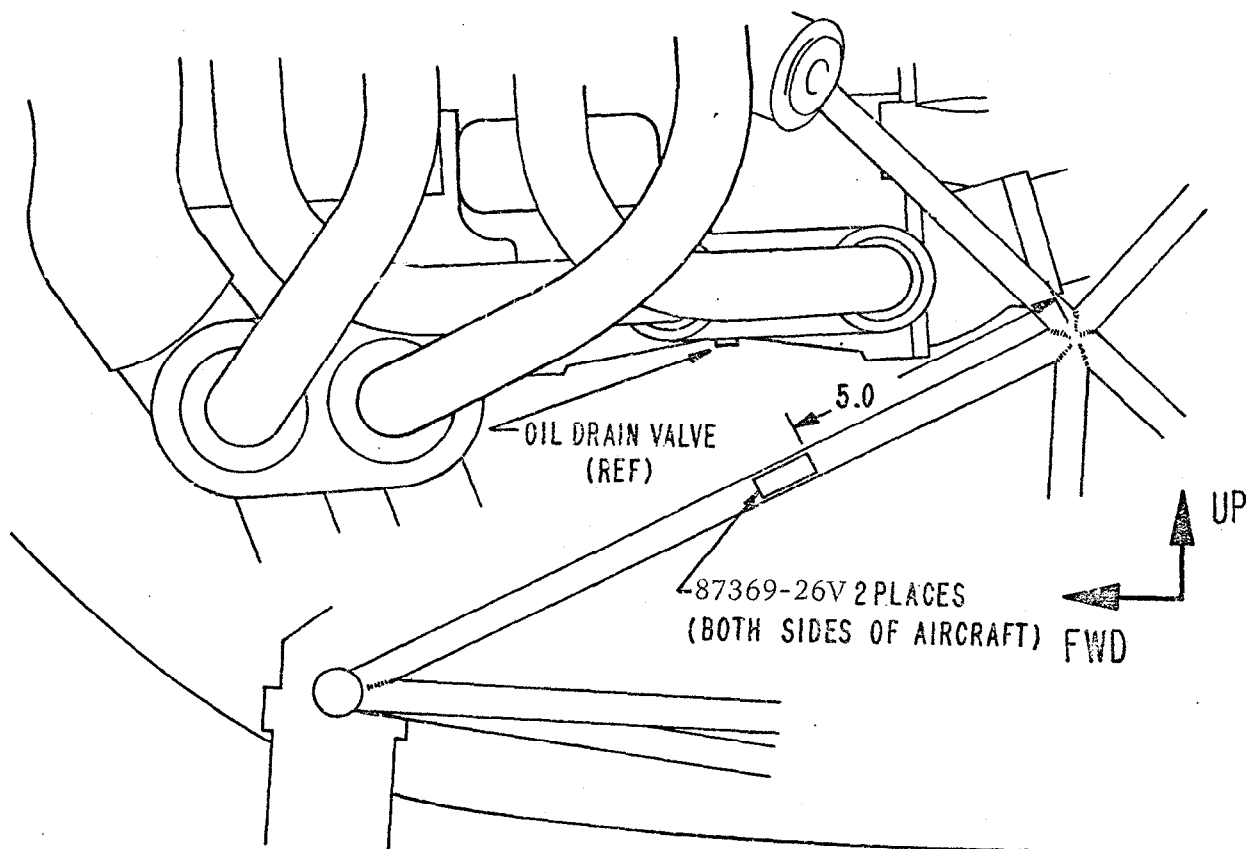
SKETCH 1

This Service Release announces the availability of warning placards (that provide precautionary information on the installation of the correct oil quick drain valve). The placards should be installed on each side of the engine mount in the area of the oil quick drain valve.

1. Gain access to the lower engine mount (beneath intake and exhaust tubes).
2. Install placard, Piper Part Number 87369-26V, two (2) places, per Sketch 1.
3. Determine if correct oil quick drain valve is installed, refer to Sketch 2.  
If incorrect valve is installed, remove incorrect valve and install correct valve, Piper Part Number 492 172V, and safety wire, using .032 safety wire.
4. Re-install items removed in Instruction 1 and make appropriate log book entry of compliance with this Service Release.

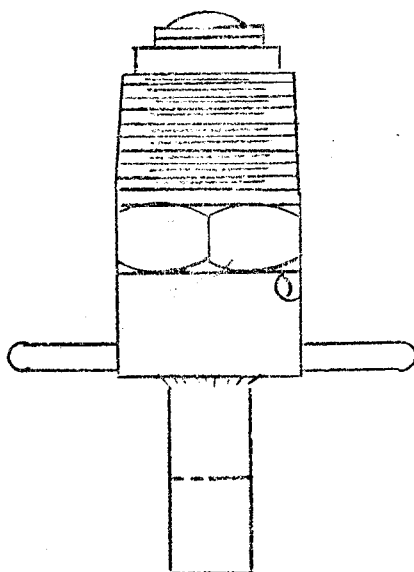
Incorrect Oil Quick Drain Valve

Do Not Use This Oil Quick Drain Valve

On Any PA-28R-200; PA-28R-201; or PA-28RT-201
