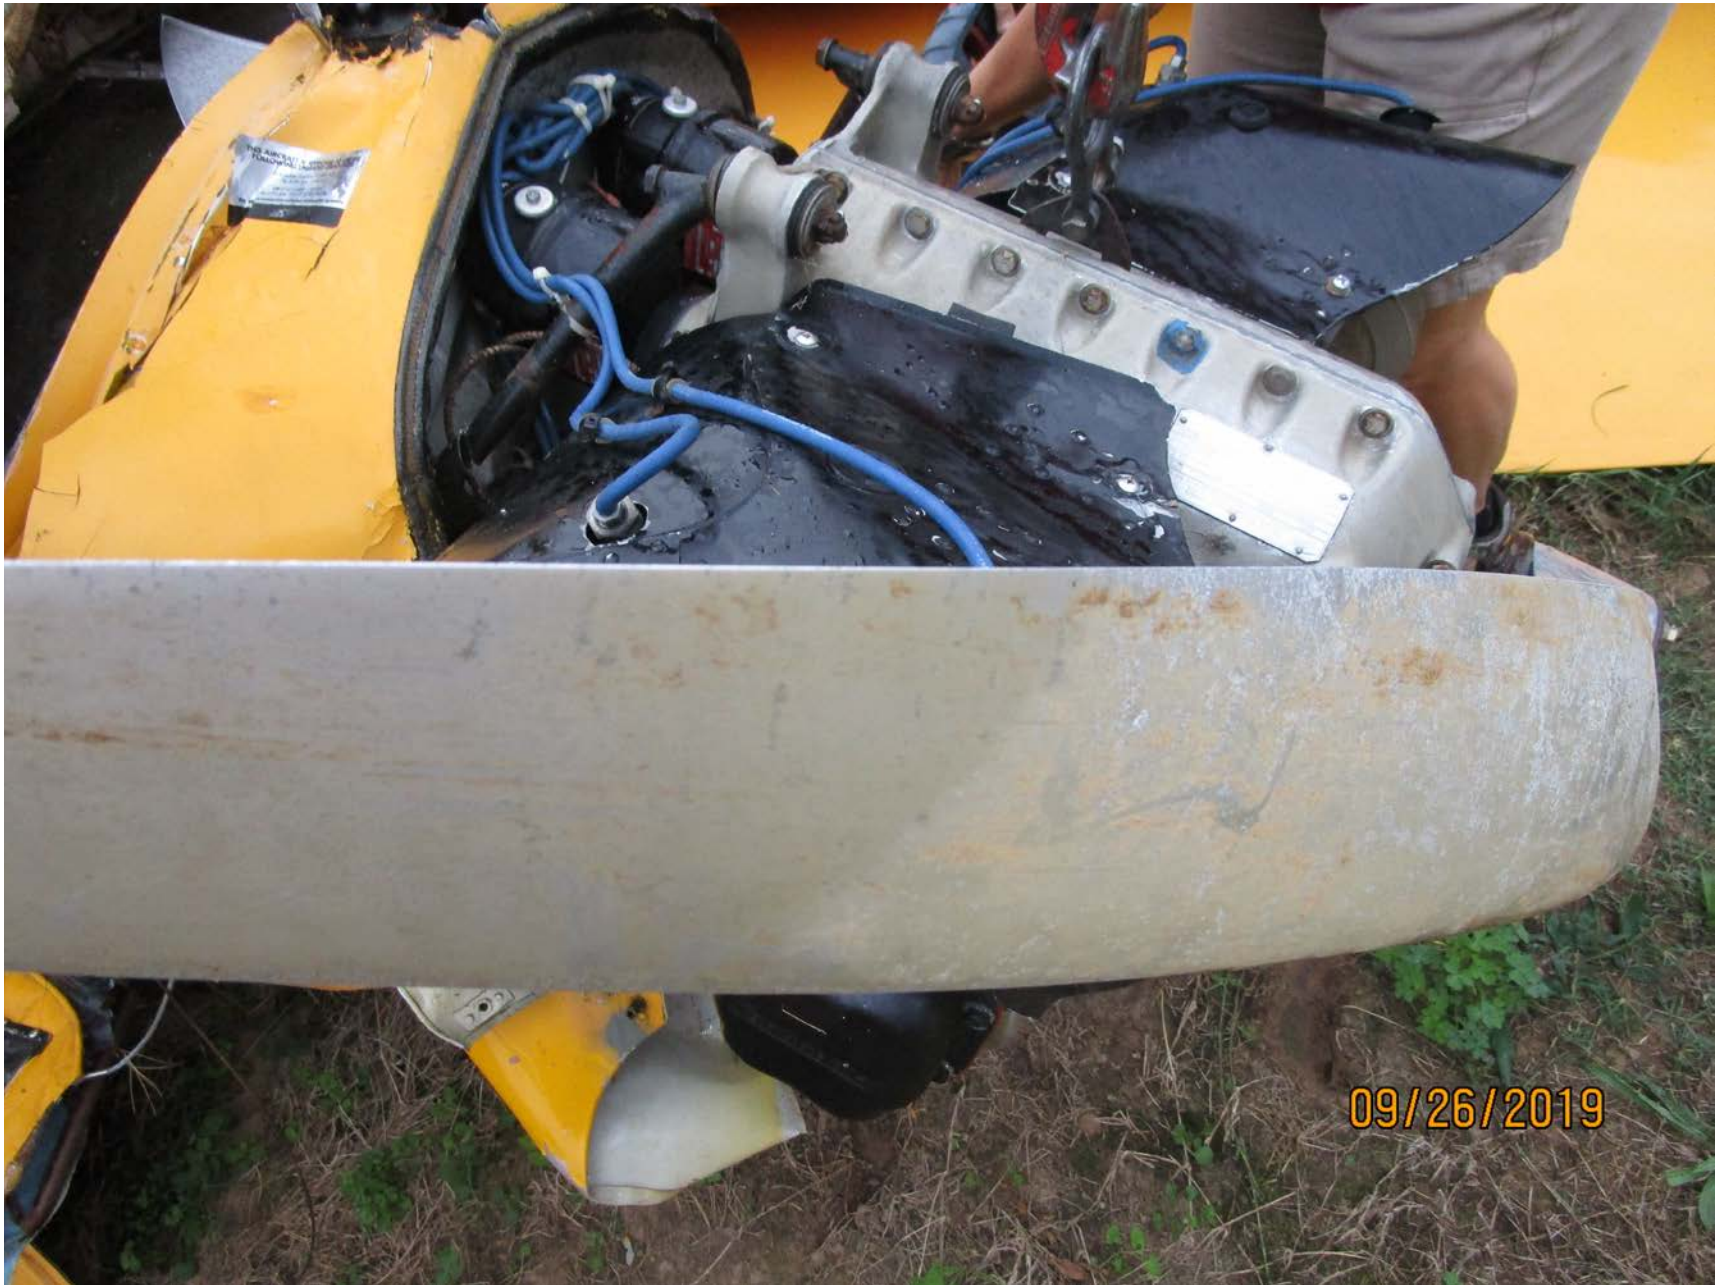
**Photo 1 – View of chordwise abrasion on a propeller blade.**

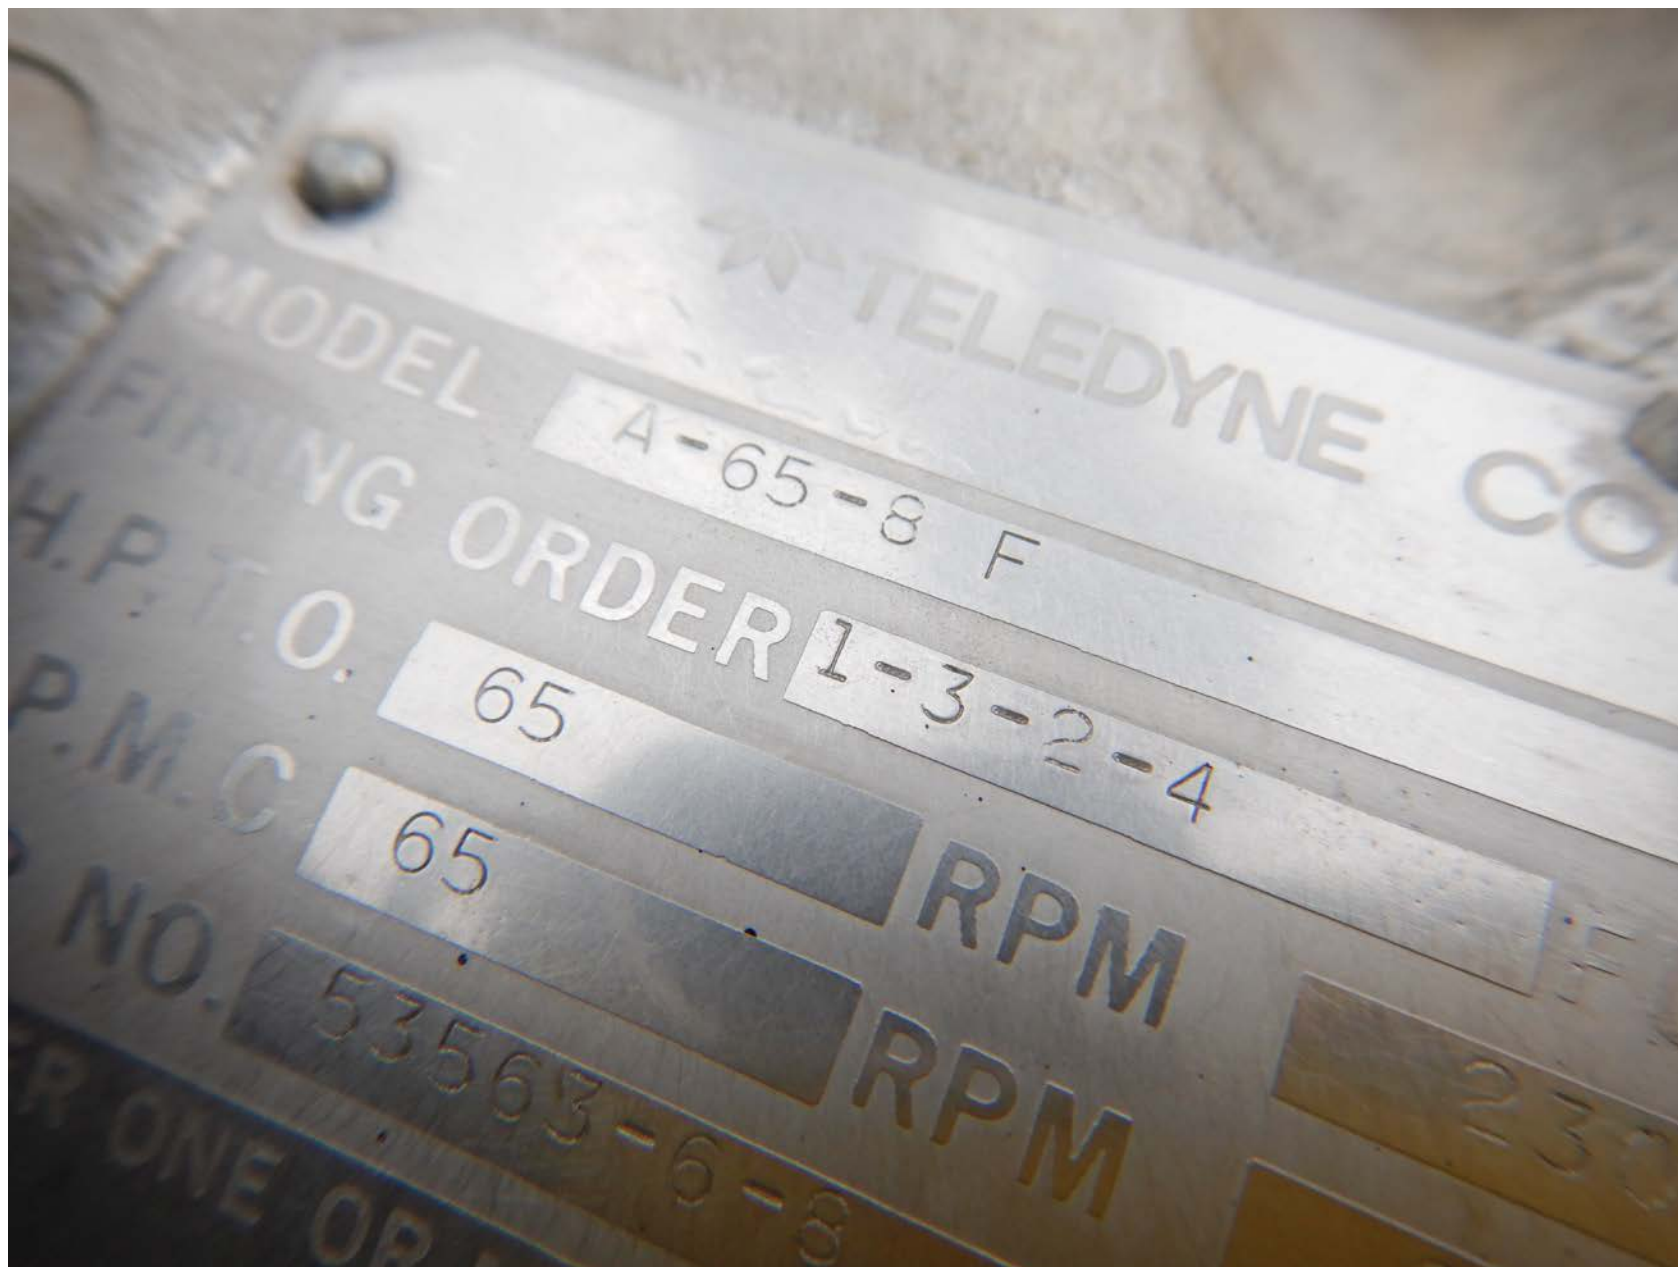
Photo 2 - View of the data plate.

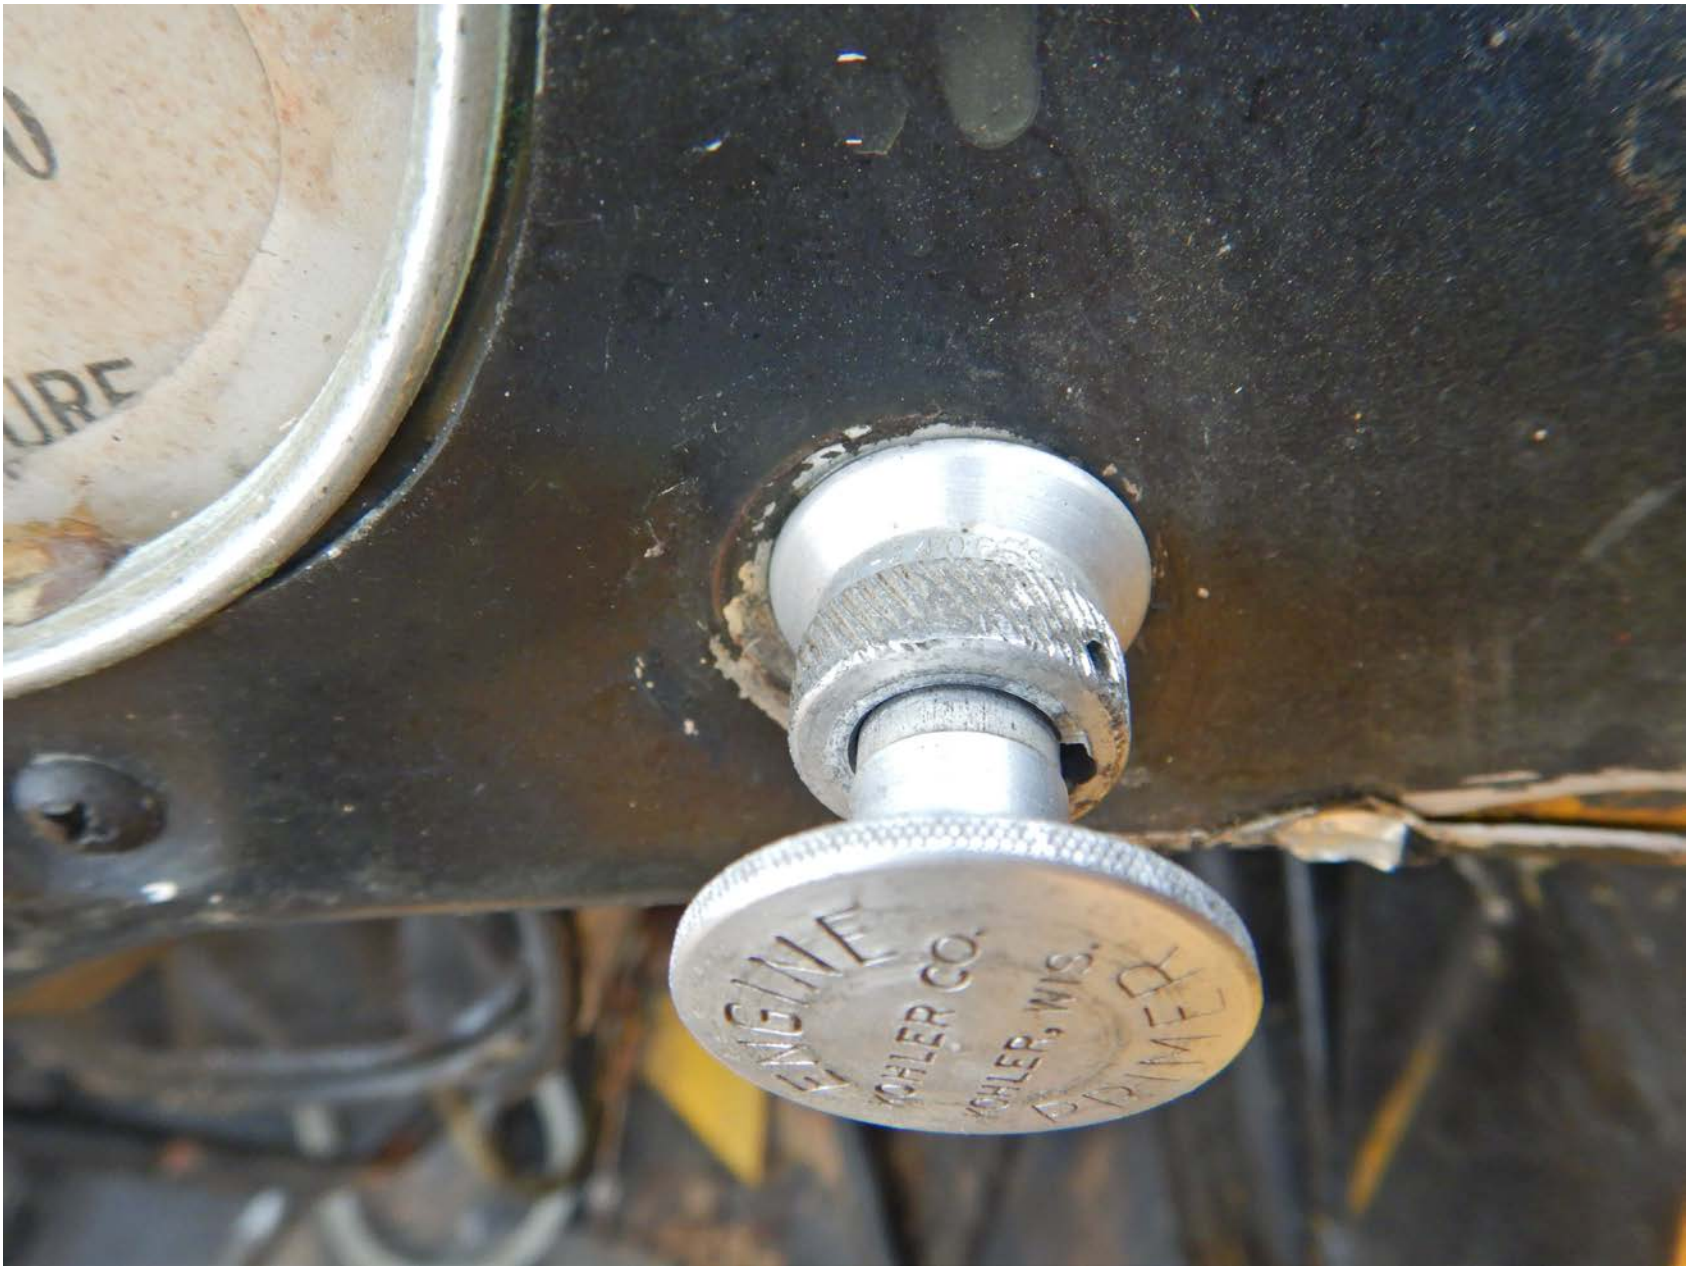
**Photo 3 - View of the engine primer.**

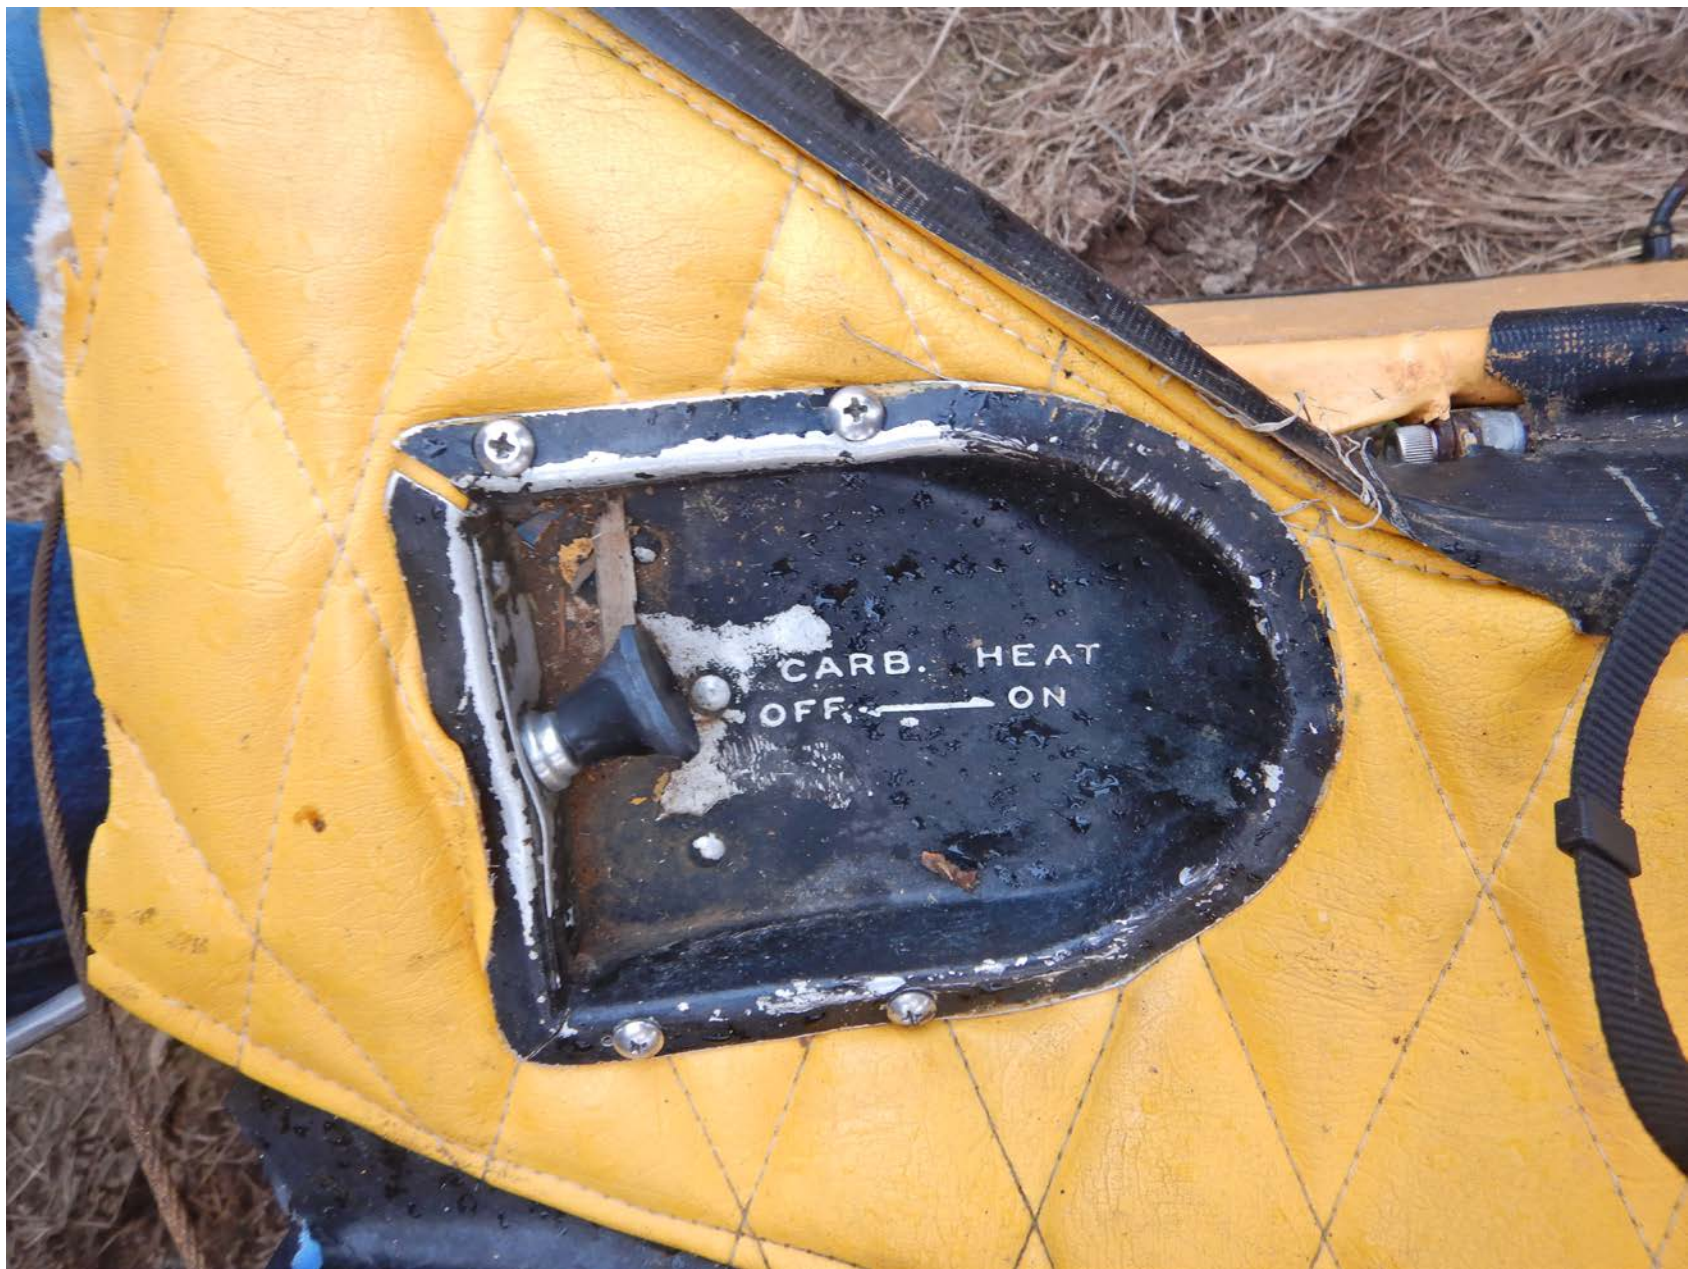
**Photo 4 - View of the carb heat selector. The selector is in the OFF position.**

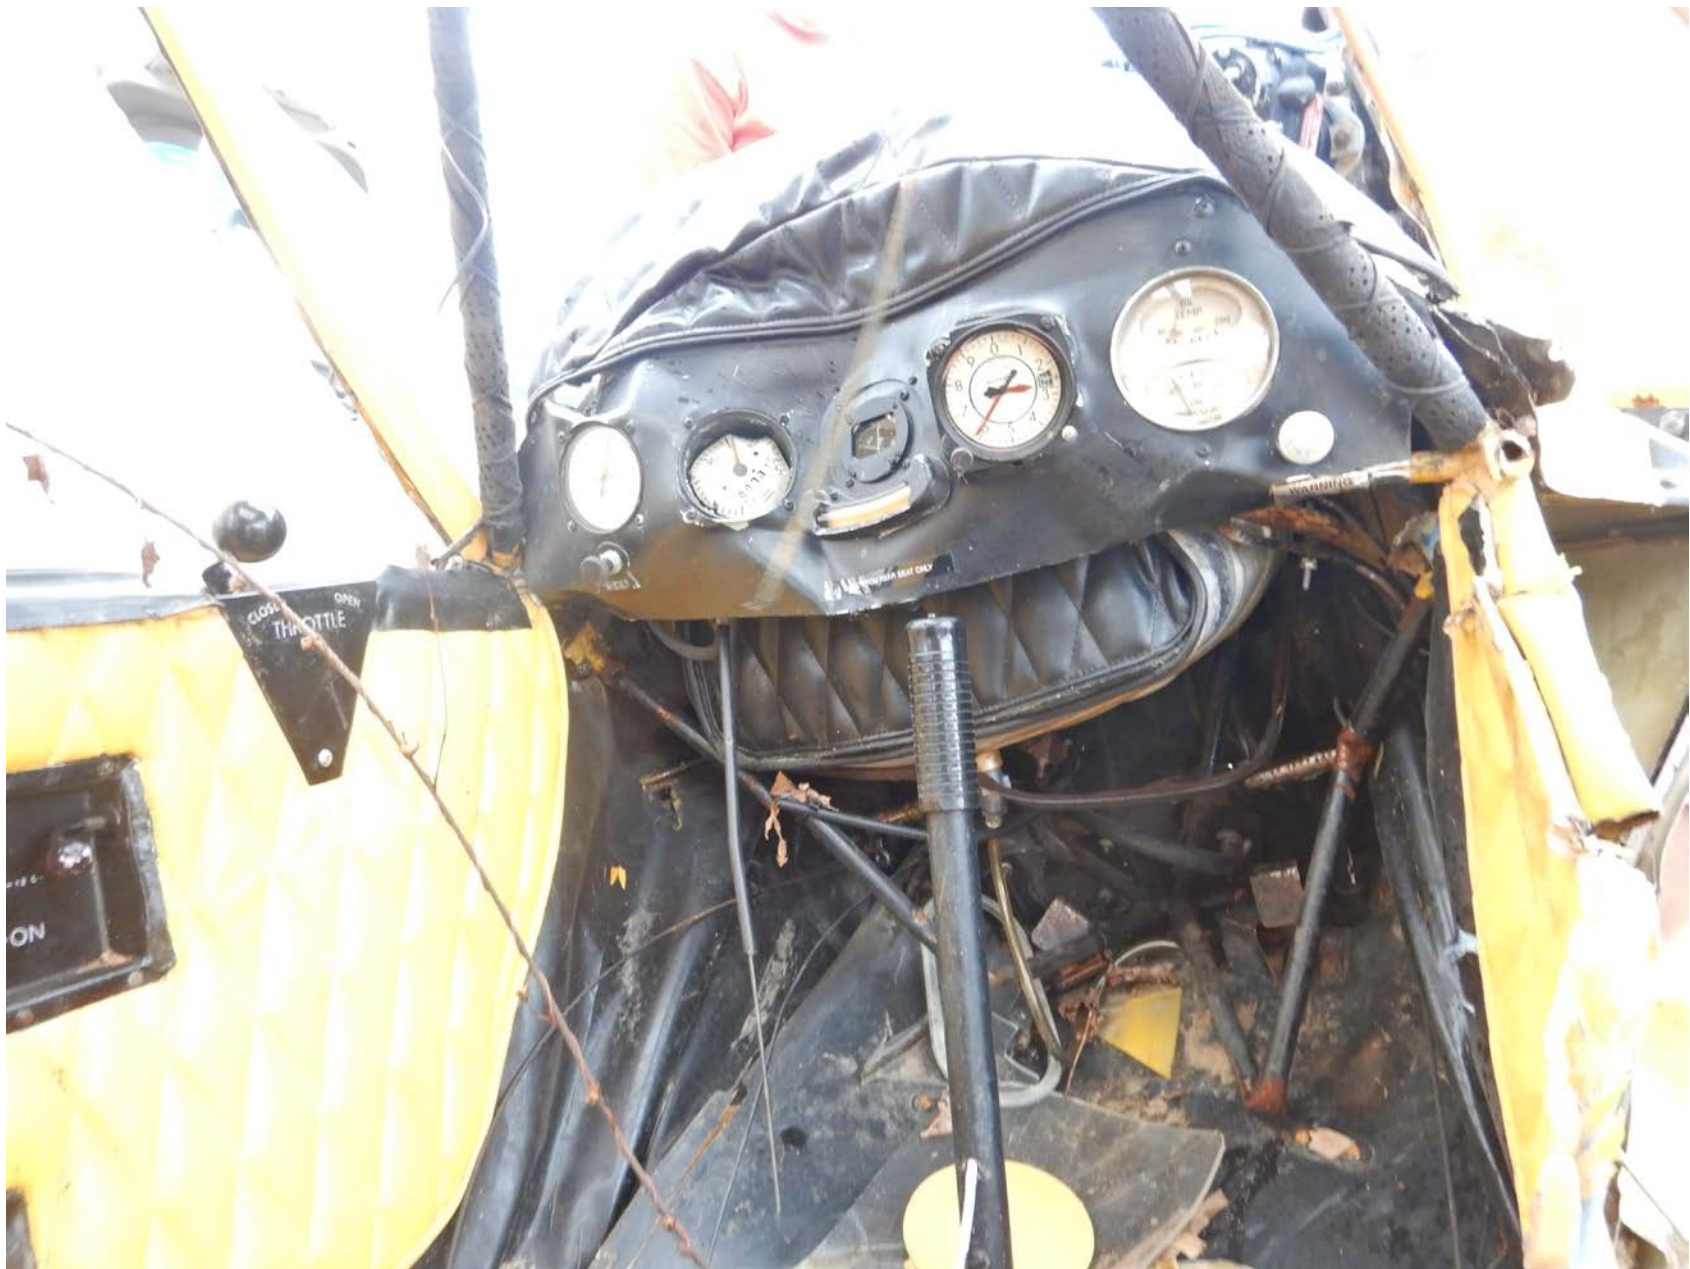
**Photo 5 - View of the cockpit and instrument panel.**

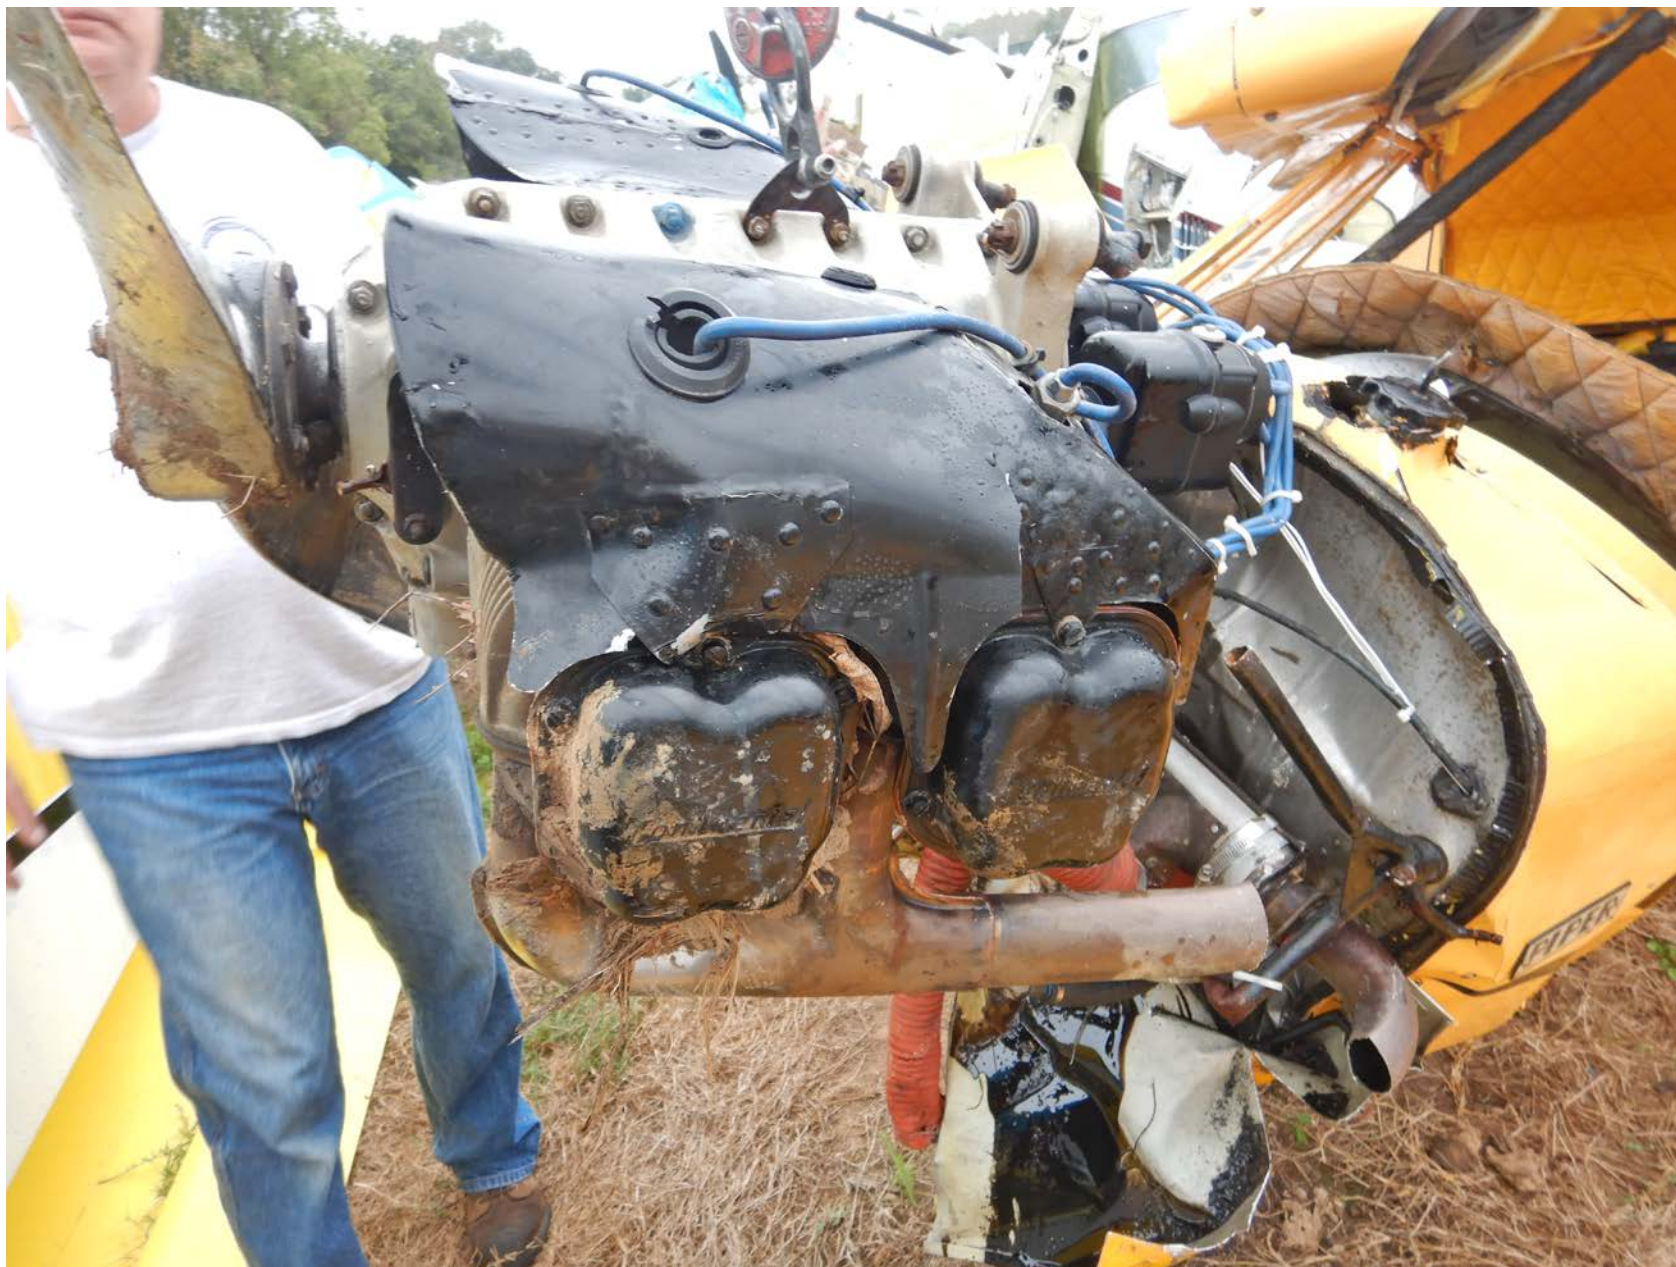
**Photo 6 - View of the left side of the engine.**

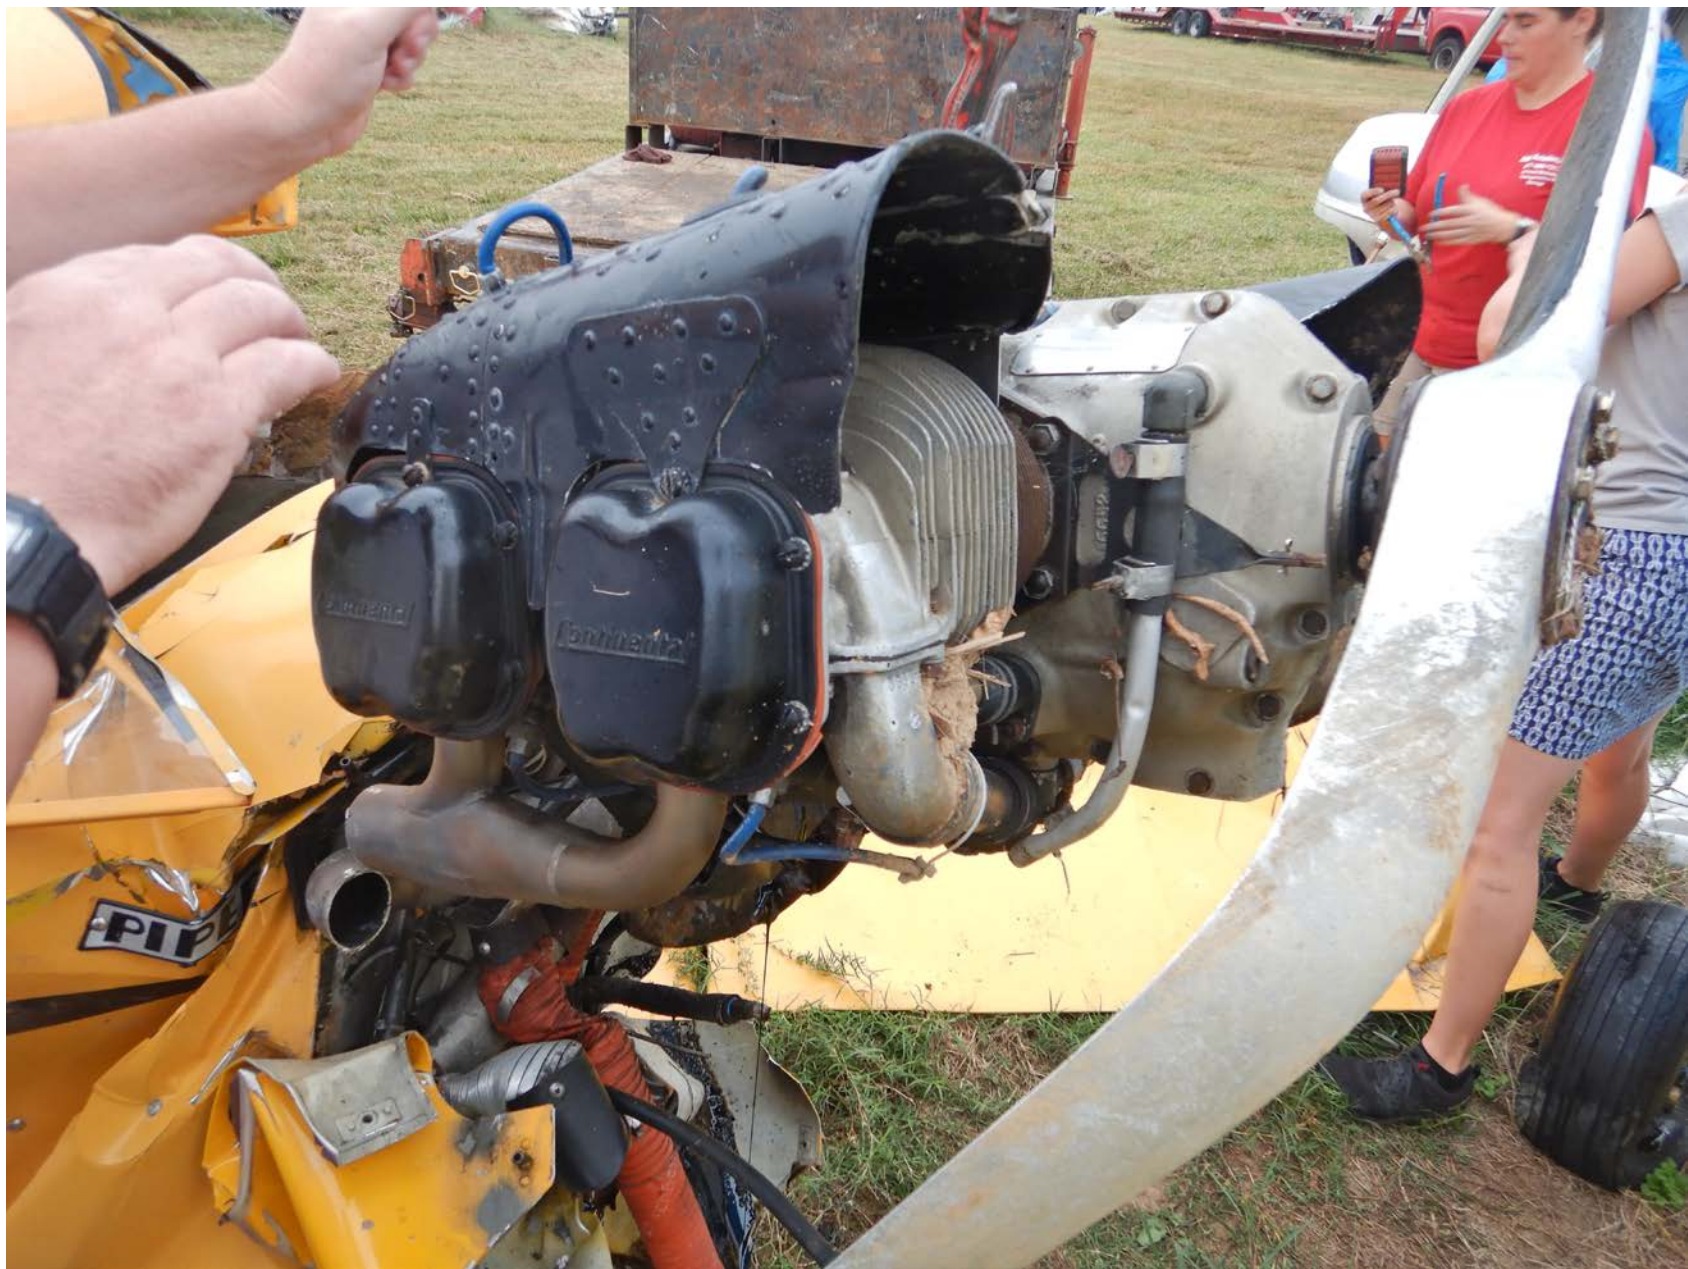
**Photo 7 - View of the right side of the engine.**

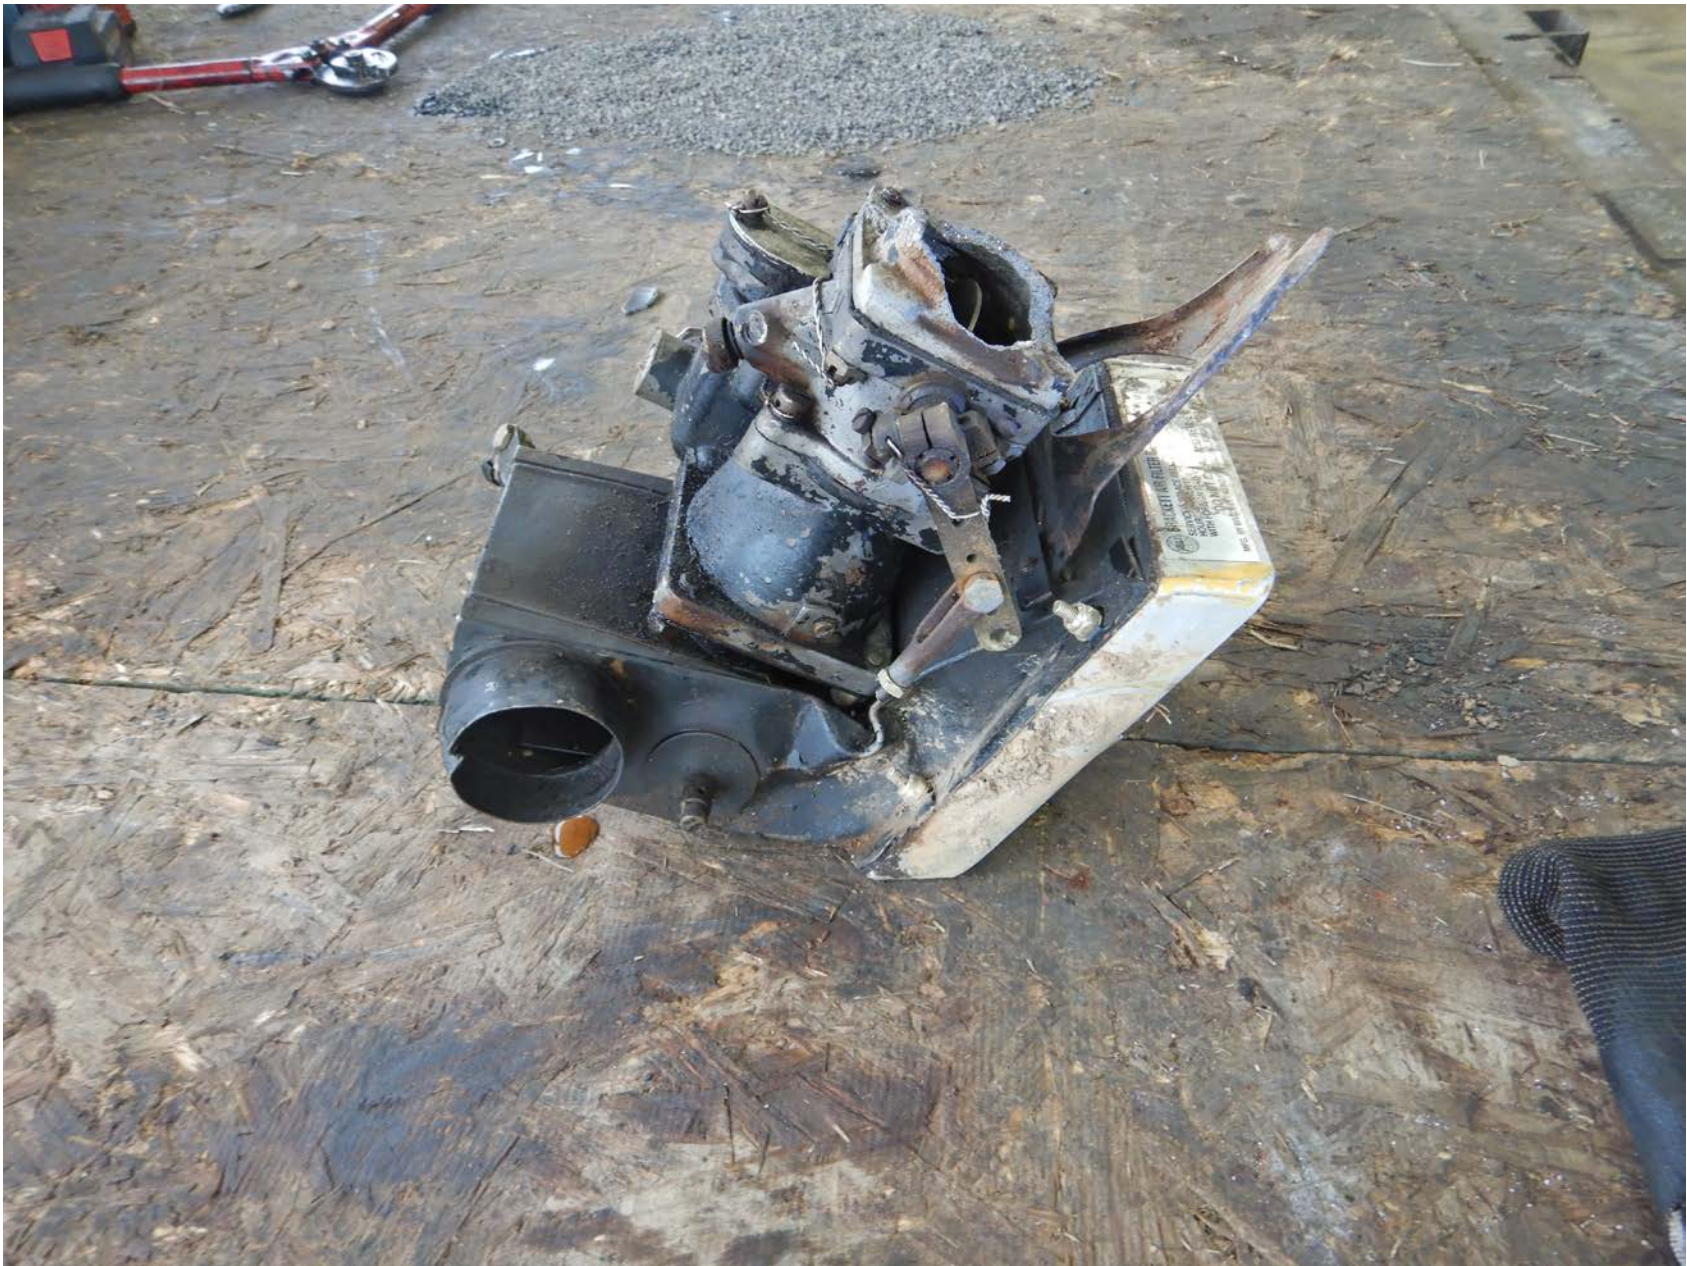
**Photo 8 - View of a side of the carburetor.**

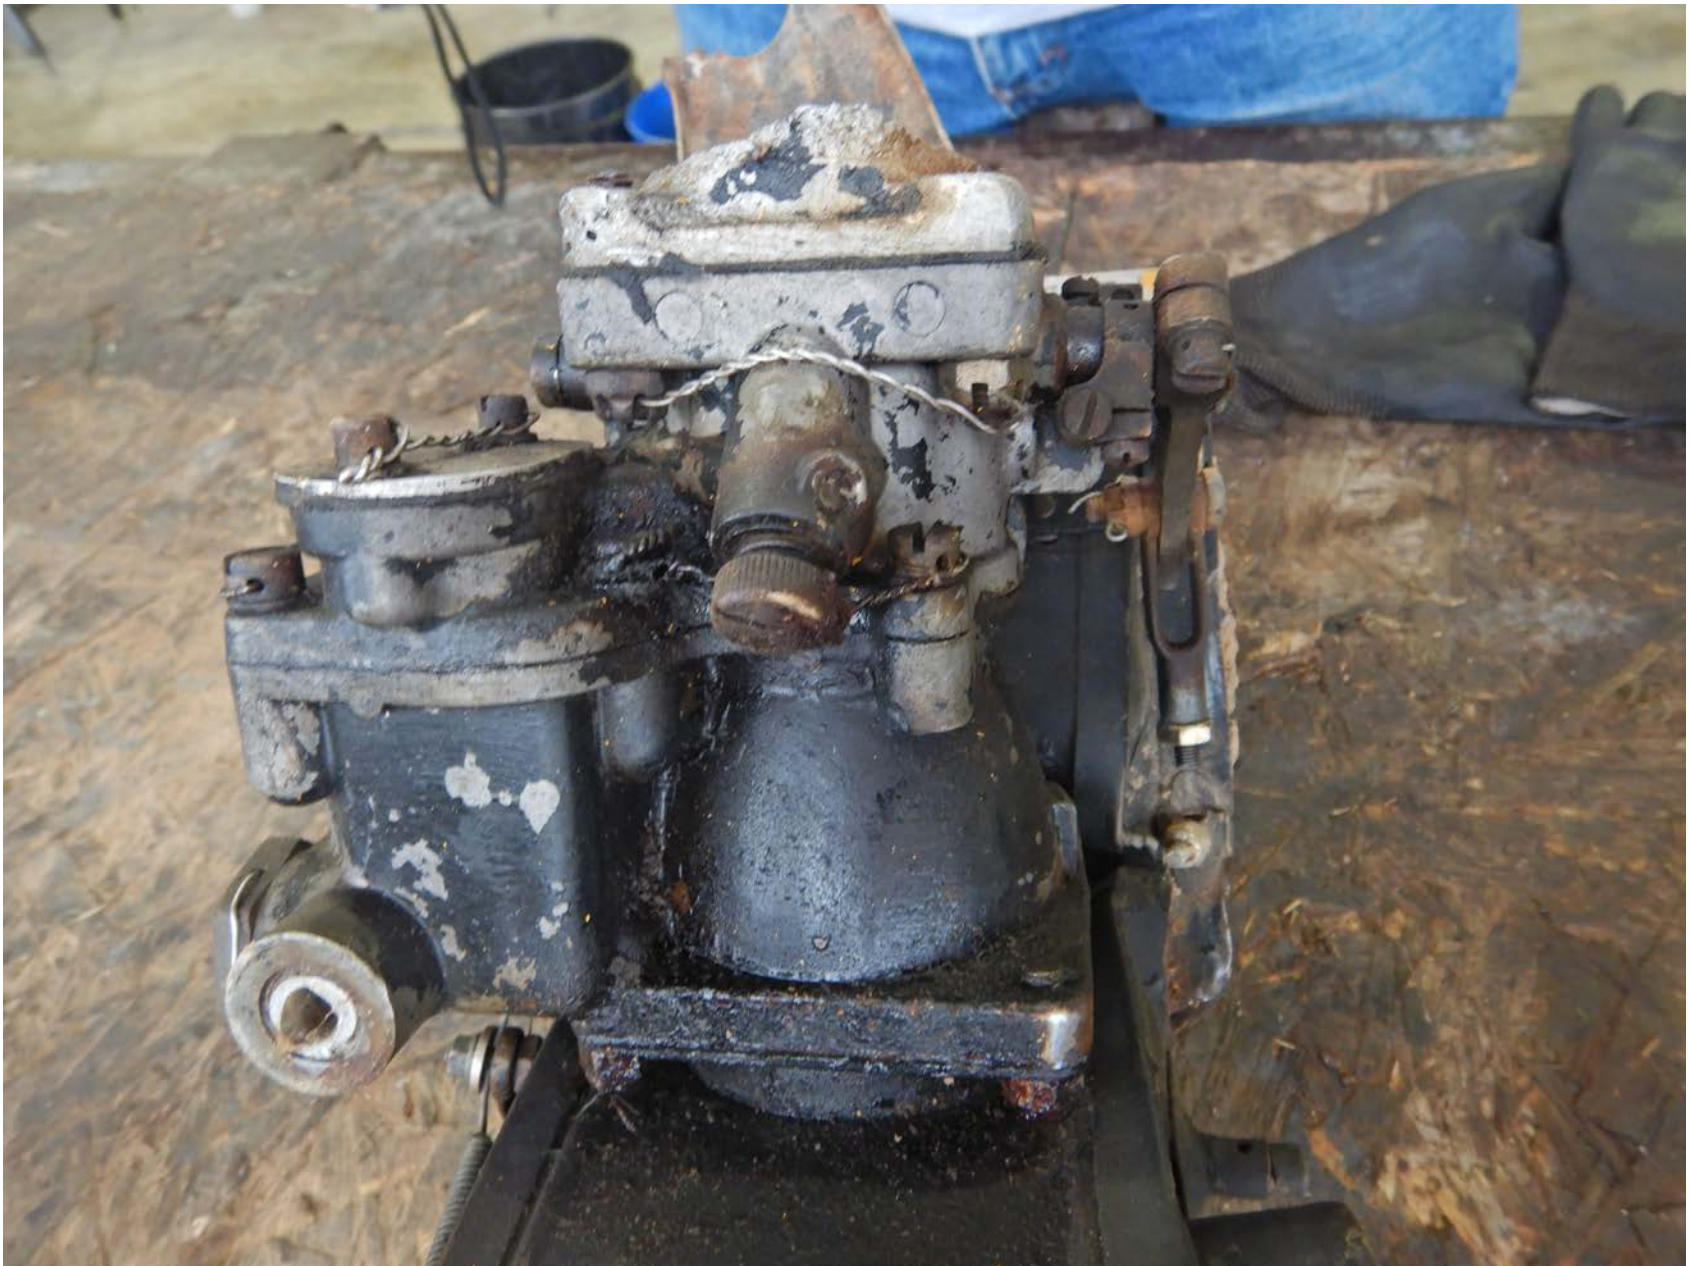
**Photo 9 - View of a side of the carburetor.**

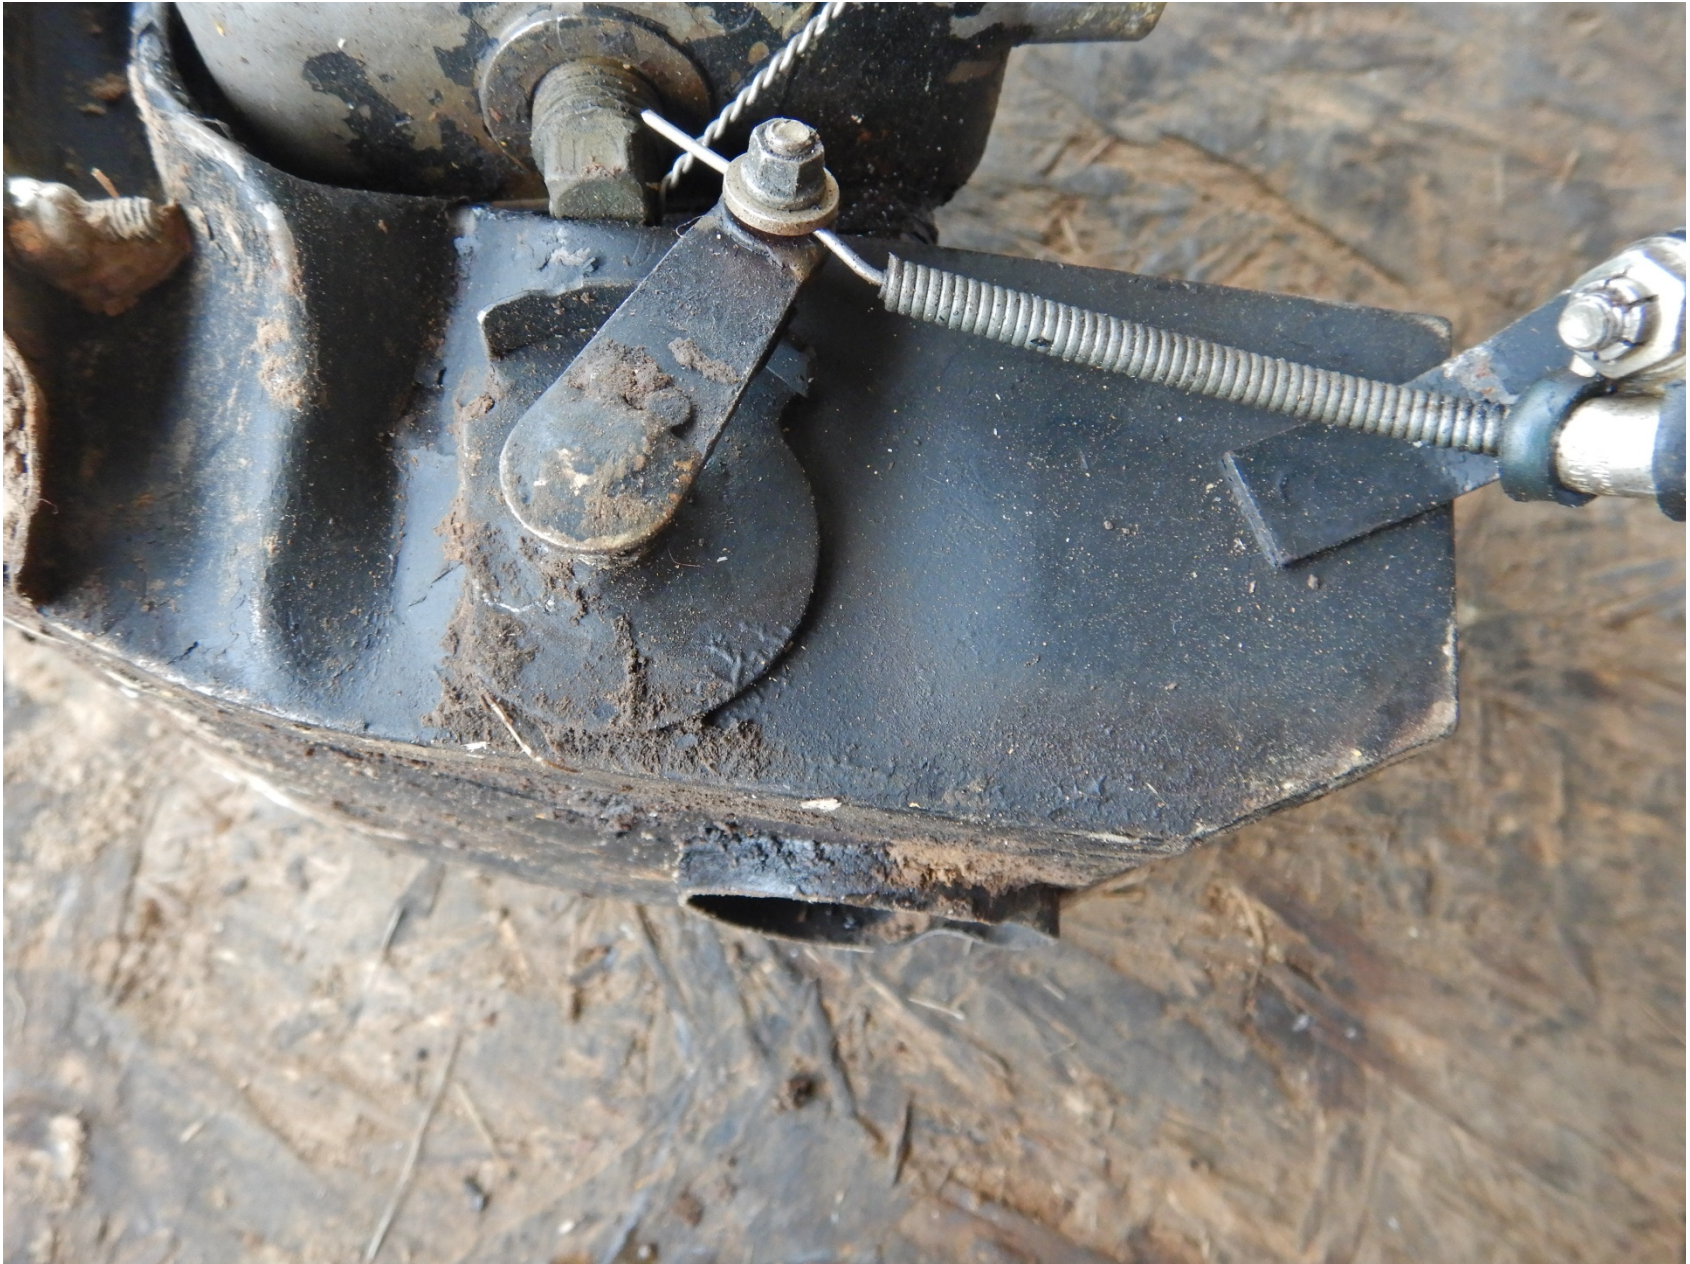
**Photo 10 - Close-up view of the carburetor heat linkage.**
