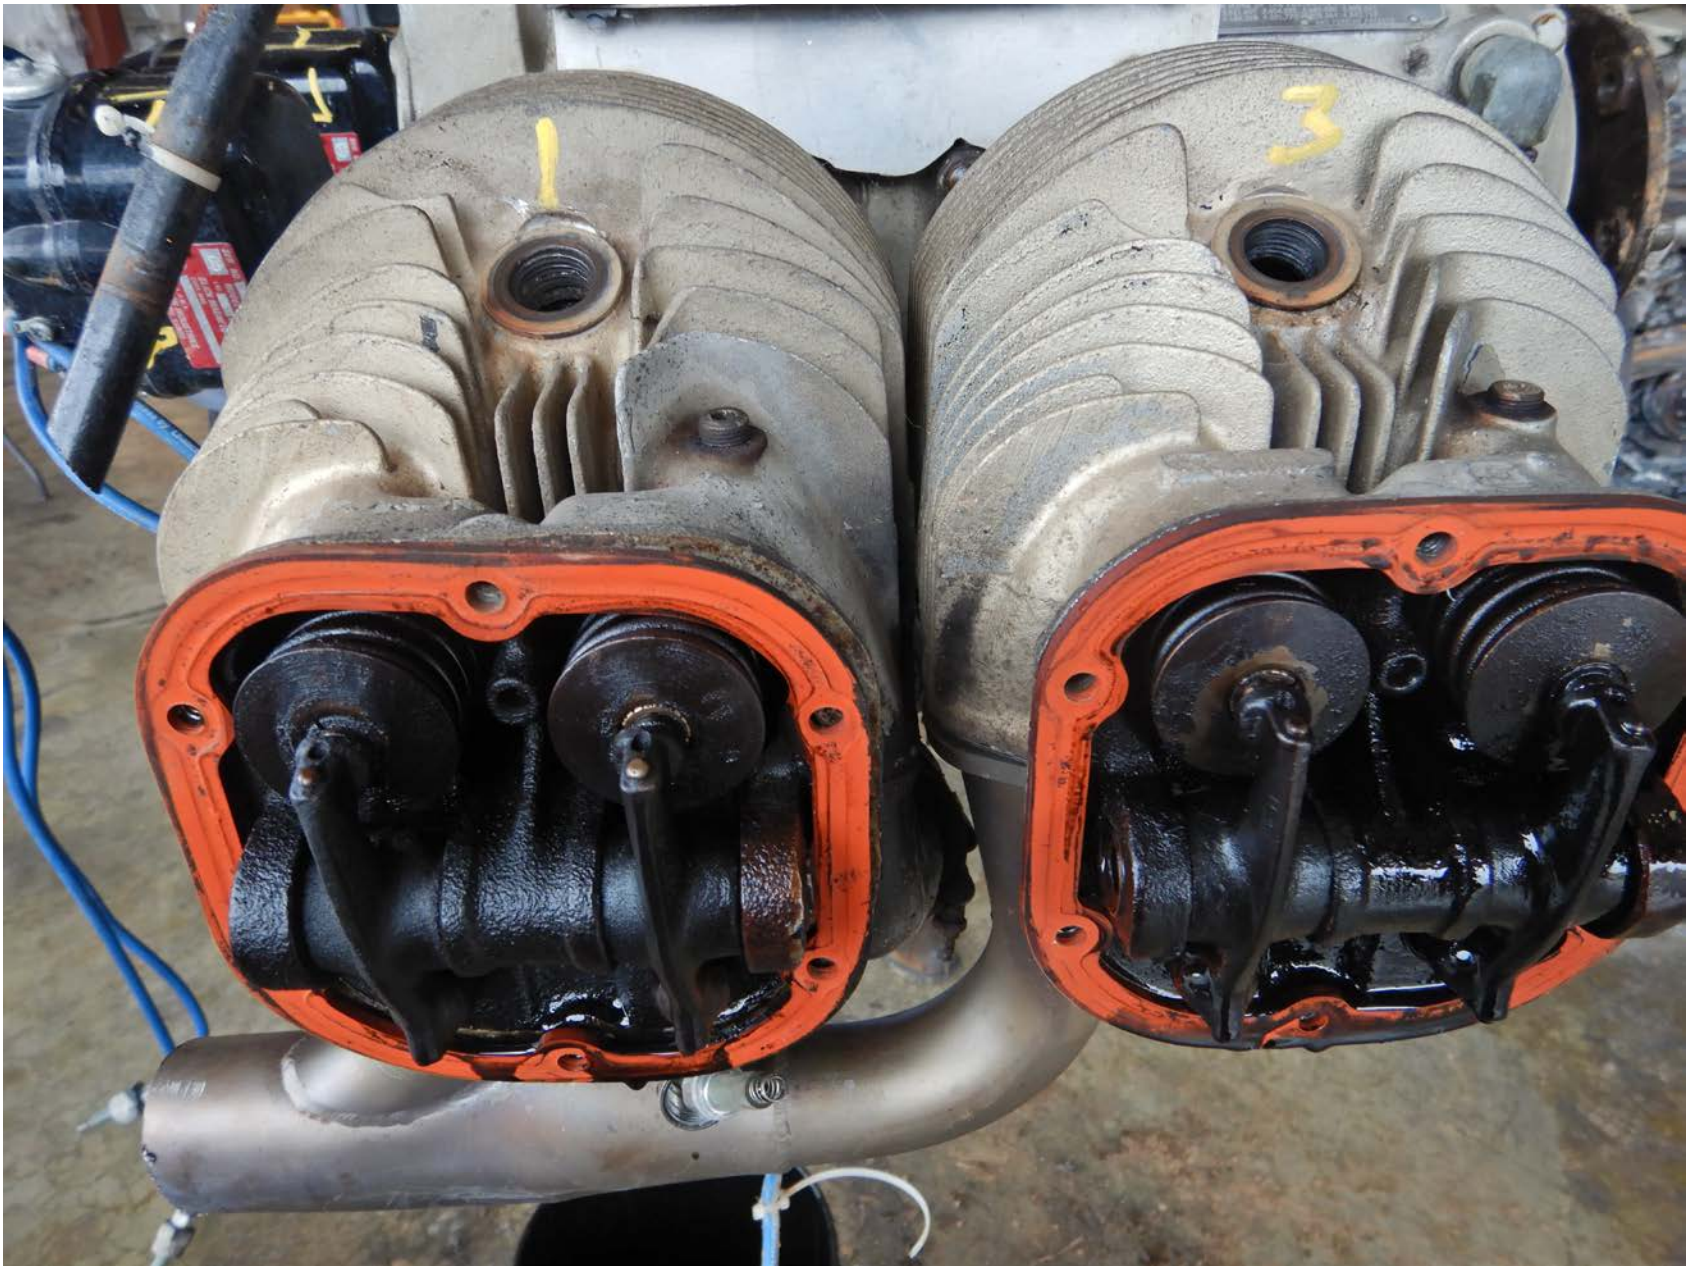
**Photo 11 - Close-up view of the No. 1 and 3 cylinders with their covers removed.**

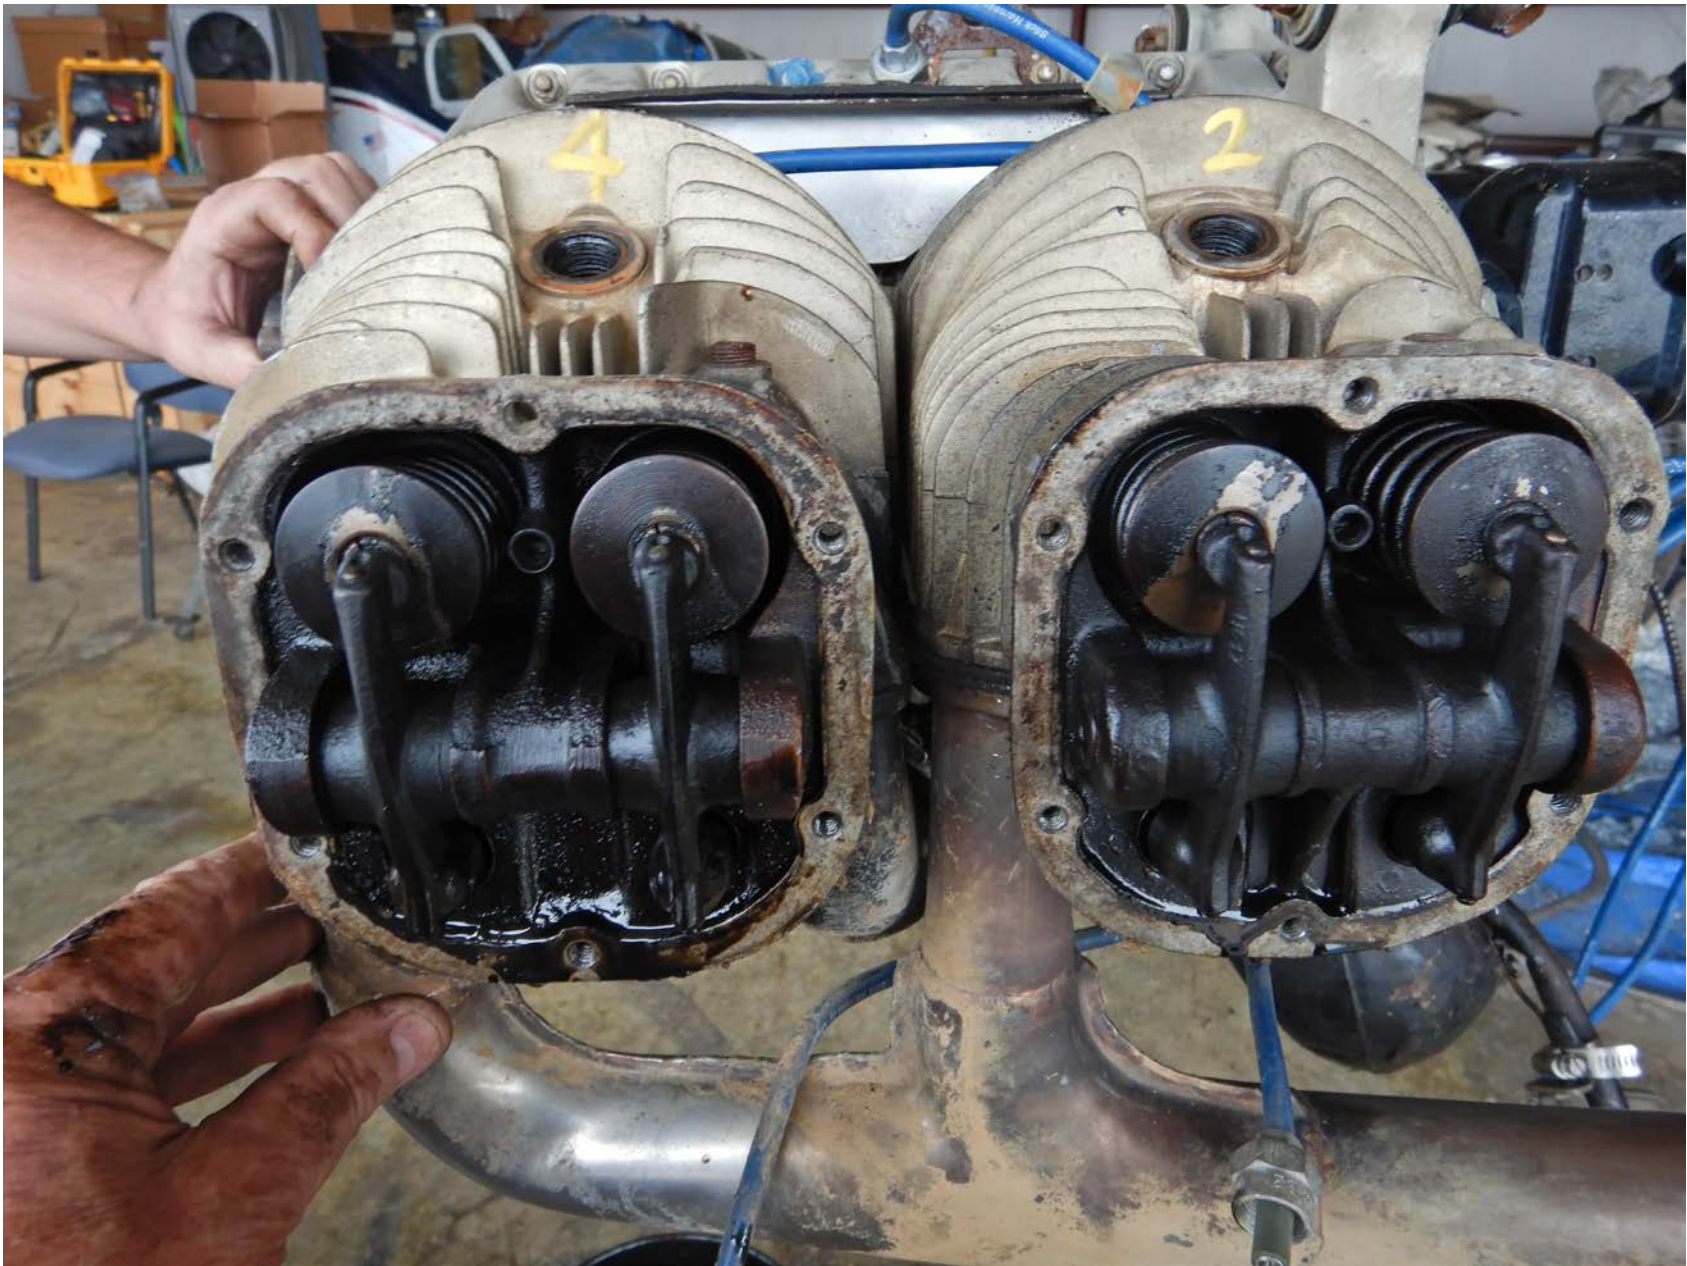
**Photo 12 - Close-up view of the No. 2 and 4 cylinders with their covers removed.**

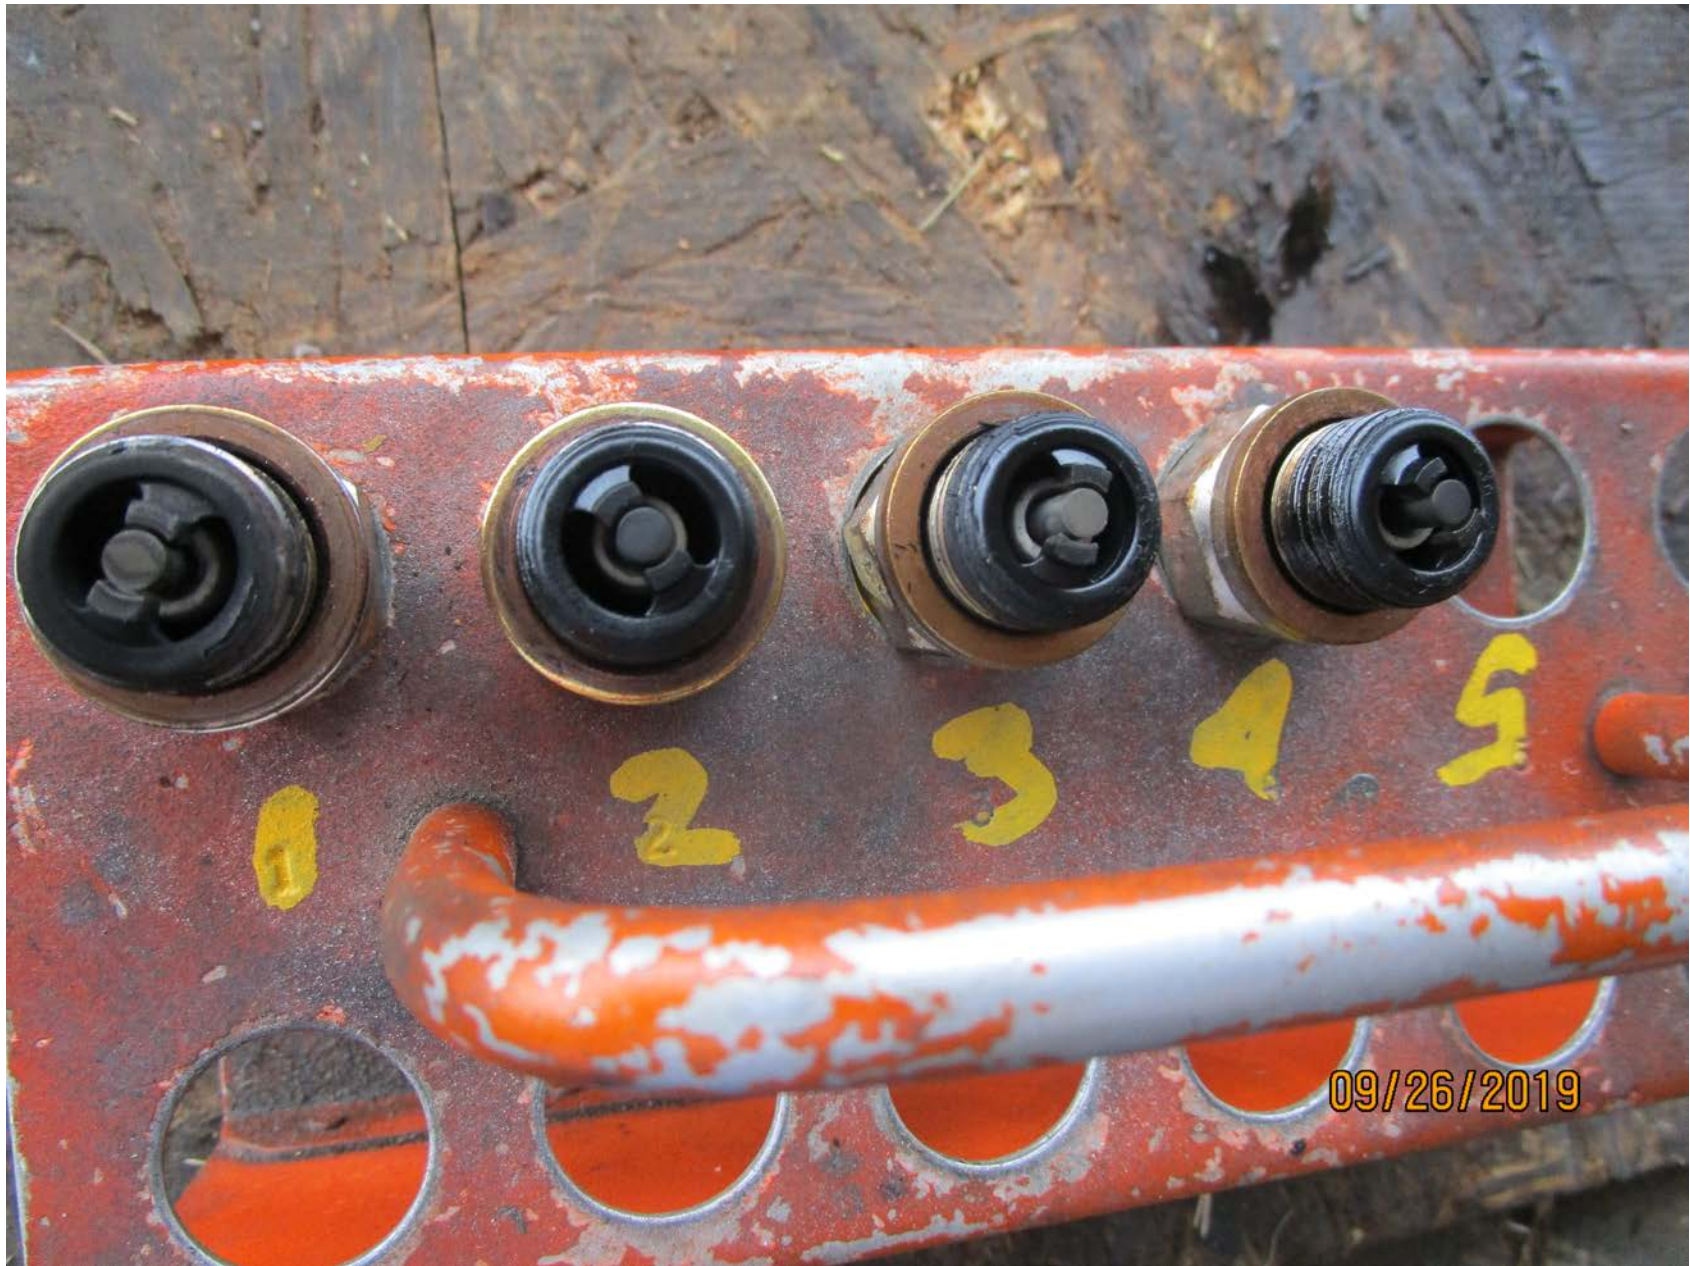
**Photo 13 - Close-up view of removed sparkplugs.**

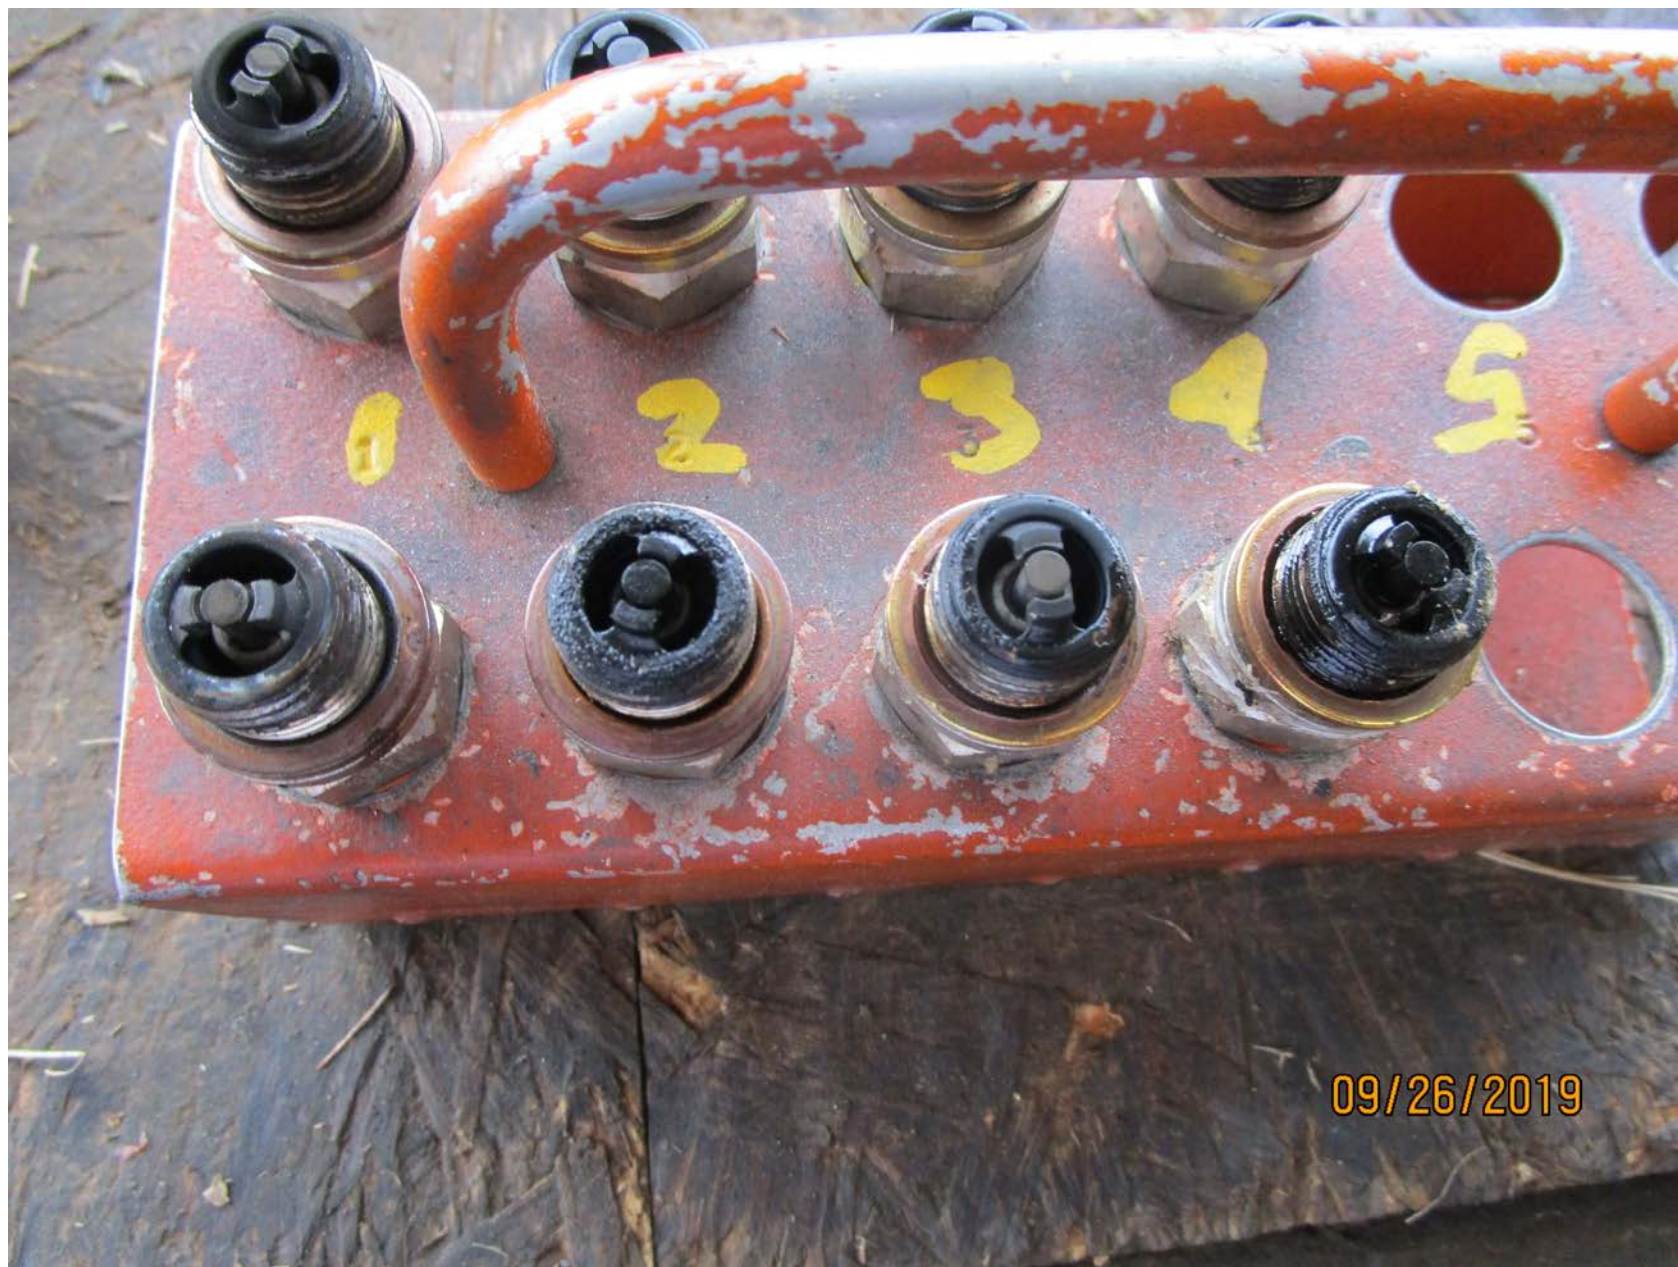
**Photo 14 - Close-up view of removed sparkplugs.**

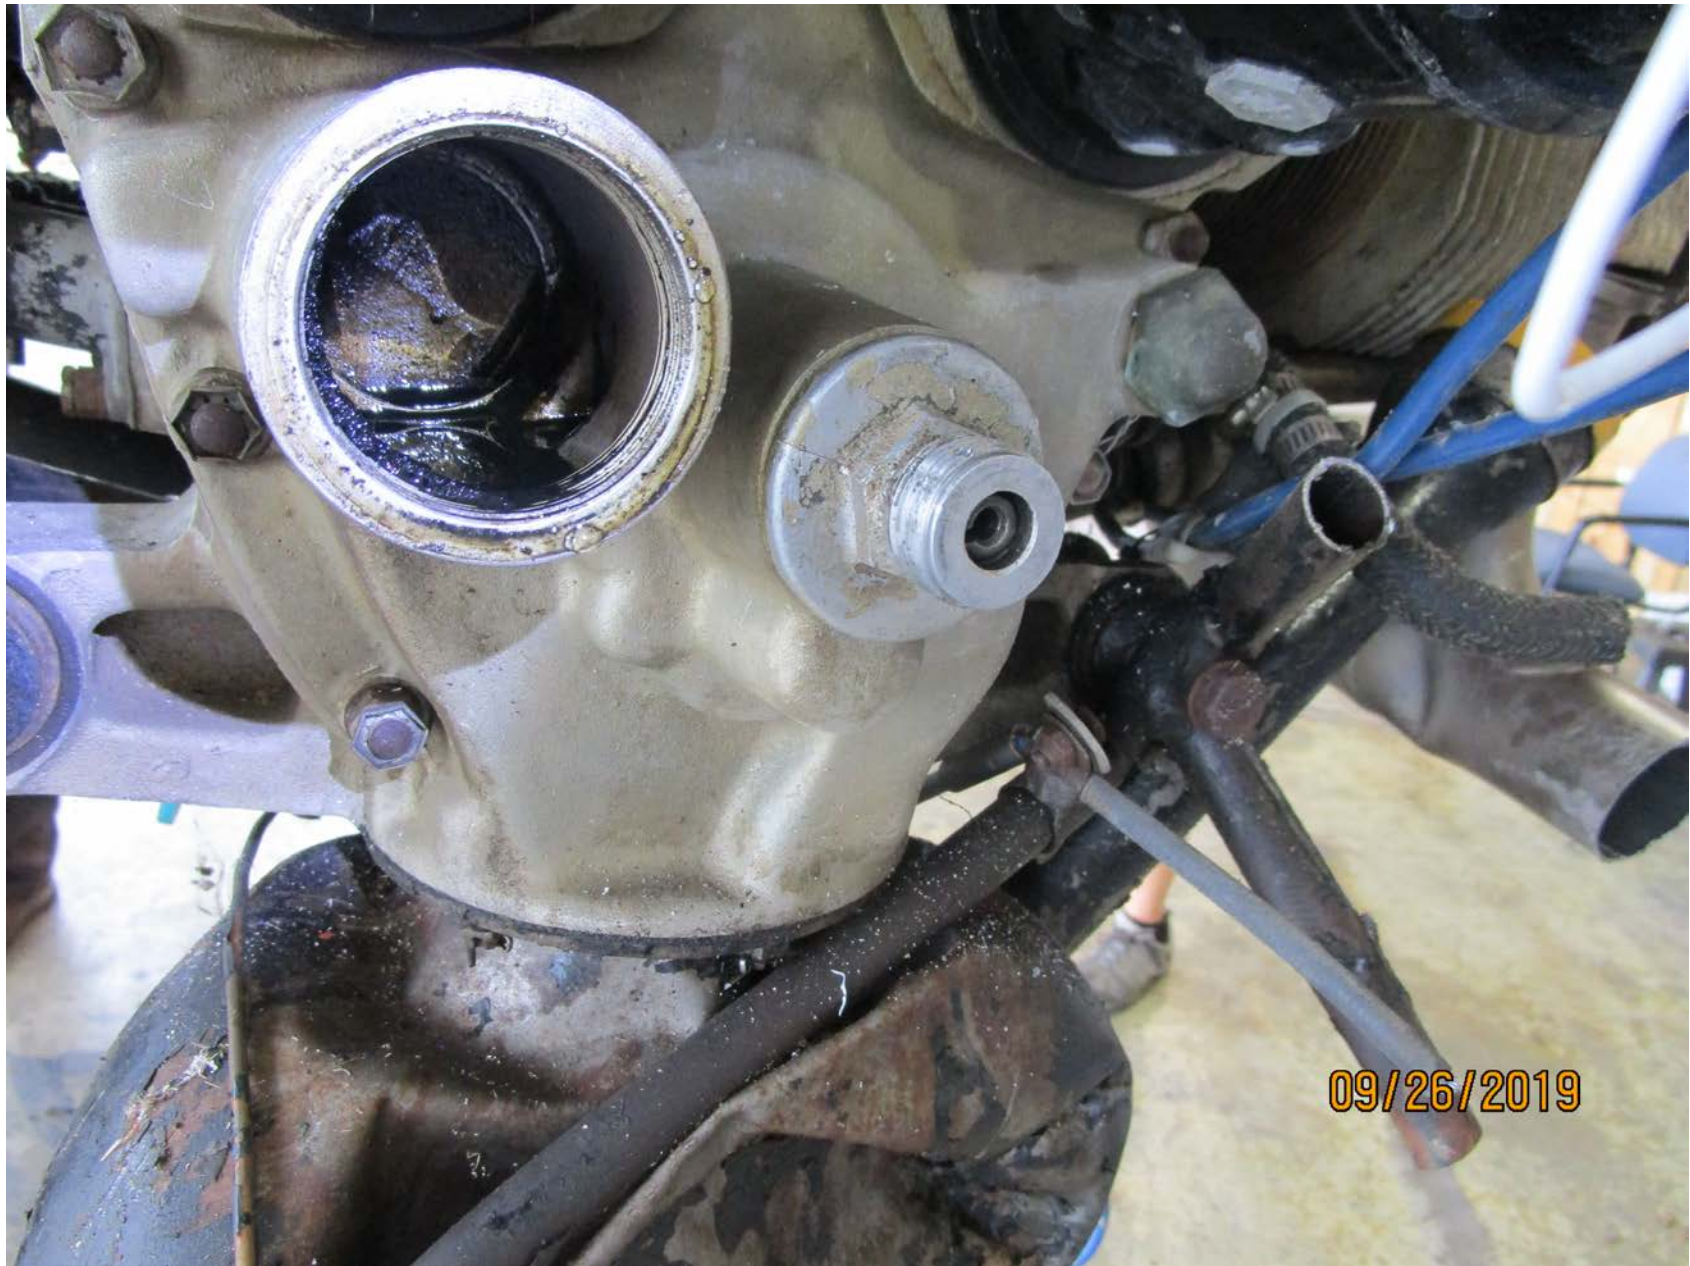
**Photo 15 - View of the oil screen cavity.**

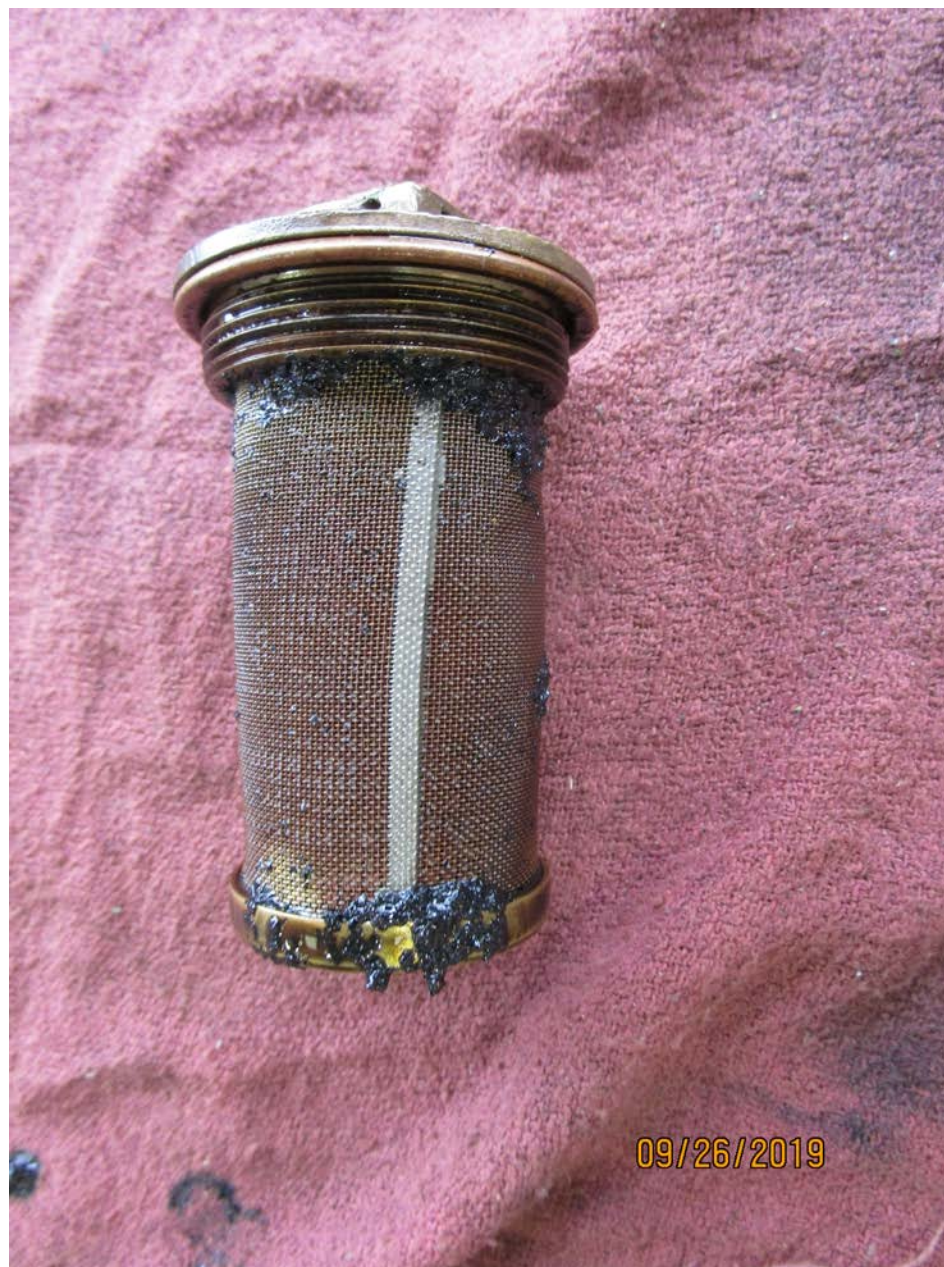
**Photo 16 - View of the oil screen.**

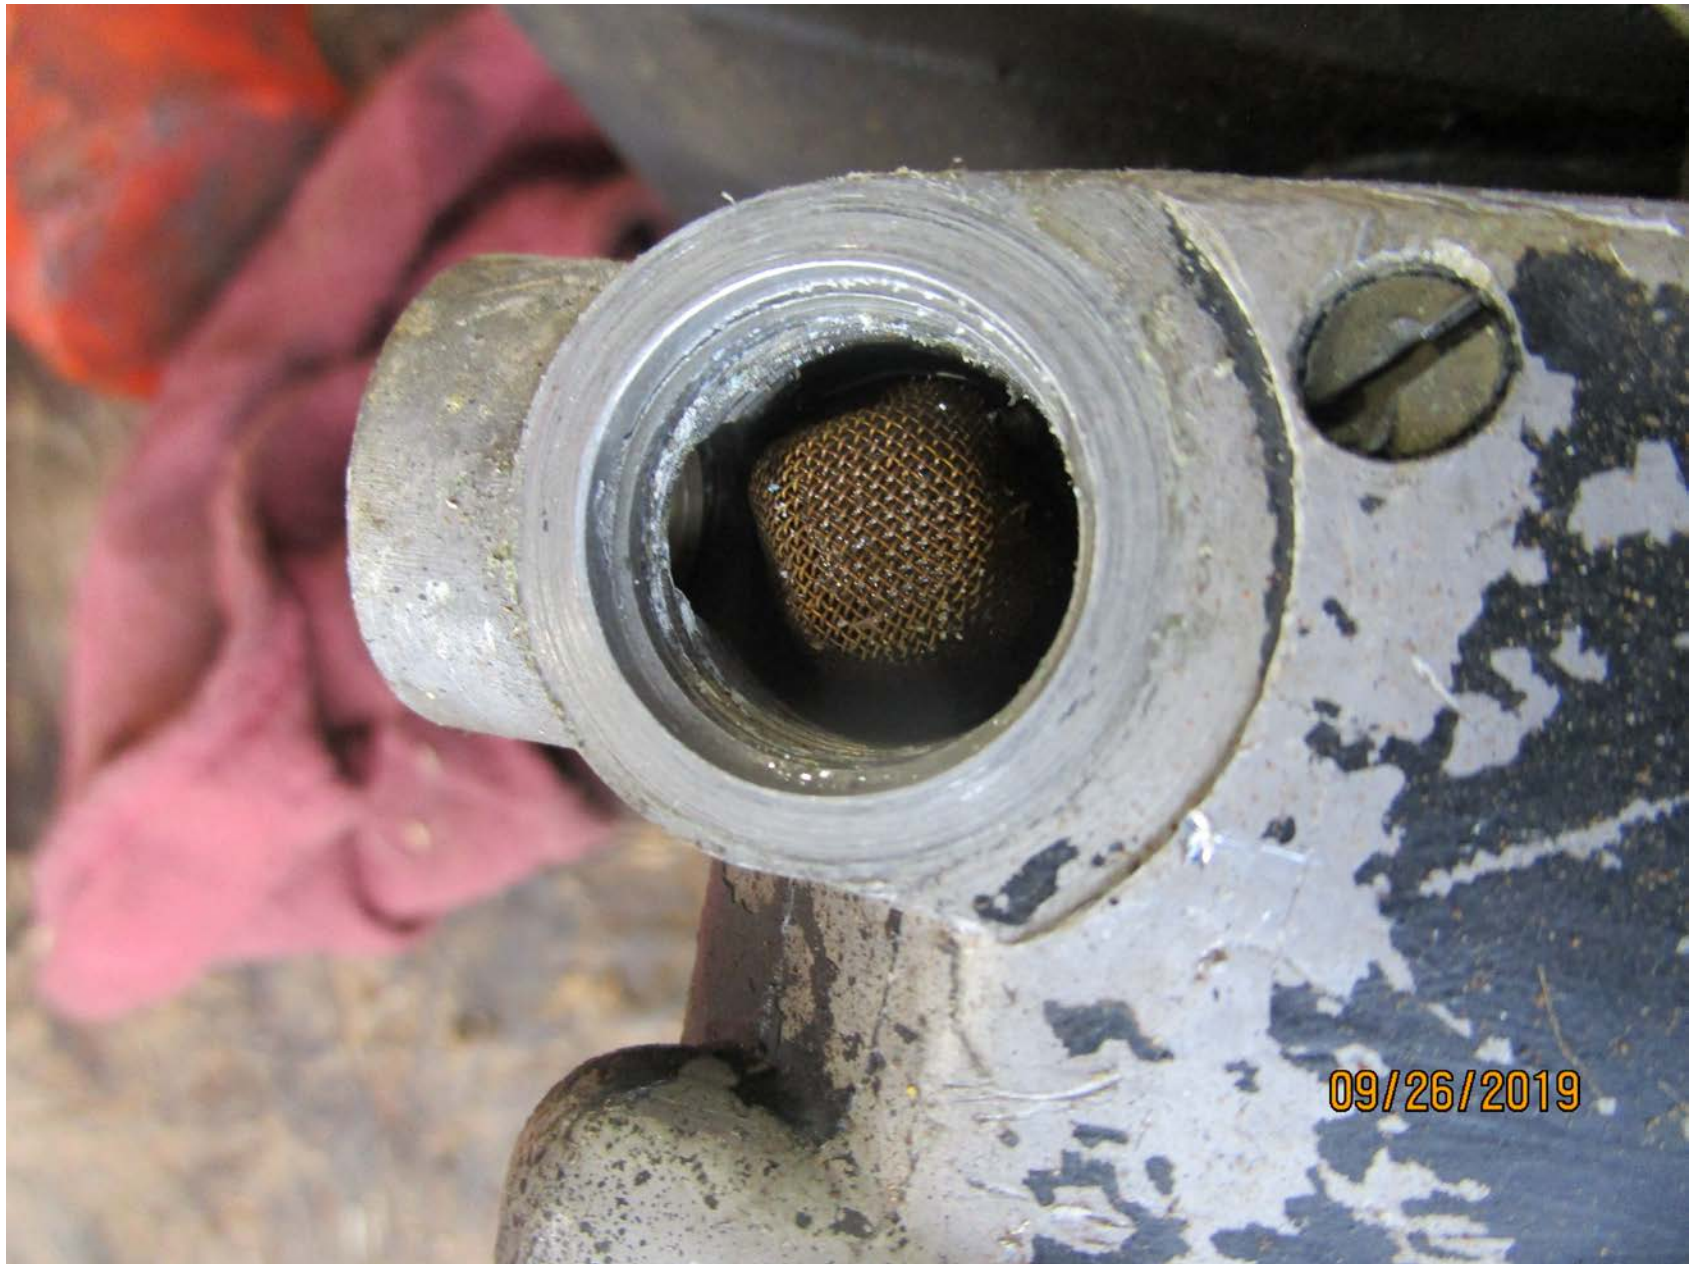
**Photo 17 - View of the fuel screen.**

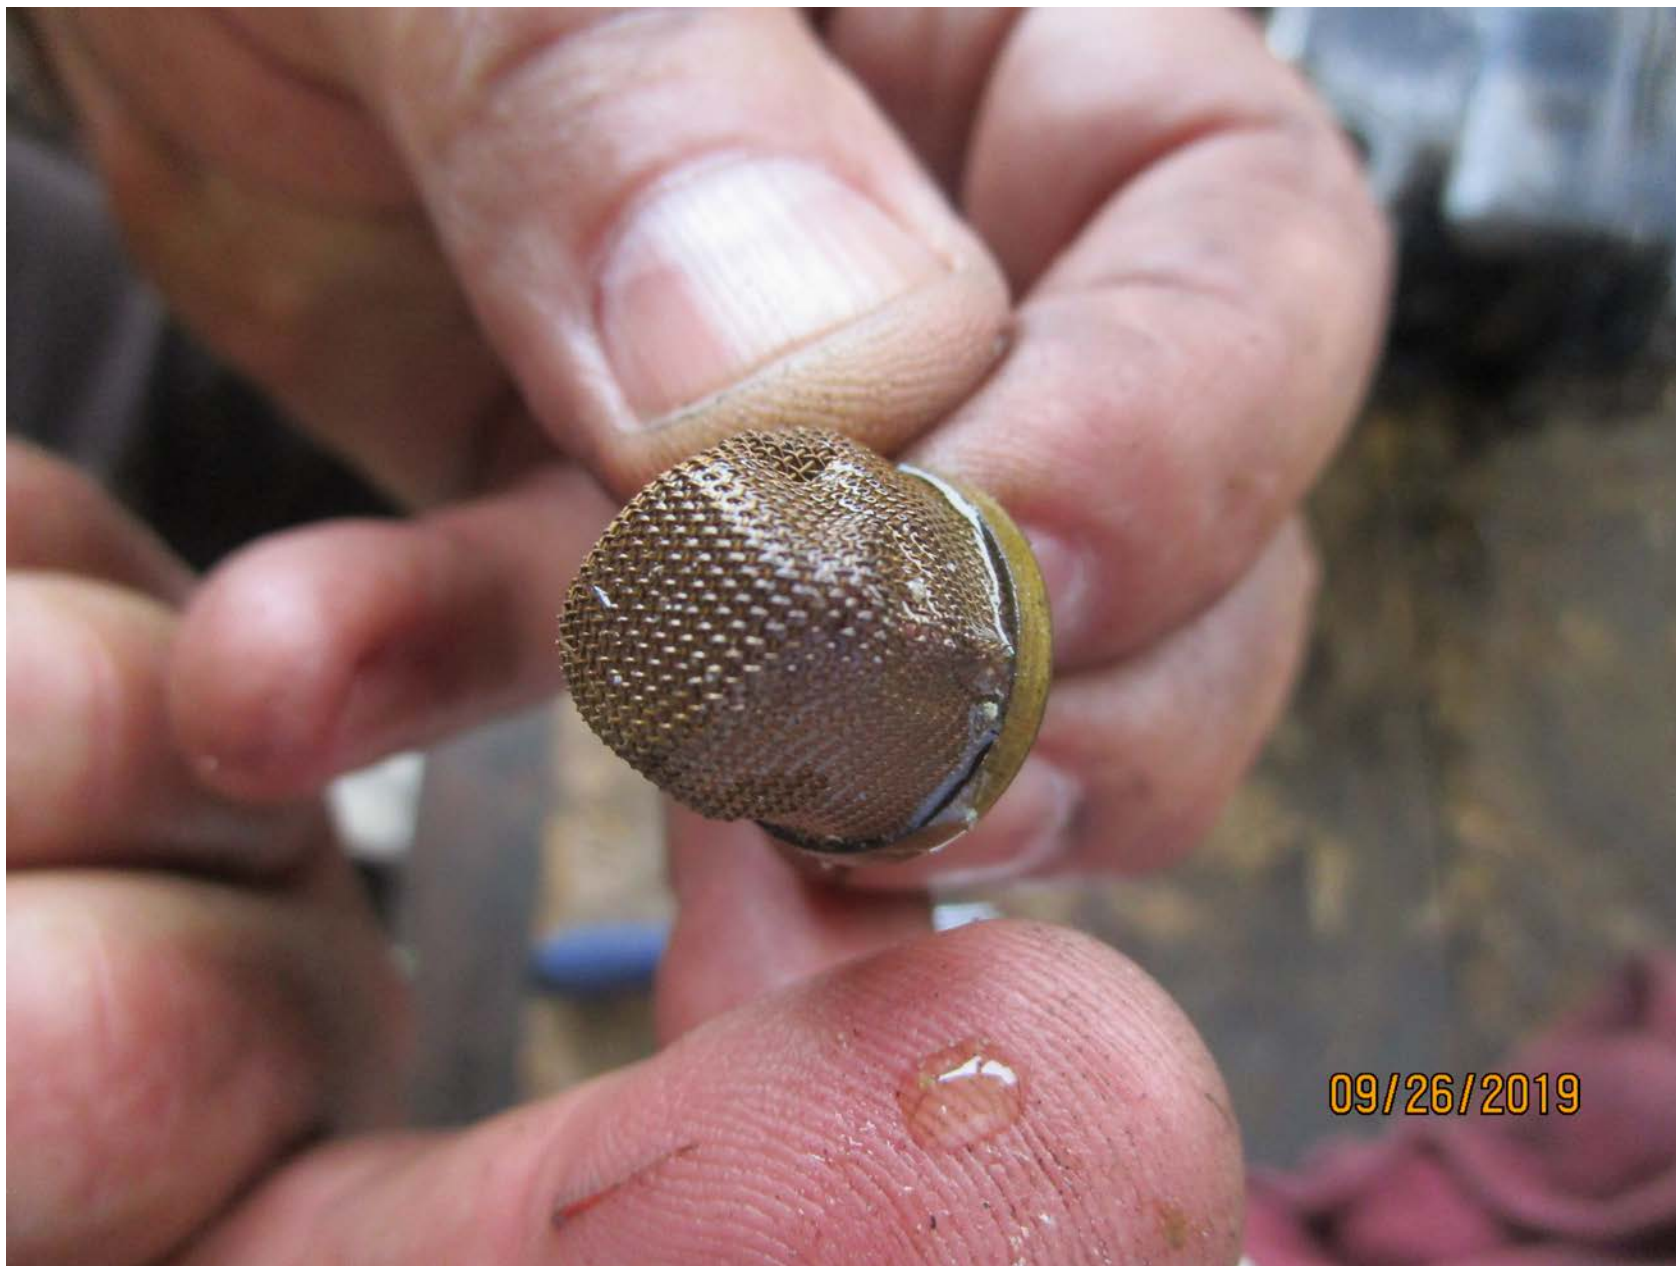
**Photo 18 - View of the removed fuel screen.**

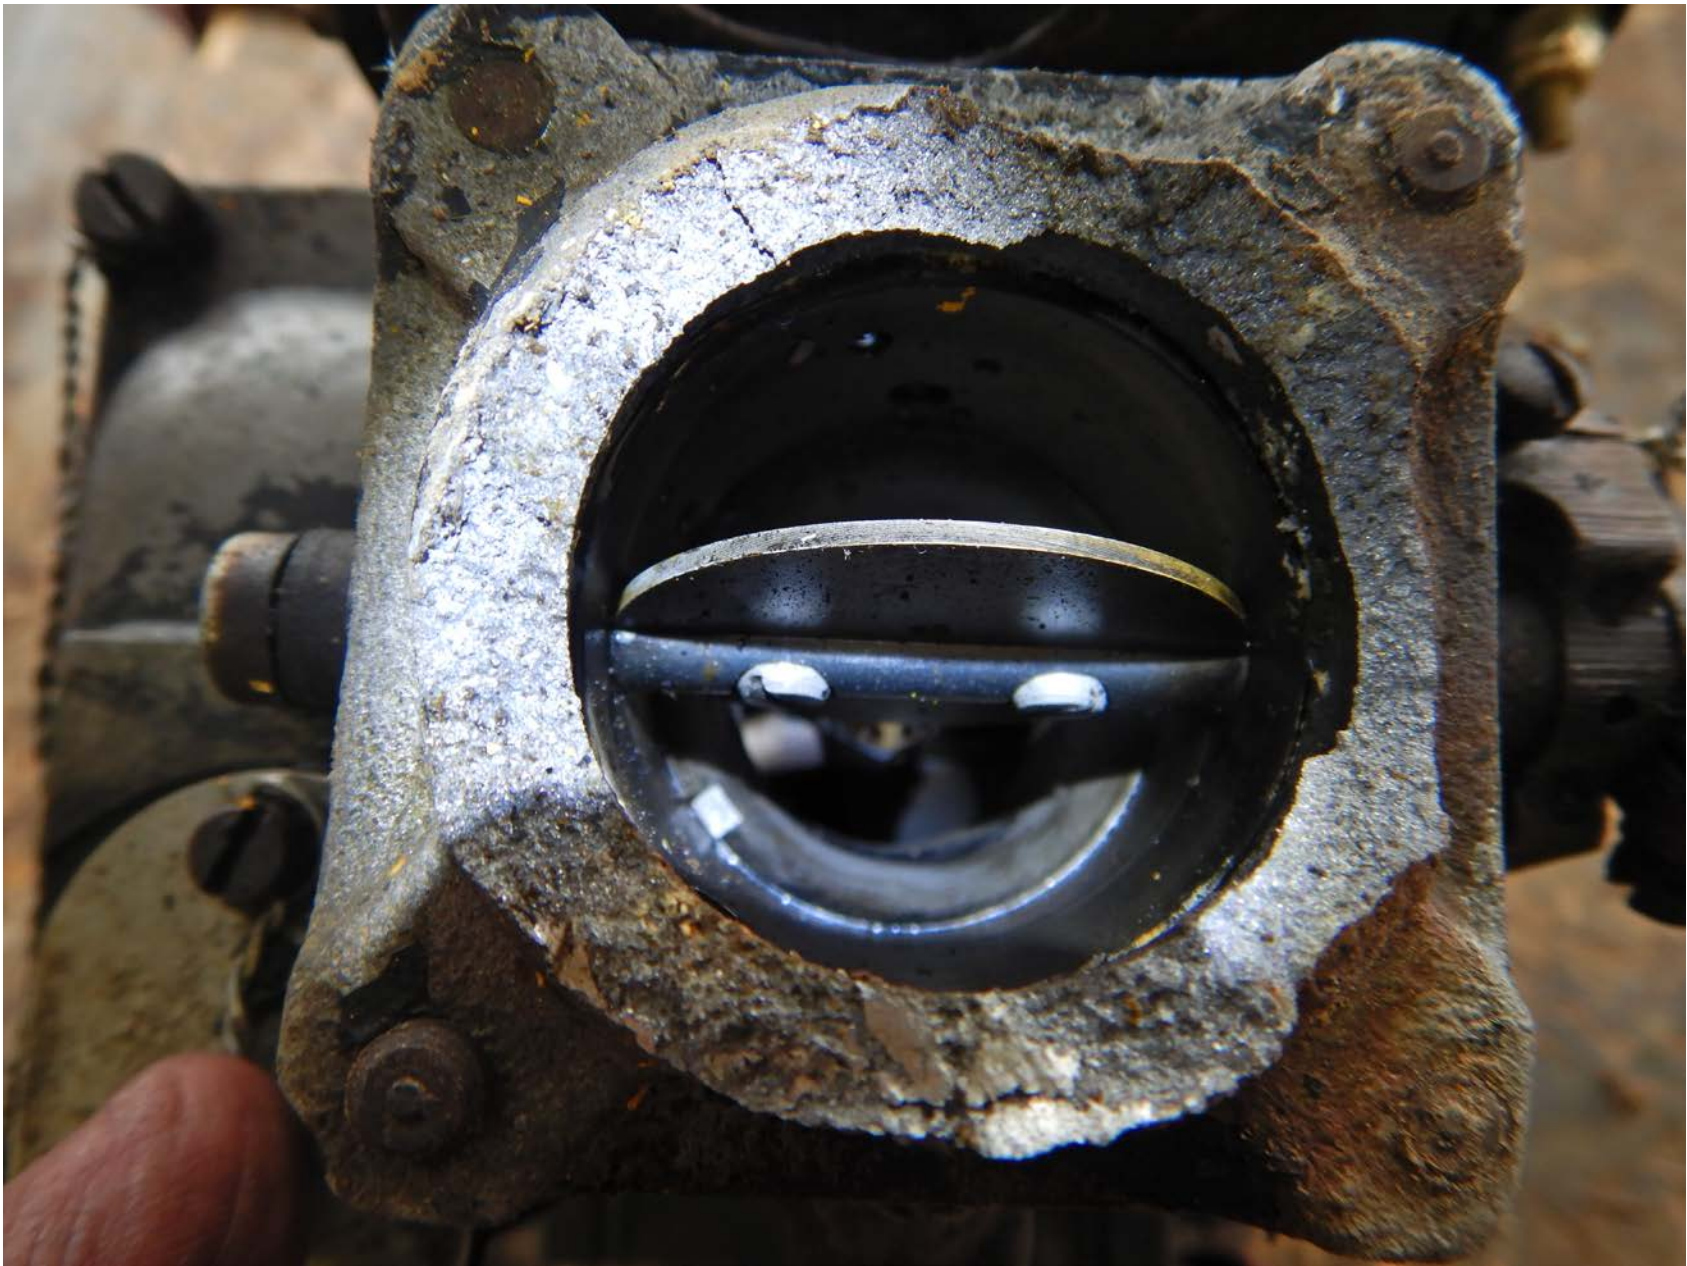
**Photo 19 - View of the separated section of the carburetor venturi and butterfly throttle valve.**

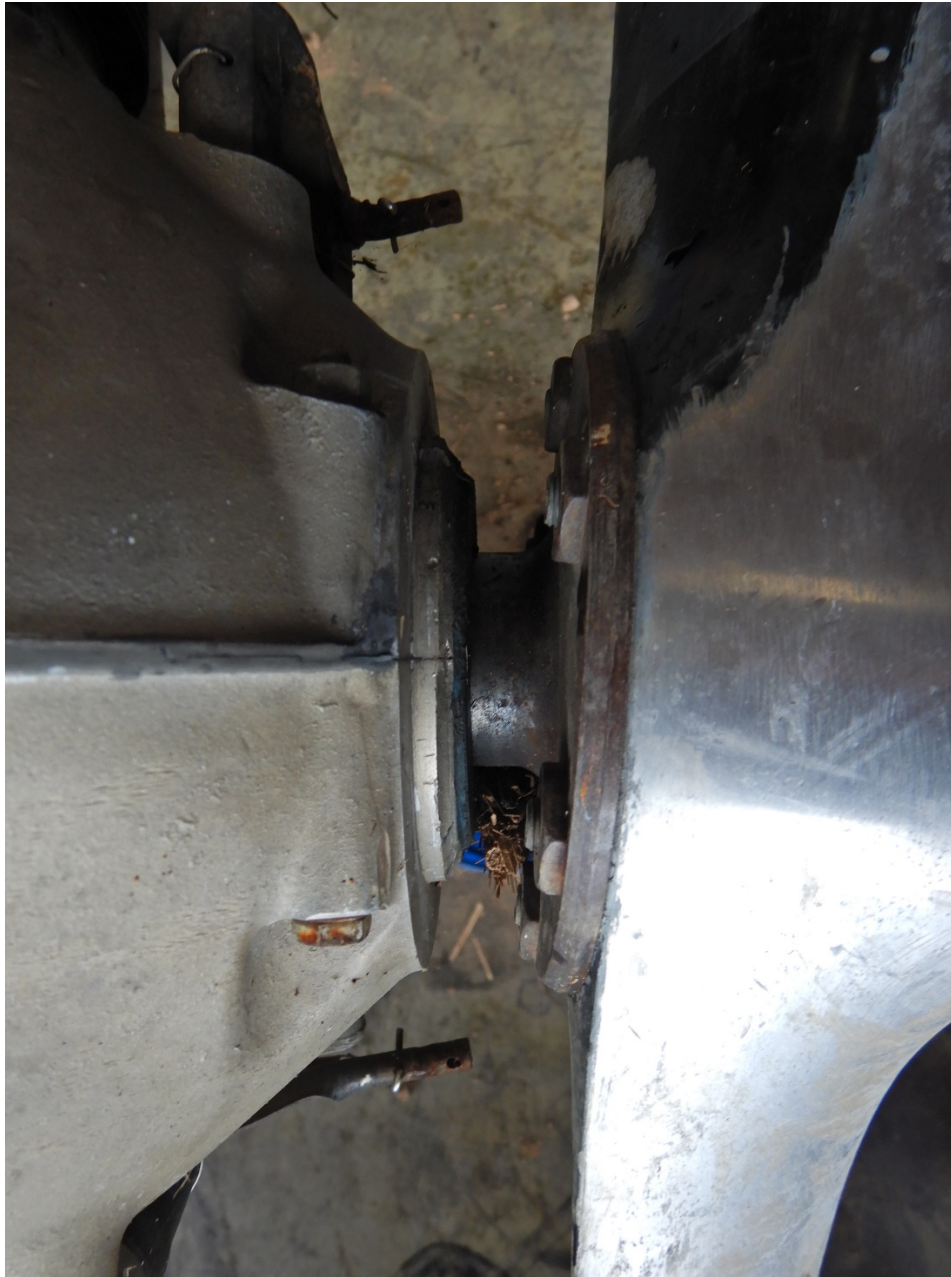
**Photo 20 - View of the bent crankshaft and propeller flange.**
