# NATIONAL TRANSPORTATION SAFETY BOARD

## Video Study

**Location:** Independence, Iowa  
**Date:** January 21, 2020  
**Aircraft:** Guimbal Cabri G2, N715RK  
**Operator:** Private  
**NTSB Number:** CEN20CA064

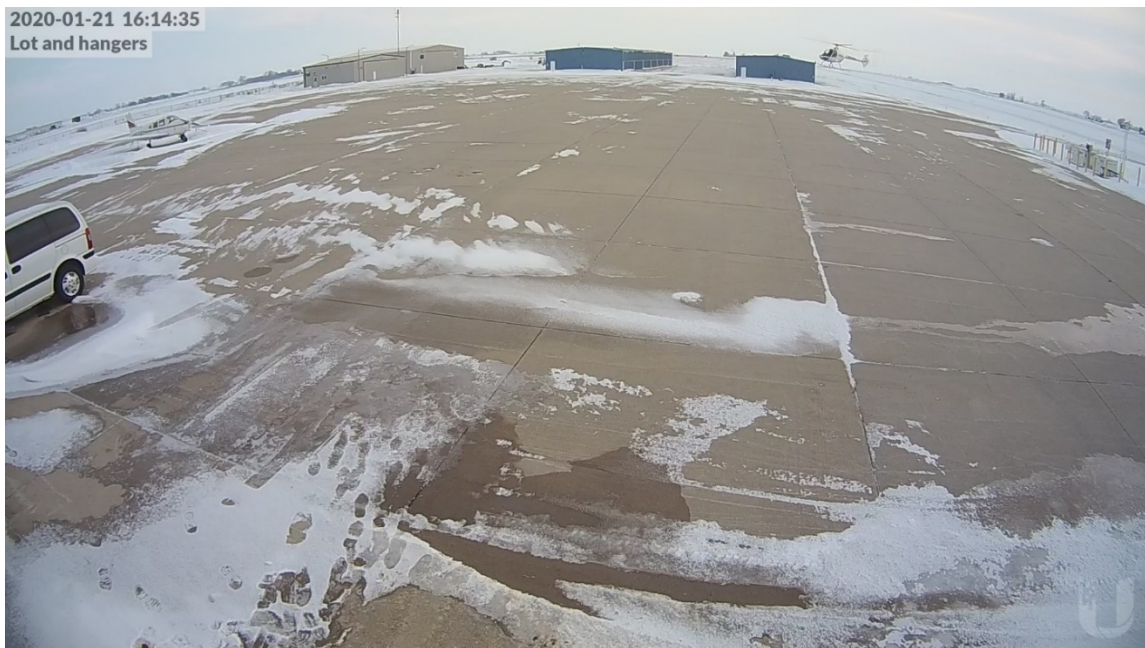
**Figure 1. Lotsandhangers.mp4 FoV.**

The Lotsandhangers.mp4 file showed integrated timestamps of 16:14:35 to 16:15:05 on January 21, 2020, for a total of 450 frames. Figure 1 is a still frame depicting the field of view (FoV).

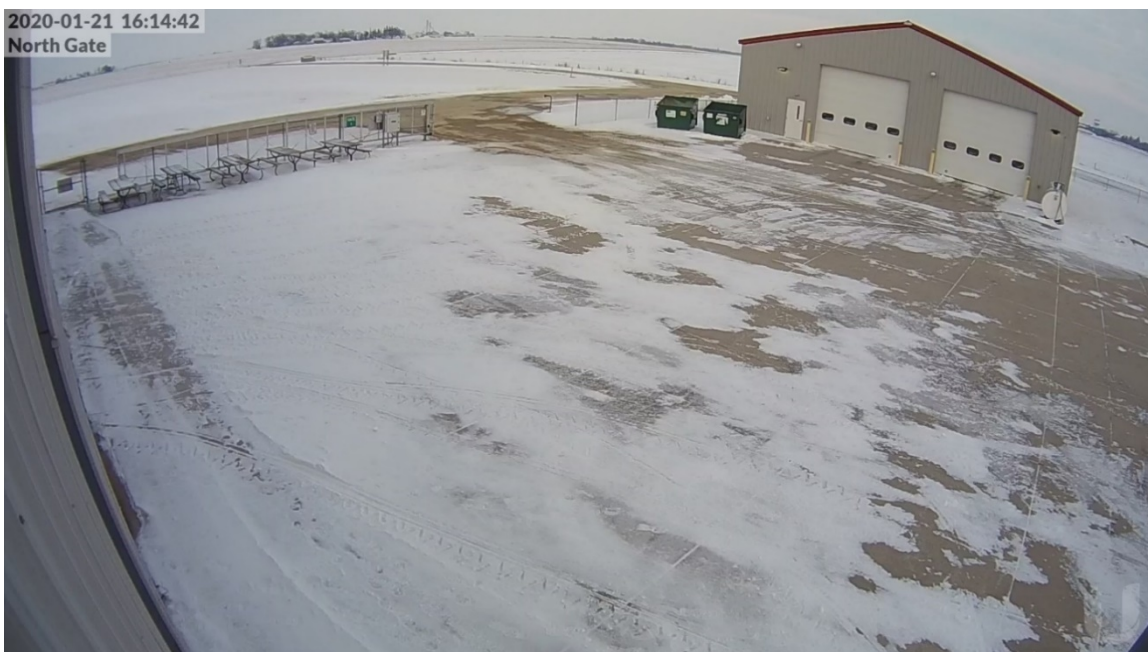
**Figure 2. NorthGate.mp4 FoV.**

The NorthGate.mp4 file showed integrated timestamps of 16:14:42 to 16:15:00 on January 21, 2020 for a total of 270 frames. Figure 2 is a still frame depicting the FoV.

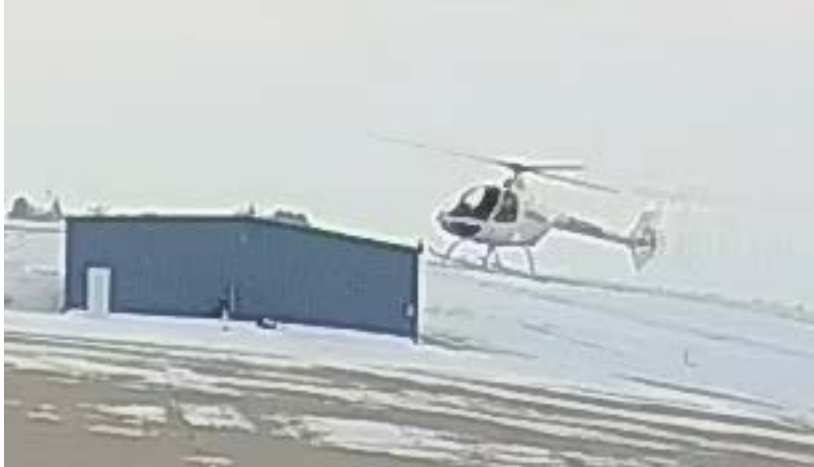
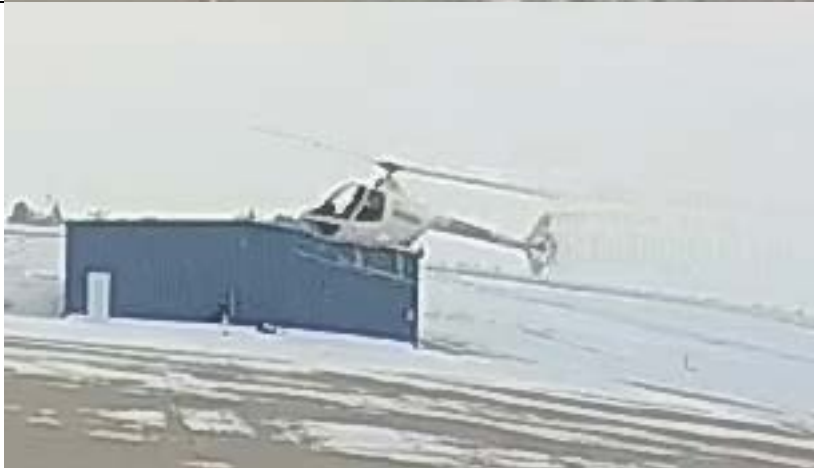
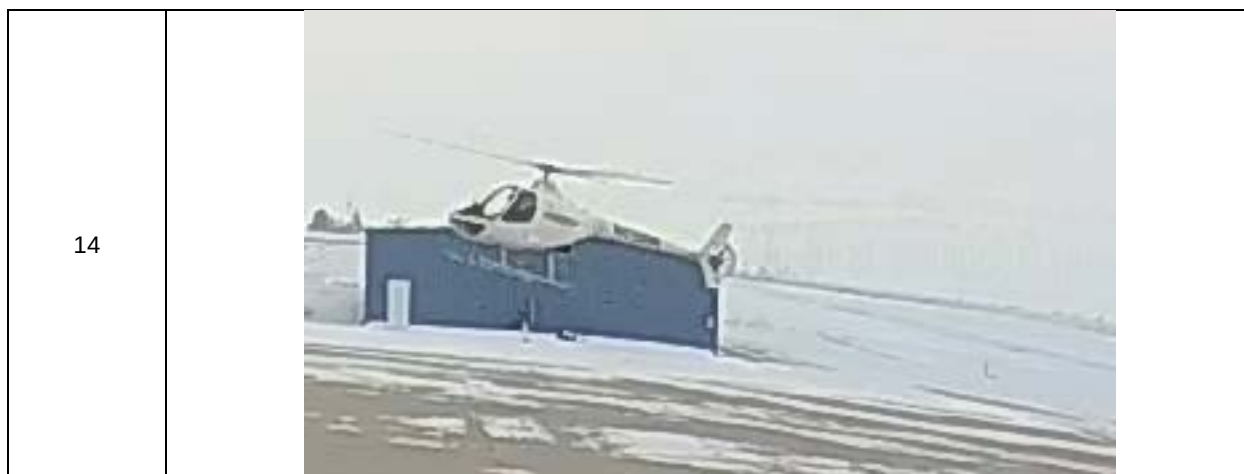
The following sequence depicts select frames from the first 14 frames of the video cropped to a region of 304 by 176 pixels, or approximately 2.6% of the full resolution. As the aircraft moves from right to left in the frame, compression artifacts of the tail rotor can be observed, resulting in a “trail” of darkened pixels following the path of the tail rotor.

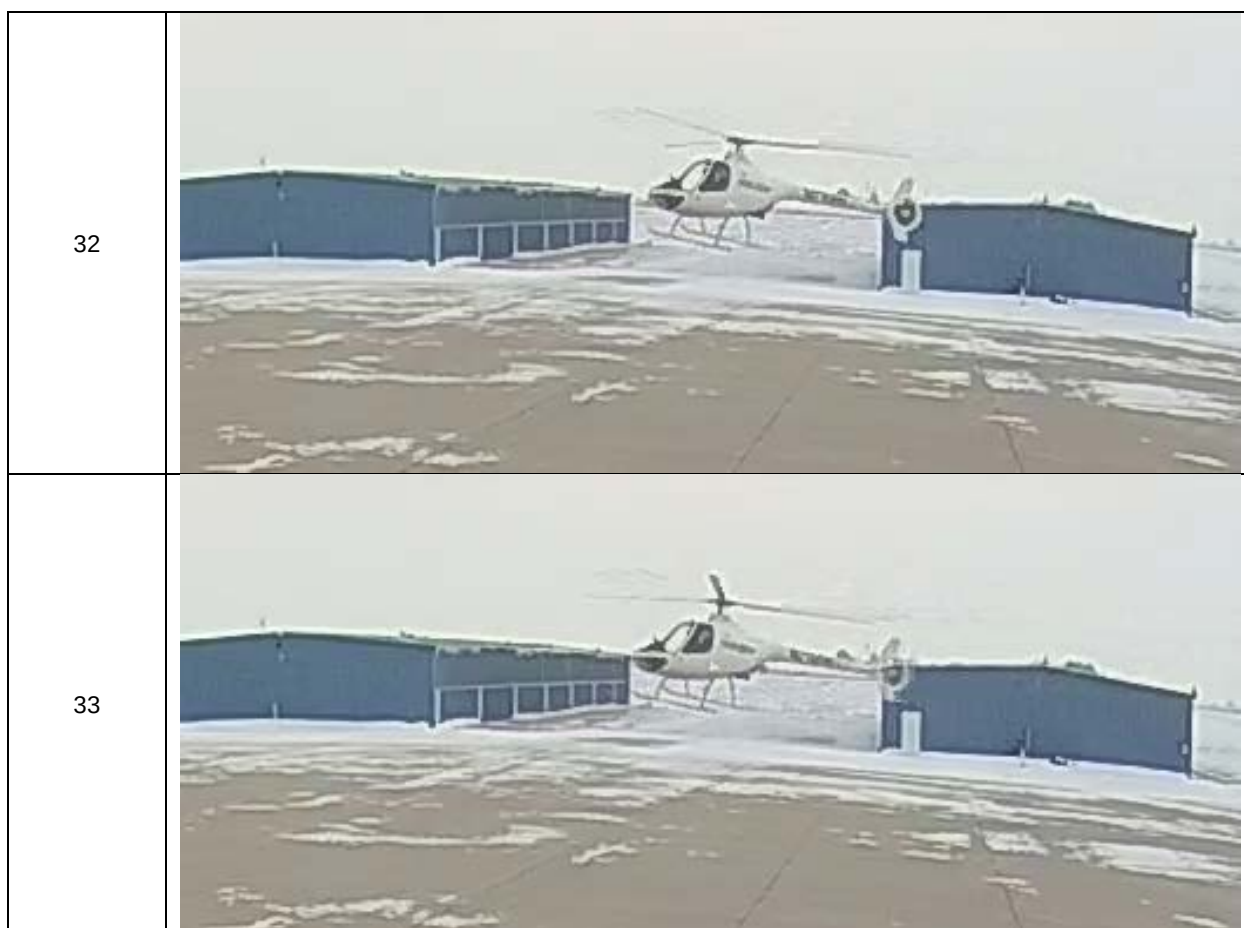
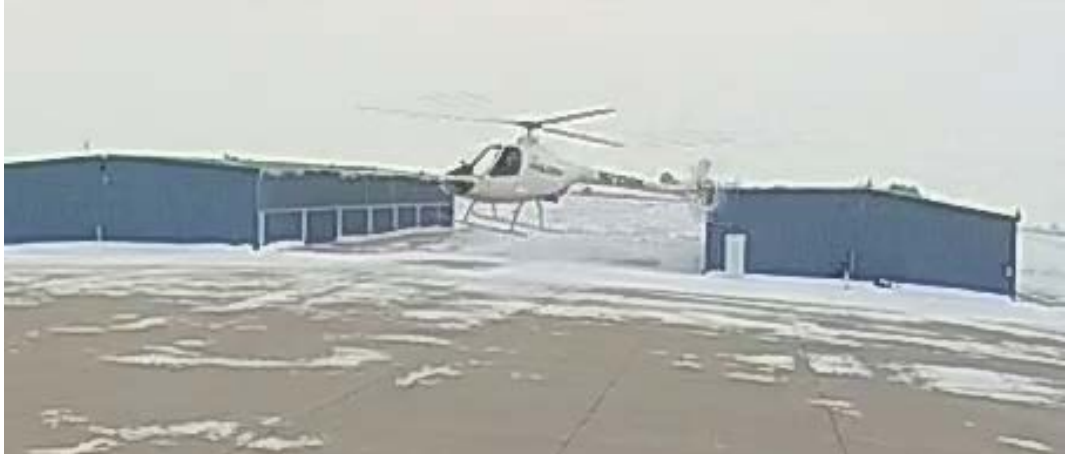
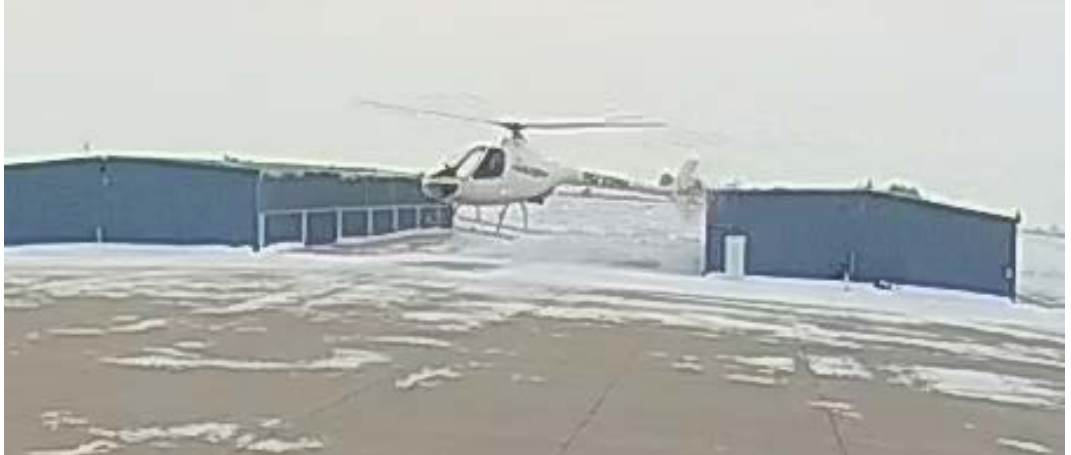
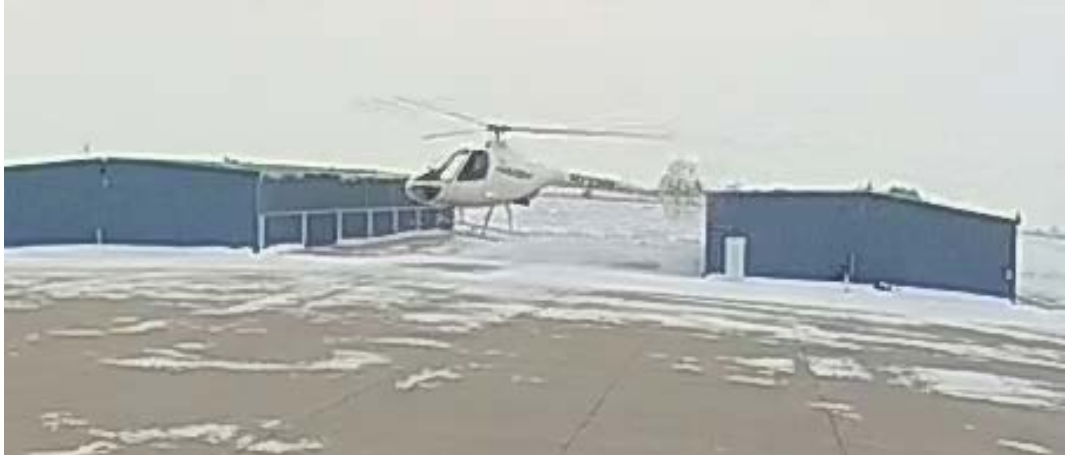
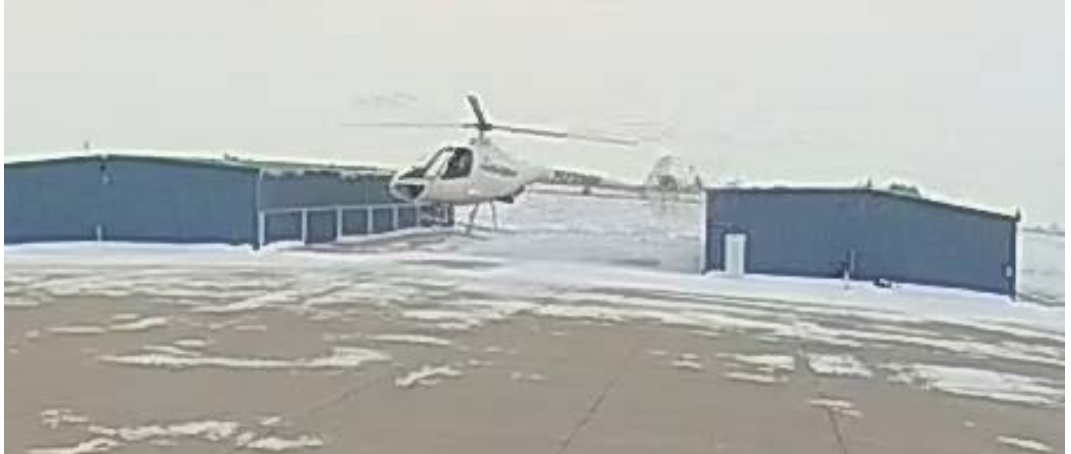
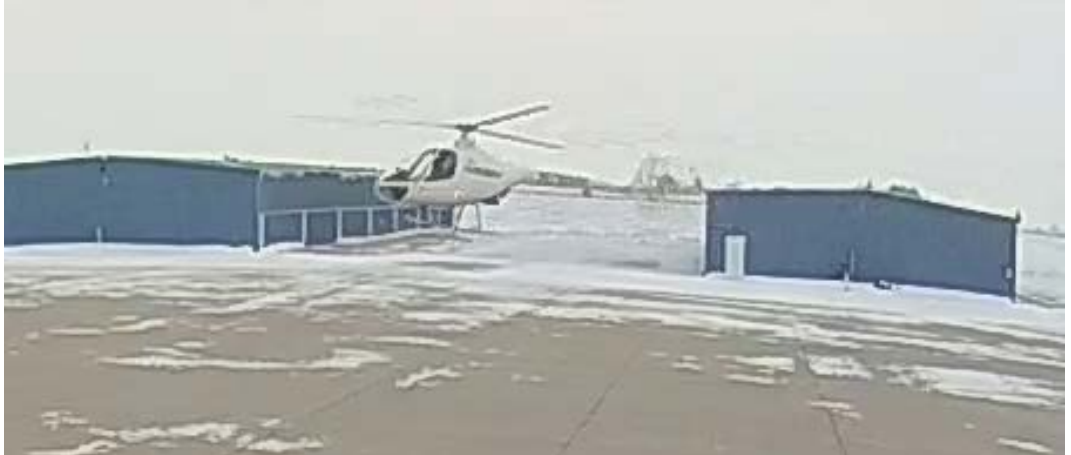
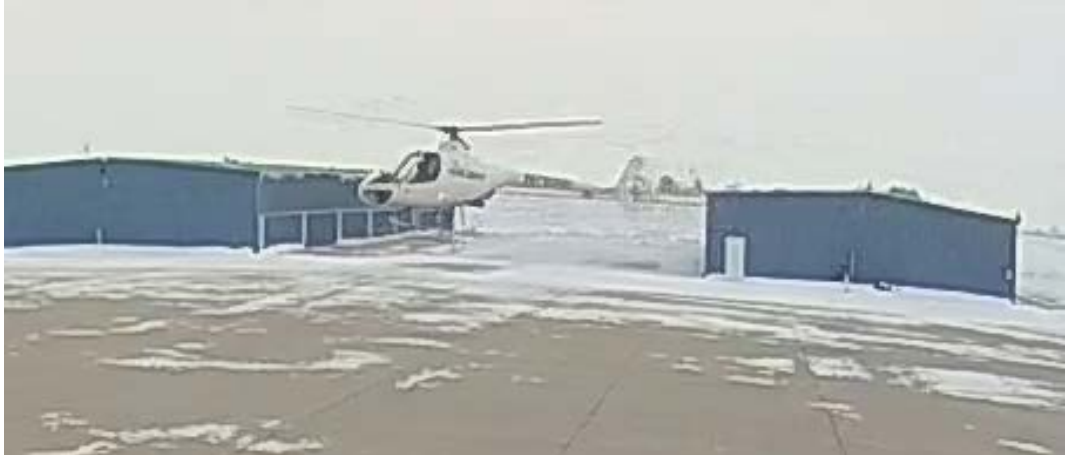
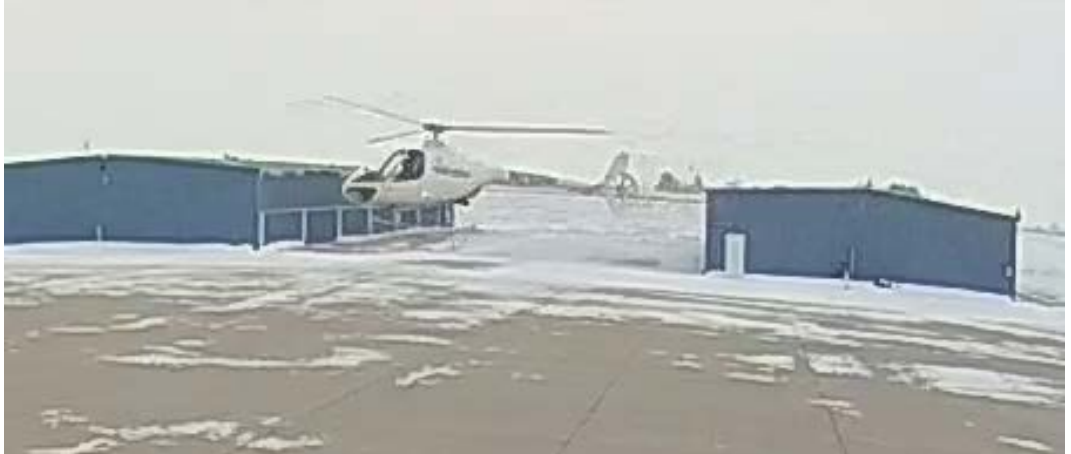
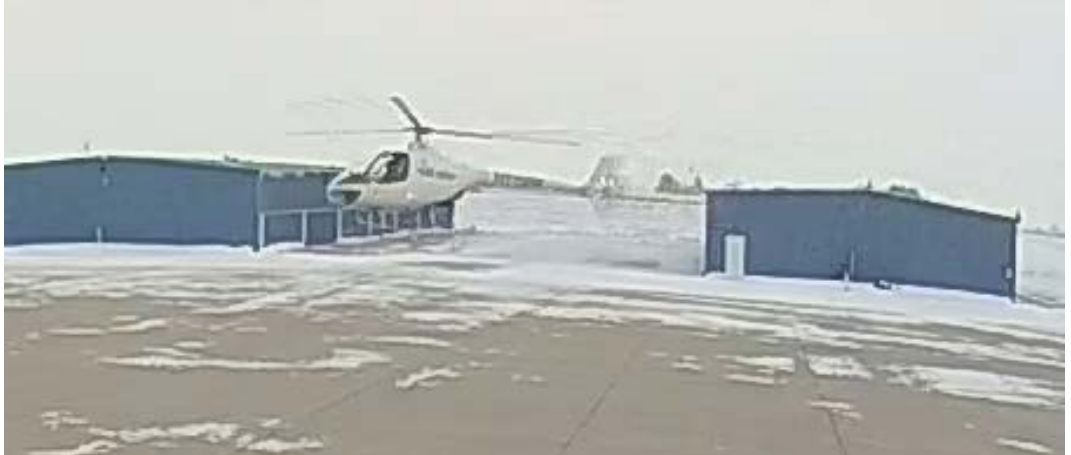
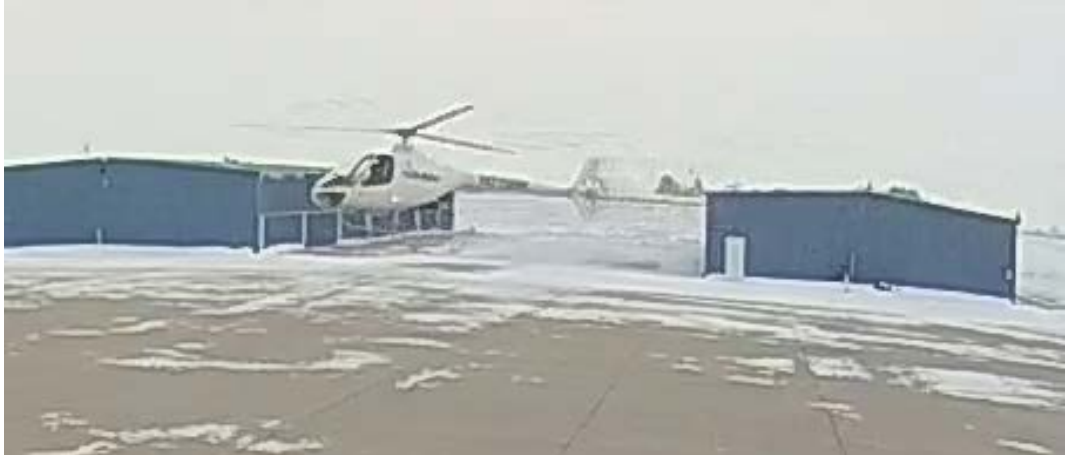
The following sequence depicts frames 32 through 42 of the video cropped to a region of 452 by 196 pixels, or approximately 4.3% of the full resolution. As the tail rotor transitions from the darker color of the hangar to the lighter color of the snow and sky, compression artifacts of the tail rotor can be observed from frame to frame. Artifacts are also observed in the main rotor. In the angle captured by the camera, the center of the tail rotor moves from right to left along the horizon. At the horizon line to the left of the hangar, there are dark objects between the ground and the sky.

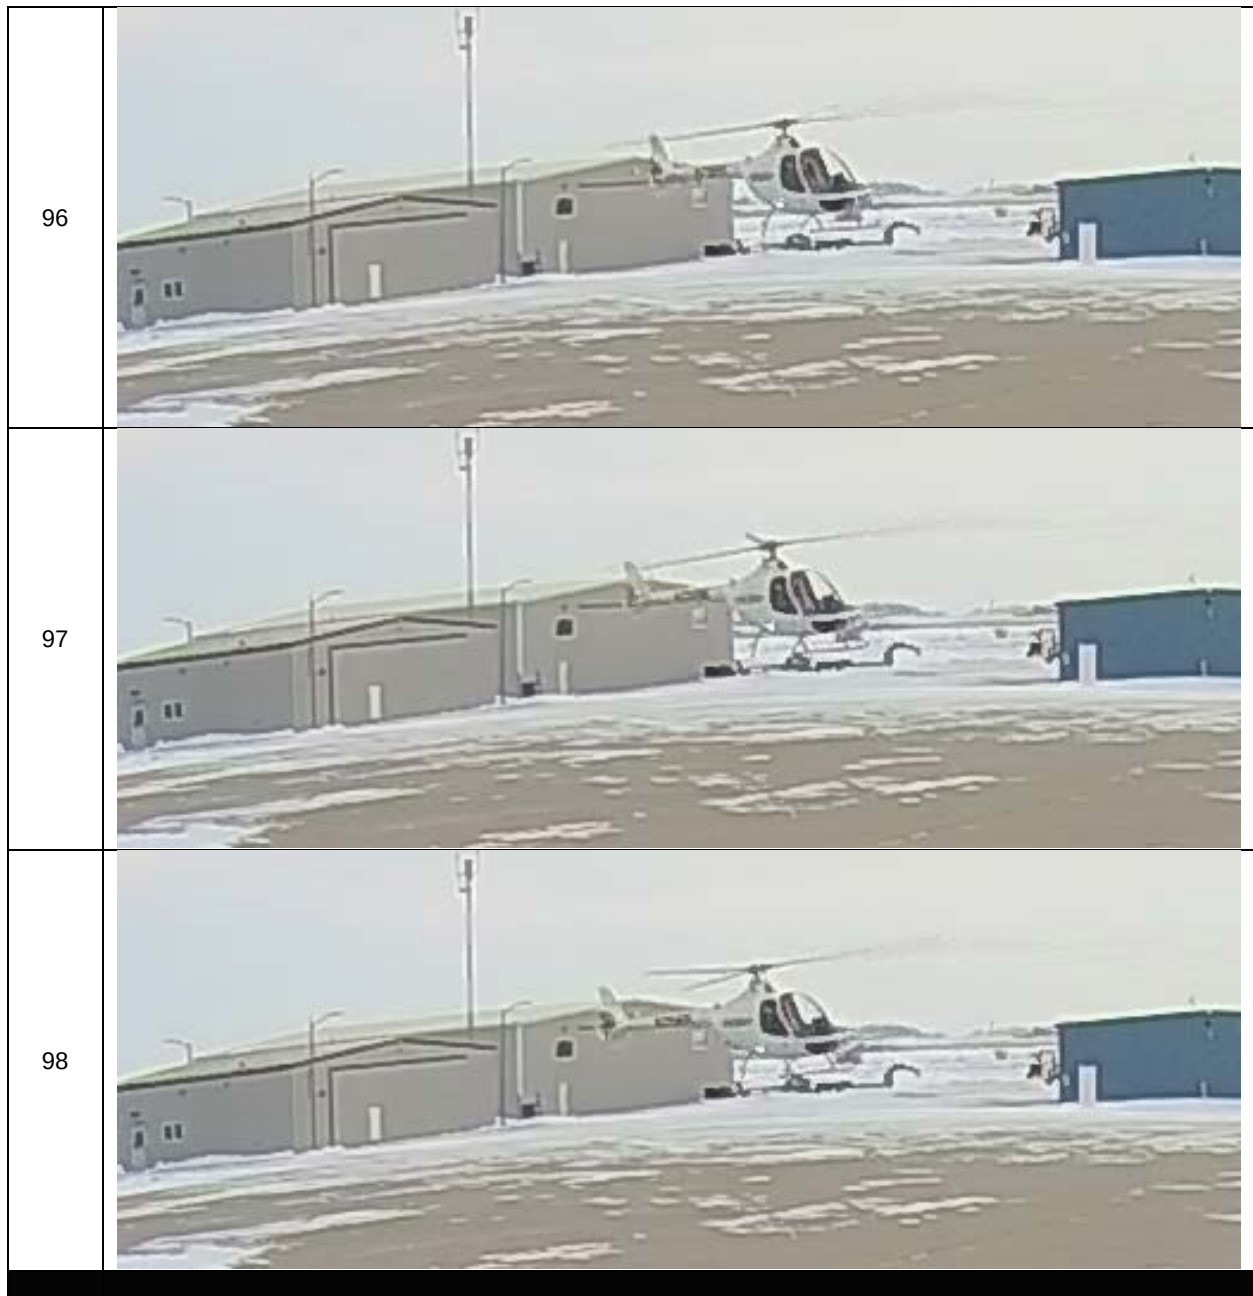
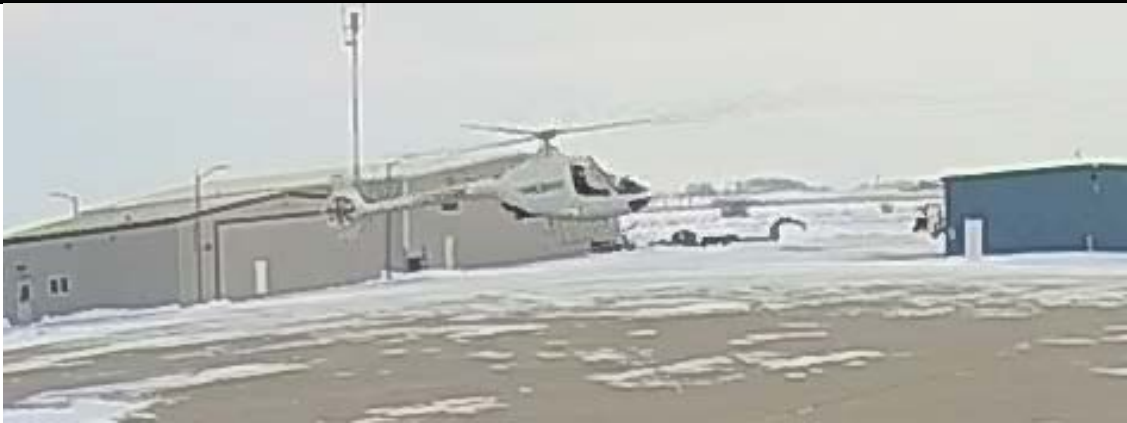
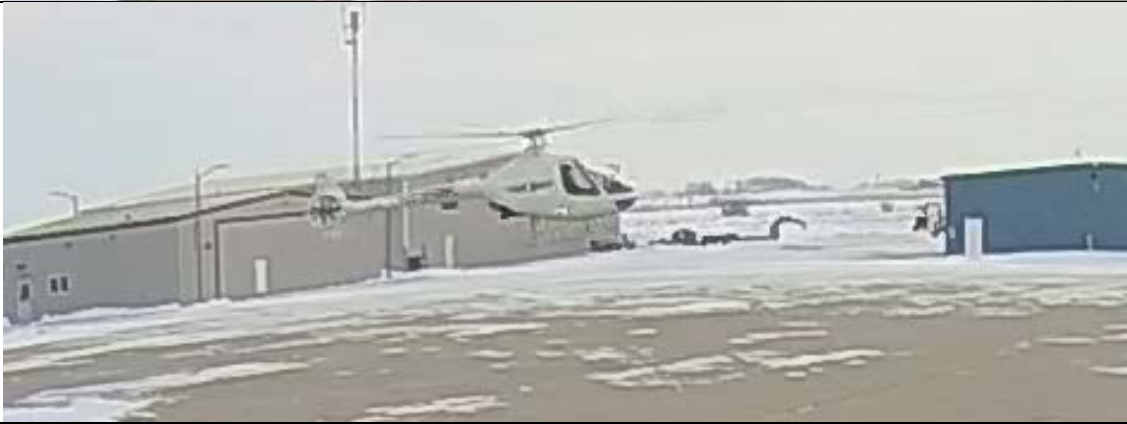
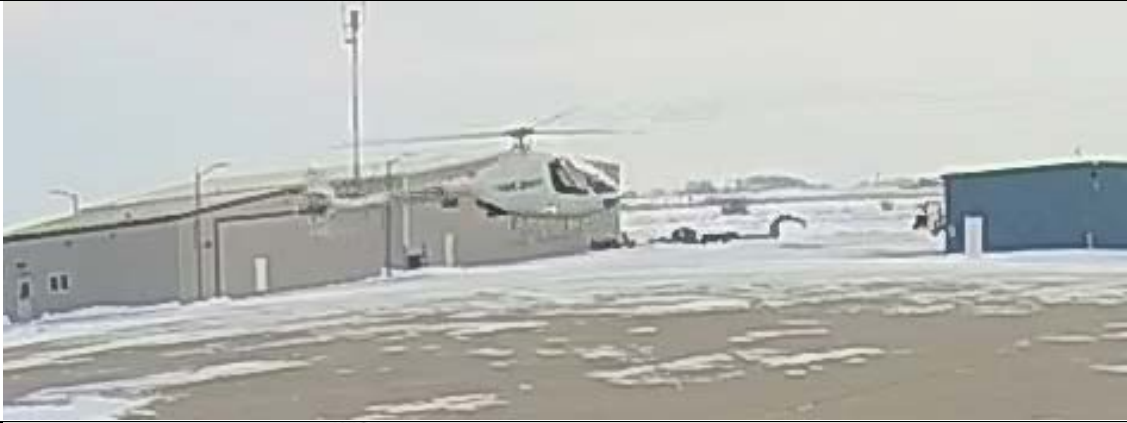
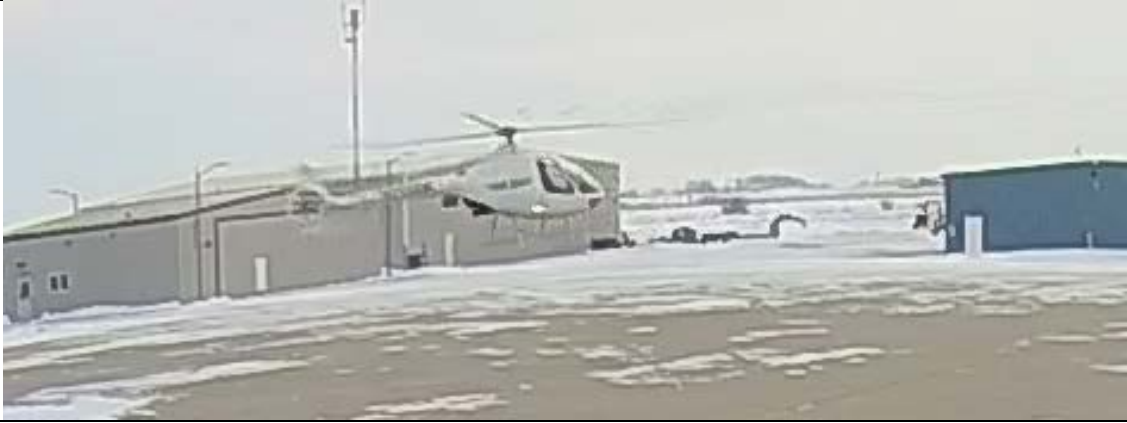
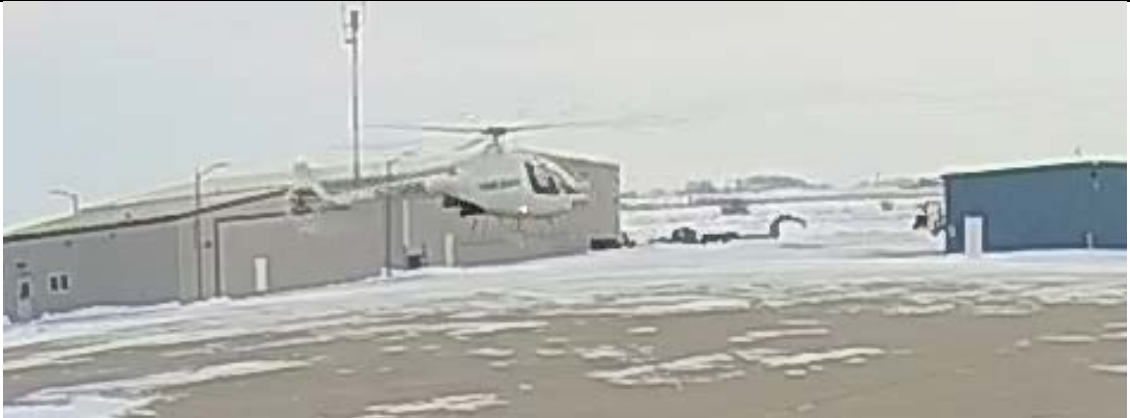
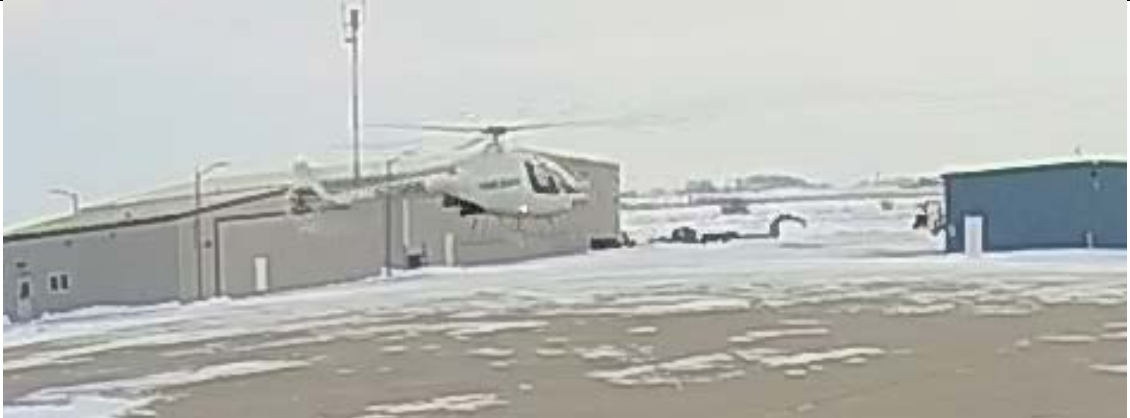
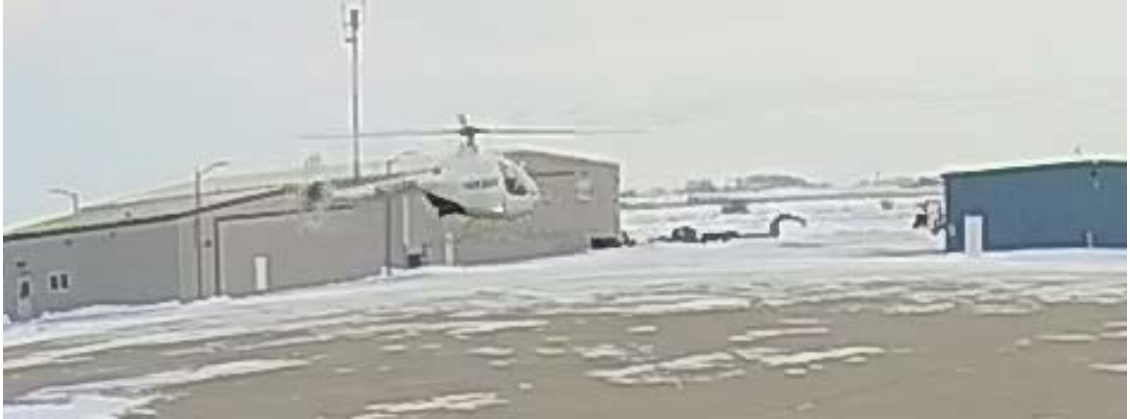
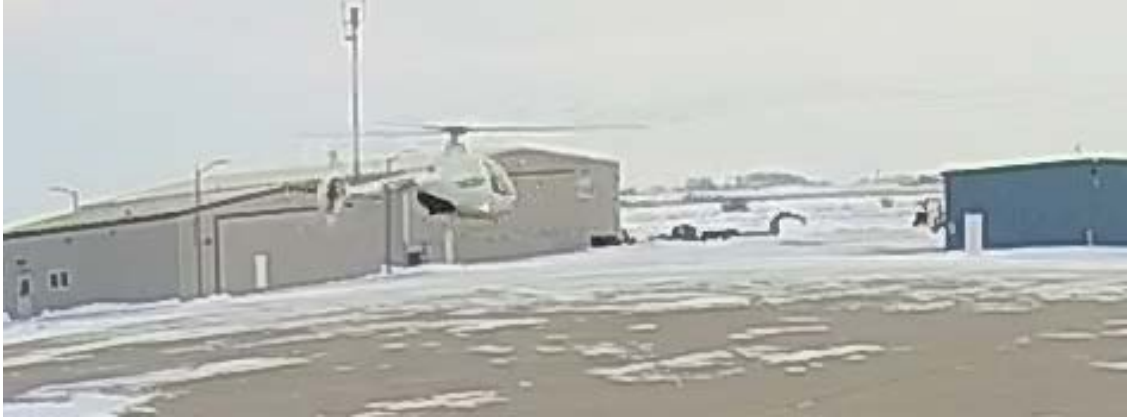
The following sequence depicts frames 96 through 98 and frames 105 through 112 of the video cropped to a region of 472 by 176 pixels, or approximately 4.0% of the full resolution. As the tail rotor moves from right to left in the frame, compression artifacts of the tail rotor can be observed from frame to frame.

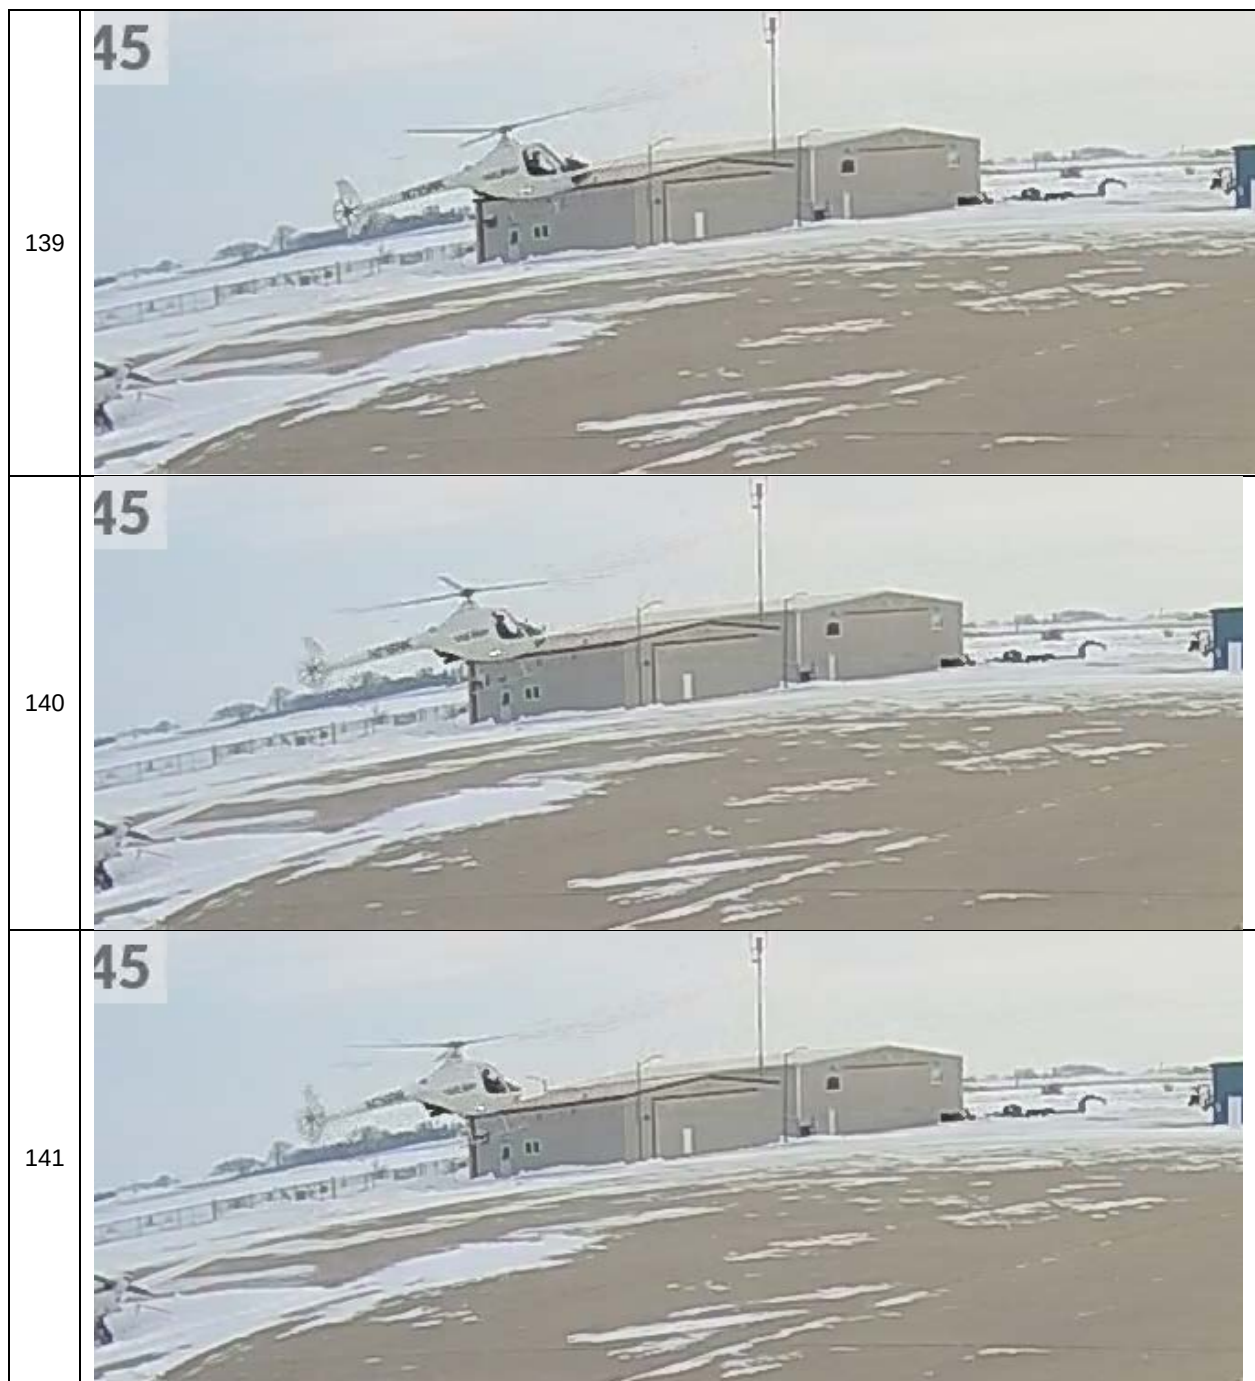
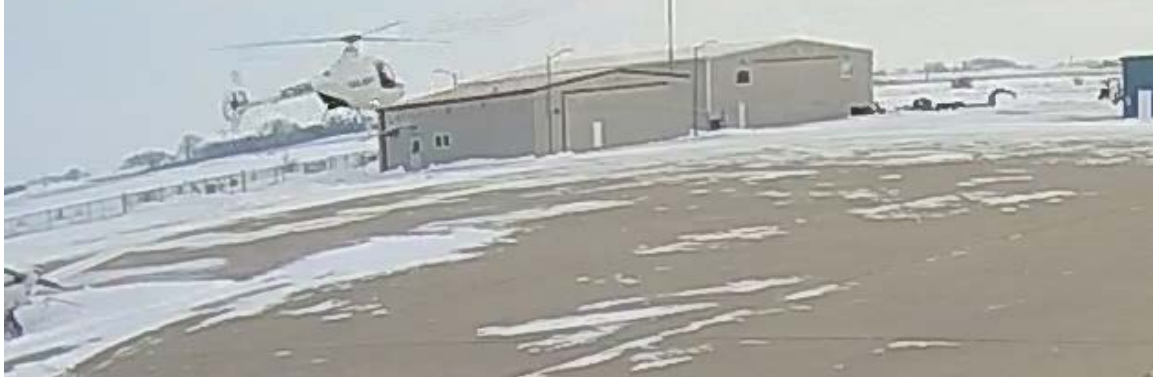
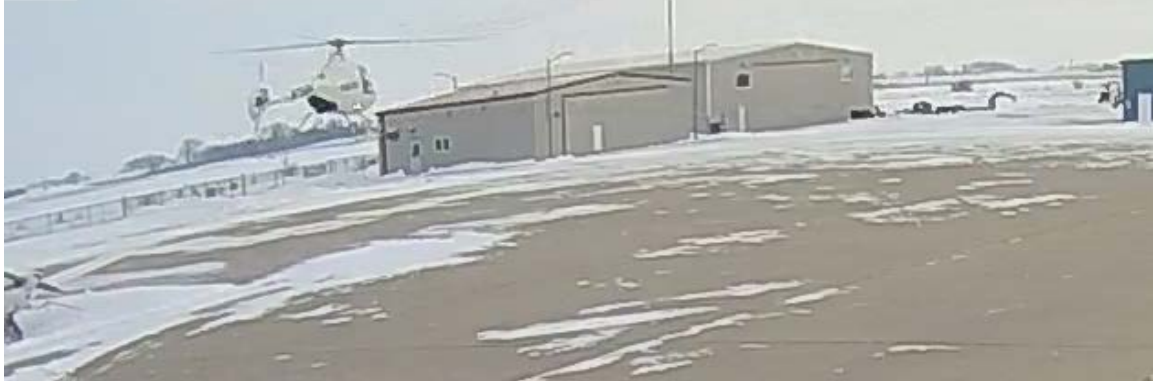
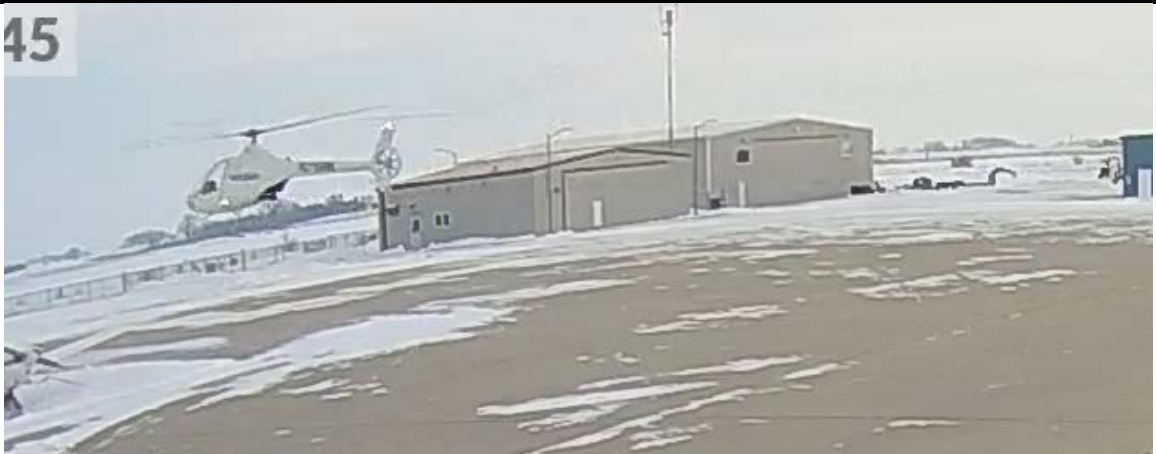
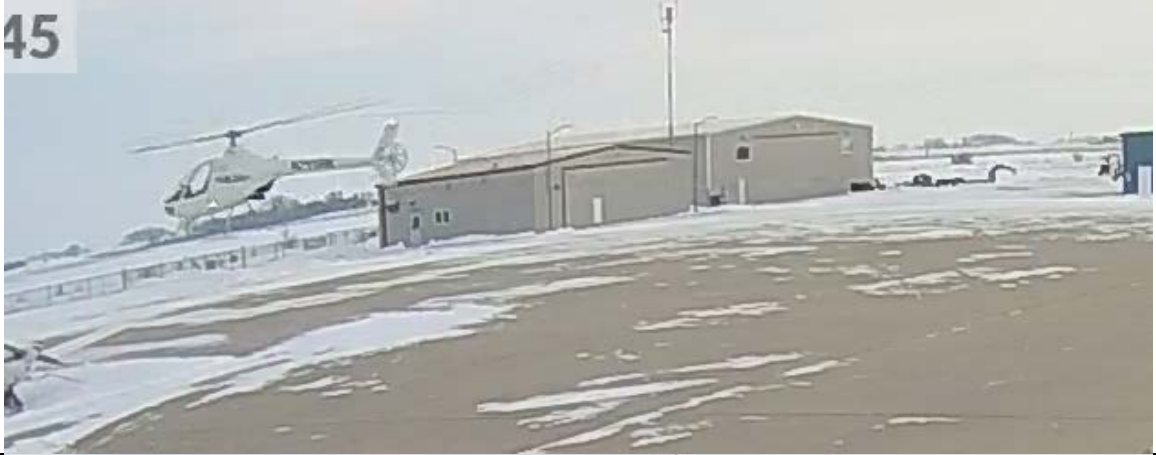
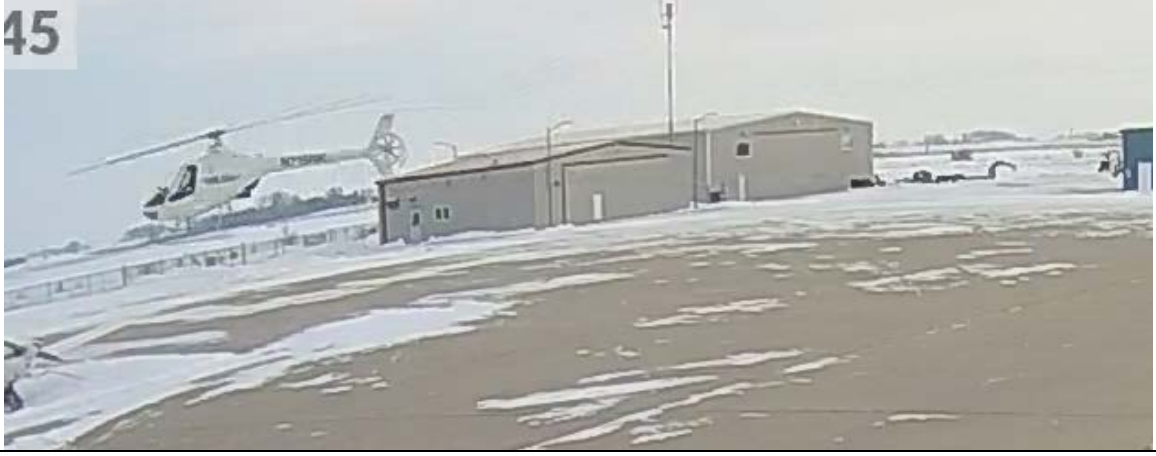
The following sequence depicts frames 139 through 143 and frames 149 through 151 of the video cropped to a region of 628 by 248 pixels, or approximately 7.5% of the full resolution. Compression artifacts of the tail rotor can be observed from frame to frame.

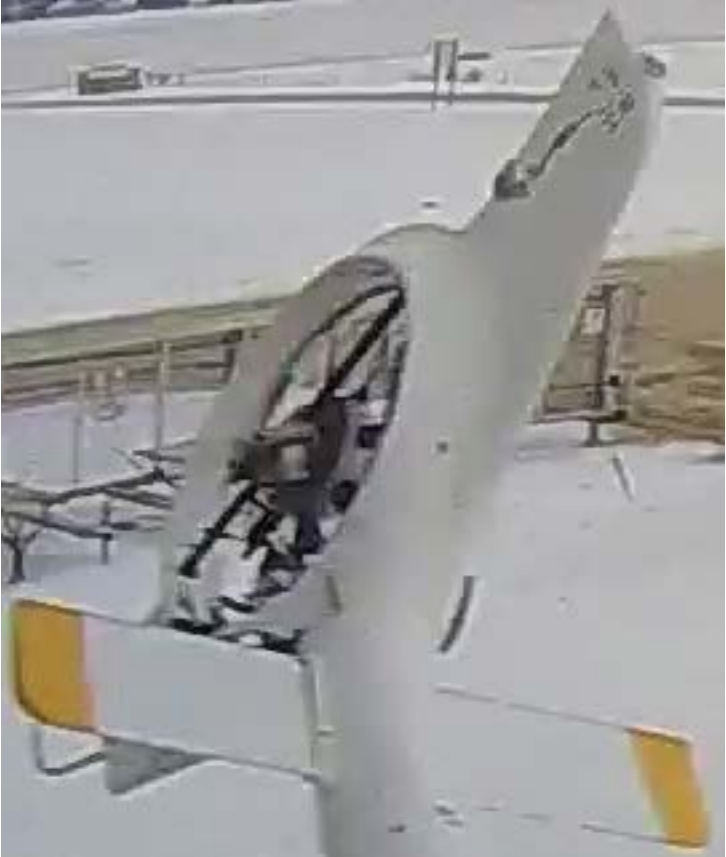
Cropped portions of frames 104 through 106 are depicted in the following sequence. The integrated timestamps of the still images are 16:14:49.
