## **NATIONAL TRANSPORTATION SAFETY BOARD**

### **Weather Study**

# **METEOROLOGY**

CEN20FA075

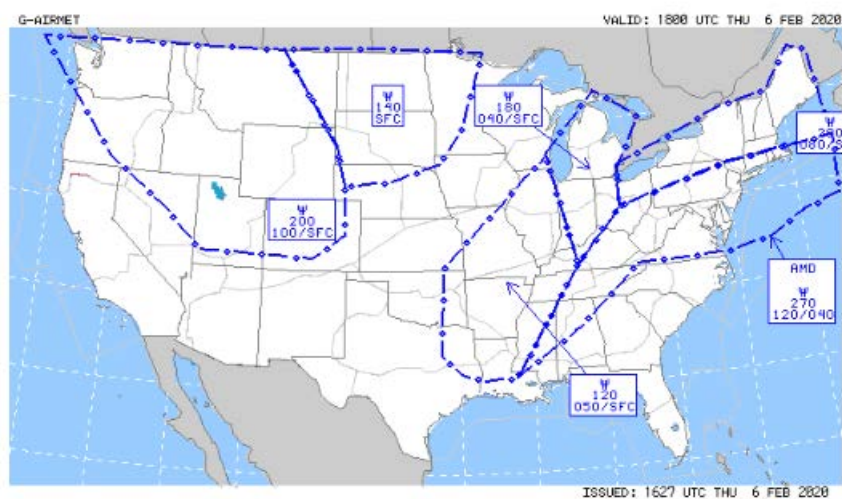
The NWS also had AIRMETs current for IFR conditions and for moderate icing conditions valid for the periods of 1200 and 1500 CST and are depicted as G-AIRMETs in figures 17-20.

**Figure 19 - G-AIRMET Zulu for icing conditions valid for 1200 CST**

The accident airplane was operating under instrument flight rules so the AIRMET Sierra was not necessarily considered a hazard and provided the extent of the IFR conditions and locations for alternate airport planning. The AIRMET Sierra for IFR conditions suggested conditions over southern Louisiana south of the route of flight provided a higher likelihood of VFR conditions. The G-AIRMET Zulu series for icing implied a threat of moderate icing. The freezing level was depicted between the surface and 4,000 ft over northern Louisiana.

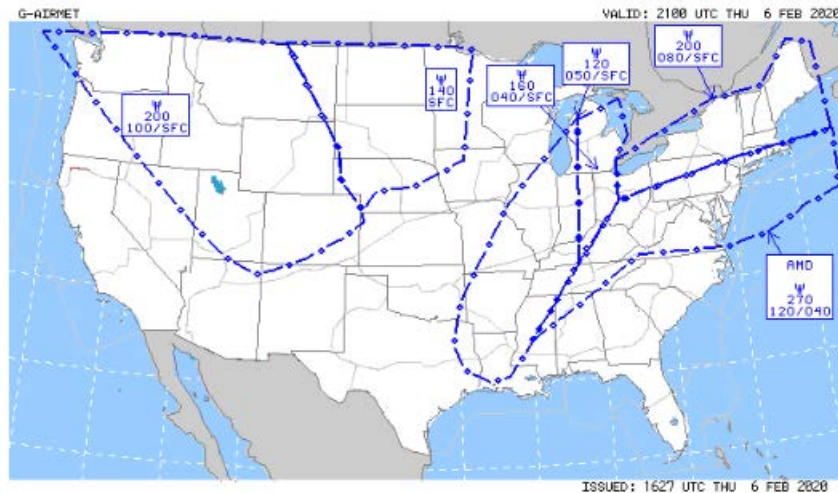
Figure 20 - G-AIRMET Zulu for icing conditions valid for 1500 CST
