## **NATIONAL TRANSPORTATION SAFETY BOARD**

### **Weather Study**

CEN20LA028

Location: Detroit, Michigan  
Date: December 3, 2019  
Time: 0833 eastern standard time  
1333 Coordinated Universal Time (UTC)  
Airplane: BAE 125-800A; Registration: N469RJ

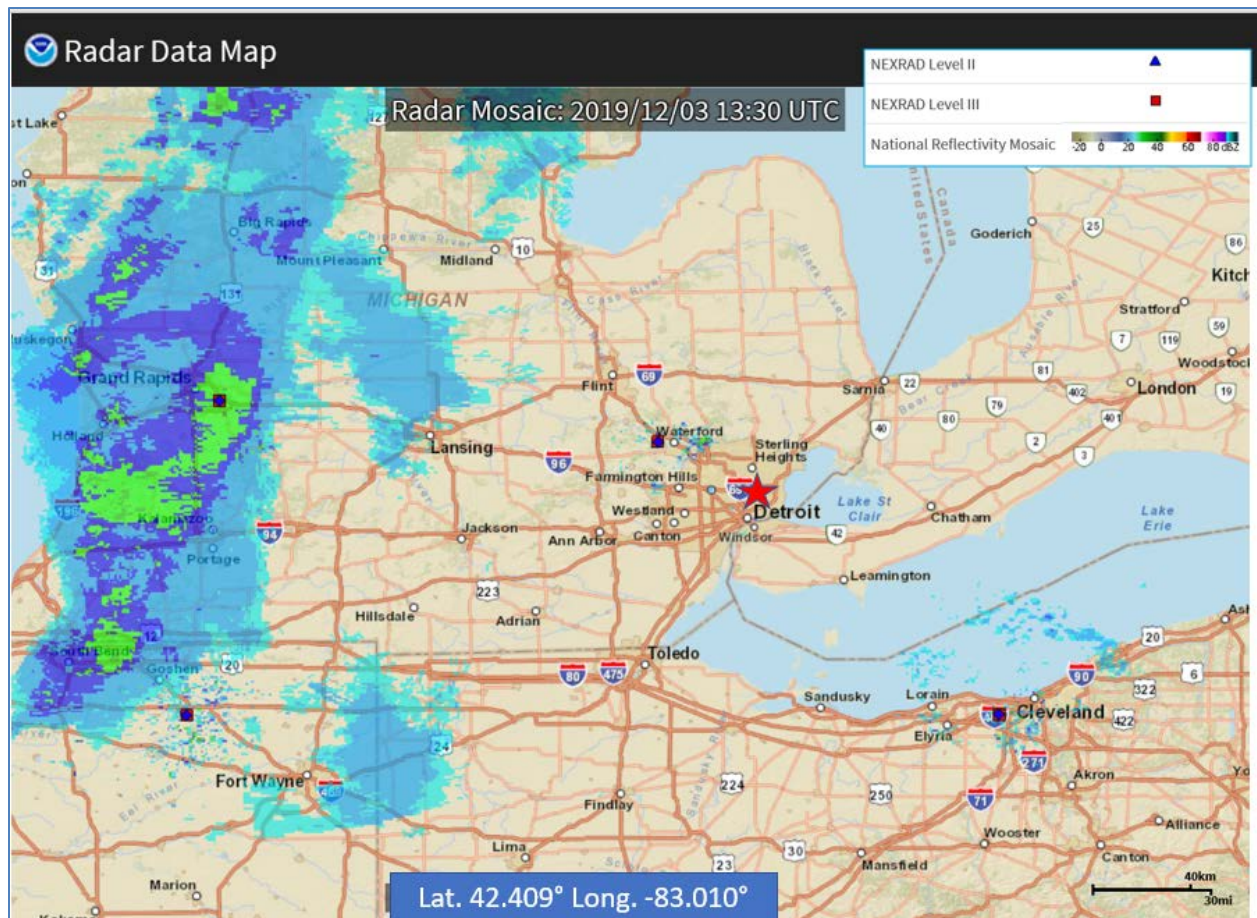
Figure 3 - National Composite Radar Mosaic for 0830 EST

The NWS National Composite Radar Mosaic centered over Michigan for 0830 EST is included as figure 3 with the accident site marked by the red star. The radar mosaic depicted a large area of light echoes over northern Indiana and western Michigan, which were associated with snow showers. No echoes were identified over the accident airplanes route of flight in the Detroit area.

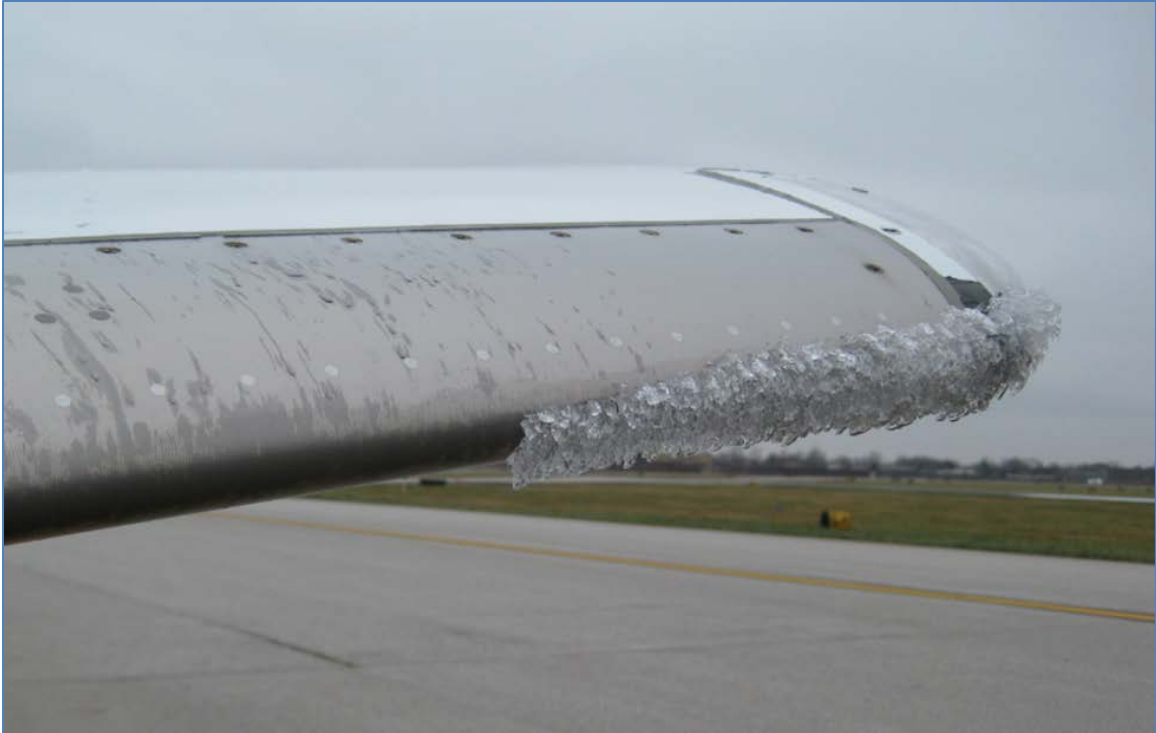
**Figure 27 - Left wing tip with ice**

The accident pilot noted after they evacuated the airplane, they observed visual signs of ice on the left wing near the wing tip and in the seams between the TKS panels. Photographs of the ice buildup on the left outer section of the wing and on the ground are included in figures 27-29.
