-- CEN20LA063 --  
**Accident Site Diagram**

Figure 1 – Accident Site Location (Provided by FAA)

OHIO TRAFFIC CRASH REPORT  
DIAGRAM / NARRATIVE CONTINUATION

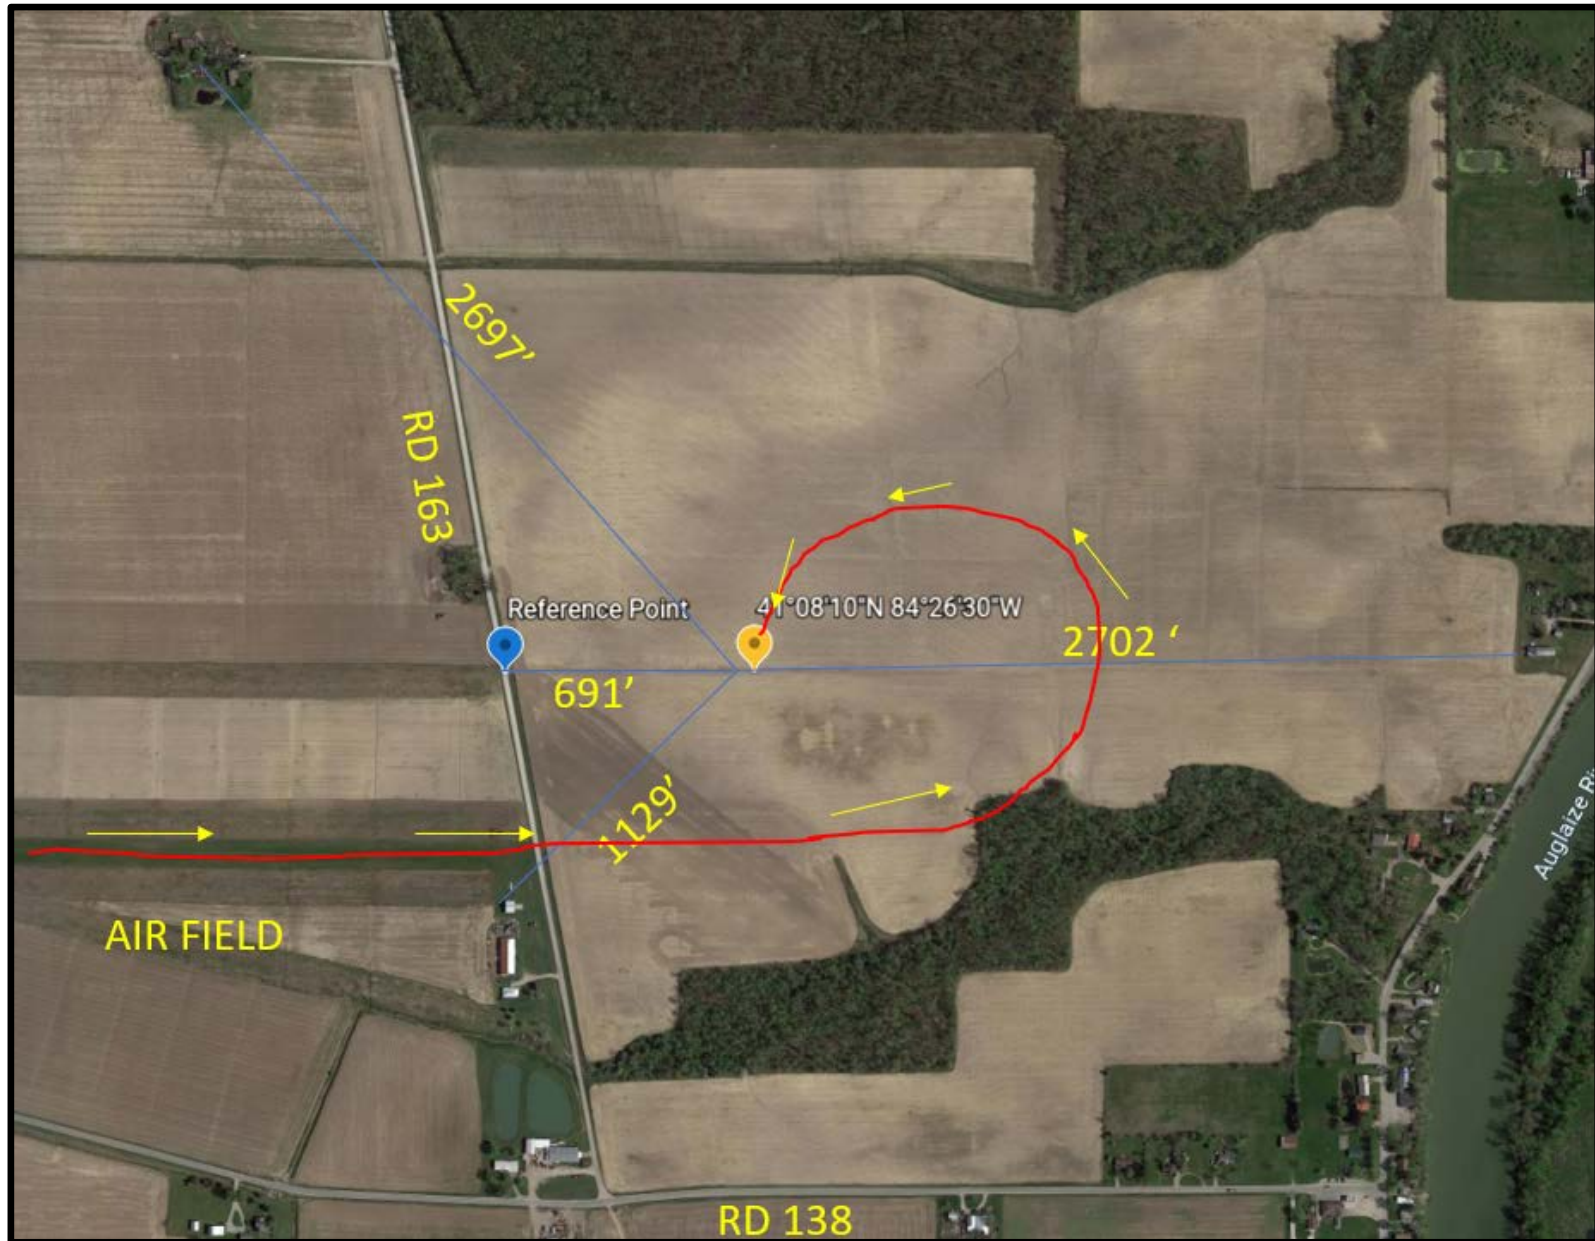
RP to Base 5.2 FT

RP: Telephone company box #2-11022

| | AR | FE | DESCRIPTION |
|---|---|---|---|
| A | 348 $\frac{1}{2}$ | 841 $\frac{1}{2}$ | TAIL OF Plane |
| B | 367 $\frac{1}{2}$ | 856 $\frac{1}{2}$ | NOSE OF Plane |
| C | 341 $\frac{1}{2}$ | 835 $\frac{1}{2}$ | Left wing INSIDE |
| D | 354 $\frac{1}{2}$ | 863 $\frac{1}{2}$ | LEFT wing outside |
| E | 355 $\frac{1}{2}$ | 862 $\frac{1}{2}$ | Right wing INSIDE |
| F | 360 $\frac{1}{2}$ | 863 $\frac{1}{2}$ | RIGHT wing outside |
| G | 355 $\frac{1}{2}$ | 851 $\frac{1}{2}$ | WINDSHIELD |
| H | 341 $\frac{1}{2}$ | 853 $\frac{1}{2}$ | SIDE WINDOW |
