## **NATIONAL TRANSPORTATION SAFETY BOARD**

# **MAGNETO AND SPARK PLUG EXAMINATION**

**CEN20LA145**

Location: Sidney, Iowa  
Date: April 10, 2020  
Aircraft: Beechcraft N35, N1258Z  
NTSB Investigator-in-Charge: Shaun Williams

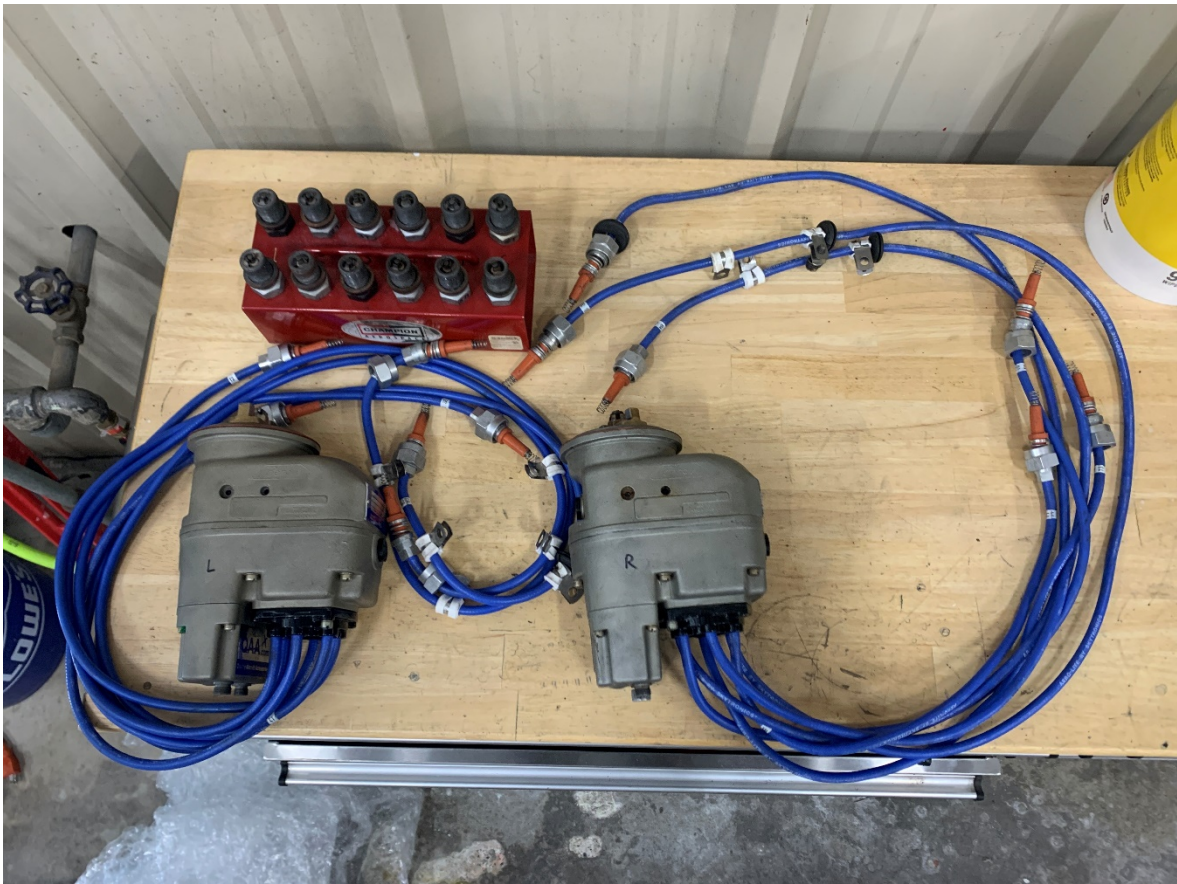
The left and right magnetos were received intact with the ignition harness caps still installed. The upper and lower spark plugs were also received intact.

Figure 1: Left and right magnetos, and spark plugs, as received.

A P-Lead adapter was installed in the “switch” port of the right magneto and the right magneto was secured using a work bench vise. Utilizing a hand drill, the magneto drive shaft was rotated at various speeds. Spark was observed on all ignition harness leads. A P-Lead adapter was installed in the “switch” port of the left magneto and the left magneto was secured using a work bench vise. Utilizing a hand drill, the magneto drive shaft was rotated at various speeds. Spark was observed on all ignition harness leads.

Utilizing one ignition lead from the right magneto, one spark plug was attached at a time, and the magneto drive shaft was rotated using a hand drill. Spark was produced across all spark plug electrodes with varying degree of differences.

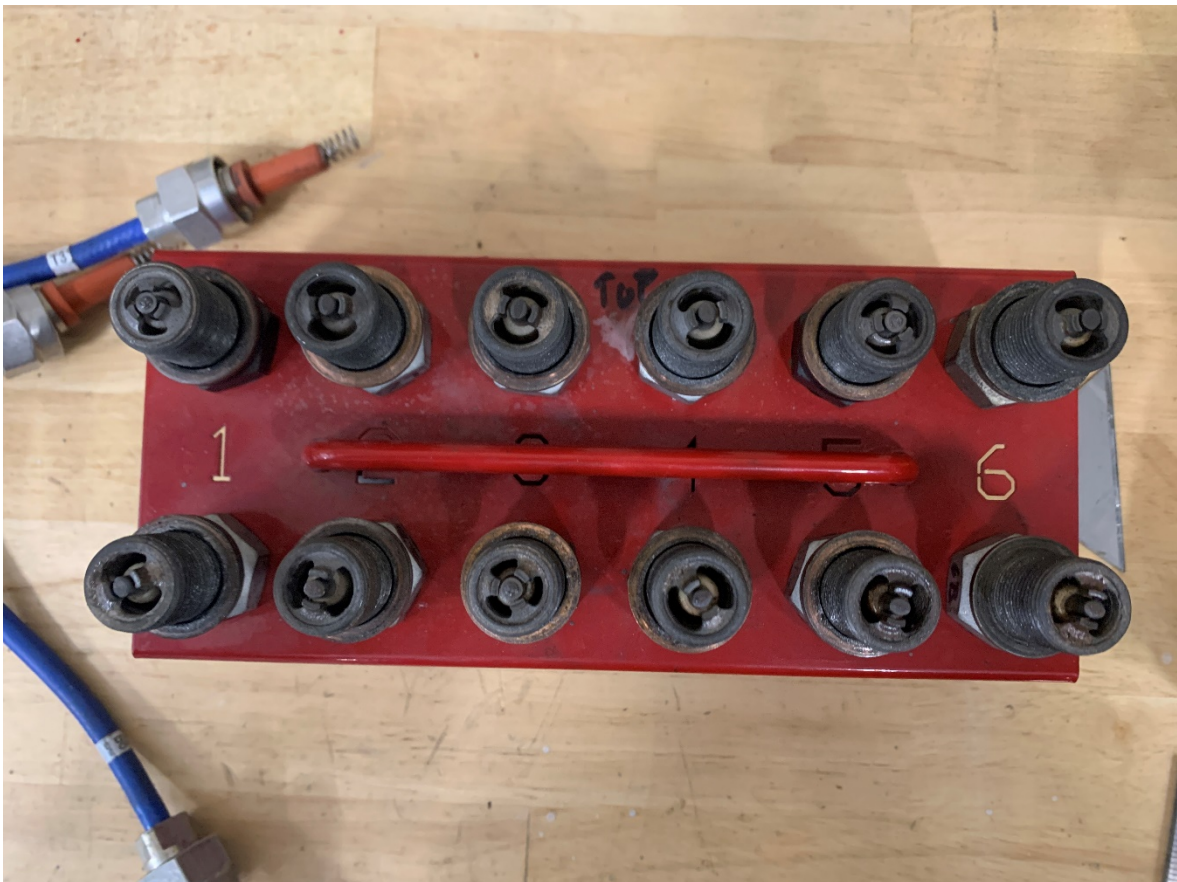
Spark plugs were intact and appeared undamaged. Each spark plug was labeled (except for 1 top), for correct cylinder location. The spark plug gaps were measured using feeler gauges along with being compared to Champion AV-27 Check-A-Plug Chart for general condition. The findings of each spark plug gap measurement along with electrode condition is noted in the below table.

Figure 2: Upper and lower spark plugs as received.

Table 1: Spark plug gap measurements, type, and general condition of electrode notes.

Per Champion Aerospace LLC Aviation Catalog, AV-14, revision date January 2010, the spark plug gap range for an RHB32E spark plug is between .016” and .021”. Information obtained from BG Spark Plug’s website (<http://bgservice.com/50.html>) showed that the BG Spark Plug 341-1 standard gap is .014”.
