# NATIONAL TRANSPORTATION SAFETY BOARD

## Video Study

NTSB Case Number:  
CEN20LA167

Location: Houston, Texas  
Date: May 2, 2020  
Time: 0203 CDT  
Aircraft: MD 369E helicopter

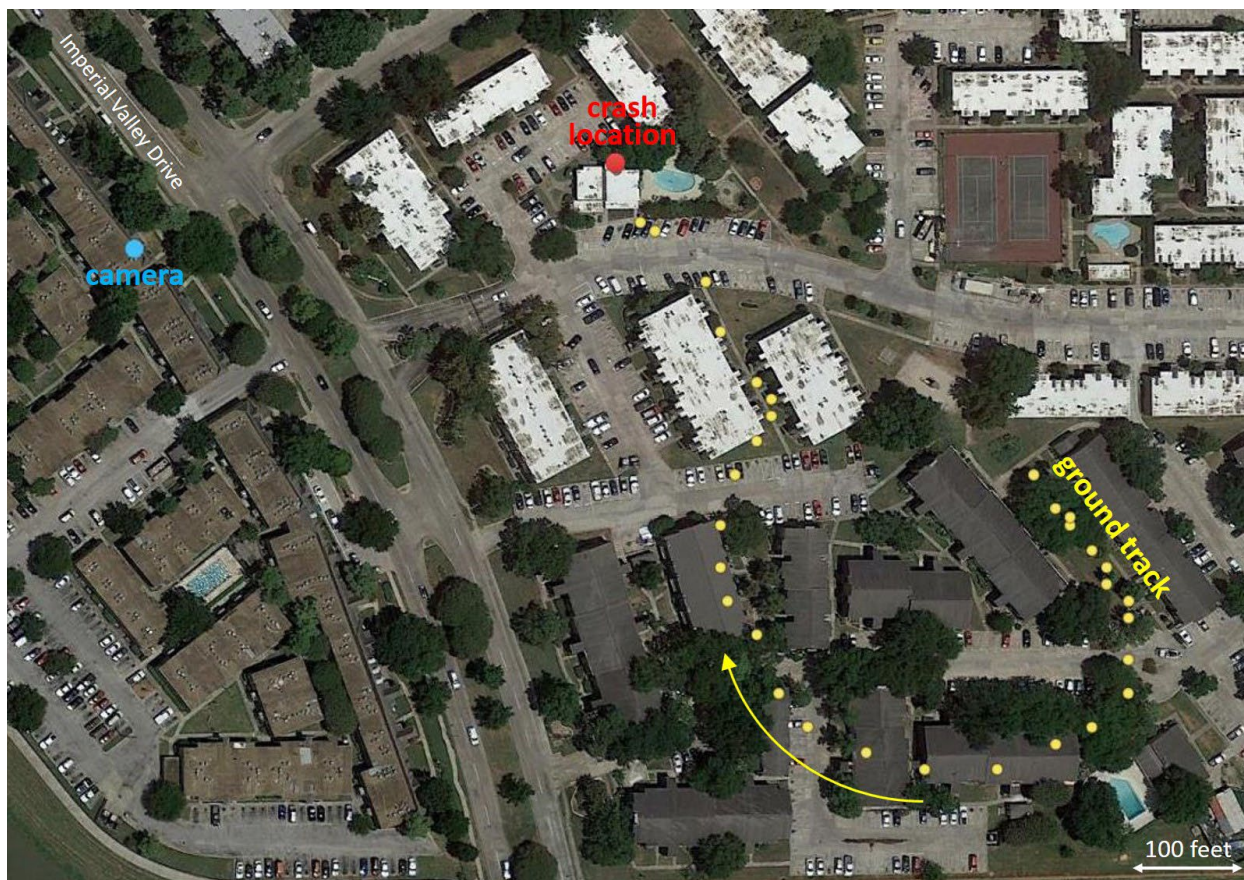
**Figure 1. Aerial View of the Accident Area**

The goal of this study was extracting information on motion and operation of the accident helicopter from a video. The video was recorded with a phone camera by a person in a residential building on Imperial Valley Drive, about 450 feet from the crash site. Figure 1 is an aerial view of the accident area. The camera location, the crash location and the ground track during the last 33 seconds that ended at the crash time are marked on the aerial view. The ground track is based on ADS-B data. Since the ground track and altitude were known, the primary objective was estimating the yaw angle and the yaw rate of the helicopter that could provide information on the cause of this accident.

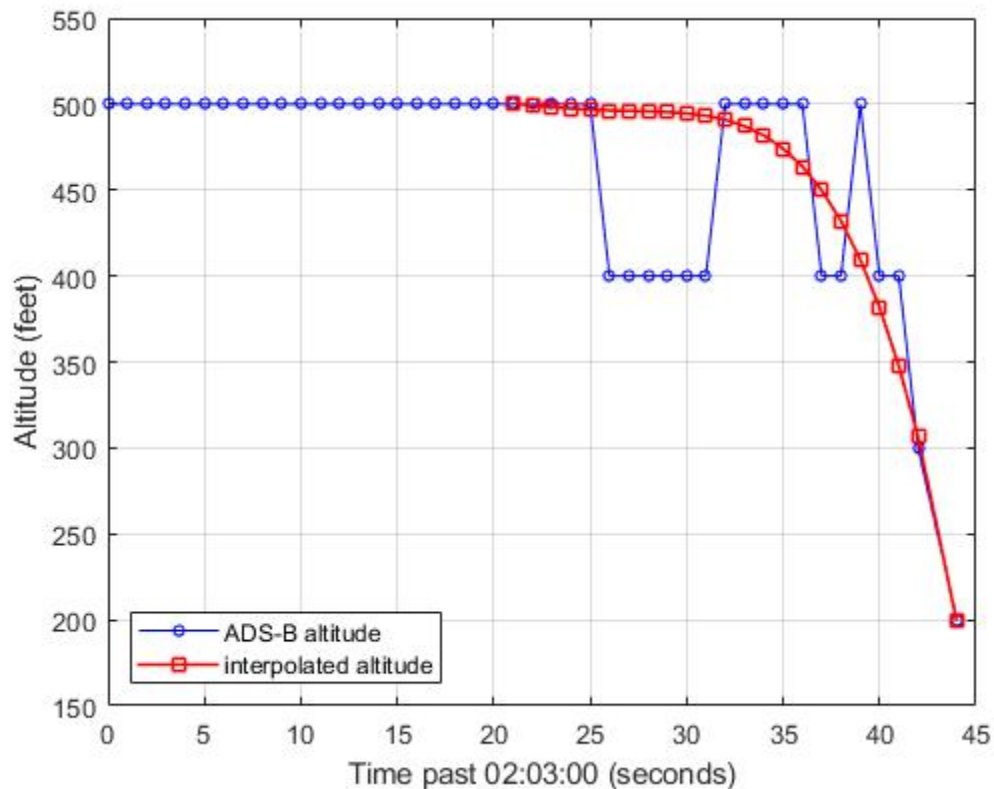
**Figure 2. Helicopter Altitude Above Mean Sea Level**

While the ADS-B latitude and longitude locations were accurate, the ADS-B altitude data had resolution of 100 feet. Therefore, the ADS\_B altitude data was interpolated to generate finer resolution. Figure 2 shows the ADS\_B altitude above mean sea level (msl) data and the interpolated data. The useful portion of the video lasted only 9 seconds so that only the interpolated altitude past time 35 seconds in Figure 2 was used in the analysis.

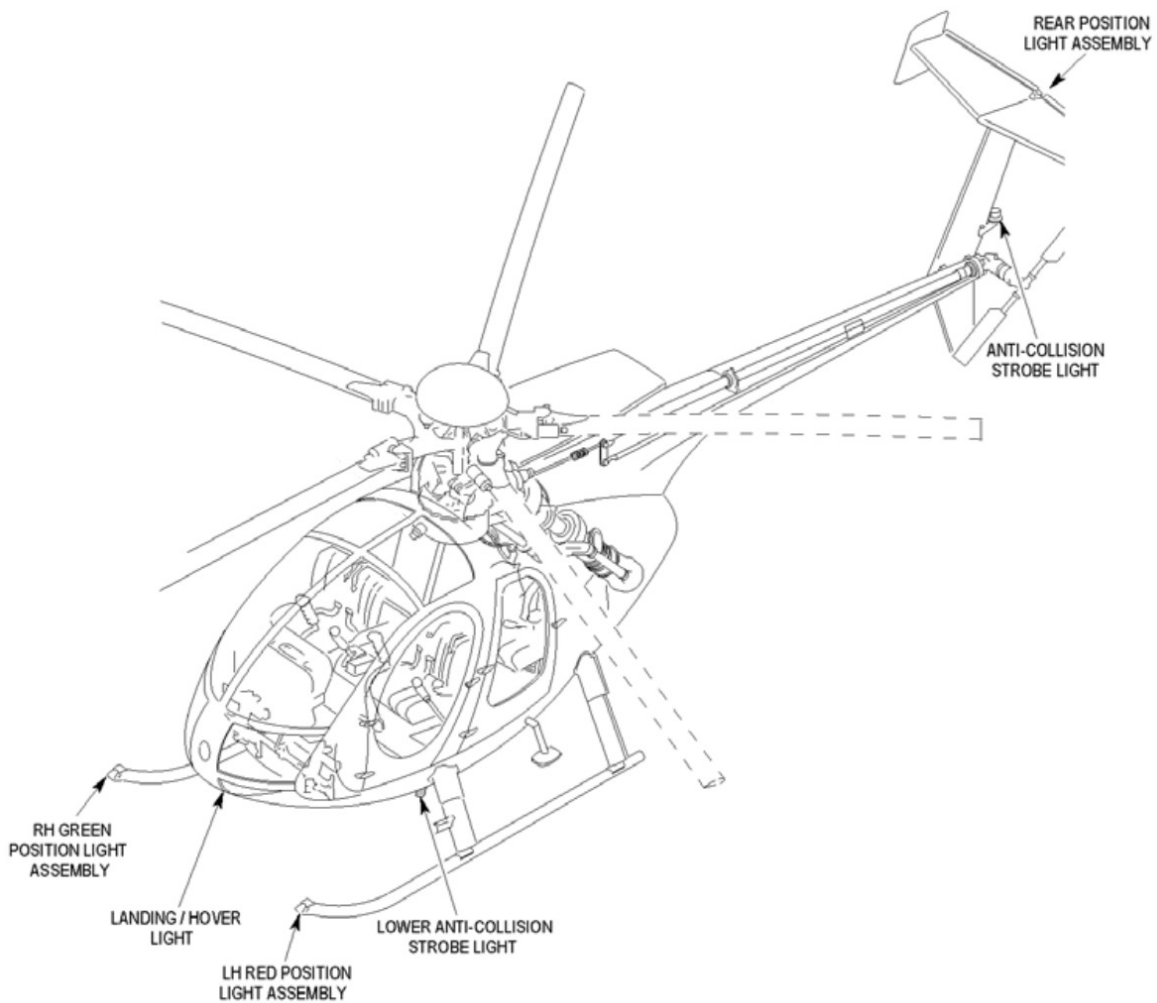
**Figure 3. MD 369E External Lighting**

The analyzed video had 1280x720 resolution and frame rate of 30 frames per second. This was a nighttime accident and, consequently, only the external lights of the helicopter were visible in the video against the background of the dark sky. Figure 3 shows the locations of the external lights on the MD 369E helicopter. A model of the helicopter was constructed that consisted of the six external lights shown in Figure 3. They were the right-side green position light, the left-side red position light, the white landing/hover light, the white rear position light and the two red anti-collision strobe lights. Figure 4 is a section from a typical video frame that shows three of these external lights.

The longitudinal distance from the position lights that are mounted on the landing skids to the rear position light on the MD 369 helicopter is about 24 feet. This allowed for relatively accurate estimation of the yaw angle of the helicopter. The largest lateral distance between helicopter lights is the 6.45 feet that separate the red and the green position light that are on the landing skids. This relatively short distance limited the accuracy of estimating helicopter pitch and roll angles because they had a similar effect on how the lateral spacings of lights were seen in the video frames. This problem was amplified by the high pitch angle of the camera. This problem does not exist in analysis of fixed-wing aircraft because the two position lights are separated by the wingspan.

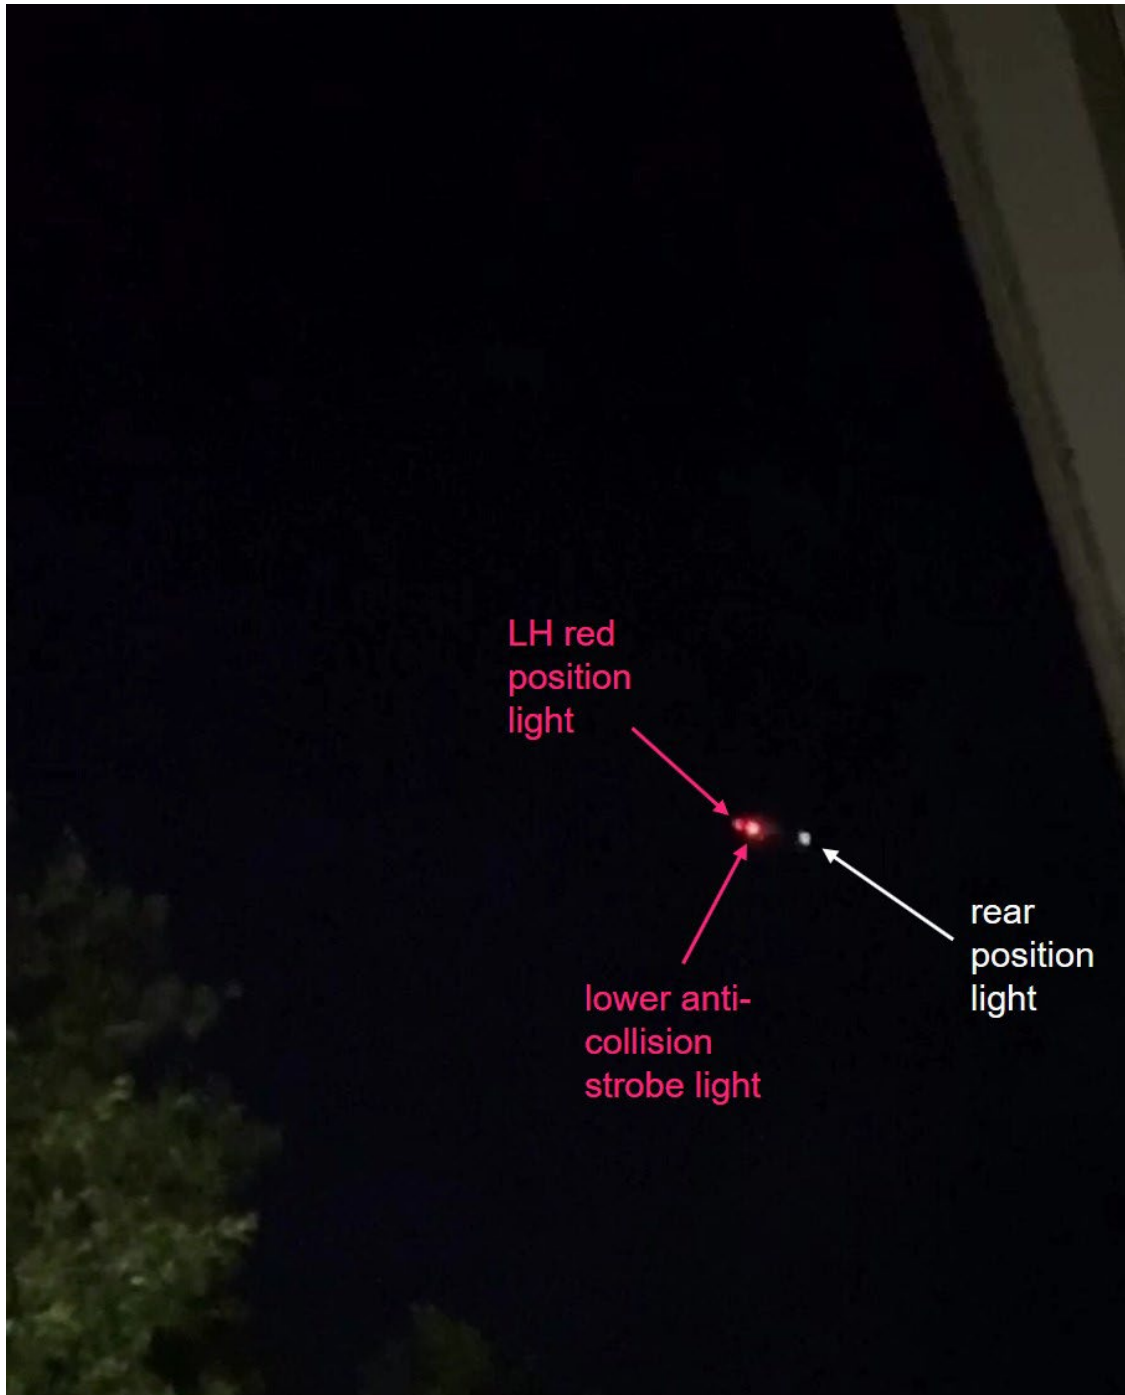
**Figure 4. Section from Video Frame at Video Time 22.033 seconds**

Once the camera orientation angles were estimated, it became possible to estimate the orientation angles of the helicopter. It was done by varying the yaw, pitch and roll angles of the helicopter model until it coincided with the image of the helicopter in the video frame. The alignment was based on the two or more lights that were visible in the video frame. Figure 4 shows a video frame where three lights were visible.

With the ADS-B latitude and longitude data, the interpolated helicopter altitude and the camera roll set to zero, it became possible to estimate the camera yaw and pitch angles as follows. The camera optics model was used to superimpose the helicopter model on a video frame such as the one shown in Figure 4. The camera yaw and pitch angles were then varied until one of the position lights of the superimposed helicopter model coincided with the image of the corresponding helicopter light seen in the video frame. Once they coincided, the camera yaw and pitch angles were estimated. The camera pitch angle above horizontal varied from 50° when analysis started to 30° when analysis ended because the helicopter image became obstructed by the tree seen in Figure 4.

the helicopter was obstructed by the tree visible in Figure 4 and it impacted the ground about two seconds later. The yaw angles are positive in the clockwise direction when viewed from above. The yaw angles are with respect to a direction perpendicular to Imperial Valley Drive at the camera location. However, since the helicopter was spinning at a high rate during the nine analyzed seconds, the yaw angle relation to this reference direction is irrelevant because the large yaw angle of the spinning helicopter was unrelated to its relatively constant ground track angle.

After video time 20 seconds, about three seconds after the helicopter emerged from being covered by the roof seen in Figure 4 and two seconds before the helicopter was at the location shown in Figure 4, the characteristics of the sound spectrum changed. There were no longer spectral peaks that could be associated with blade passage frequencies due to rotors rotating at their nominal speeds.

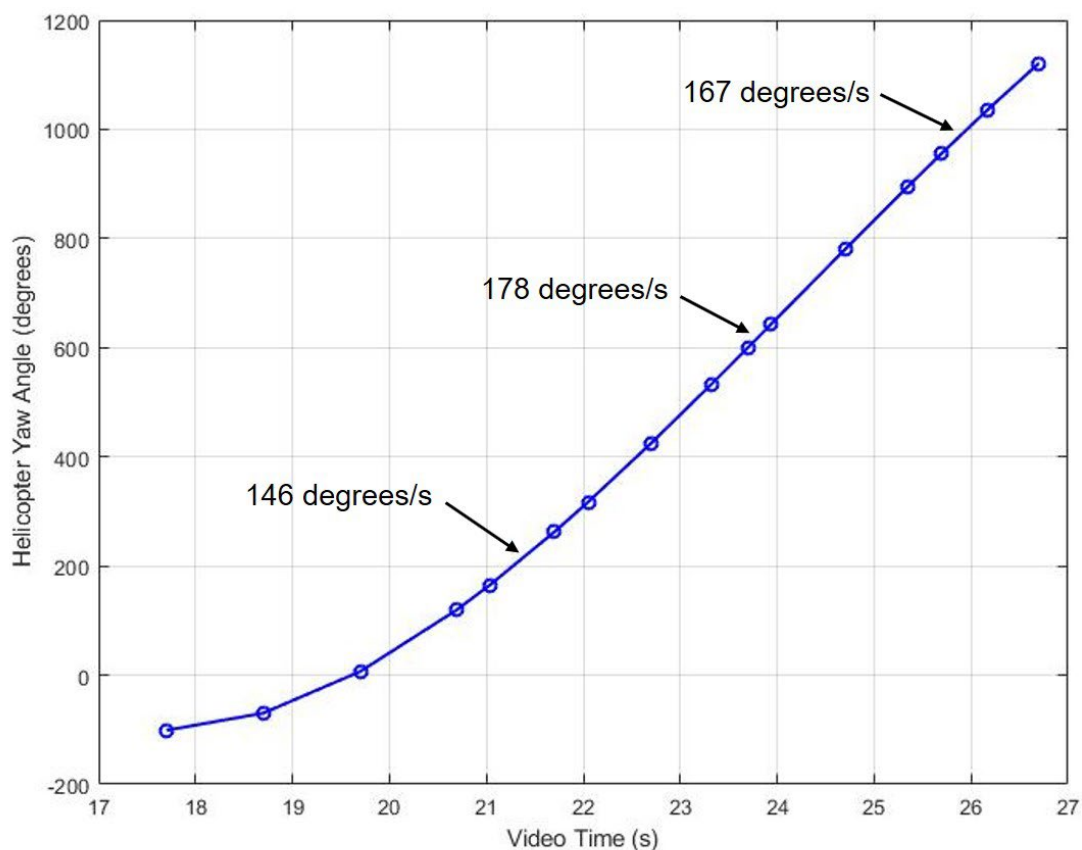
**Figure 5. Estimated Helicopter Yaw Angles**

Figure 5 is a plot of 16 helicopter yaw angles estimated based on 16 video frames over 9 seconds that started at video time 17.7 seconds. Past video time 27.5 seconds,

Figure 5 shows the cumulative yaw angle as the helicopter was yawing clockwise. It executed 3.4 rotations (1224 degrees) about its vertical axis during the analyzed 9 seconds. The yaw rate is marked in the figure at three analysis times. A constant yaw rate fit to the raw data between video time 21.7 seconds and video time 26.7 seconds indicates that the average yaw rate during these last analyzed five seconds was 174 degrees/second.

Orientation angles of a helicopter that crashed were estimated based on a video recorded with a phone camera. The video indicated that the average helicopter yaw rate during the last five analyzed seconds that ended about two seconds before ground impact was 174 degrees/second in the clockwise direction.

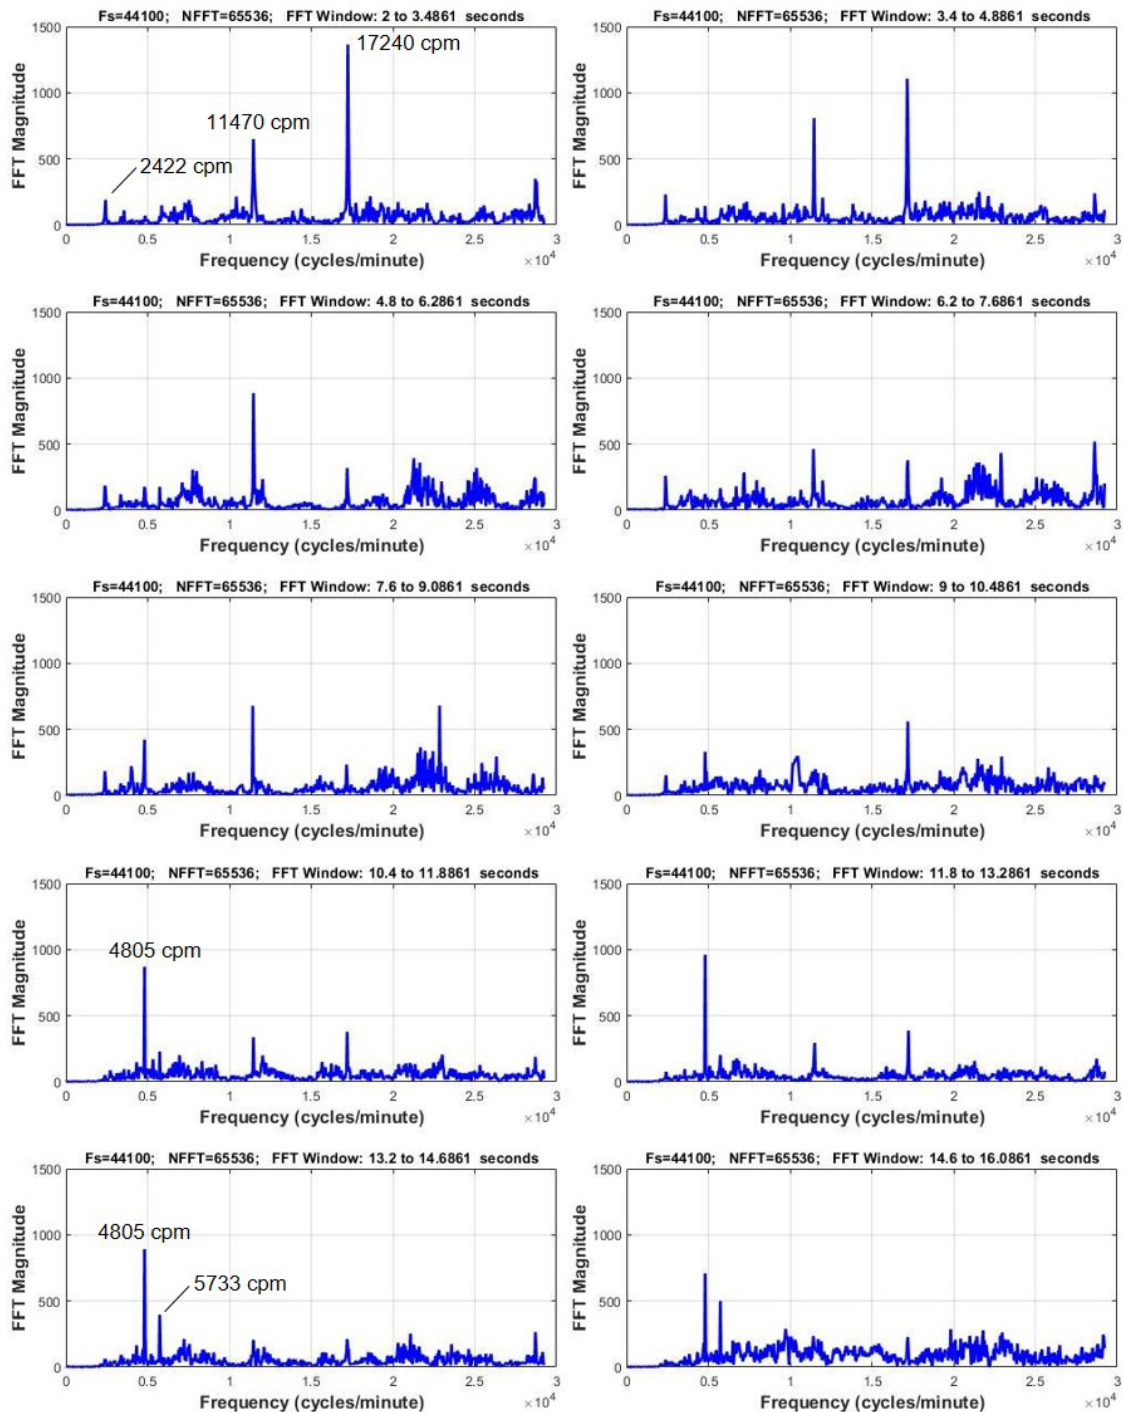
Figure 6. Sound Spectrum up to Video Time 16 seconds

Spectra were computed in 1.5-second-wide windows with a 65536-point FFT algorithm that had 40 cpm frequency resolution. Figure 6 shows spectra during the first segment of the video, when the helicopter was not spinning. Spectral peaks that could be associated with the frequencies listed above are marked in the figure. The peak at 2422 cpm corresponds to BPF<sub>main</sub> and the peak at 4805 cpm corresponds to

2×BPFmain. The peak at 5733 cpm corresponds to BPFtail, the peak at 11470 cpm corresponds to 2×BPFtail and the peak at 17240 cpm corresponds to 3×BPFtail. Because of the close match between the blade passage frequencies and their harmonics and the measured frequencies, it can be concluded that during the first video segment, both the main rotor and the tail rotor were operating at their nominal operating speeds.

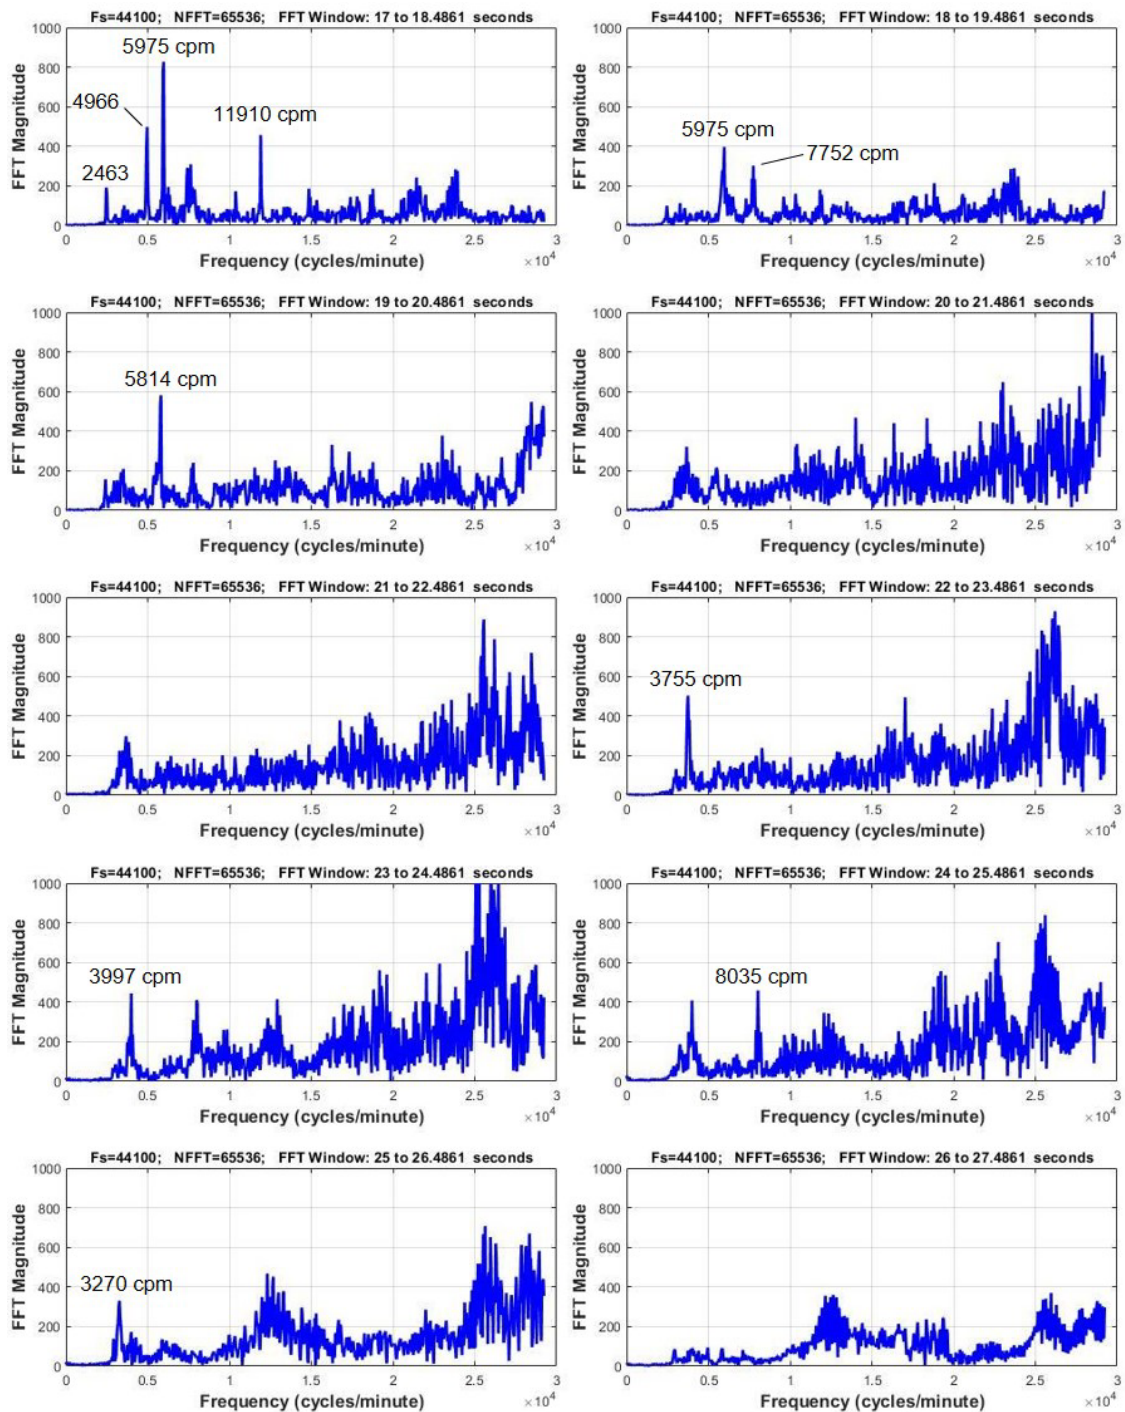
Figure 7. Sound Spectrum past Video Time 17 seconds

Figure 7 shows spectra during the second segment of the video, when the helicopter was spinning. Spectral peaks between times 17 seconds and 20.5 seconds that could be associated with the frequencies listed above are marked in the figure. The peak at 2463 cpm corresponds to BPFmain and the peak at 4966 cpm corresponds to  $2 \times \text{BPFmain}$ . The peak at 5975 cpm corresponds to BPFtail and the peak at 11910 cpm corresponds to  $2 \times \text{BPFtail}$ . These frequencies are slightly higher than the corresponding frequencies in the first video segment, pointing to slightly higher engine output shaft speed.

The spectrum in the processing window that starts at video time 18 seconds includes a peak at 7752 cpm. This peak could correspond to frequency  $3 \times \text{BPFmain}$ . The spectrum in the processing window that starts at video time 19 seconds includes a peak at 5814 cpm that is believed to correspond to BPFtail. This could point to decreasing engine output shaft speed that resulted in BPFtail decreasing from 5975 cpm at video time 18 seconds to 5814 cpm at video time 19 seconds.

Peaks appeared at 3755 cpm, at 3997 cpm and at its possible second harmonic at 8035 cpm, and at 3270 cpm. It is not clear what was the source of these frequencies. One possibility is that these were  $2 \times \text{BPFmain}$  and/or BPFtail generated when the engine output shaft was operating significantly below its nominal speed.

The spectra in Figure 7 that correspond to video times past 20 seconds show significant content at frequencies above 15000 cpm, unlike the spectra before time 20 seconds. This high-frequency content is due to the camera owner's voice. It was verified by splicing together signal segments where the owner's voice is not heard and computing the spectrum of the spliced signal. The computed spectrum showed the same spectral peaks as those marked in Figure 7 but without the high-frequency content above 15000 cpm.

Spectral analysis of the helicopter sound when the helicopter was not spinning at a high yaw rate detected spectral peaks at frequencies that corresponded to main rotor and tail rotor blade passage frequencies at the nominal operating speeds of the rotors. When the helicopter was spinning at a high rate, the frequencies of the spectral peaks were lower than those corresponding to the blade passage frequencies at the nominal operating speeds of the rotors.
