**NATIONAL TRANSPORTATION SAFETY BOARD**  
Vehicle Recorder Division  
Washington, D.C. 20594

## **Multiple Electronic Devices**

**Specialist's Factual Report**  
**by Sean Payne**

Location: Sioux Falls, SD  
Date: June 7, 2020  
Aircraft: Mitsubishi MU-2B  
Registration: N44MX  
Operator: McNeely Charter Service, Inc.  
NTSB Number: CEN20LA215

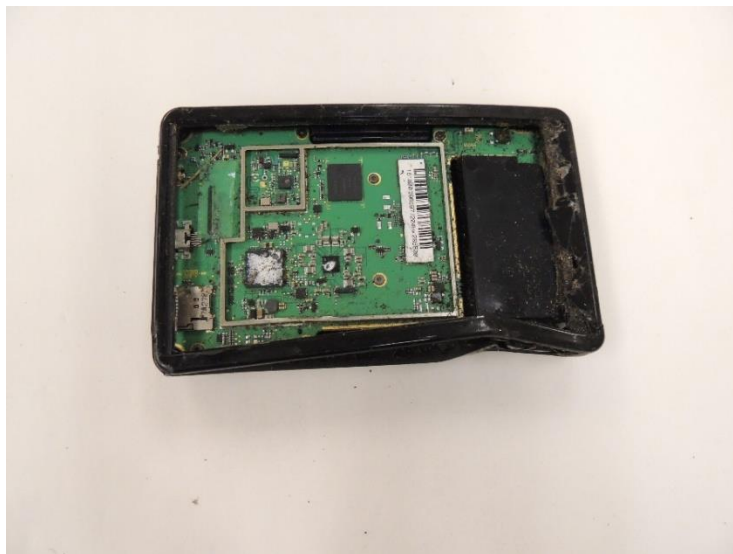
The device was badly damaged as shown in figure 1. The device would have required a “chip-off” and subsequent binary conversion of data in order to create a track log. Garmin Aera devices that require chip off and binary conversion typically do not recover the final moments of an accident flight, and typically do not include the aircraft’s ground track up until the wreckage location. This is attributed to a volatile memory loss schema that occurs when the unit is shut down improperly, in this case an impact with terrain. In addition to the known history of data loss, the GPS data from the Garmin GTN 750 discussed in section 2.1. contains better quality data set than the Garmin Aera 660 could have produced. For that reason, the Garmin Aera 660 data was determined to be redundant and was not recovered.

**Figure 1. The Garmin Area 660 from the accident airplane.**

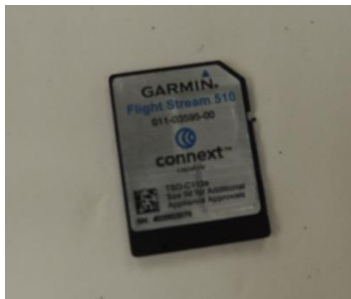
The device in good condition as shown in figure 2. The device was connected to a PC via a USB write blocker and read normally. A review of the data showed no stored flight data, only chart information, as expected.

Figure 2. The Garmin FlightStream 510 from the accident airplane.

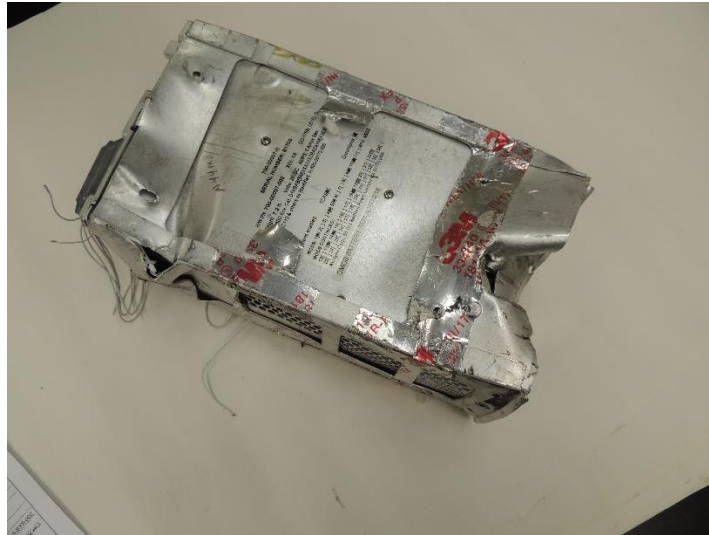
The device had severe impact damage as shown in figure 3. The unit was cut open and the CF card was removed. The CF card was read normally using a PC, the contents of

Figure 3. The Avidyne EX-500 from the accident airplane.

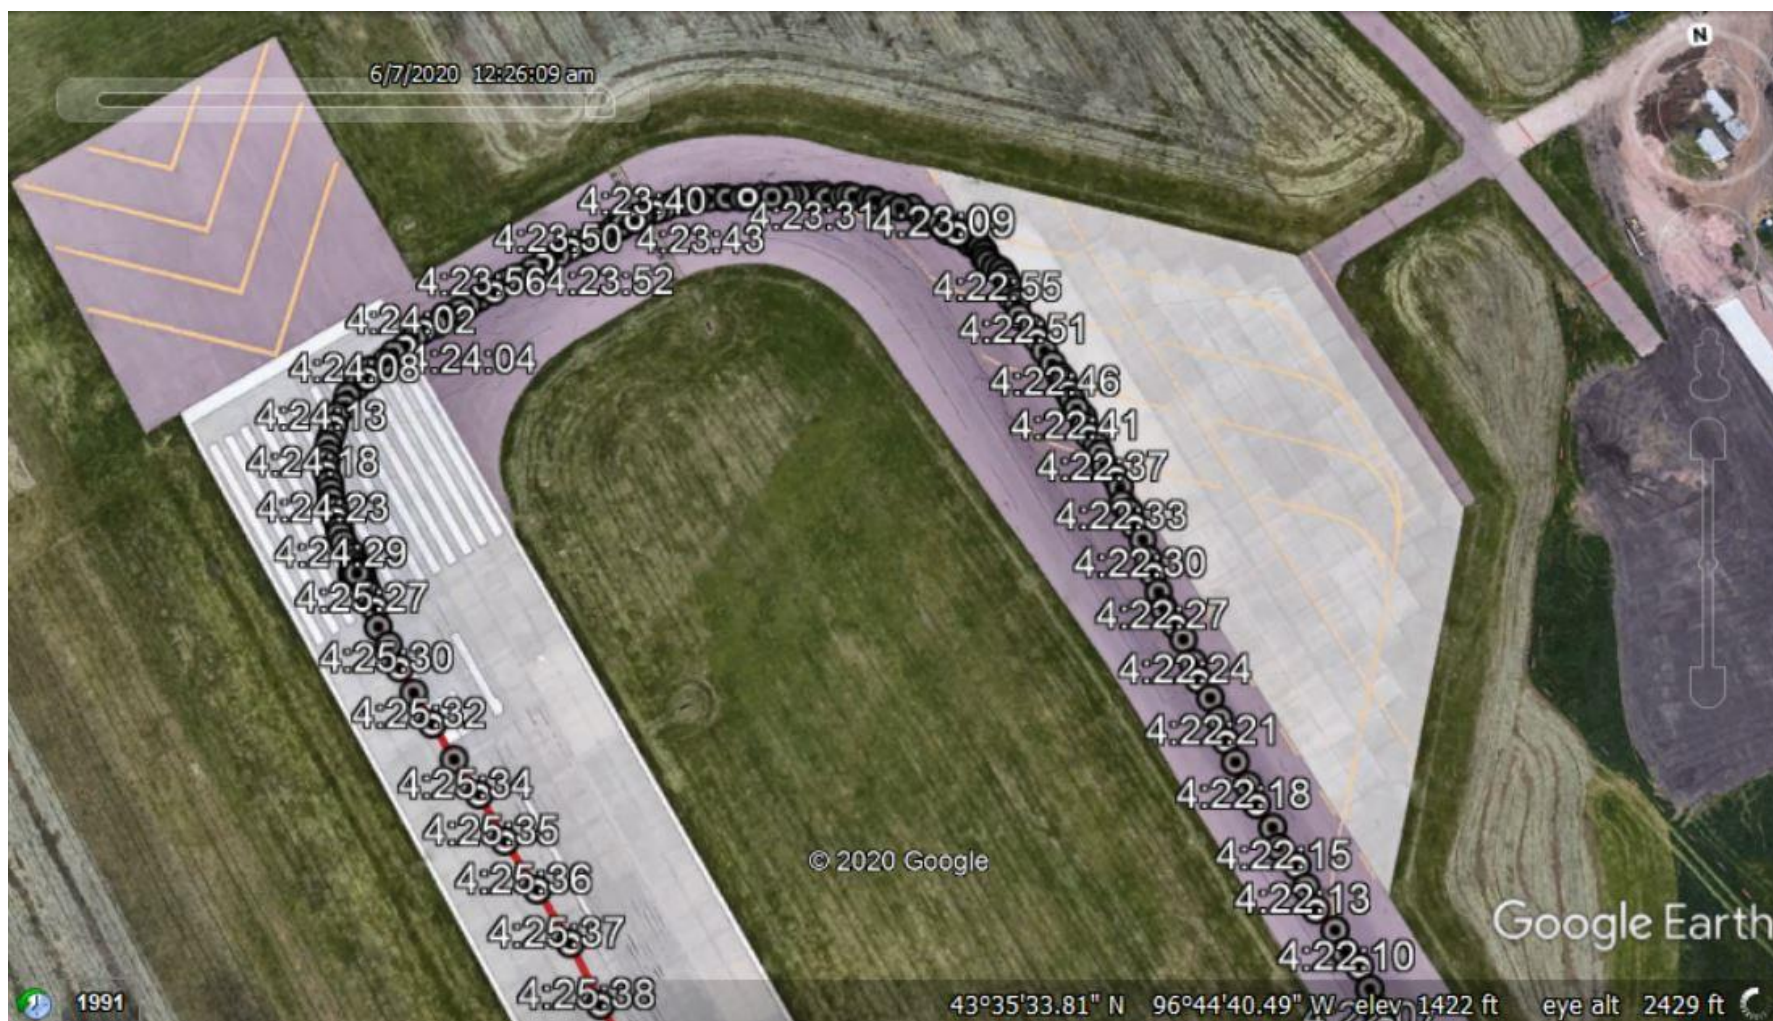
Figure 6 is a Google Earth plot showing the accident aircraft's ground track in the vicinity of the run-up apron and the beginning of the aircraft's takeoff roll on the accident flight. The purpose of this plot is to show the timeframe of the accident aircraft in the vicinity of the run-up apron and the time of its departure on takeoff roll.

Figure 6. A Google Earth plot showing the accident aircraft's ground track in the vicinity of the run-up apron and subsequent departure.

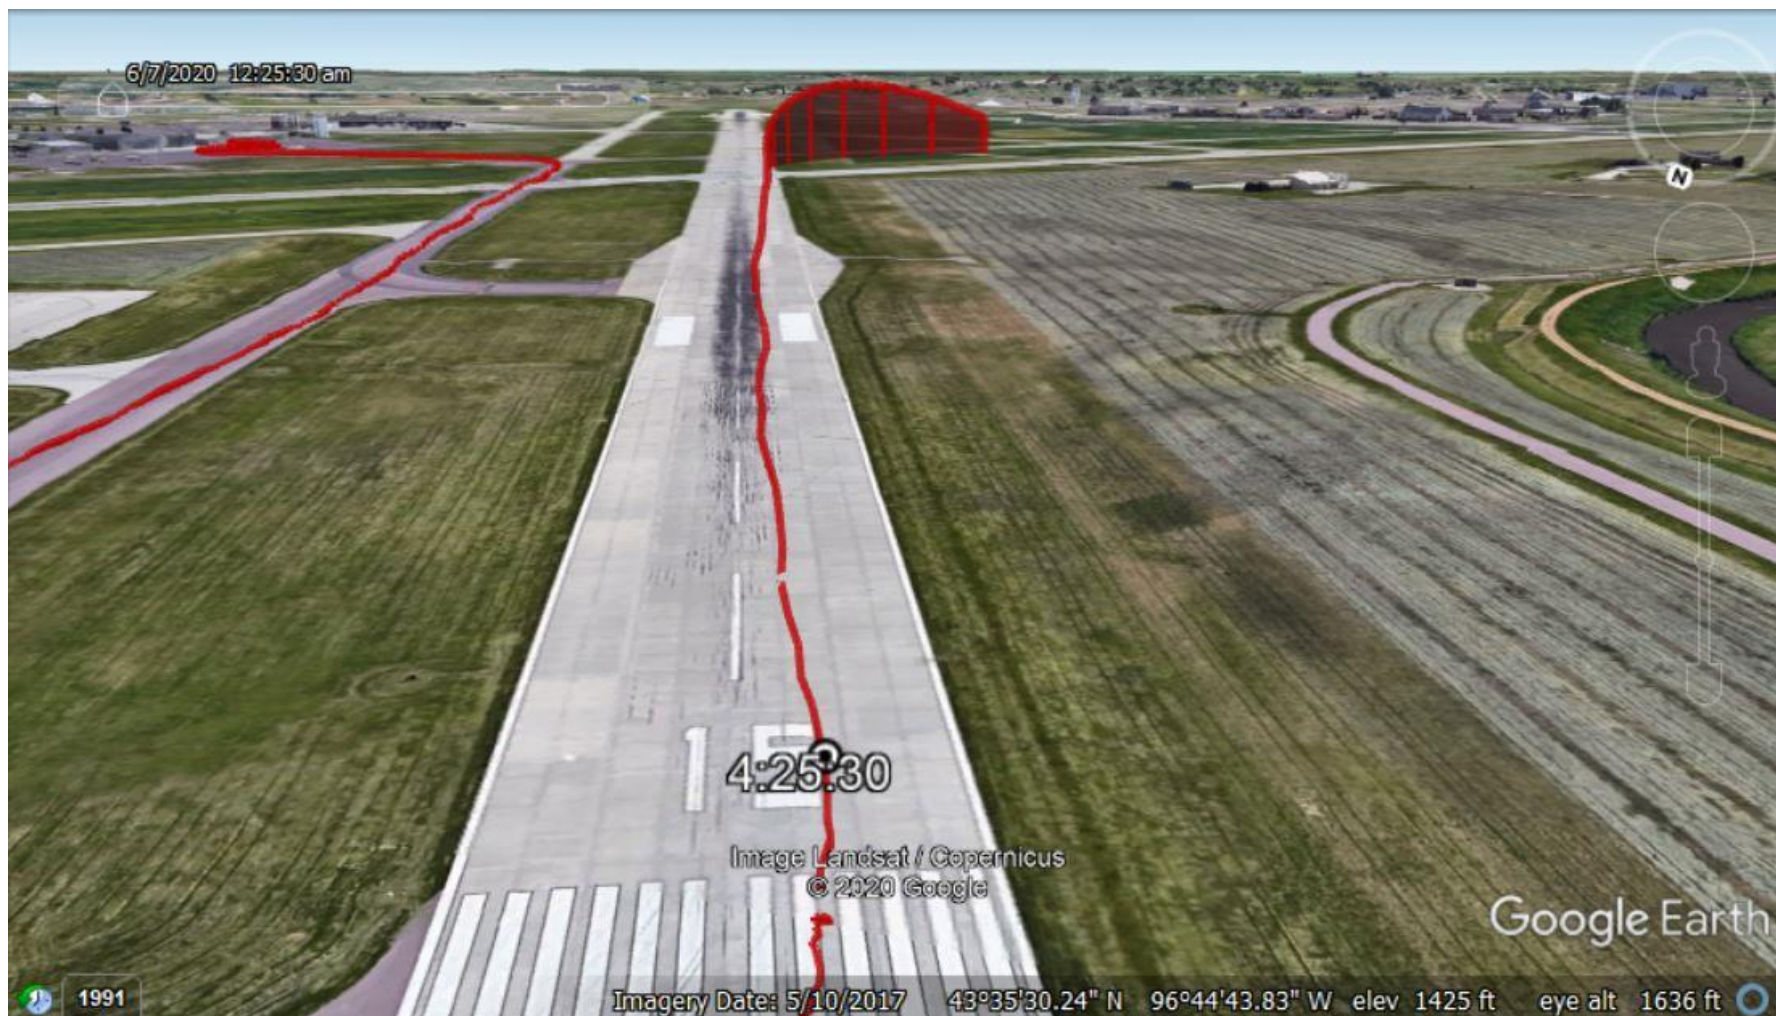
Figure 7 is a Google Earth plot showing the accident aircraft's ground track and recorded altitude data in relation to the runway's centerline. The figure is from the perspective of the runway's threshold.

Figure 7. A Google Earth plot showing the accident aircraft's ground track and recorded altitude data in relation to the runway's centerline.

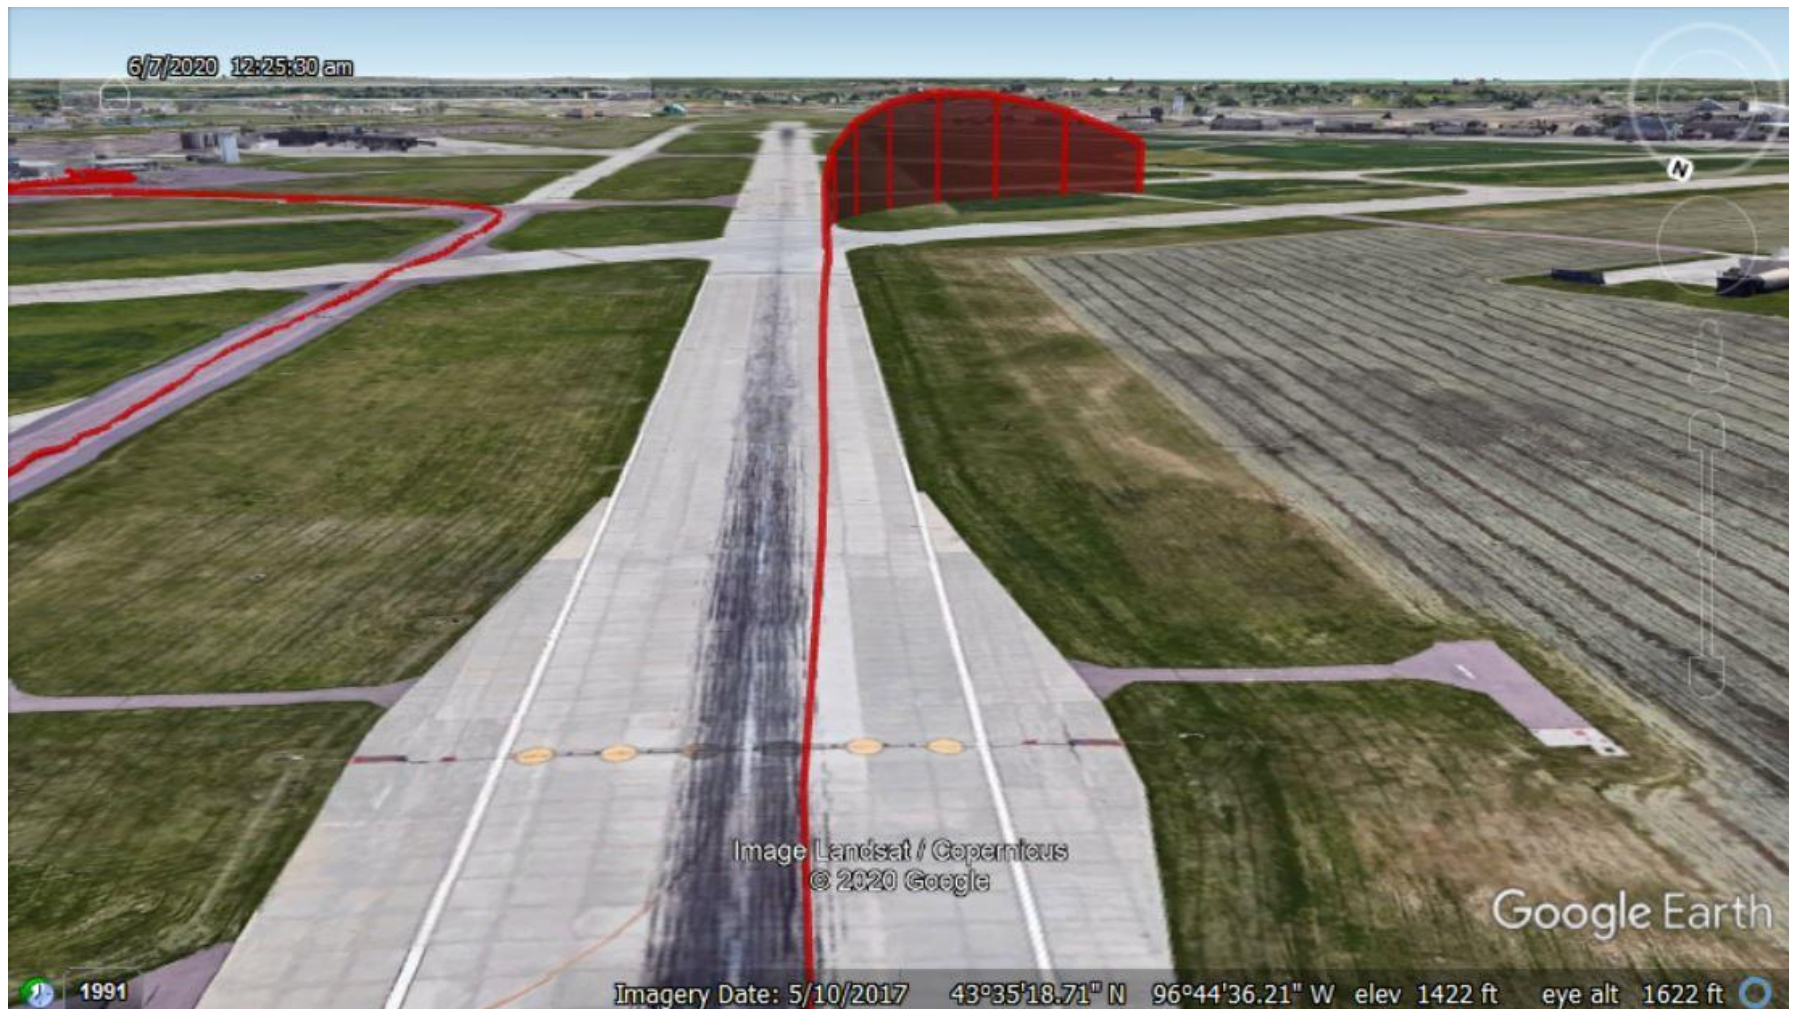
Figure 8 is a Google Earth plot showing the accident aircraft's ground track and recorded altitude data in relation to the runway's centerline. There is a noticeably right ground track that begins about 1500 feet from the departure runway's threshold. This figure is from the perspective near the region 1500 feet from the departure runway's threshold. The Google Earth imagery shows markings for the airport's land based arresting gear, which was not rigged at the time of the accident.

Figure 8. A Google Earth plot showing the accident aircraft's ground track and recorded altitude data in relation to the runway's centerline. There is a noticeably right ground track that begins about 1500 feet from the departure runway's threshold.
