# Carter Aviation Services

## NTSB Accident Report

N7511D

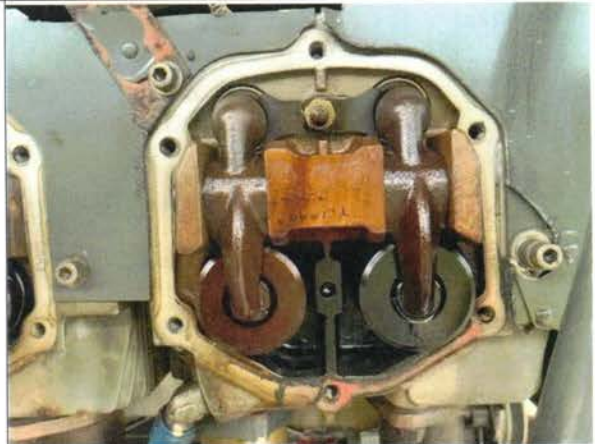
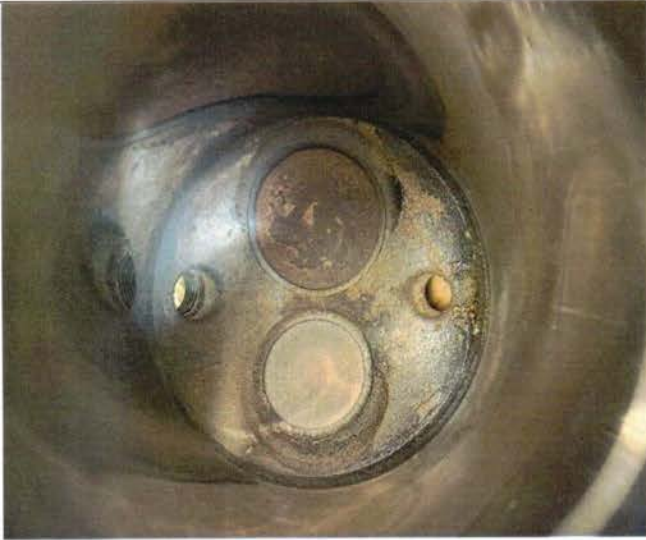
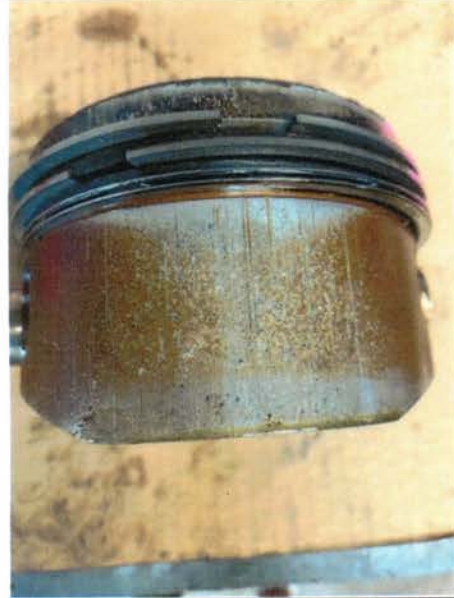
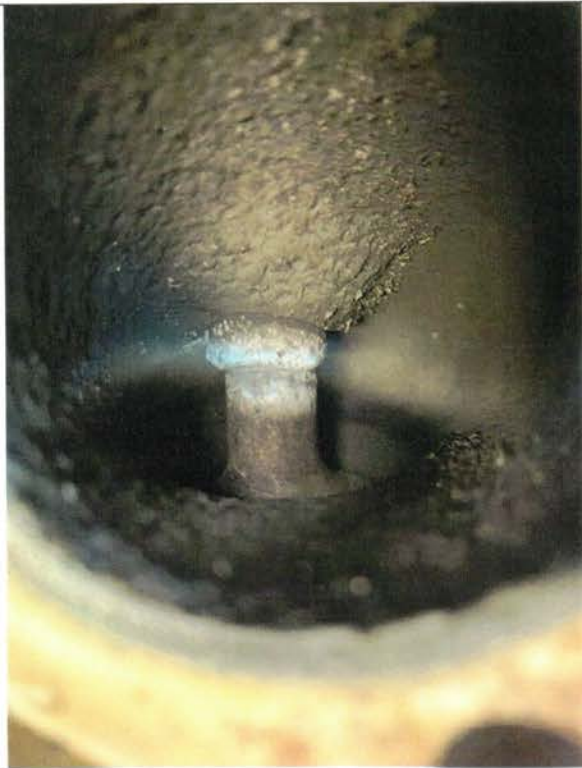
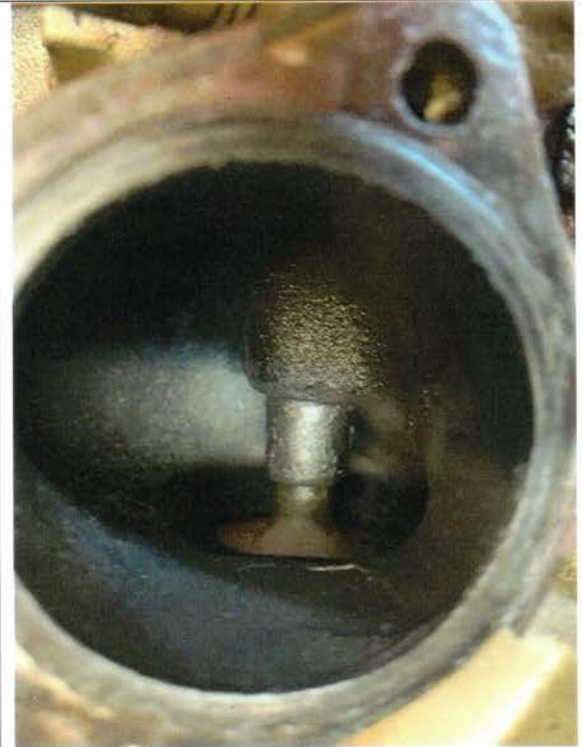
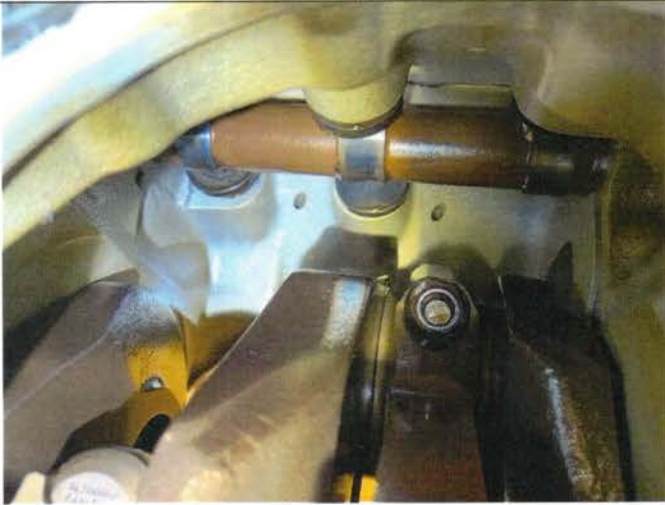
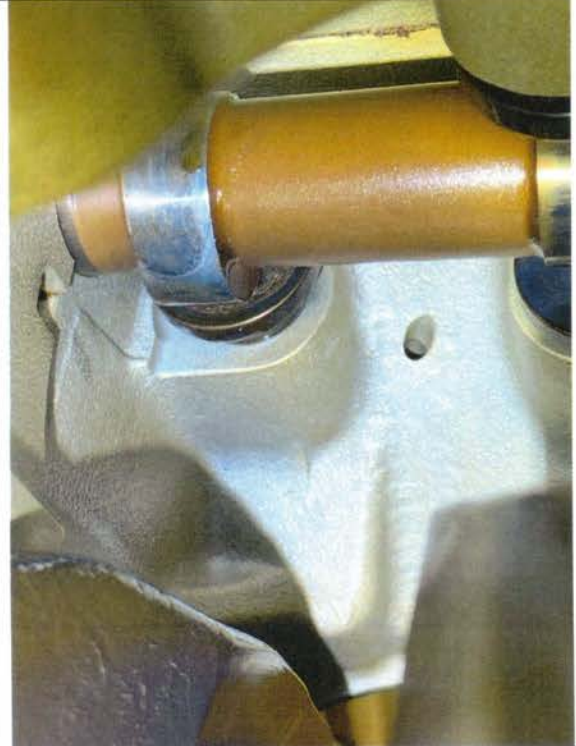
## Cylinder 1

- Differential Compression Hot 60/80 psi
- Borescope inspection shows coking on exhaust valve and slight longitudinal scratching on cylinder wall at 12:00 position
- Exhaust valve shows signs of getting too hot
- Lifter face hammering
- Cam lobe excessively worn

Cyl #1 - exhaust valve is getting hot + burning  
Longitudinal scratching along cylinder wall 12 o'clock position.  
Coking on Valve Stem Exhaust Side

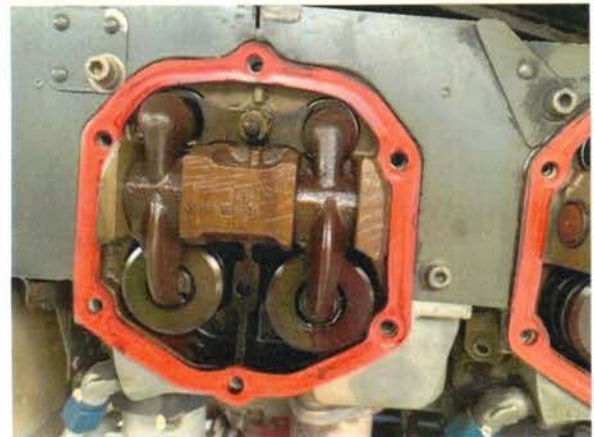
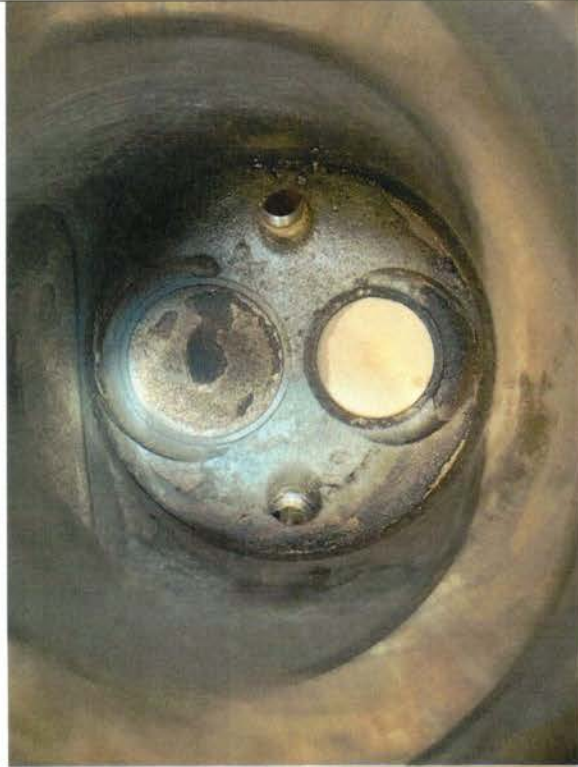
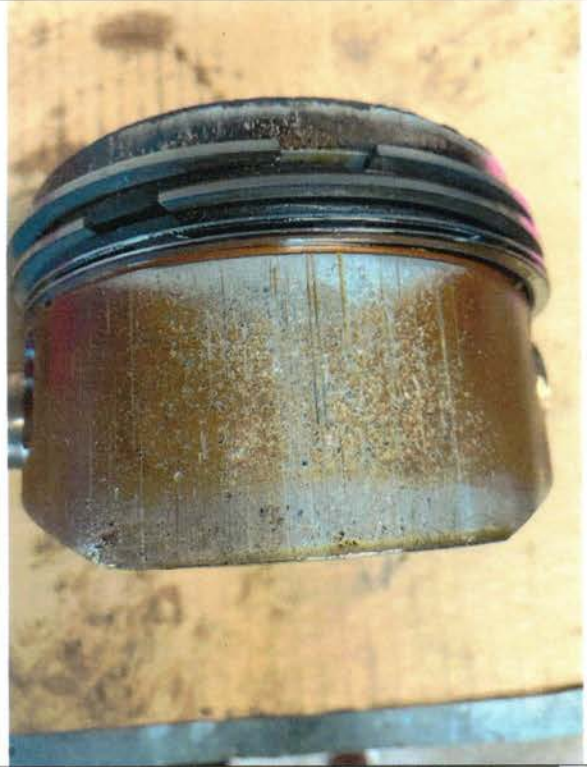
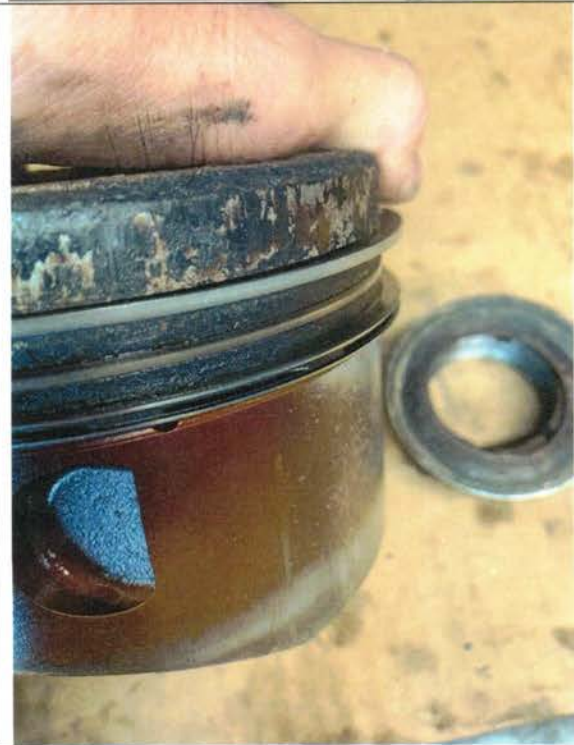
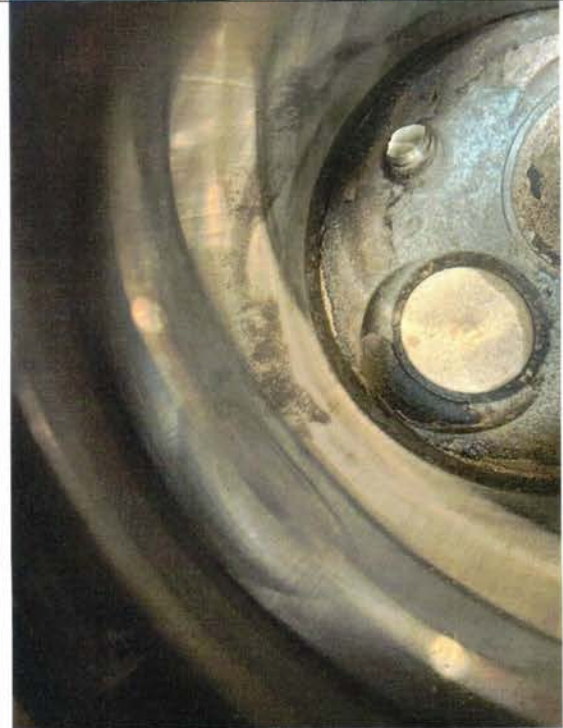
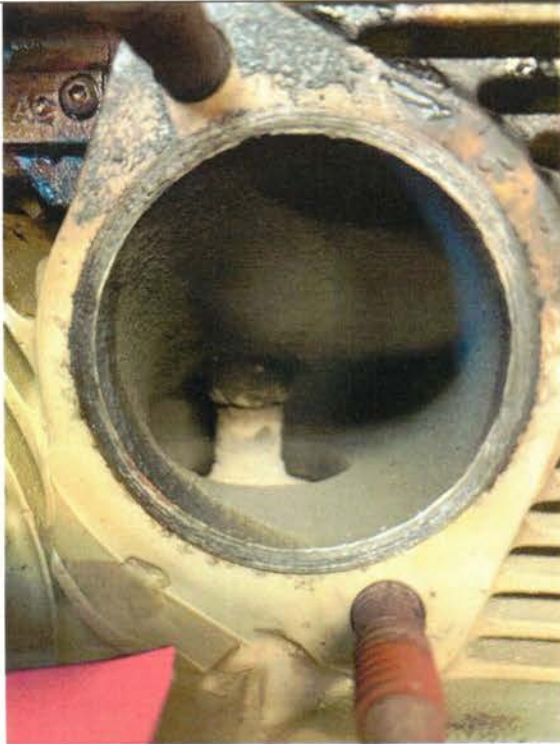
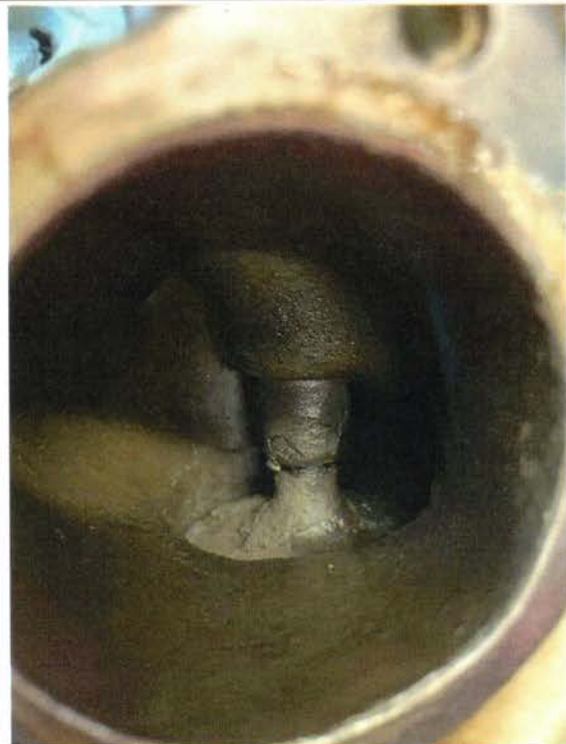
### Cylinder 2

- Differential Compression Hot 18/80 psi
- Differential Compression Cold 60/80 psi
- Compression ring #2 frozen
- Lead Buildup
- Rust on cylinder wall
- Sludge buildup on intake valve

Cyl #2 - lots of lead @ top of barrel, rust on cylinder wall 3 o'clock pos.

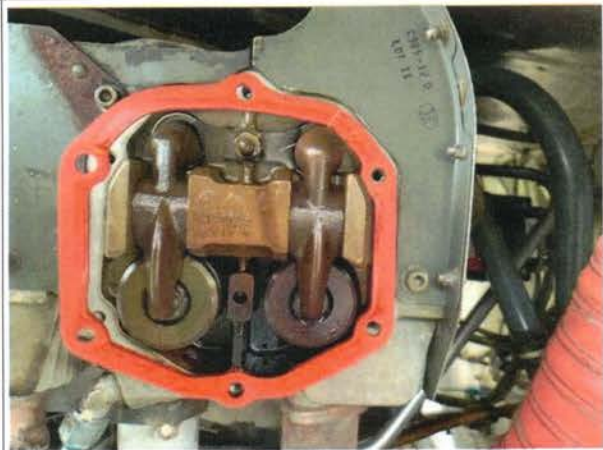
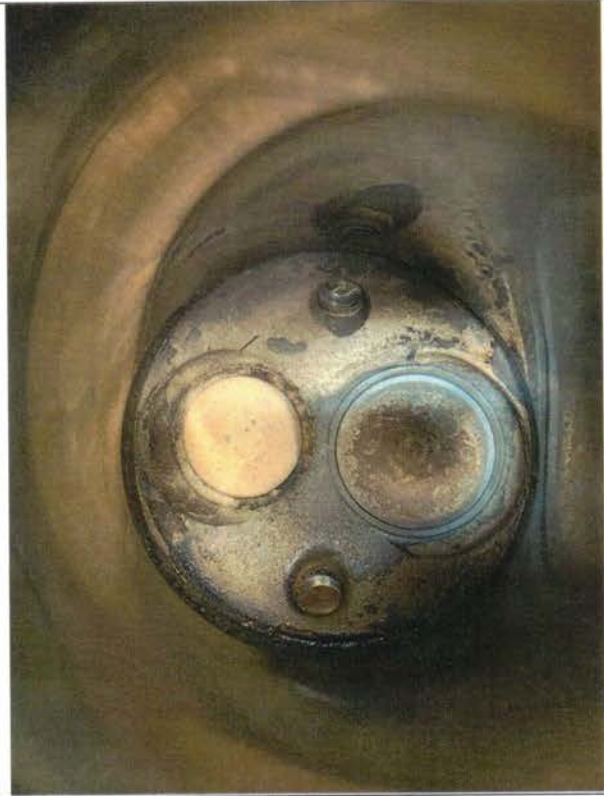
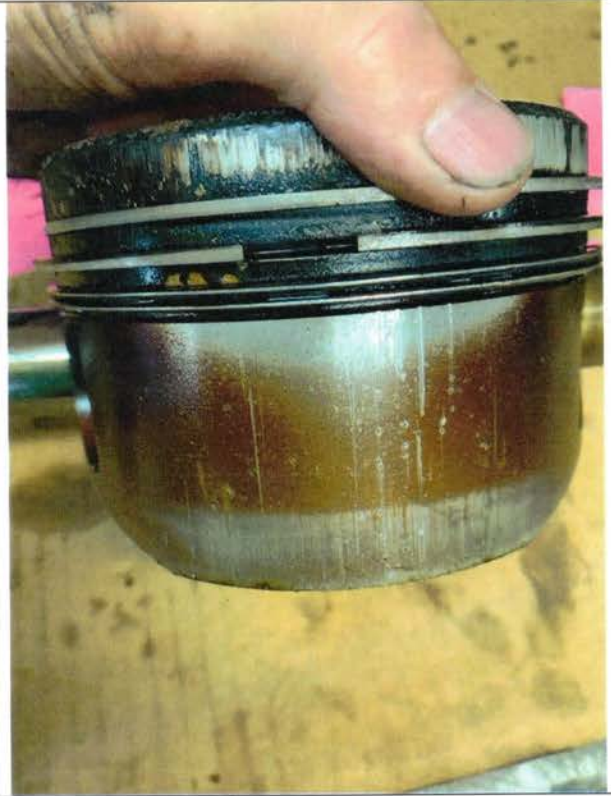
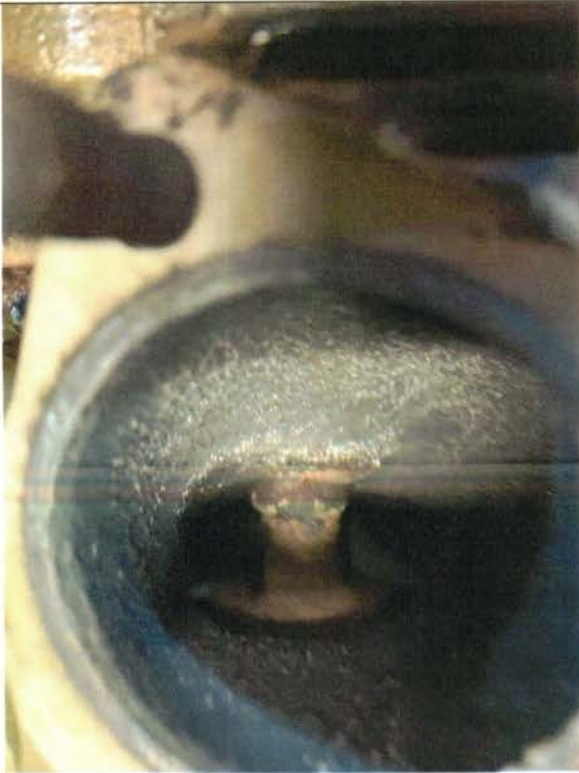
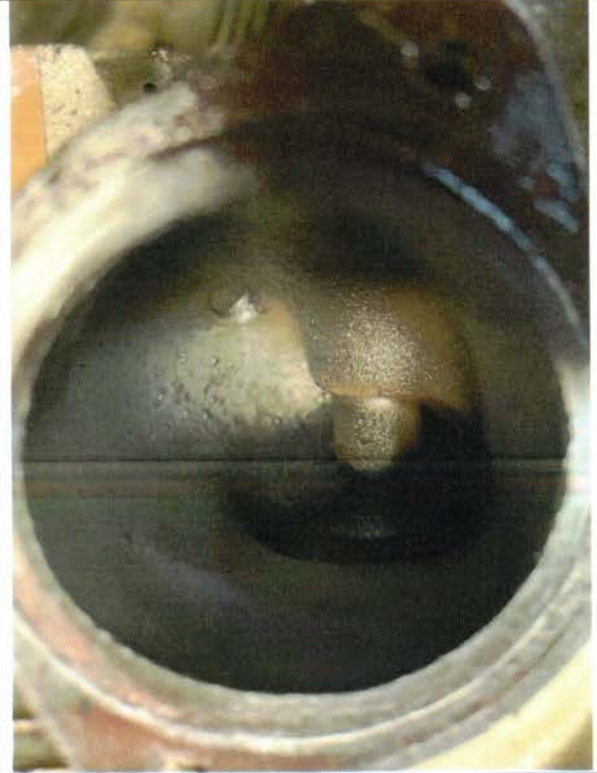
### Cylinder 3

- Differential Compression Hot 73/80 psi
- Slight lead buildup
- Slight discolorization on exhaust valve
- Normal wear for high time engine

Cyl #3 - Not bad, normal wear

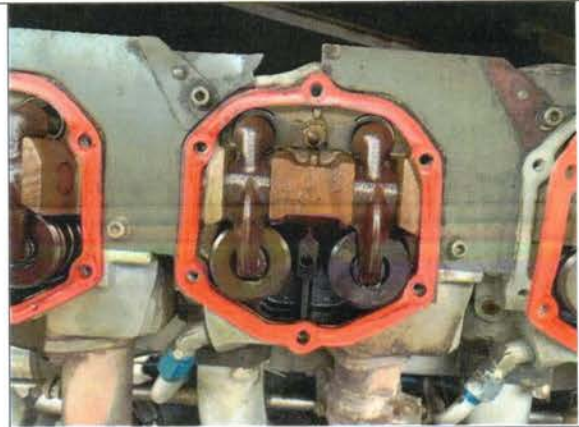
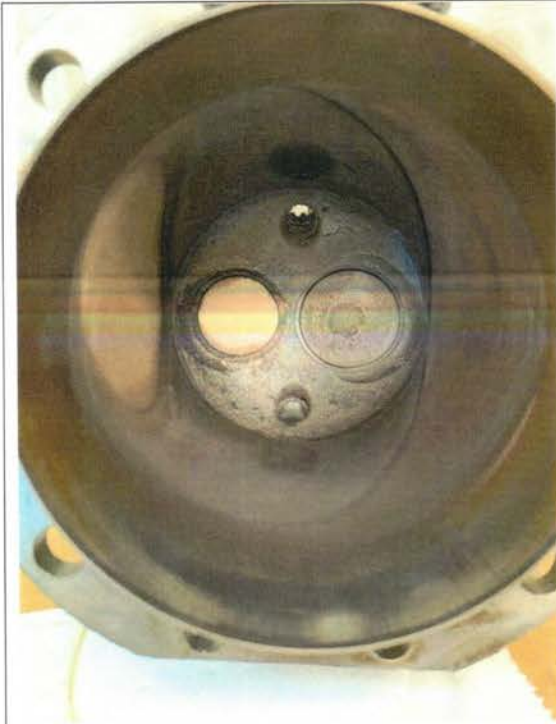
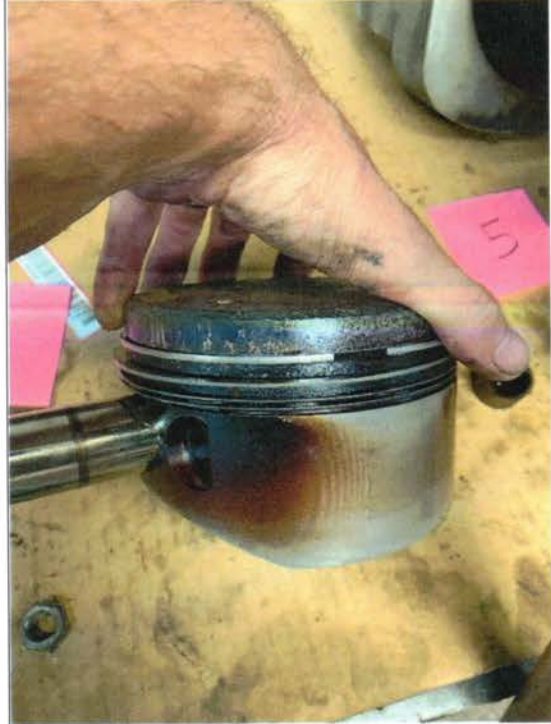
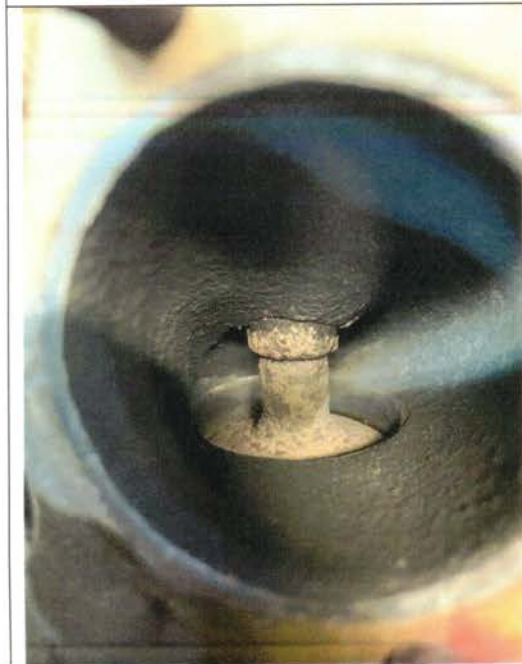
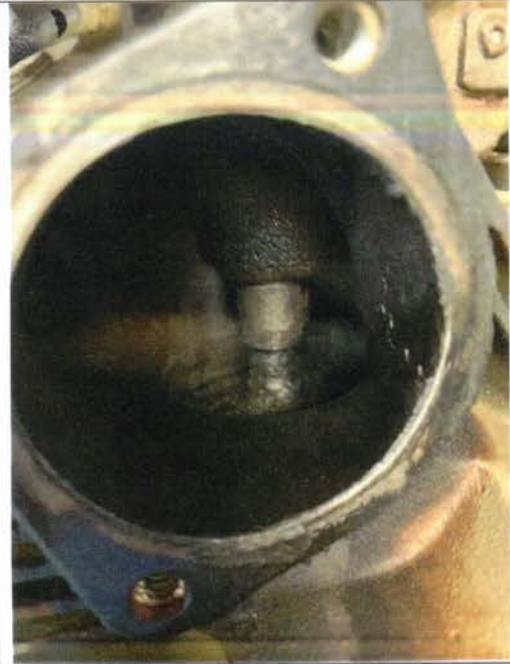
#### Cylinder 4

- Differential Compression Hot 76/80 psi
- Dicolorization on exhaust valve due to heat
- Slight lead buildup
- Piston ring clearance excessive
- Sludge buildup on intake Valve

Cyl #4 - slight coking on exhaust valve

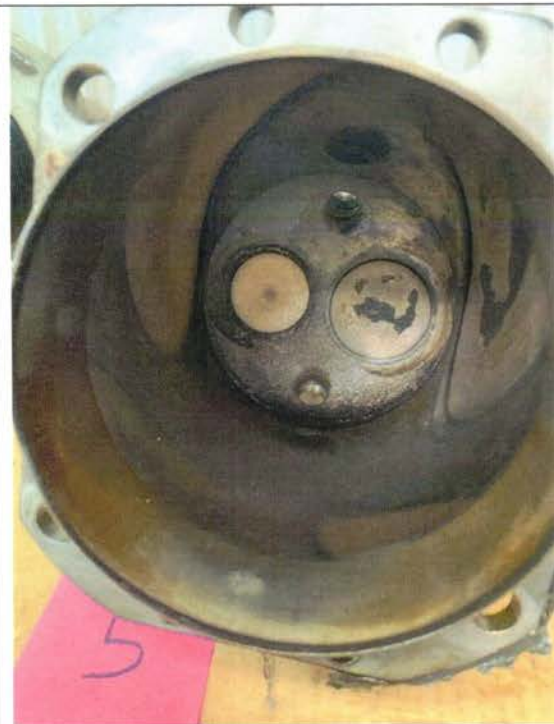
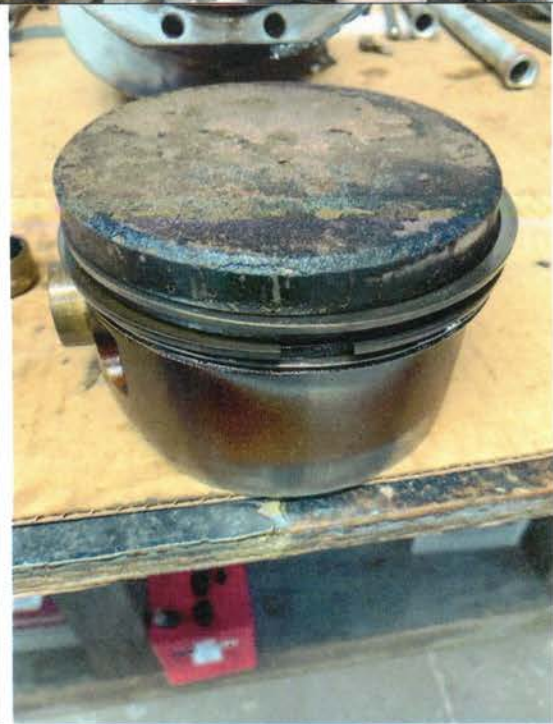
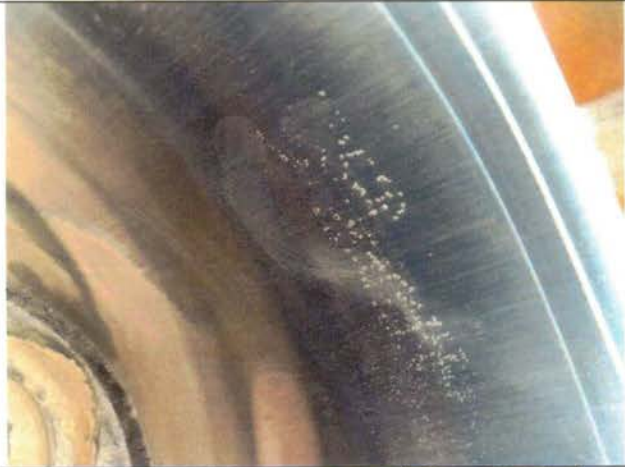
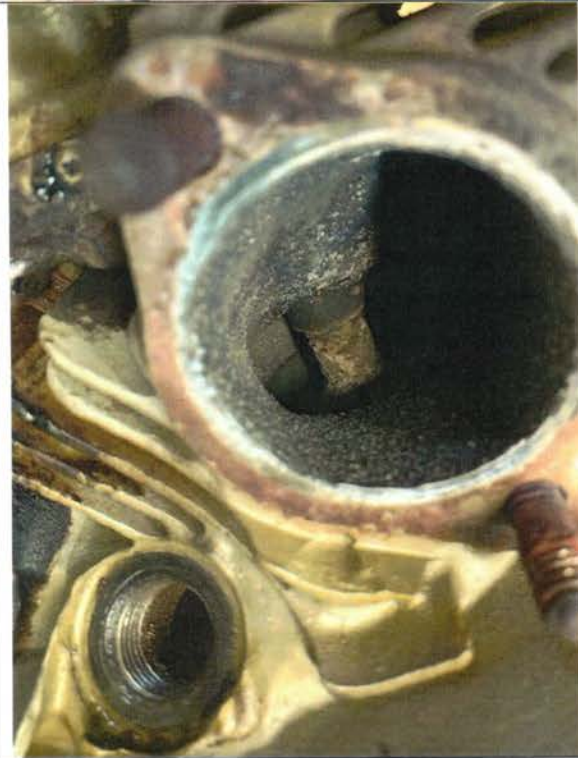
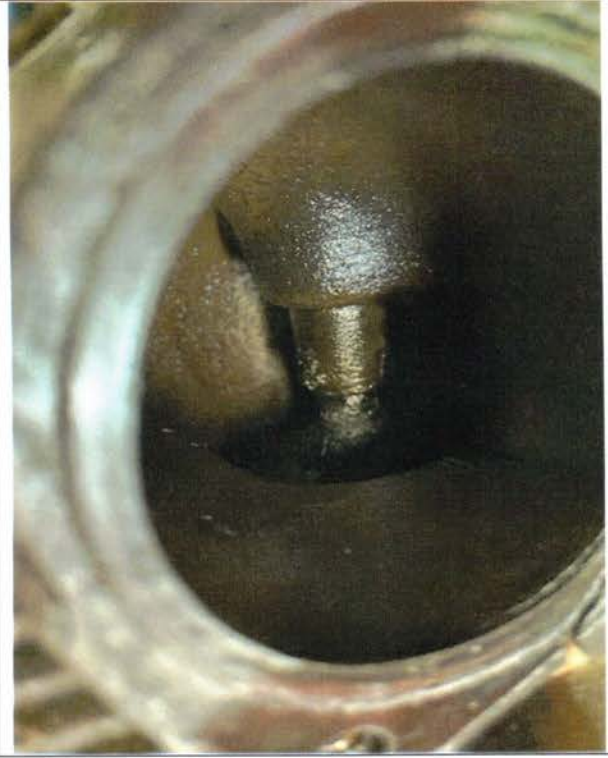
### Cylinder 5

- Differential Compression Hot 72/80 psi
- Dicolorization on exhaust valve due to heat
- Sludge buildup on intake valve
- Spots on cylinder wall
- Piston ring clearance excessive

Cyl #5 - Not bad, normal wear, slight amounts of lead.

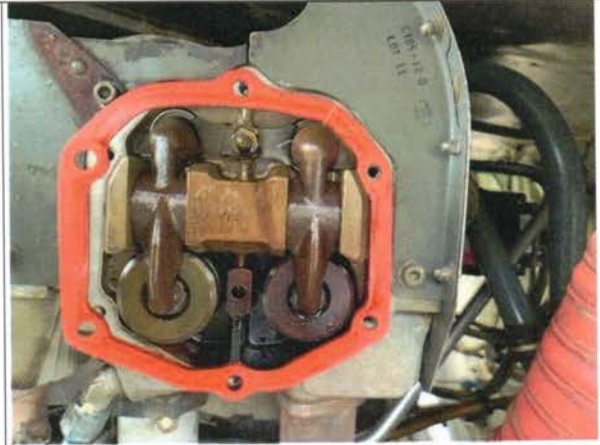
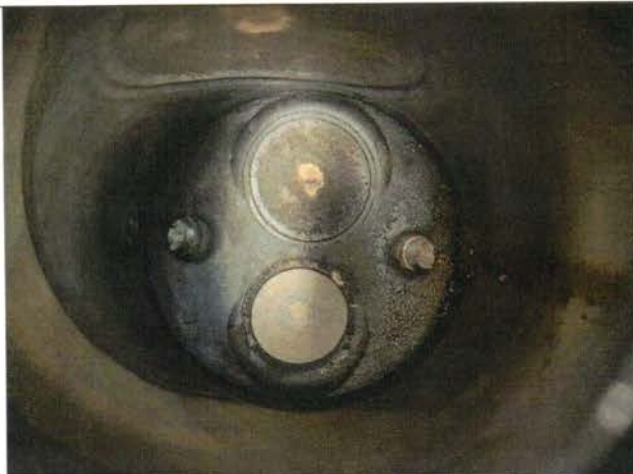
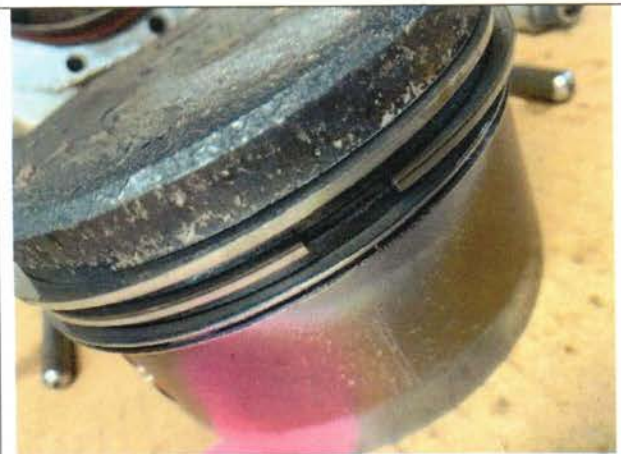
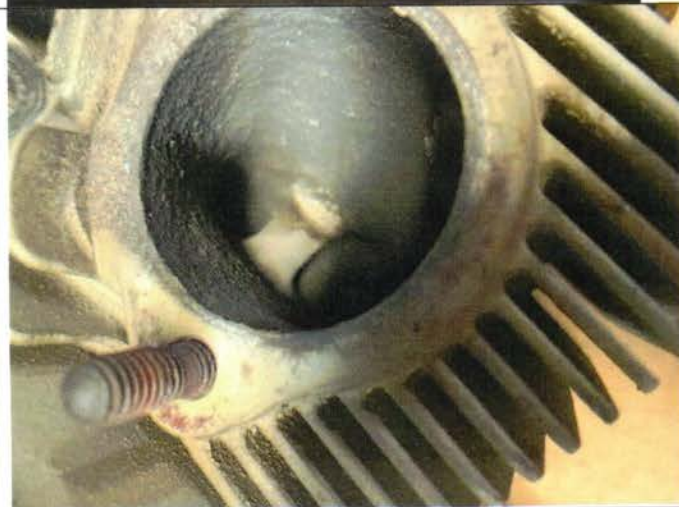
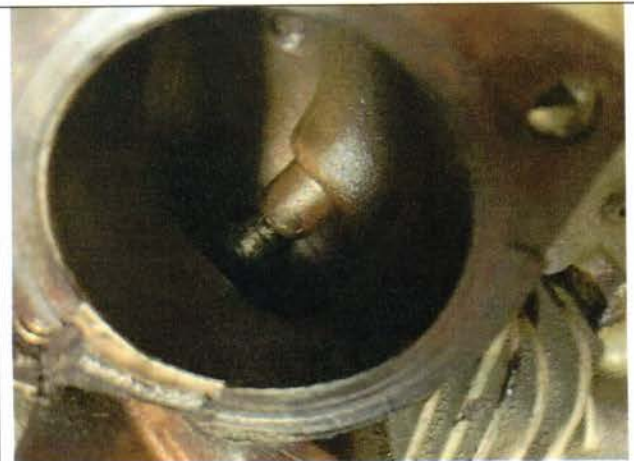
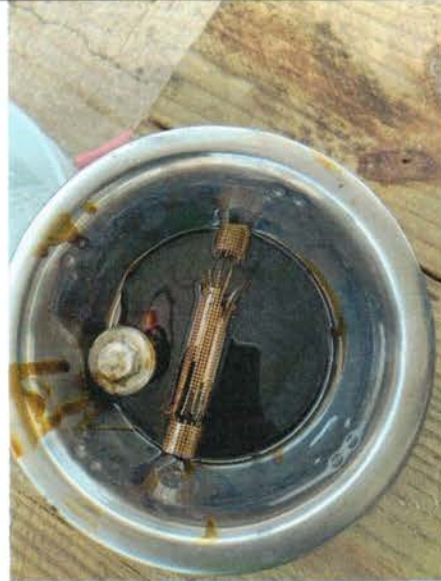
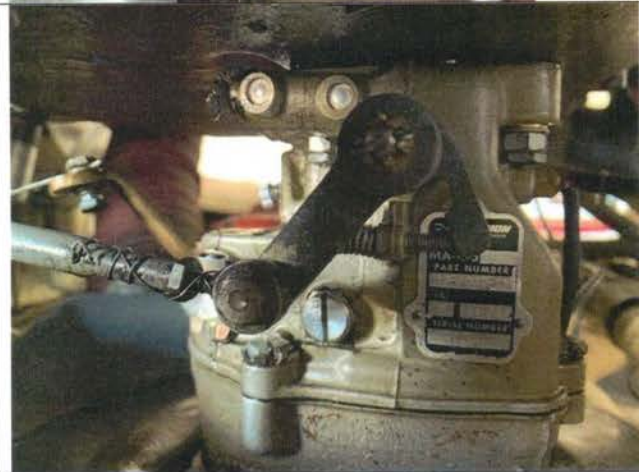
### Cylinder 6

- Differential Compression Hot 60/80 psi
- Exhaust valve getting hot
- Lead buildup
- Excessive oil in cylinder
- Sludge buildup on intake valve
- Piston ring clearance excessive

Cyl #6 - exhaust valve getting hot, slight coking
