**From:** Hap Pool [REDACTED]  
**Sent:** Friday, October 9, 2020 4:11 PM  
**To:** Williams Shaun  
**Subject:** Re: NTSB Accident Report

Yesterday I had the time to look at the airplane specifically the tailwheel.

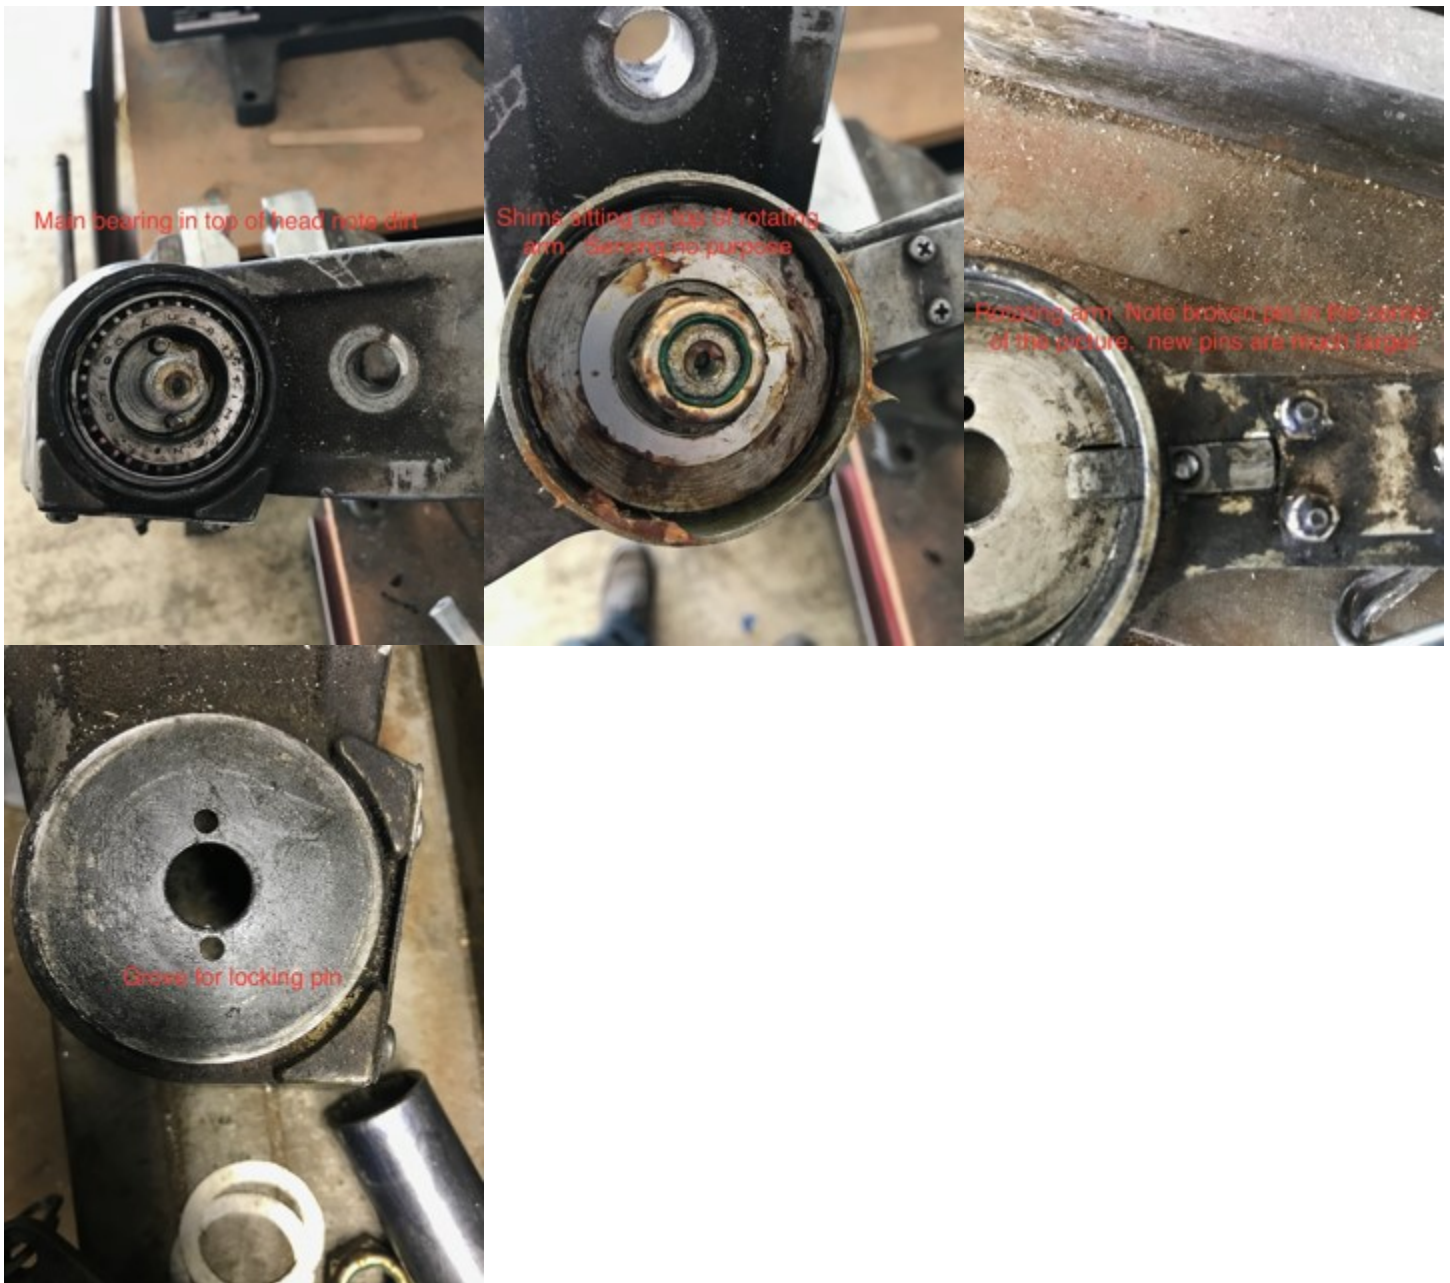
It appears that others have had problems with the Maule tailwheel hanging up turned to the side after the tail wheel breaks from aggressive rudder input. Several have had the airplane do an abrupt 90 deg turn on landing.

The cause has normally been that the tailwheel is dirty and the locking pin catches on the guide.

I am attaching pictures of the subject tailwheel and as you can see it is quit dirty and has not been well maintained. Additionally, the locking pin is broken.

The consensus on the web is the Maul tailwheel should regularly be dismantled and cleaned. Some pilots were recommending twice a year.
