**NATIONAL TRANSPORTATION SAFETY BOARD**

**Global Positioning System (GPS) & Attitude Heading  
Reference System (AHRS) Device**

**Specialist's Factual Report  
By Sean Payne**

Location: Rockford, Illinois  
Date: August 20, 2020  
Aircraft: Beech 200  
Registration: N198DM  
Operator: Private  
NTSB Number: CEN20LA352

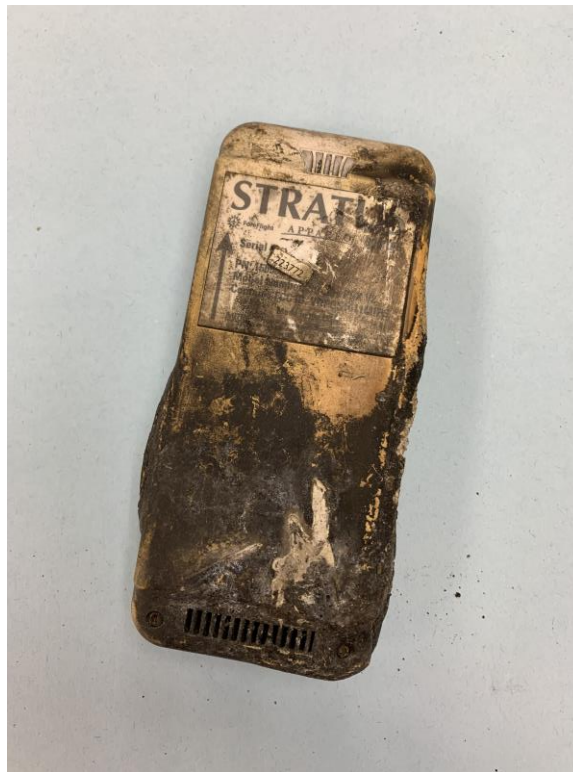
**Figure 1.** Photo of fire damaged Appareo Stratus unit, as received.

Upon arrival at the Vehicle Recorder Laboratory, an examination revealed the unit had sustained both impact and fire damage. The device did not turn on. The device is pictured in figure 1.

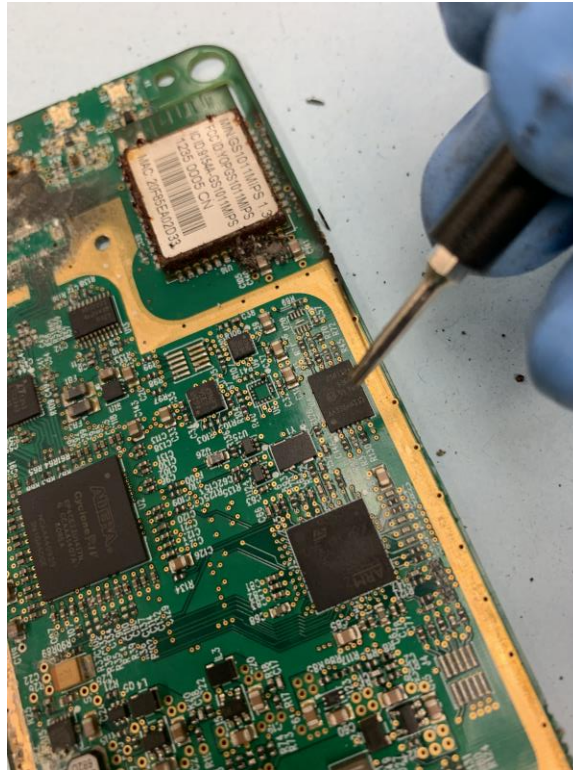
**Figure 2.** Photo of the device's internal NVM memory prior to being removed and read.

The device was both fire and impact damaged and did not power. The device was deconstructed, and the NVM chip was located and removed from the unit's board. Figure 2 shows the device's NVM chip that contains the flight data indicated with a tool.

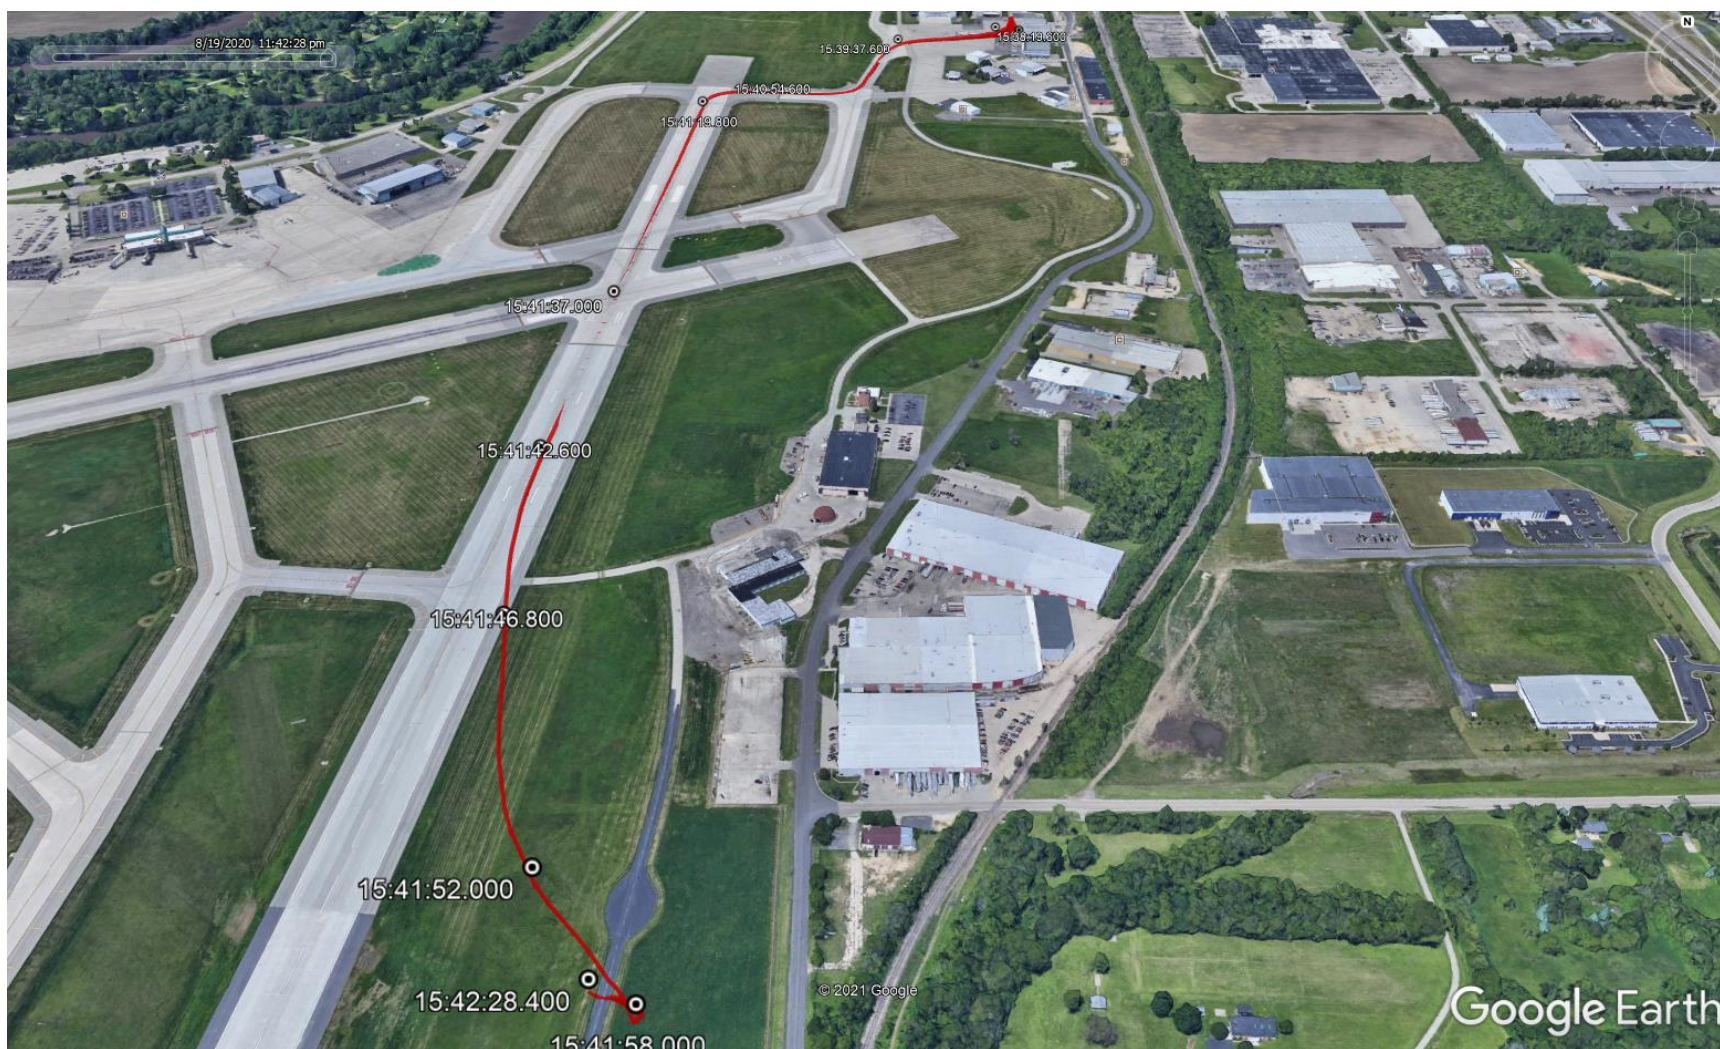
**Figure 3.** A north-up Google Earth overlay of the entire accident flight tracklog.

Figure 3 is a north-up Google Earth overlay of the accident tracklog recording. The data show the device began recording around 15:35:45 in a ramp area in the northeast corner of the airport. Around 15:38, the aircraft began taxiing to runway 19. Around 15:40:34, the aircraft crossed the hold short line for runway 19. Around 15:41:19, the aircraft began a takeoff roll on runway 19. Around 15:41:42, the aircraft began to depart runway centerline to the left of the runway. Subsequent tracklog points show the aircraft gaining some

altitude and the tracklog terminating adjacent to a taxiway in a grassy area. Note that the weather and lighting conditions depicted in Google Earth are not necessarily representative of the weather conditions at the time of the accident.

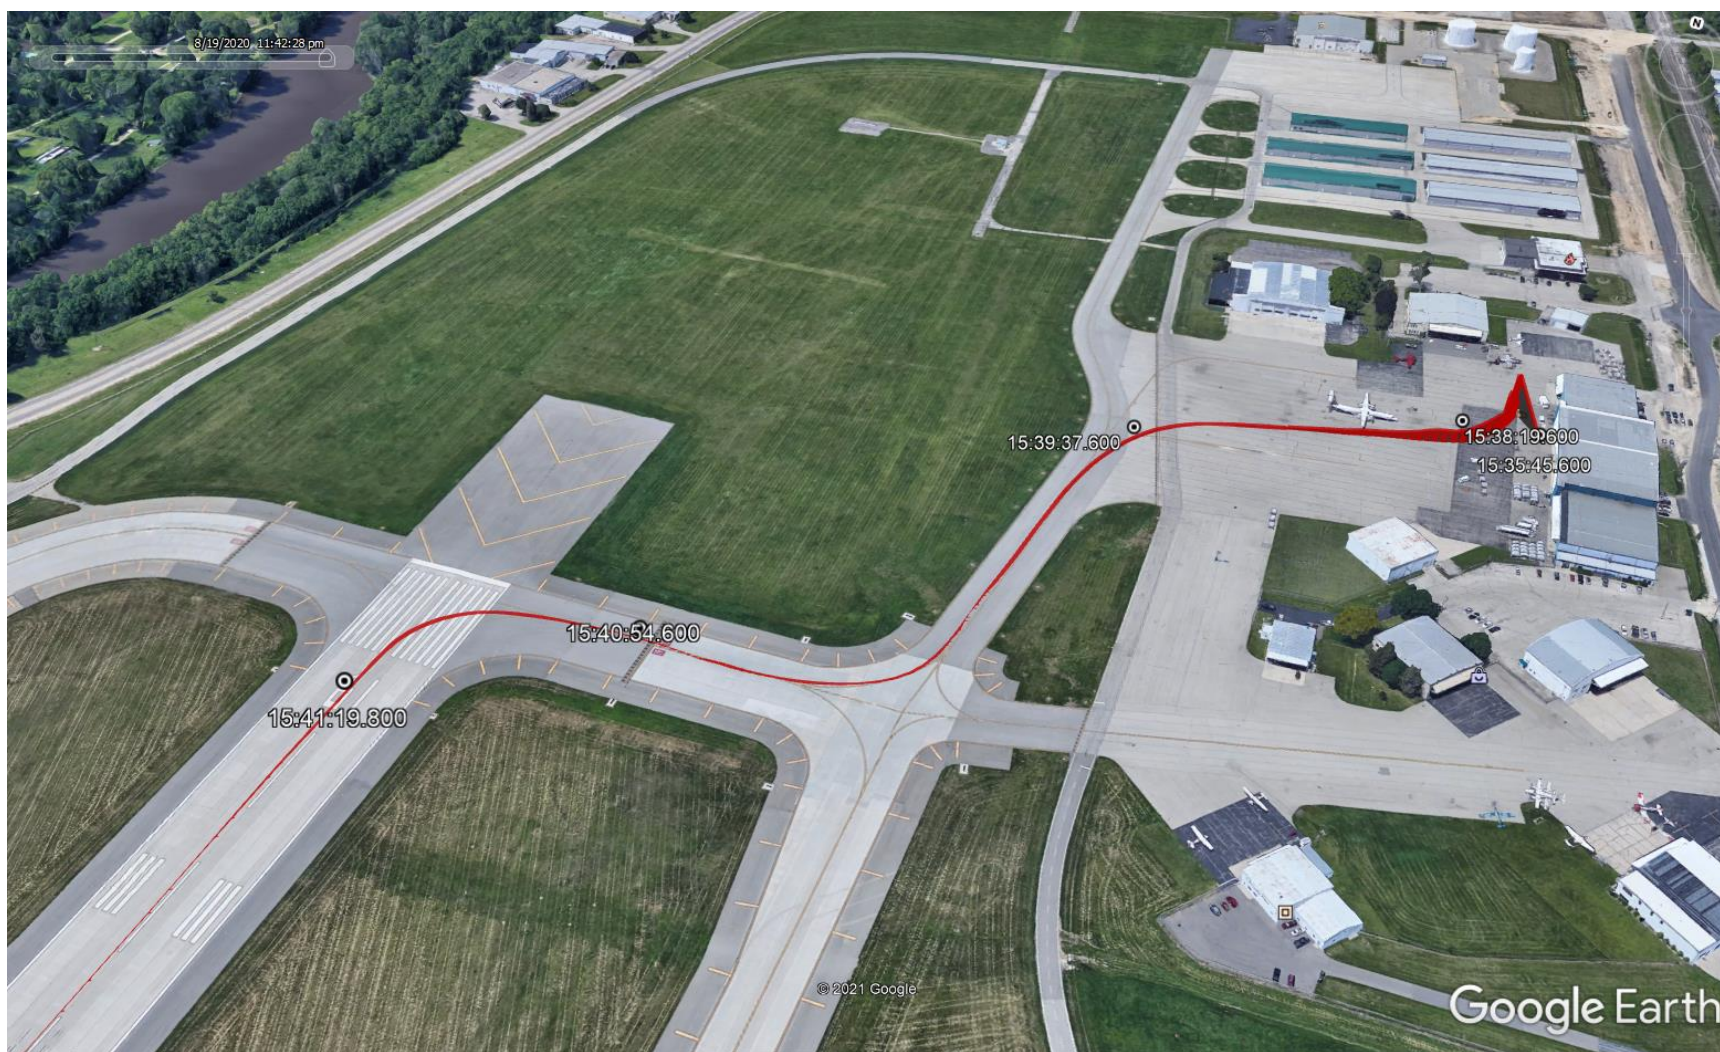
**Figure 4.** A Google Earth overlay that highlights the aircraft's location at the start of the recording and its subsequent taxi to the active runway.

Figure 4 is a Google Earth overlay oriented in such a way to highlight the aircraft's taxi toward runway 19. Note that the weather and lighting conditions depicted in Google Earth are not necessarily representative of the weather conditions at the time of the accident.
