## **NATIONAL TRANSPORTATION SAFETY BOARD**

### **Specialist's Factual Report**

# **METEOROLOGY**

CEN21FA125

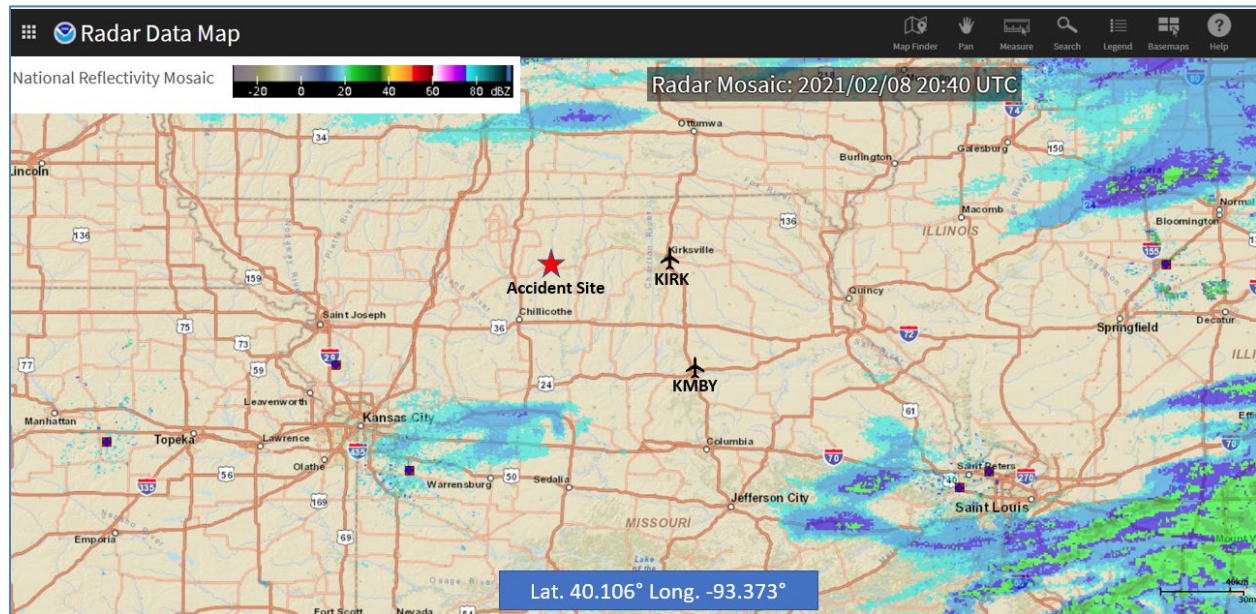
A regional view of the National Composite Radar Mosaic for 1440 CST over northern Missouri is included as Figure 2 with the approximate accident site marked by a red star. Several west-to-east bands of light intensity echoes associated with snow were depicted north of the accident site over Iowa and to the south between Kansas City and St. Louis. No significant echoes were depicted in the vicinity of the accident site; however, the accident site was in an area of a data gap in radar coverage as depicted in figure 3, where there was no coverage in the WSR-88D below 6,000 ft. A separate review of the closest NWS WSR-88D was from Kansas City/Pleasant Hill, Missouri (KEAX), which was located approximately 90 miles from the accident site. The lowest elevation scan of the 0.45° beam extended from approximately 6,670 ft to 15,770 ft over the accident site and could not identify any low level reflectivities over the area. The radar did detect an extensive area

of very light intensity echoes over the region with a band of 15 dBZ echoes extending eastward from the Kansas City area as depicted in Figure 2 below.

Figure 2 - Regional view of the National Composite Radar Mosaic for 1440 CST
