# NATIONAL TRANSPORTATION SAFETY BOARD

## Cockpit Display – Recorded Flight Data

Specialist's Factual Report

Location: Conifer, Colorado  
Date: April 3, 2021  
Aircraft: Magnus Fusion 212  
Registration: N434MA  
Operator: Private  
NTSB Number: CEN21FA177

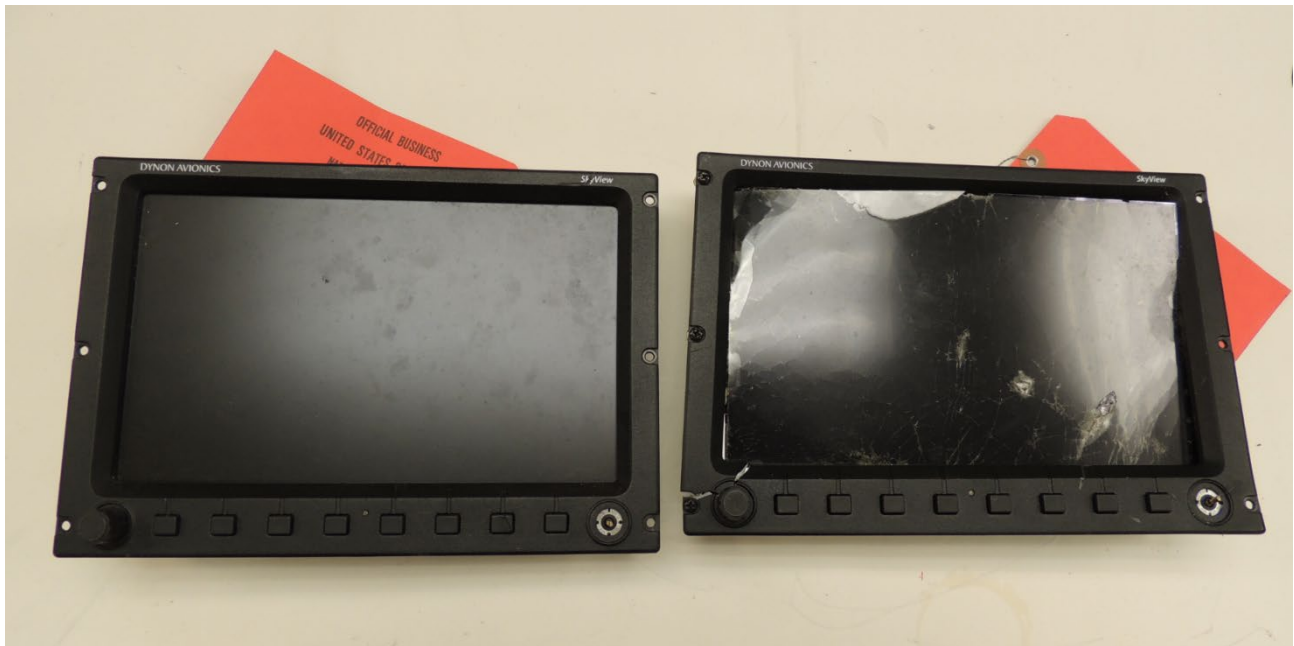
**Figure 1: Front view of two Dynon SV-D1000s, as received.**

Figures 1 and 2 show the condition of the two Dynon SV-D1000s upon arrival at the Vehicle Recorder Division. One of the devices served as a PFD and the other device served as an MFD on the accident aircraft. The device with serial number 8311 (on the left side of Figure 1) powered on normally, and its data were downloaded using the manufacturer’s procedure. Based on past experience, the data stored on the other device (on the right side of Figure 1) would be identical, thus no download was attempted. Figure 3 shows the Dynon USB thumb-drive. This USB thumb-drive stored system and configuration data for the Dynon devices and did not contain any flight data.

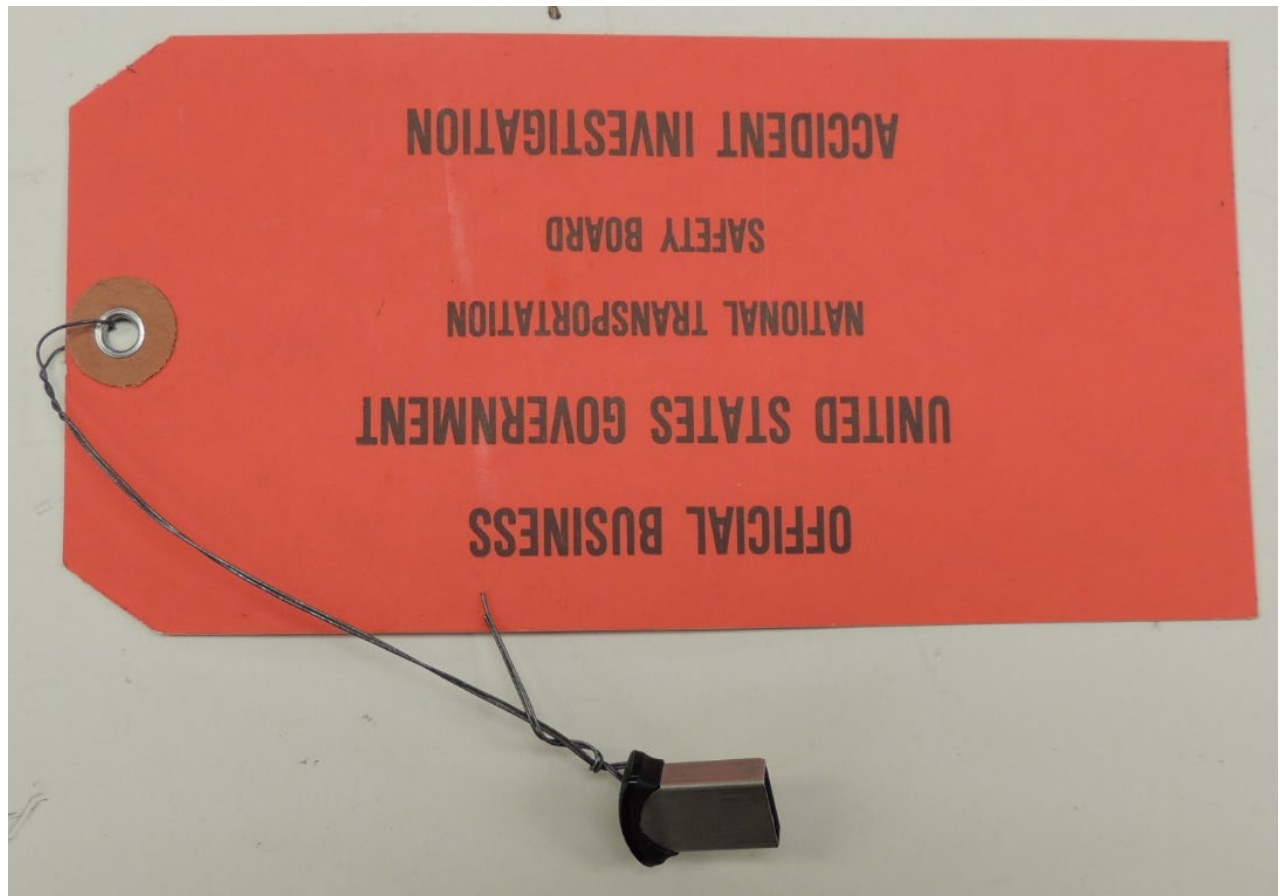
Figure 3: Dynon USB thumb-drive, as received.

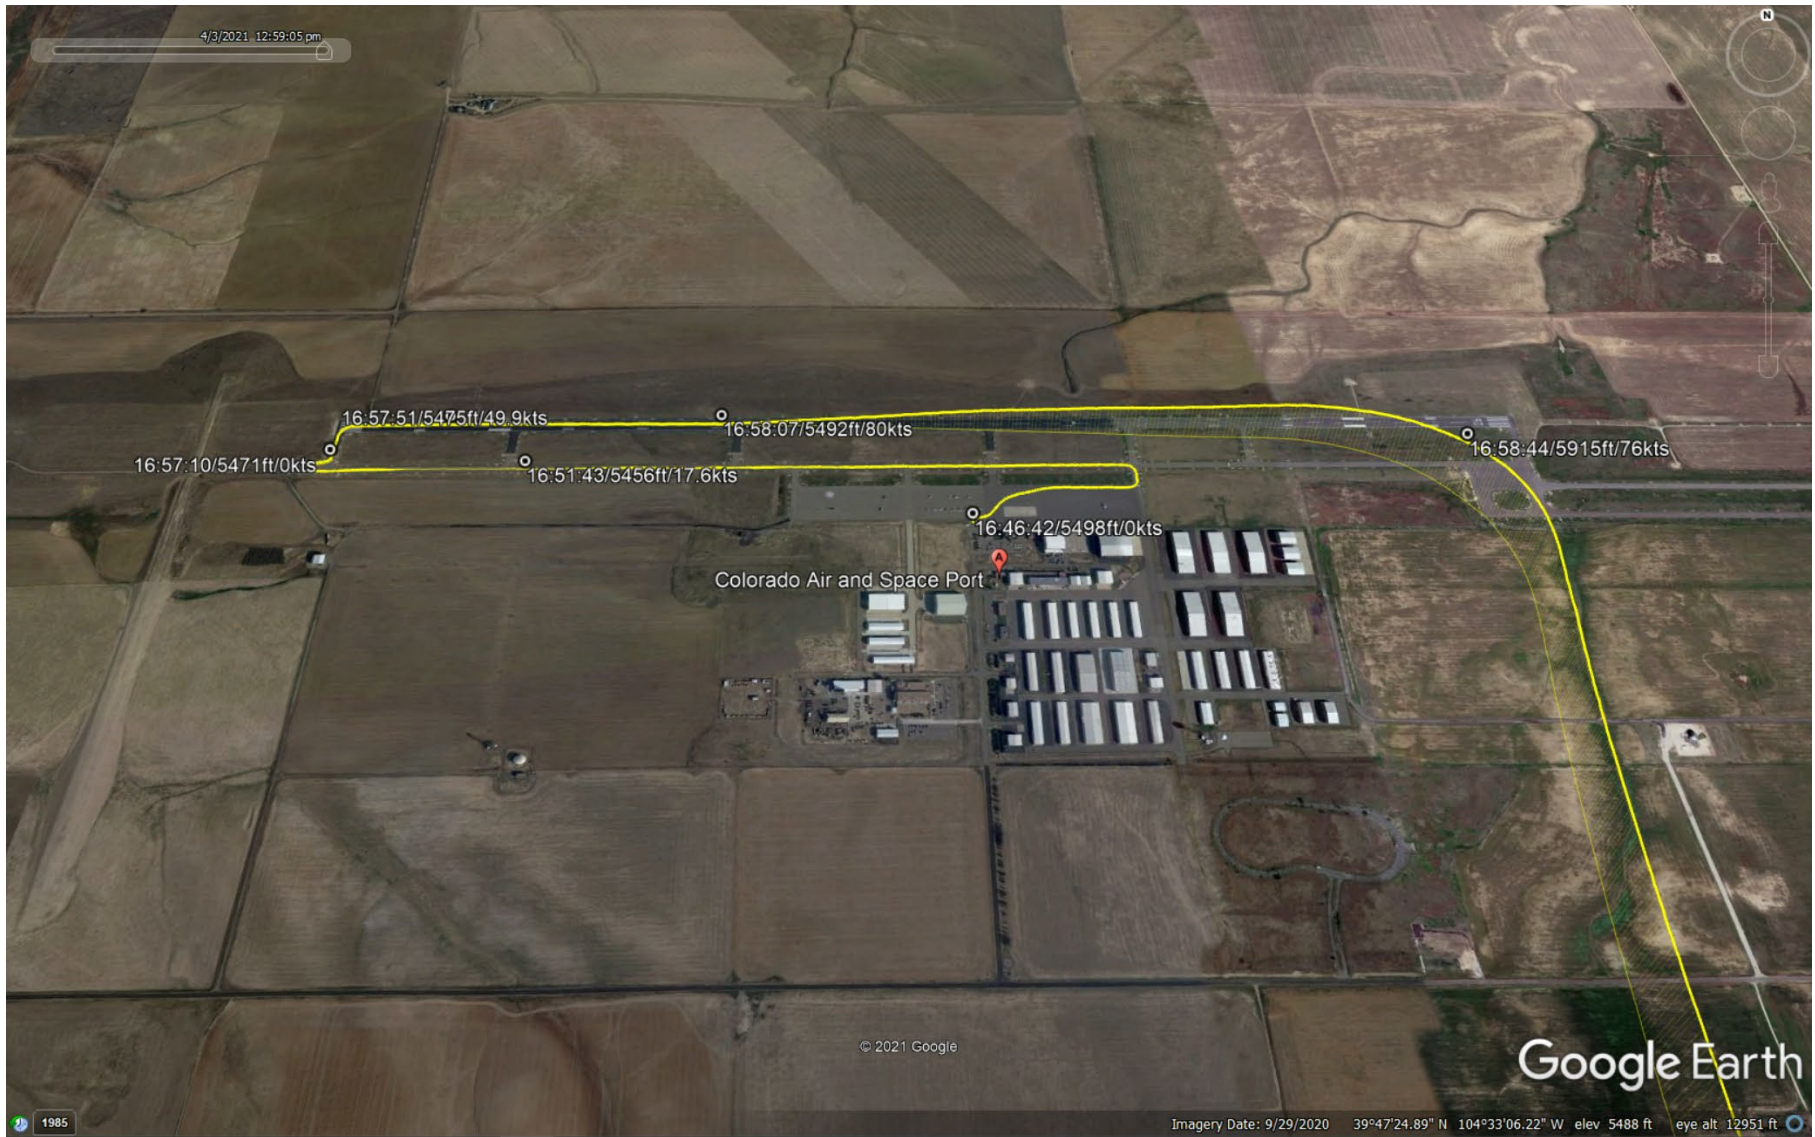
Figure 11: Google Earth overlay of the beginning of the accident flight.

Figure 11 is a Google Earth overlay of the beginning of the accident flight. It shows the aircraft took off the Runway 8 at Colorado Air and Space Port around 16:58:07 MDT, then it turned to the right and headed south around 16:58:44 MDT.

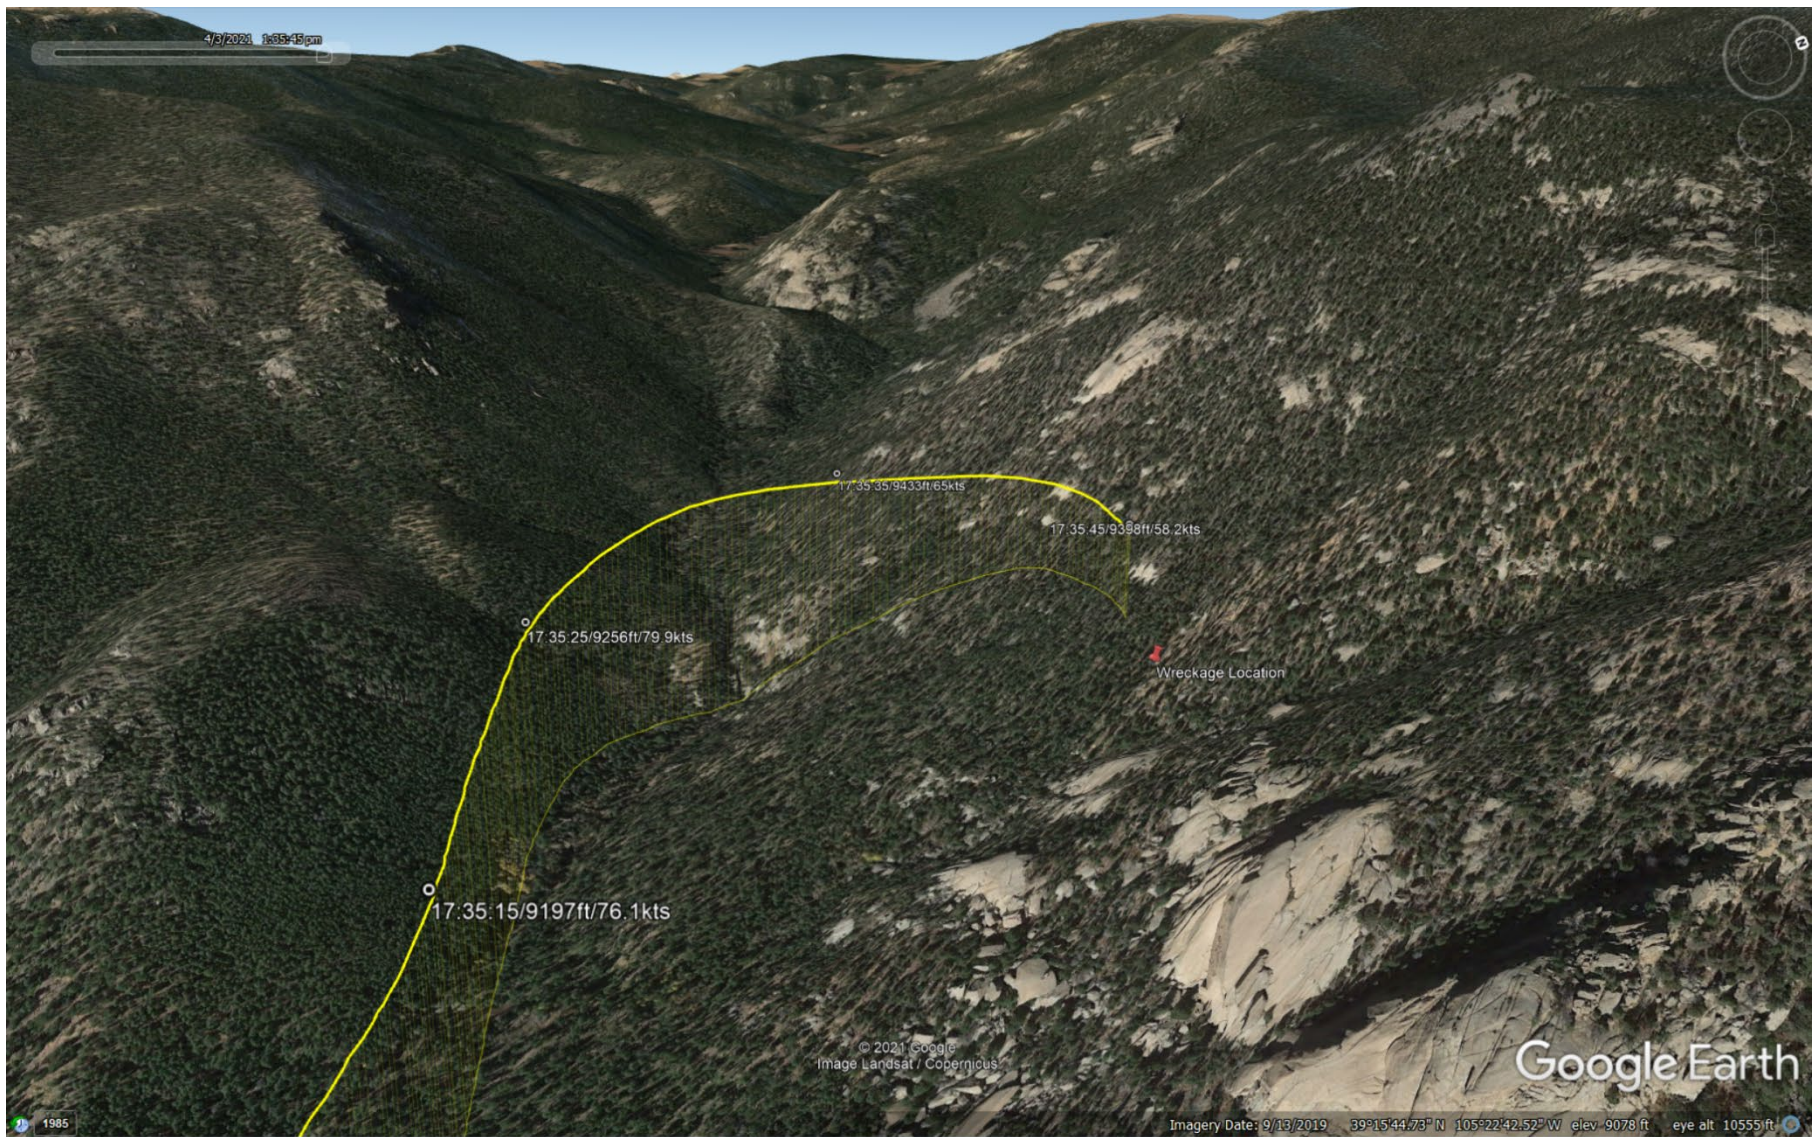
Figure 13: Google Earth overlay of the final portion of the accident flight.

Figure 13 is a Google Earth overlay of the final portion of the accident flight viewed at a different angle. It shows the aircraft was flying along the valley, then at around 17:35:25 MDT, it turned to the right toward the higher terrain.
