**From:** [REDACTED]  
**To:** [REDACTED]  
**Cc:** [REDACTED]  
**Subject:** CEN21FA272 - (Parker, CO) - GoPro Hero 9 Camera - Email Report  
**Date:** Thursday, December 2, 2021 10:37:00 AM

**From:** [REDACTED]  
**To:** [REDACTED]  
**Cc:** [REDACTED]  
**Subject:** CEN21FA272 - (Parker, CO) - Appareo Stratus 3 - Email Report  
**Date:** Tuesday, January 4, 2022 2:14:14 PM  
**Attachments:** [stratus1.jpg](#)  
[stratus2.jpg](#)  
[StratusDataOverlay.PNG](#)  
[CEN21FA272\\_StratusData\\_Attachment1.csv](#)

**From:** [REDACTED]  
**To:** [REDACTED]  
**Cc:** [REDACTED]  
**Subject:** CEN21FA272 - (Parker, CO) - Garmin Autopilot Servos- Email Report  
**Date:** Tuesday, January 18, 2022 12:28:36 PM  
**Attachments:** [AileronServoOpened.jpg](#)  
[ElevatorServoOpened.jpg](#)  
[ElevatorServo.jpg](#)  
[AileronServo.jpg](#)

**From:** [REDACTED]  
**To:** [REDACTED]  
**Cc:** [REDACTED]  
**Subject:** CEN21FA272 - (Parker, CO) - Garmin G900/1000 Series MFD, Garmin G5 and Unknown Electronic Device - Email Report  
**Date:** Thursday, December 2, 2021 8:38:07 AM

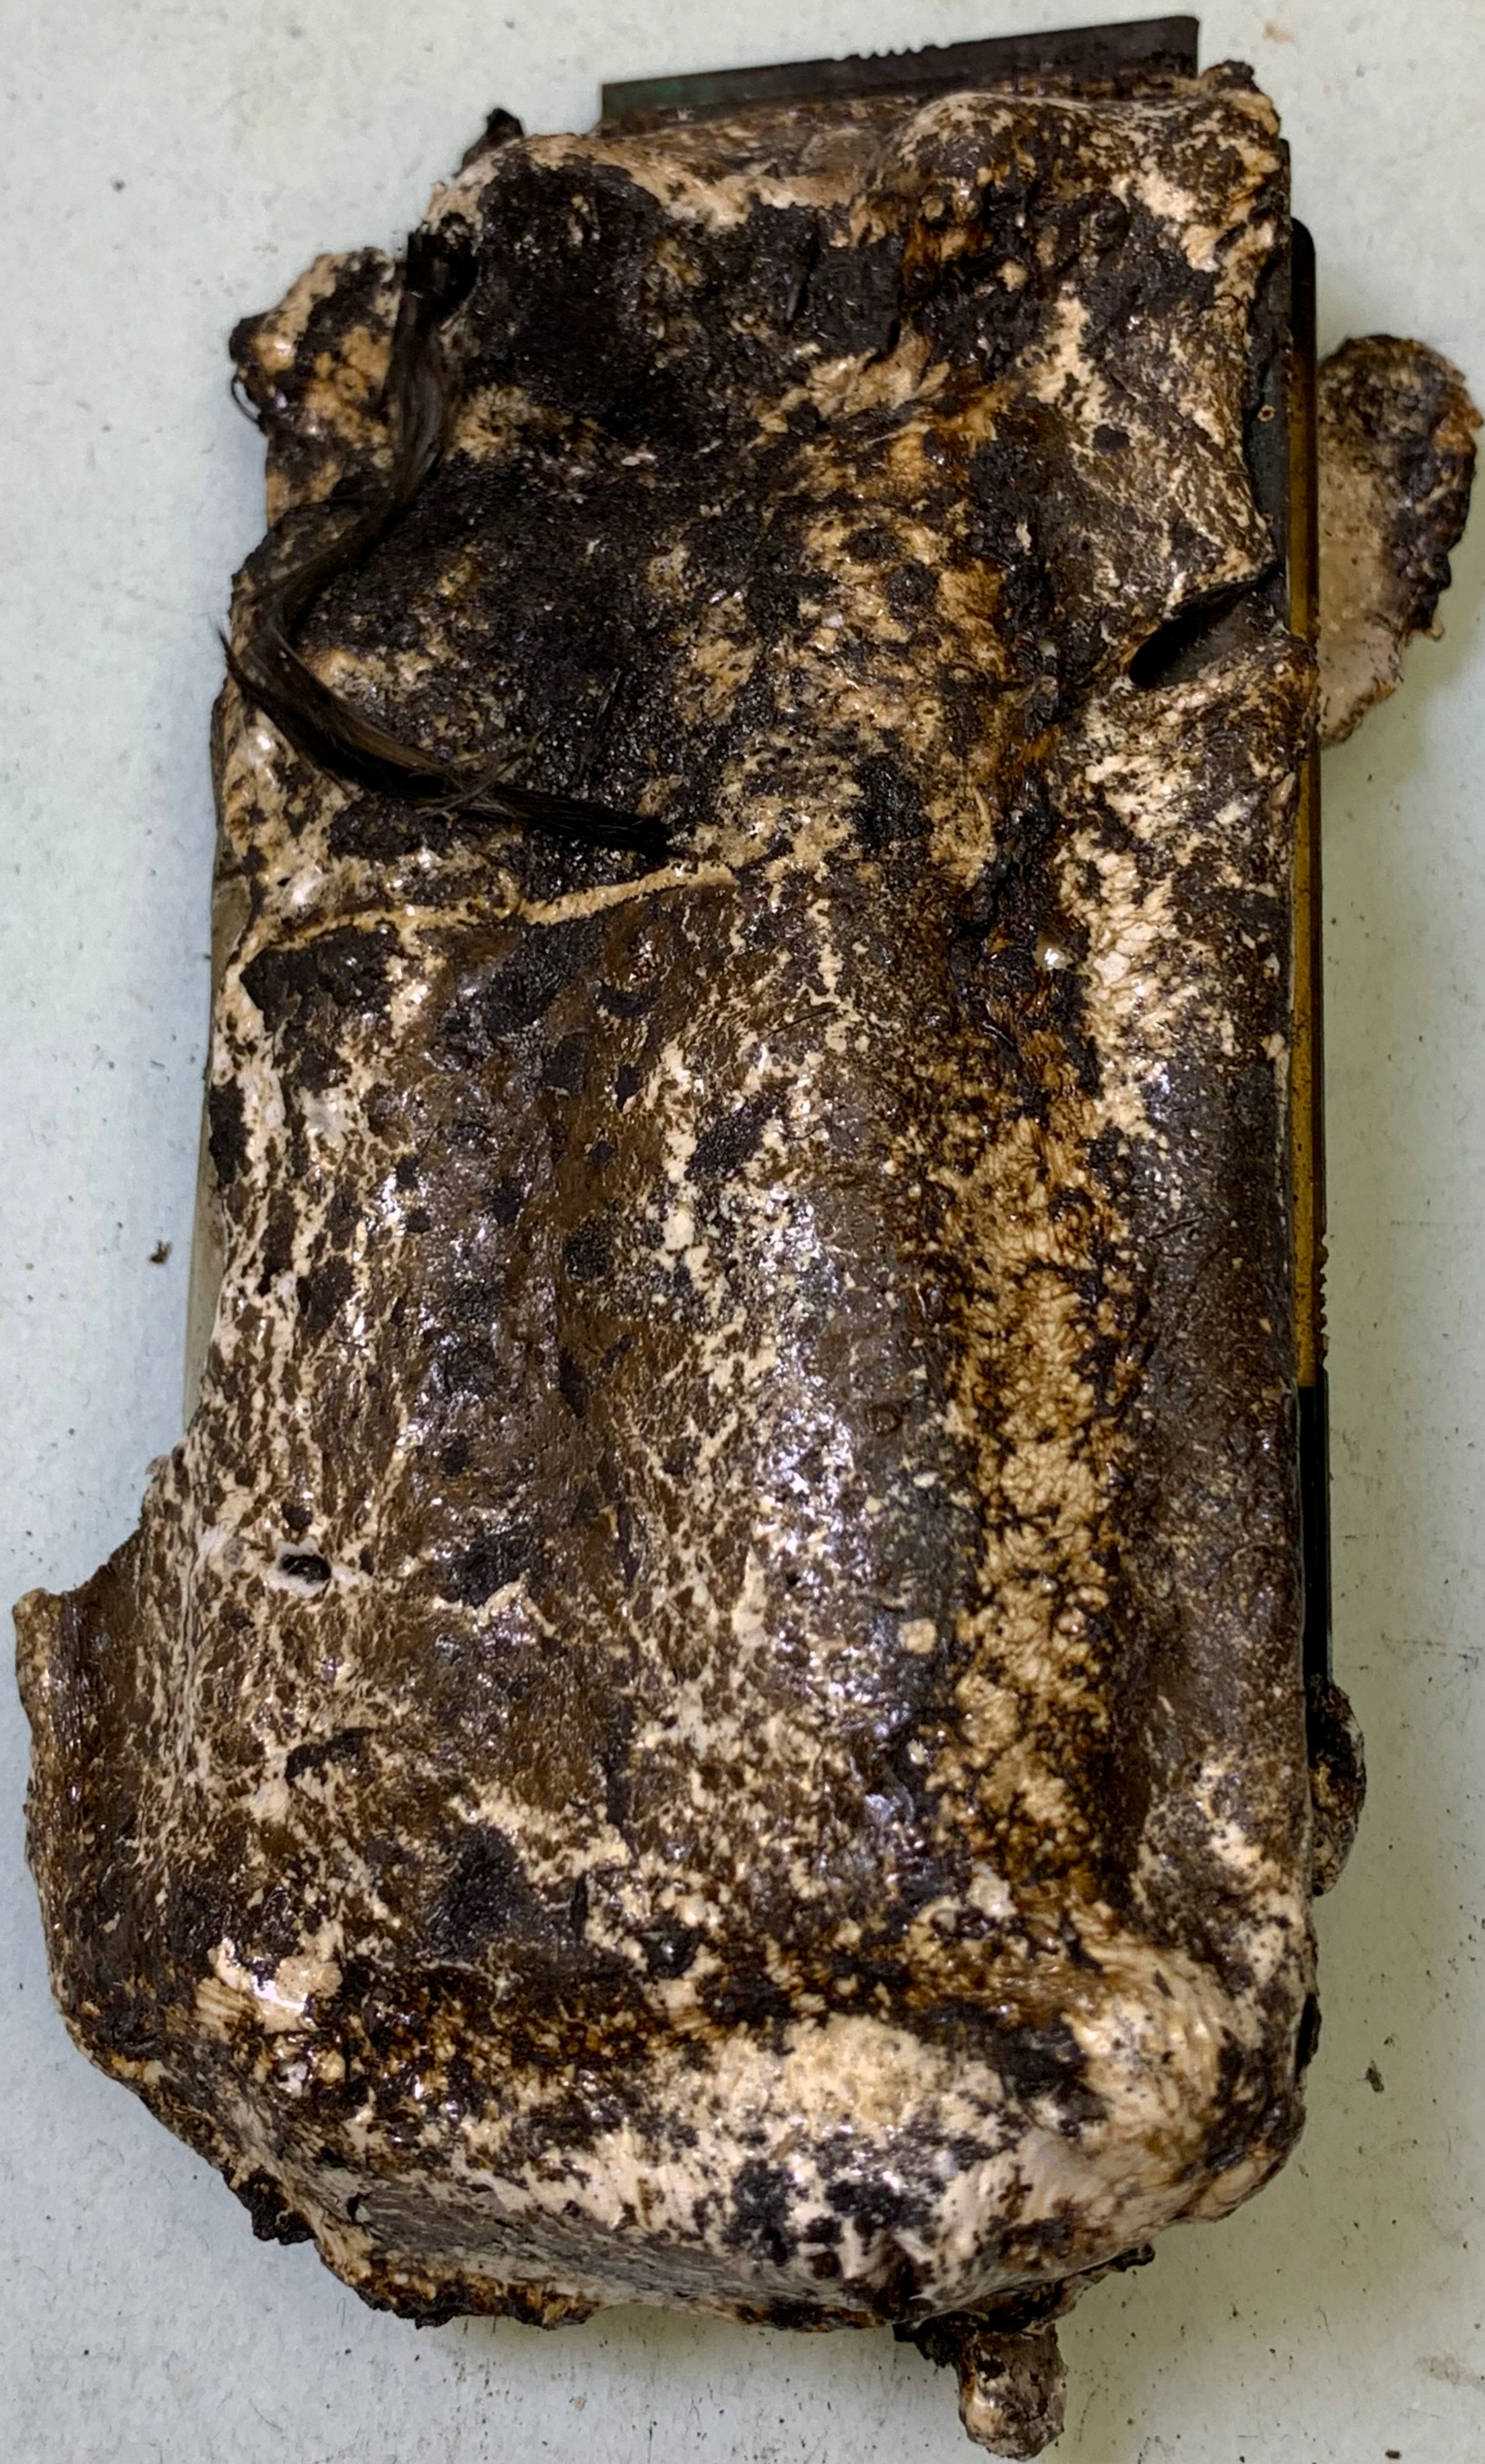
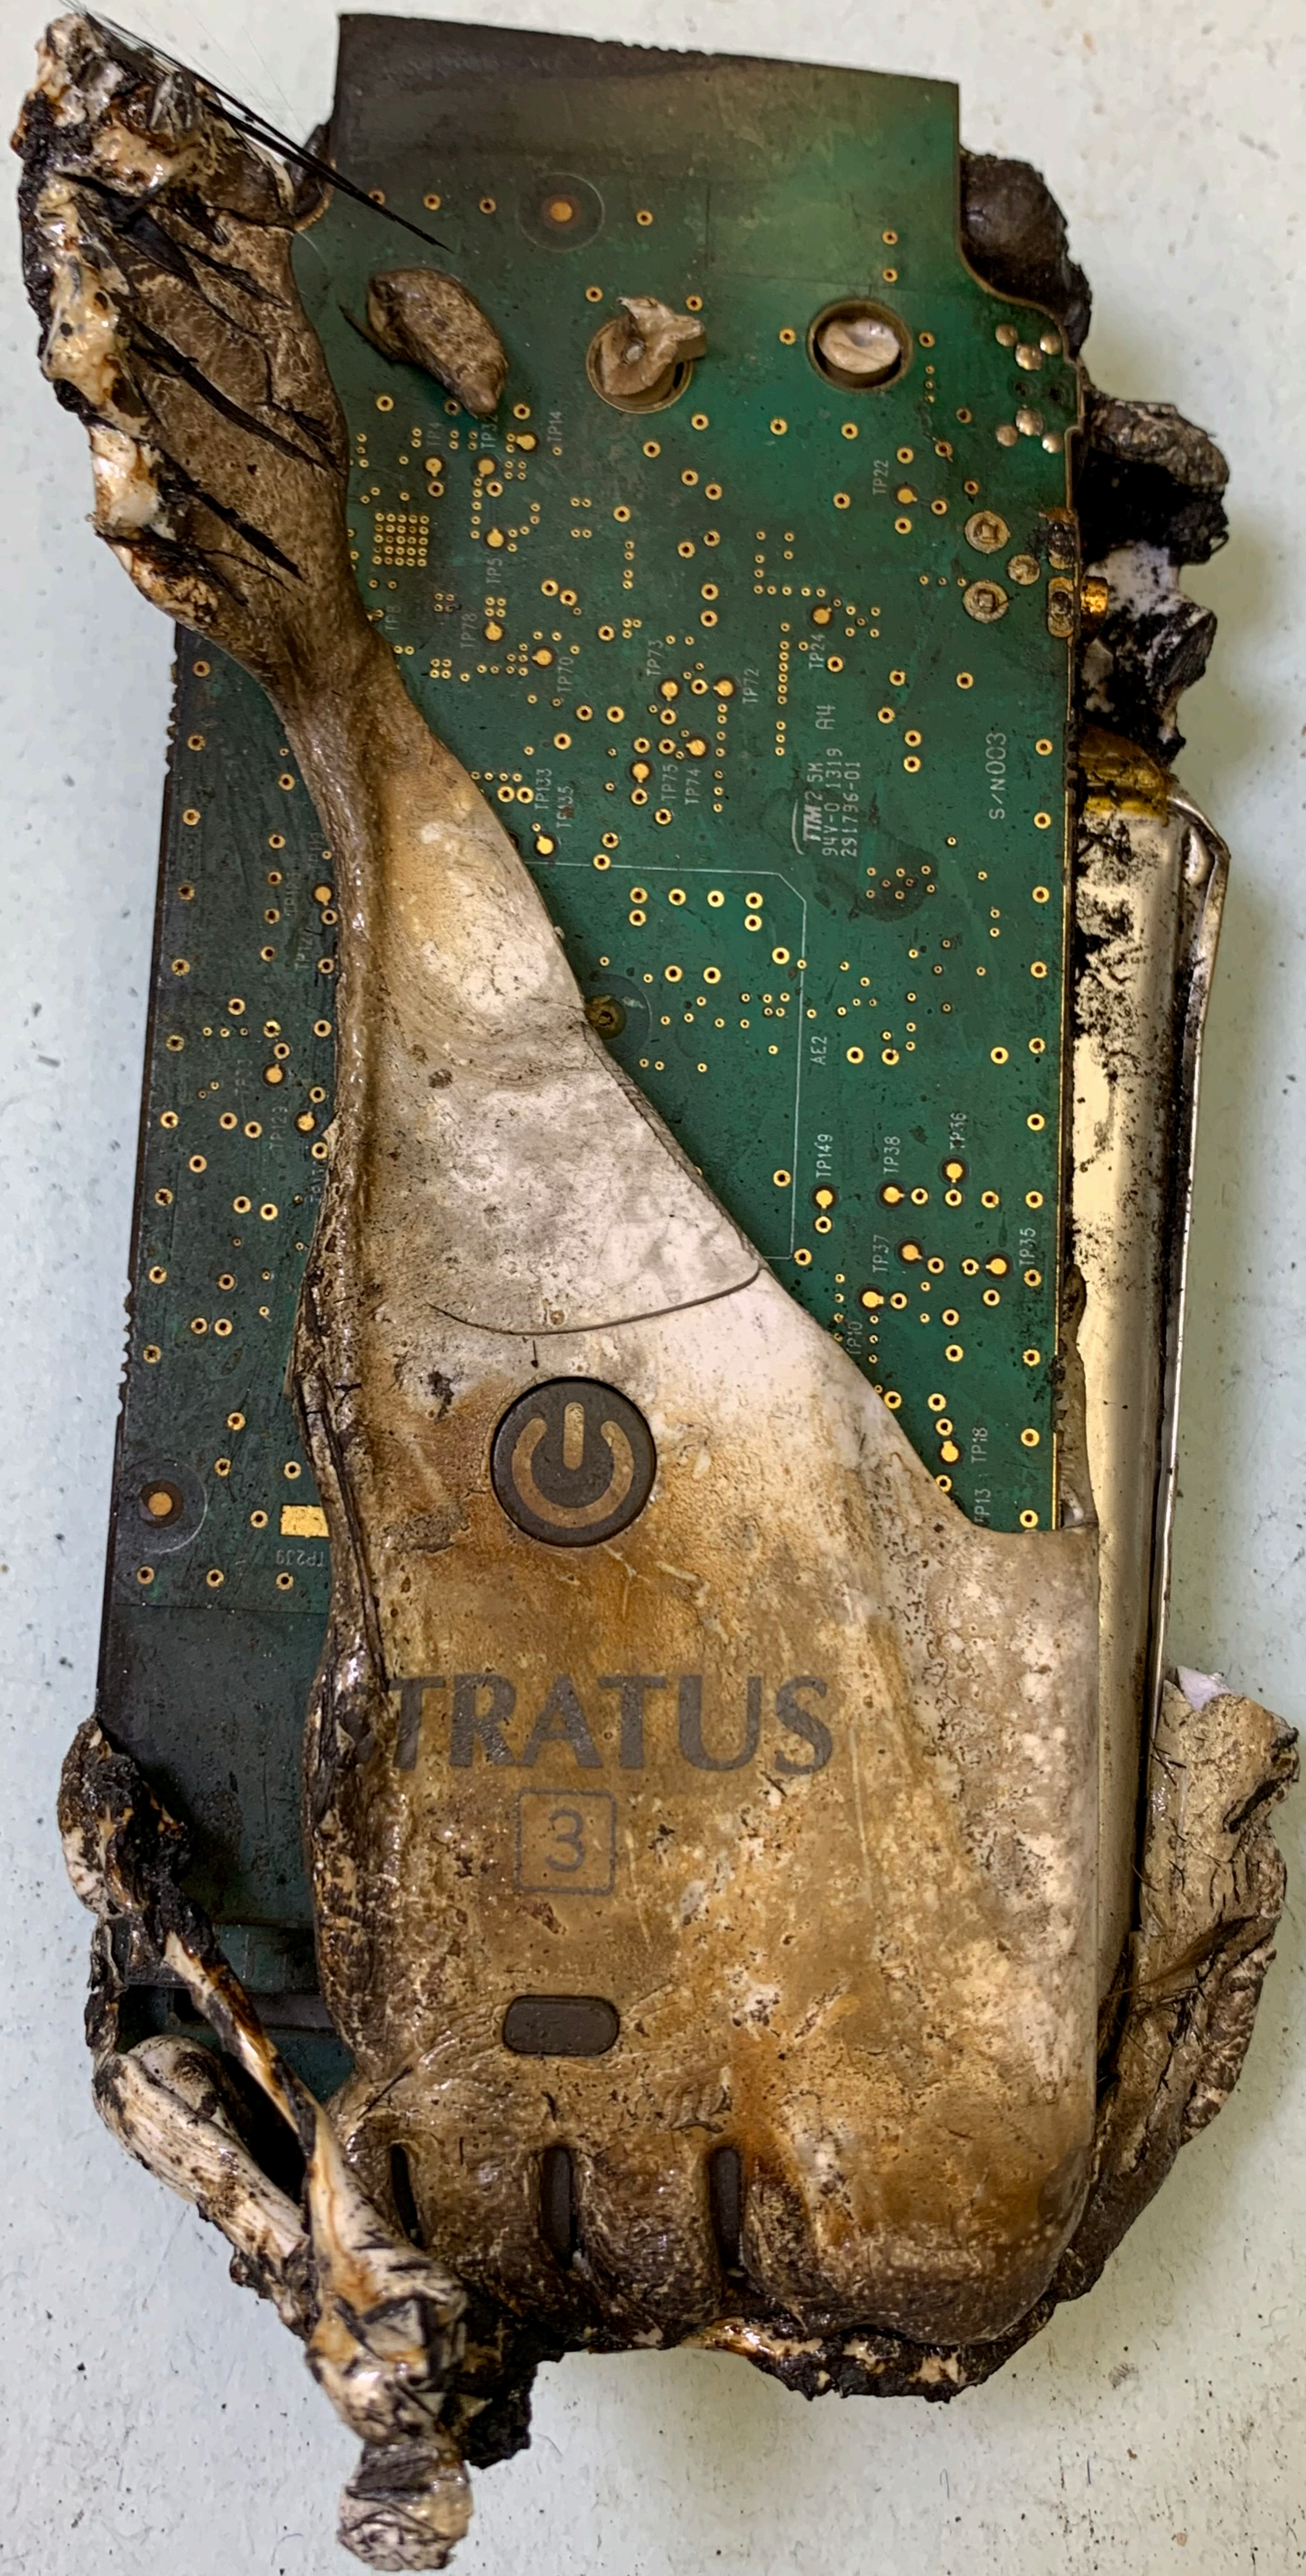
The device sustained both fire and impact damage. The device is pictured in stratus1.jpg and stratus2.jpg which are attached to this email. The device was disassembled and the battery was removed. The unit's non-volatile memory (NVM) chip was identified and removed from the device's board. The NVM chip was read out on the appropriate socket reader and the contained information was converted to flight data.

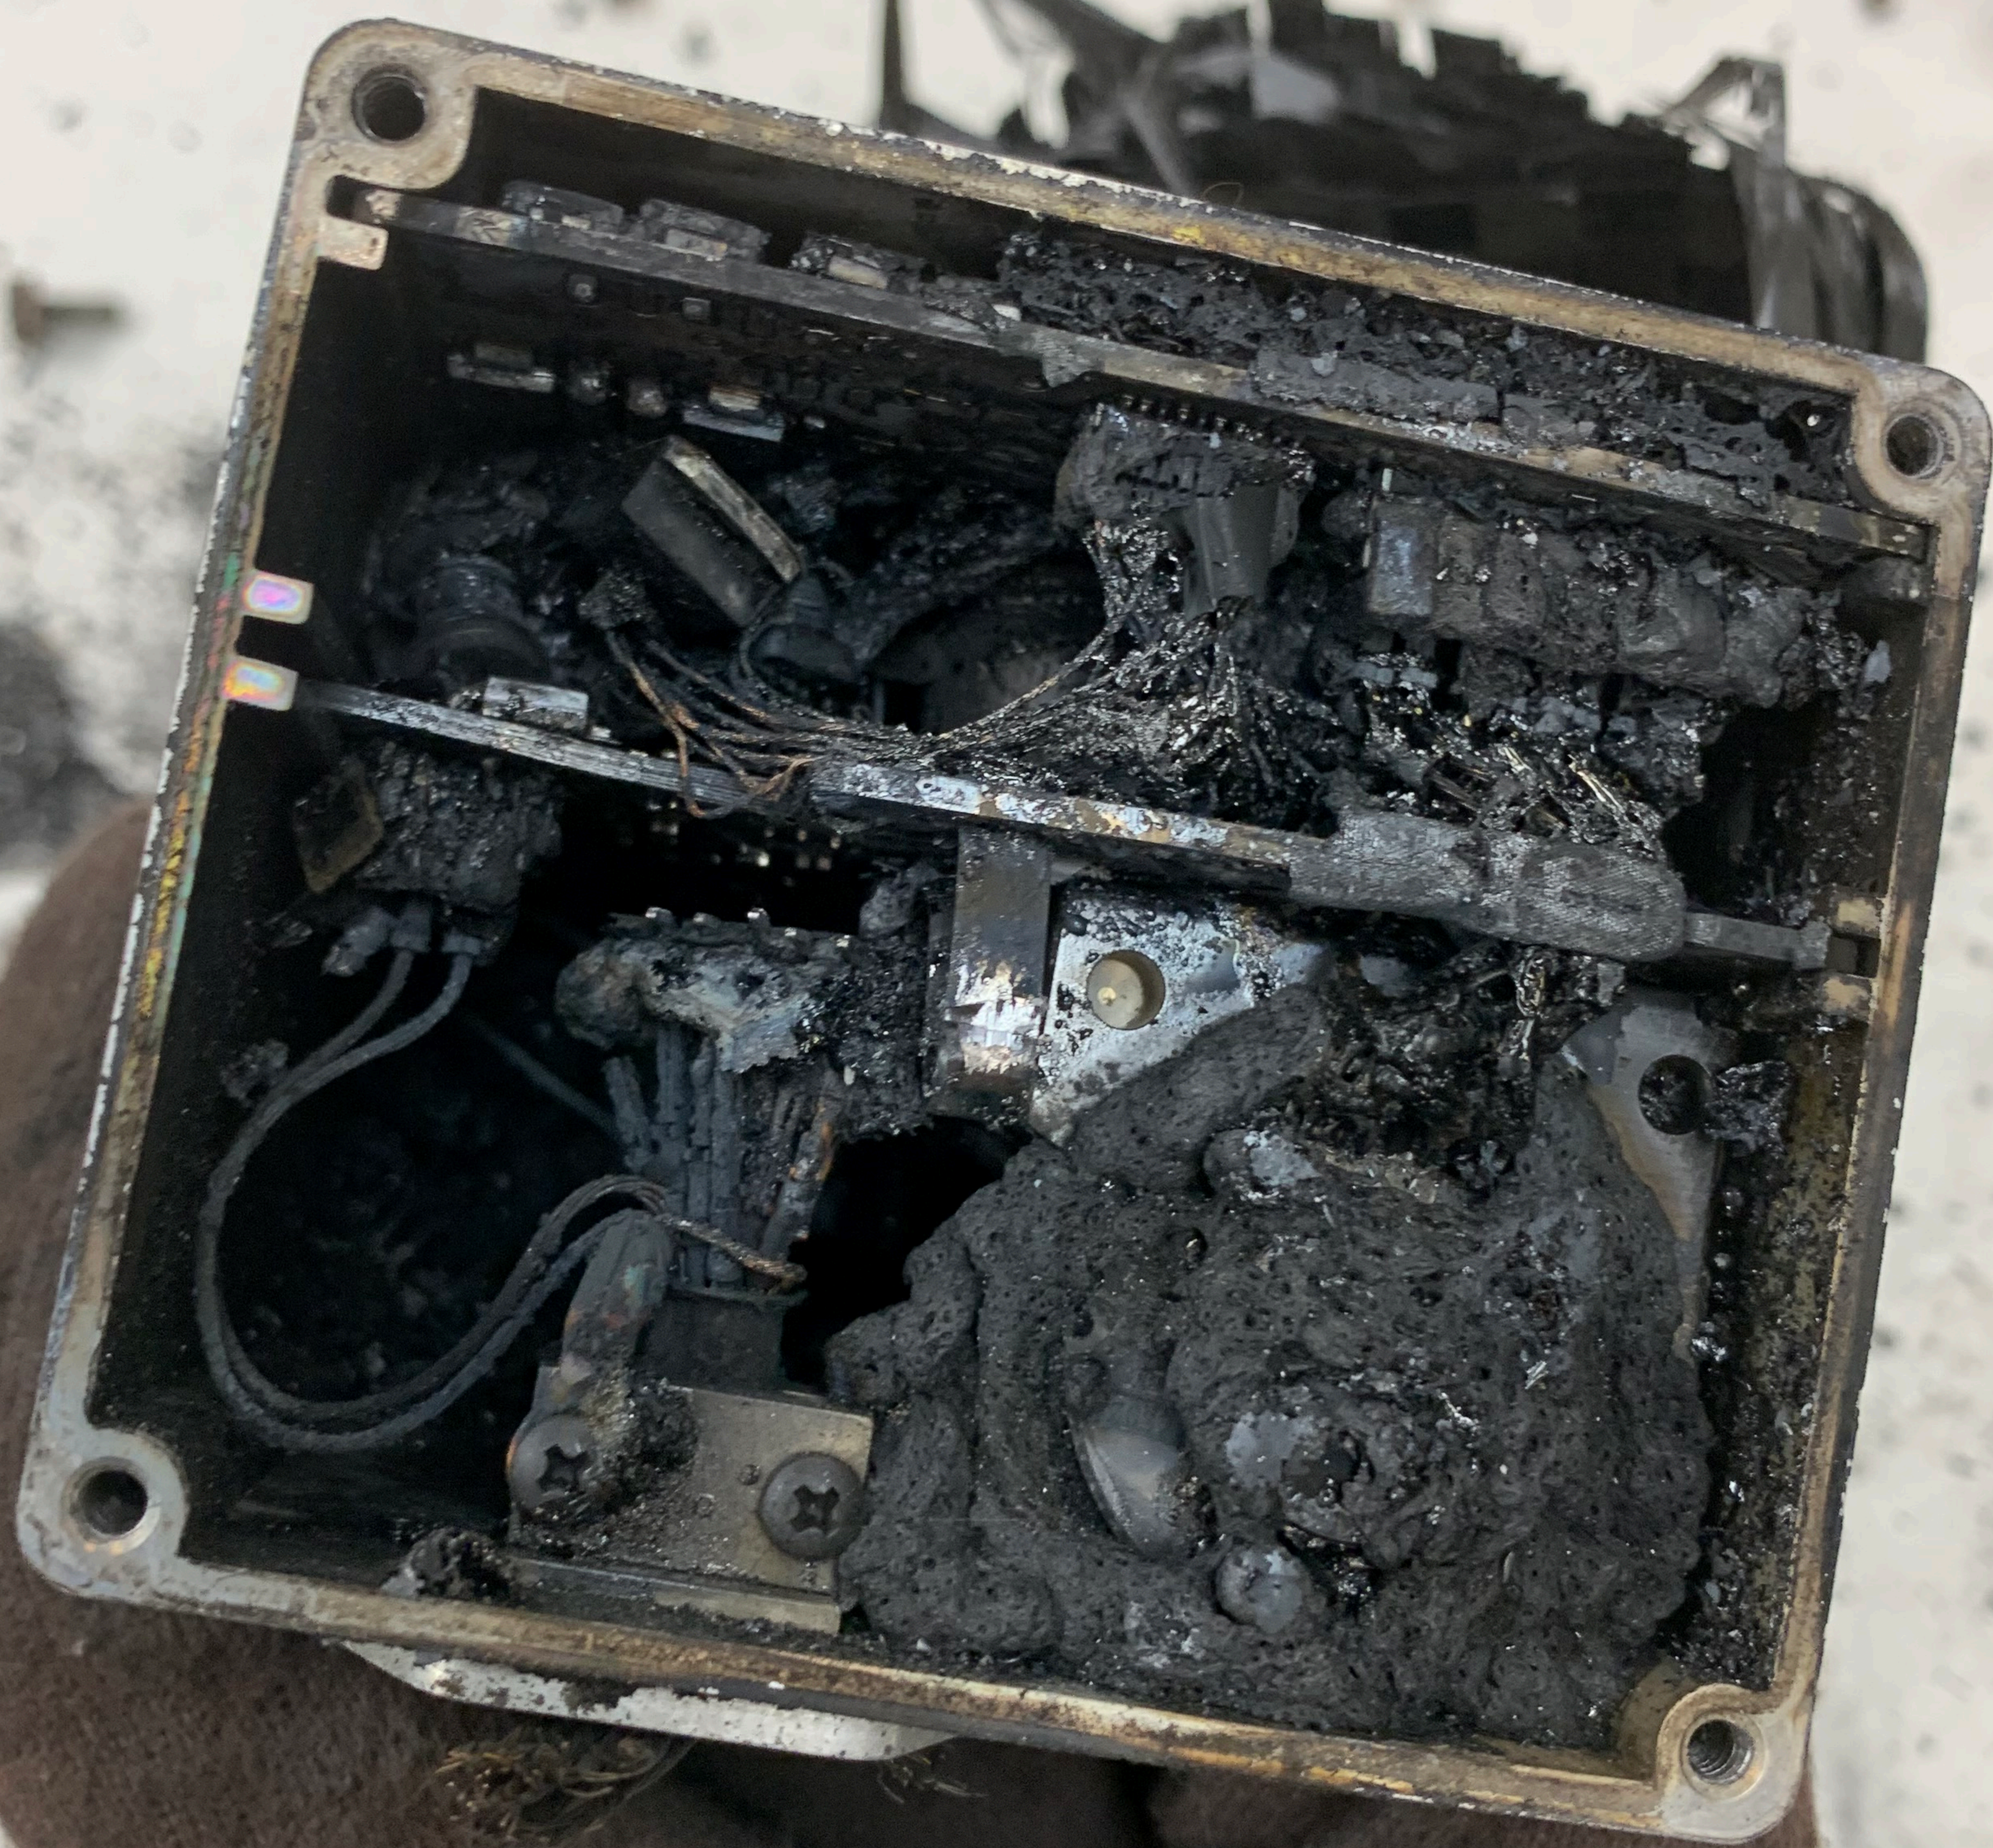
N704AK  
Elevator  
Garmin GFL

The devices sustained both fire and impact damage. The devices are pictured in their arrival state as **AileronServo.JPG** and **ElevatorServo.JPG**. The devices were opened on the bench in the laboratory. Photos **AileronServoOpened.JPG** and **ElevatorServoOpened.JPG** show the internal contents of the devices. It was evident that all internal components of both devices had been destroyed by fire and heat damage. Electronic remains also fell out of the devices as they were opened. These electronic remains were examined for recoverable non-volatile memory (NVM) components, and no NVM were identified.

Due to extensive internal fire and heat damage, there was no recoverable electronic components discovered inside the devices. No data was recovered from the units.
