NATIONAL TRANSPORTATION SAFETY BOARD  
Vehicle Recorder Division  
Washington, D.C. 20594

## Personal Electronic Devices

Specialist's Factual Report  
By W. Deven Chen

Location: Comstock, Texas  
Date: July 17, 2021  
Aircraft: Luscombe 8F  
Registration: N2054B  
Operator: Private  
NTSB Number: CEN21FA327

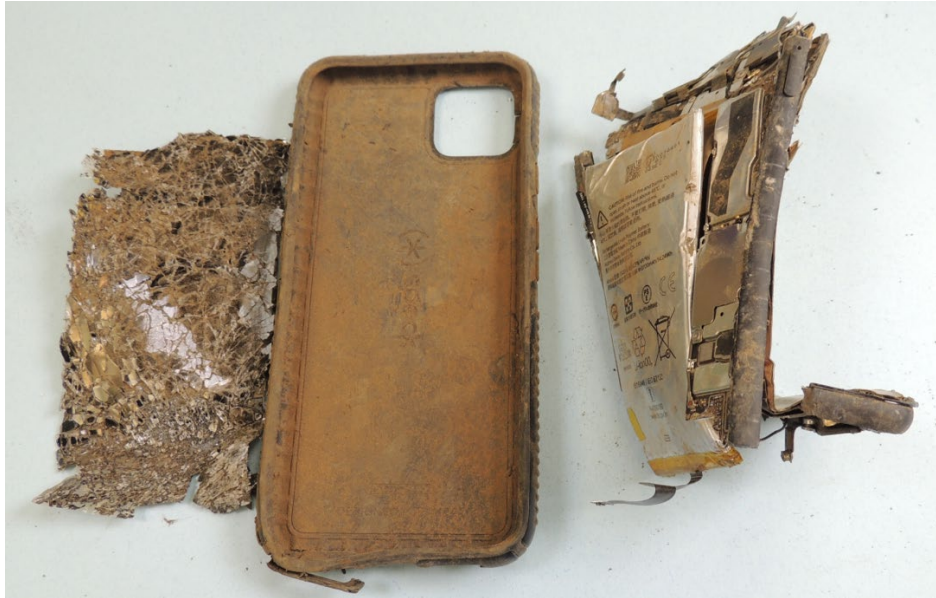
Upon arrival at the Vehicle Recorder Division, an exterior examination revealed that the device had sustained severe impact damage, as shown in Figure 1. The motherboard was removed from the device and found to be snapped in half during the impact, as shown in Figure 2. The device was sent to a commercial data recovery facility where a chip-level transplant was attempted. However, due to the severity of the damage, no data was recoverable.

Figure 1. Google Pixel 4 XL as received.

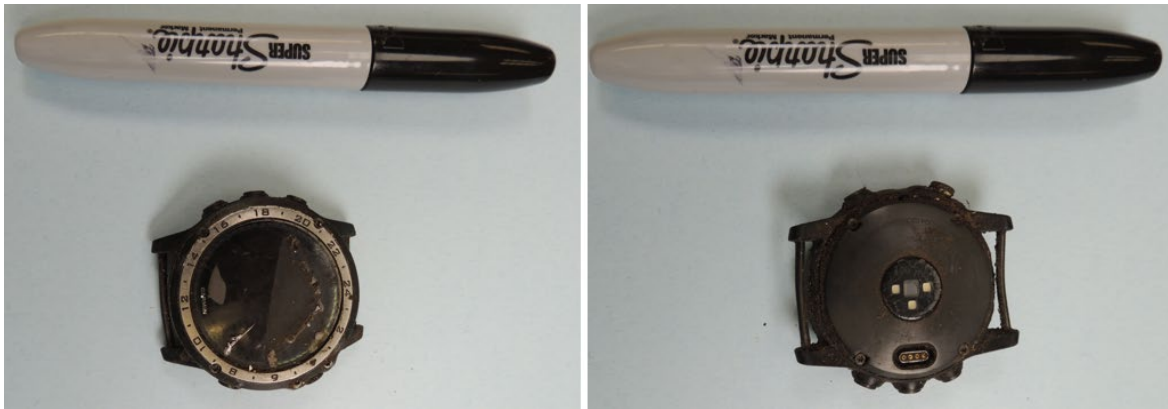
Upon arrival at the Vehicle Recorder Division, an exterior examination revealed that the device had sustained damage, as shown in Figure 3. The device was cleaned and connected to a PC with a Garmin charging/data cable. The device powered on and data were downloaded to the PC.

**Figure 3.** Front and Back of the Garmin D2 Charlie Watch as received.

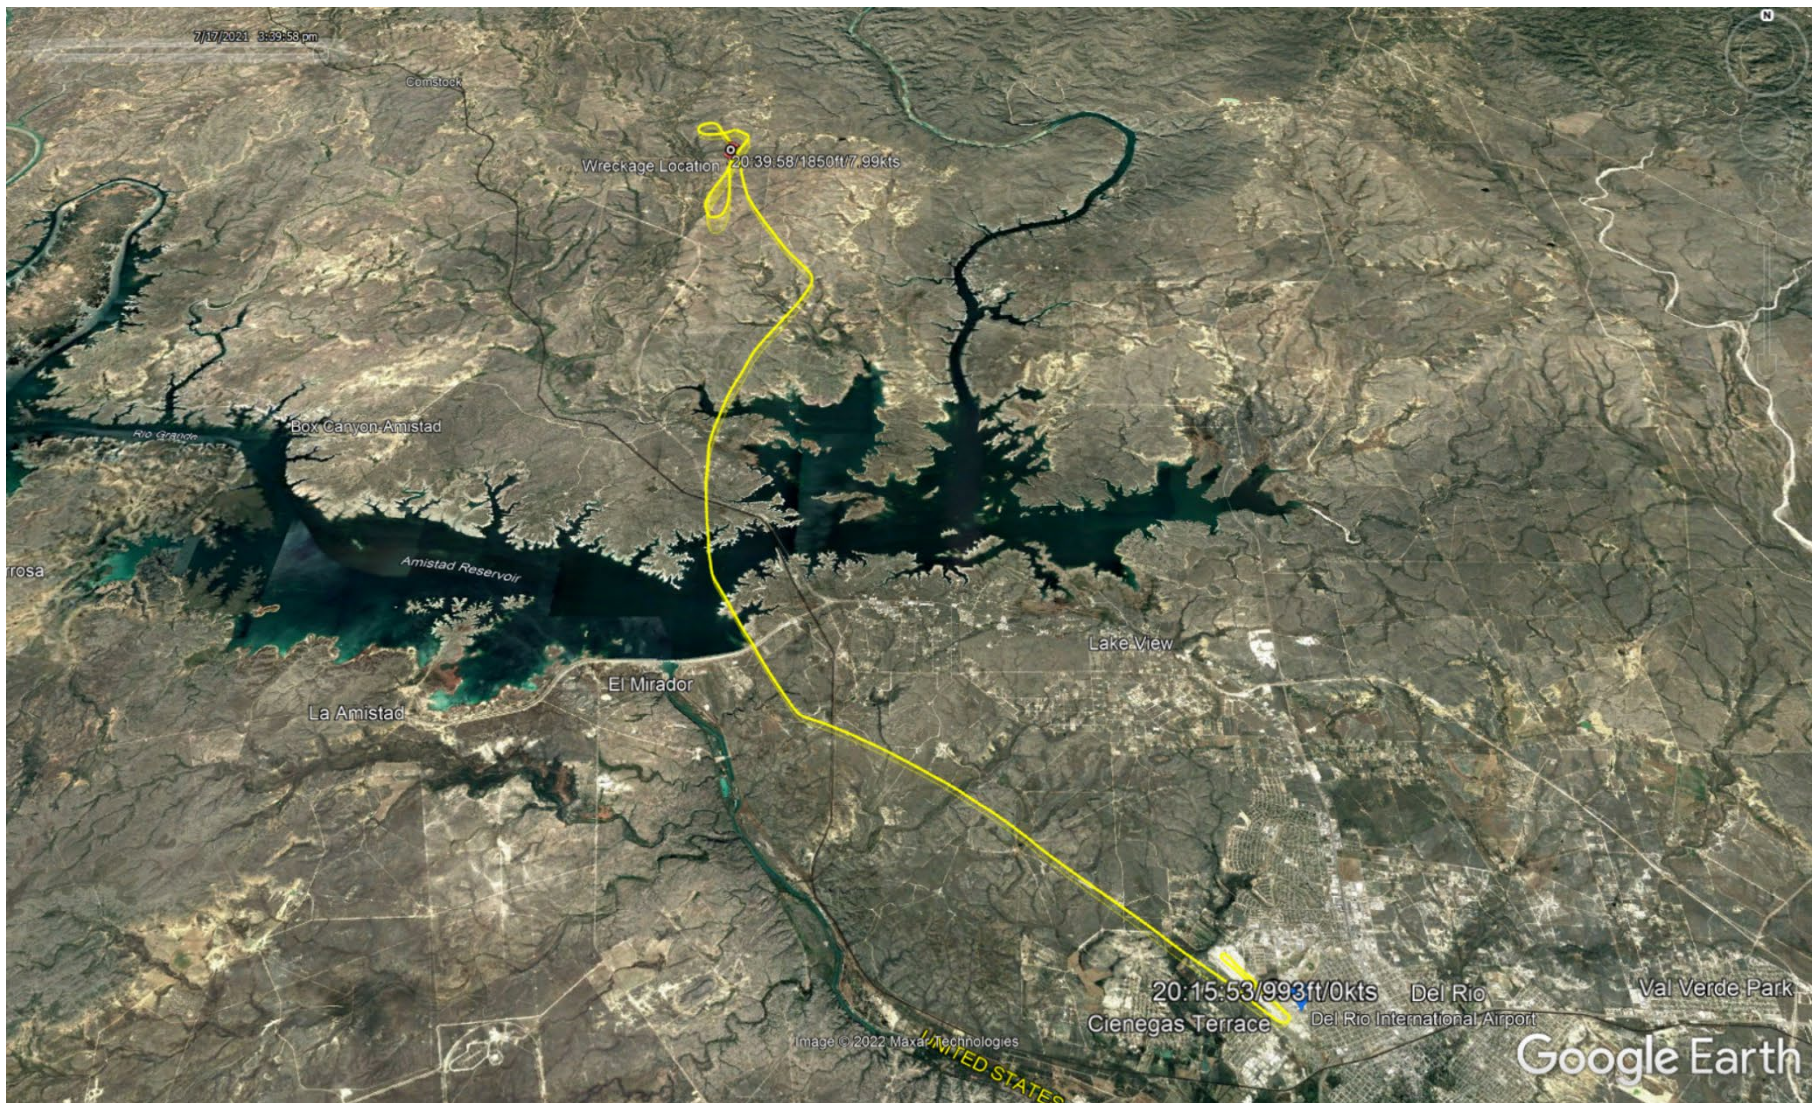
Figure 4 is a Google Earth overlay of the entire event flight. The weather and lighting conditions in Google Earth are not necessarily the weather and lighting conditions present at the time of the recording.

Figure 4. Google Earth overlay showing the entire event flight.
