## **NATIONAL TRANSPORTATION SAFETY BOARD**

### **Specialist Restraint Study**

# **SURVIVAL FACTORS**

CEN21FA345

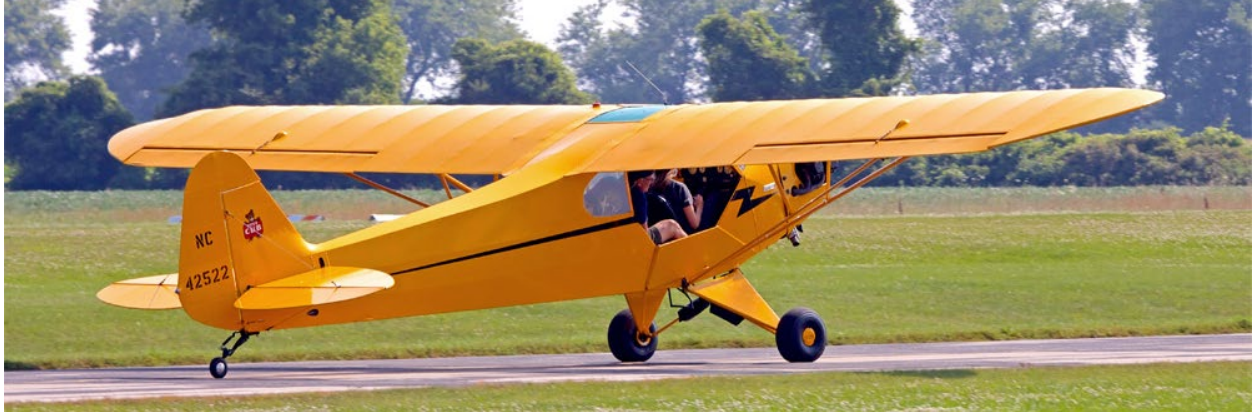
**Figure 1.** Pre-accident photo of N42522 found on [airpigz.com](https://airpigz.com)<sup>1</sup>. In this photo the door is in a lowered and locked position, however that was not the configuration in the accident aircraft. Note that in the photo the side of the airplane is open, and the lower door can be seen in the down and secured position for flight.

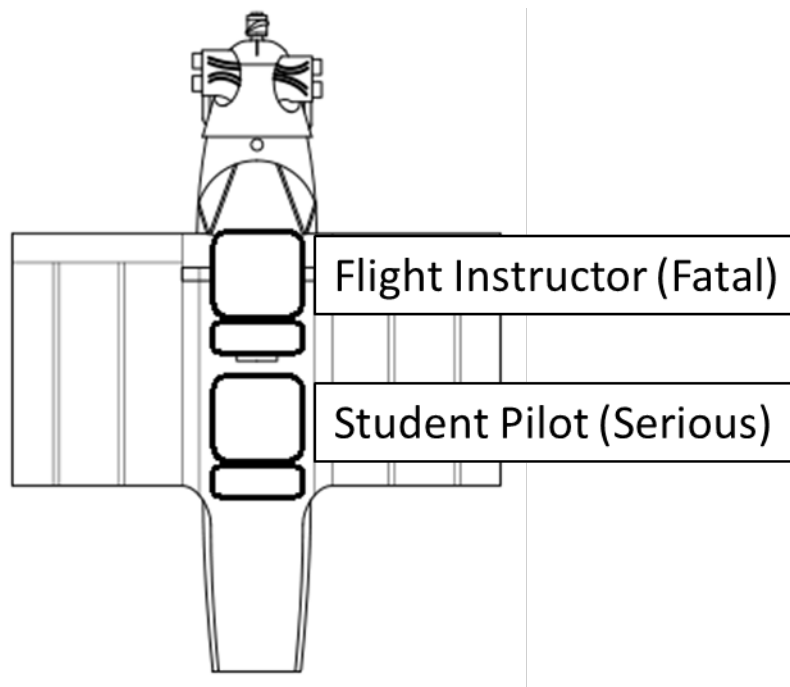
**Figure 2.** Line drawing of the Piper Cub seating.

The airplane was a Piper Cub J3C-65, non-pressurized single engine airplane. Configured with two seats in line, one in front and one in back, the aft seat could be used for passengers or for instruction. The airplane had a door and window combination for entry, where the window rotated upward and the door downward. In the accident airplane the window had been rotated upward and latched in that position for flight and the door was up in the closed and locked position. Both seats were equipped with a two-point lap belt with a lift latch buckle, which was secured to airplane structure, near the legs of the seat frame. The airplane also included a control stick in front of both the front and the aft seat.

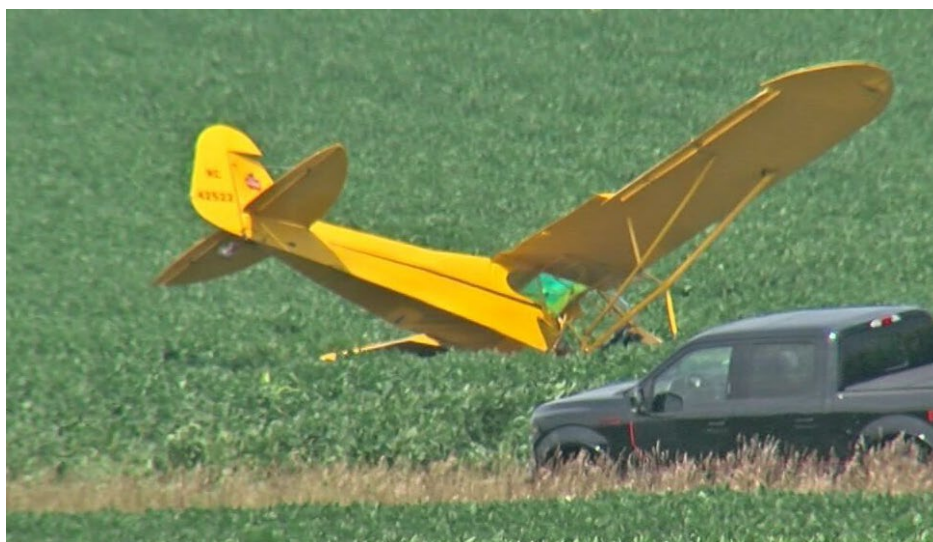
Based on impact signatures and witness statements, the airplane impacted in a left-wing low, nose low attitude, with the airplane coming to rest about 35 ft west of the initial impact point. The left wing was broken, and the landing gear was damaged (see figure 3). According to first responders the damage to the right side of the airplane cabin occurred when extricating the occupants.

**Figure 3.** Postaccident photograph of N42522.

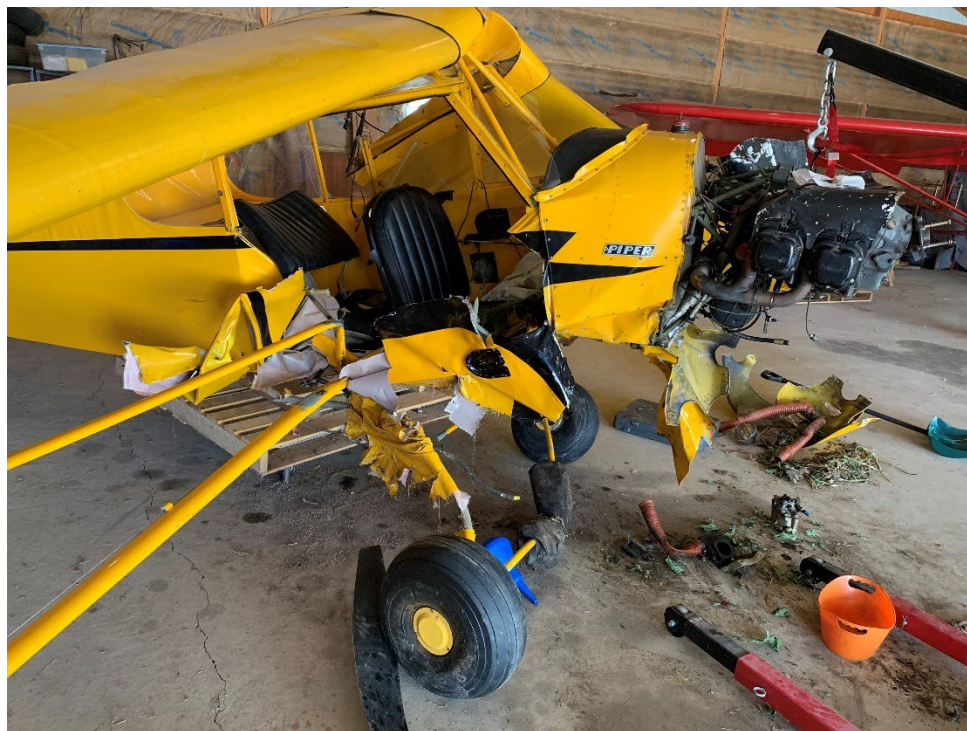
The cabin area was mostly intact with the damage to the right-side structure and seats occurring when the occupants were extricated according to first responders (see figure 4).

**Figure 4.** Photograph of N42522 at salvage facility during documentation.

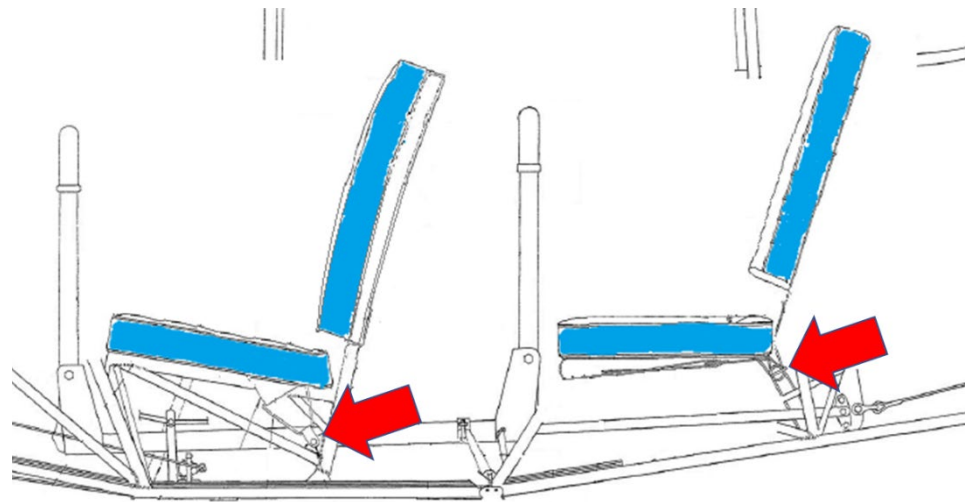
The seats were constructed of metallic tube frames with fabric seatpans and backs. Leather covered cushions were attached to the seat pan with hook and loop strips, and leather covered cushions secured over the seatback frames. Both seats were equipped with two-point lap belts with lift latch buckles. The lap belts were secured toward the bottom of the seat frame (see figure 5).

**Figure 5.** Line drawing showing seats, belt anchor locations, and control sticks.

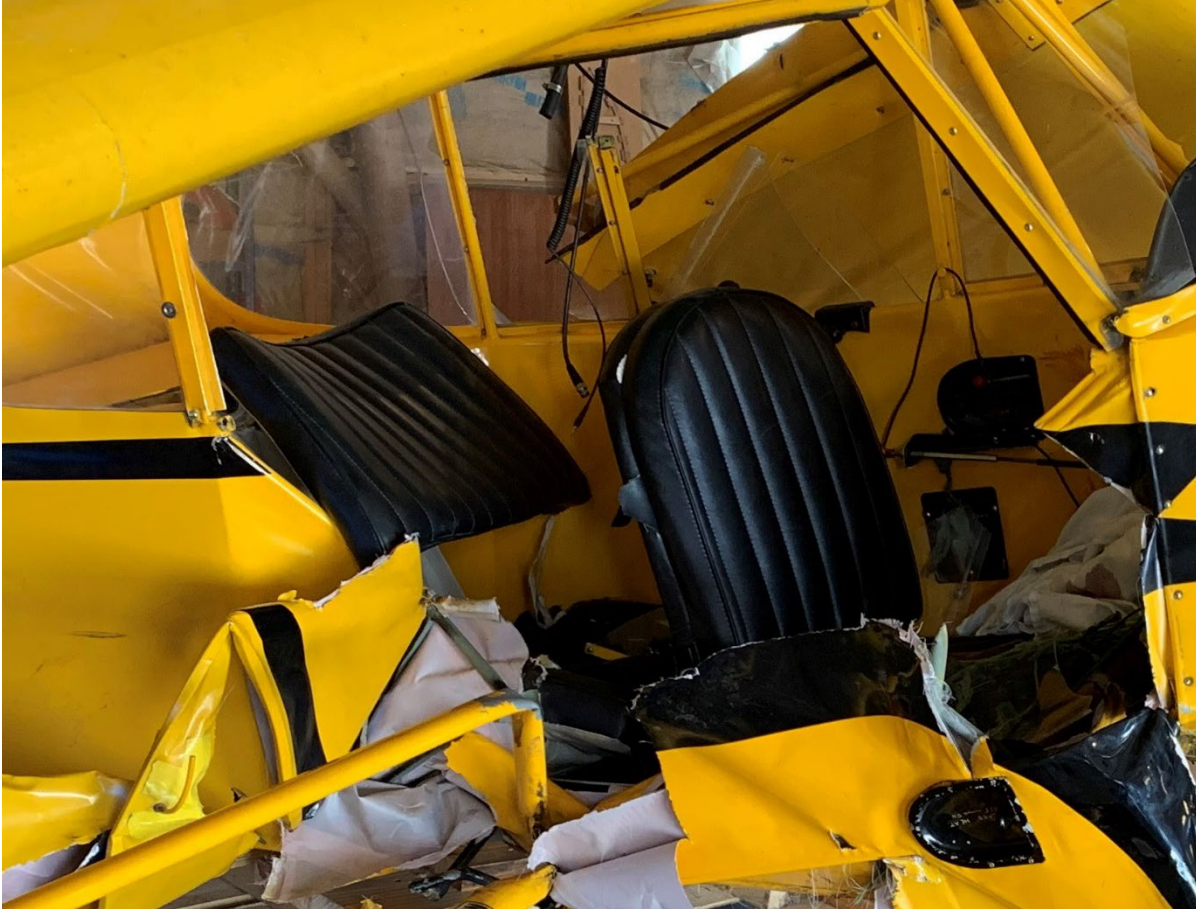
The flight instructor was in the forward seat (see figure 6). According to the first responders the occupant's legs were trapped under the instrument panel, and much of the seat back and bottom were damaged during the extrication. The student was in the aft seat. The rear seat occupant was removed first and to aid in the removal of the occupant, the seat back and control stick were bent.

**Figure 6.** Seat after the airplane was recovered to the salvage facility.

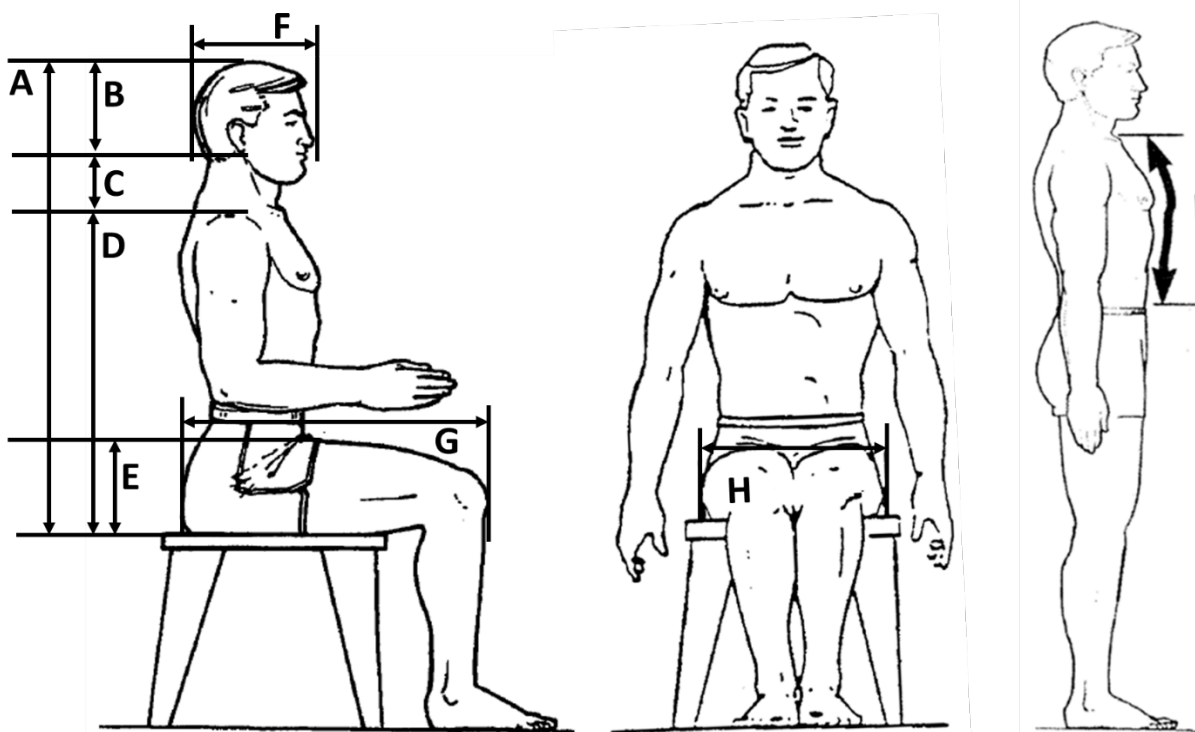
male. Using these percentiles, estimates for body segment lengths were made, see table 1. For a graphical representation of the segment lengths see figure 7 which has drawings from the CAESAR and labels to identify them in table 1.

**Figure 7.** Body segment length measurement locations for table 1.

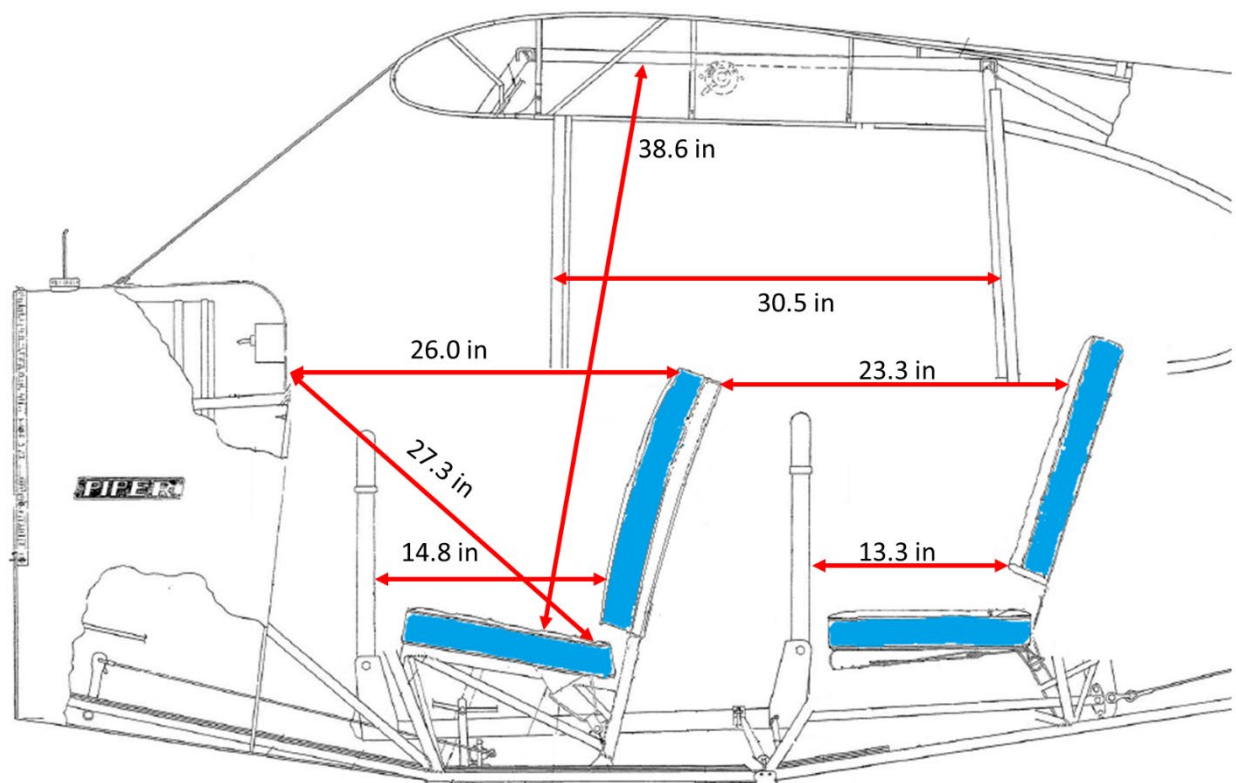
Post-accident damage done while extracting the occupants did not allow for accurate seat belt measurements. Instead, measurements were performed on an

exemplar airplane of the same type and configuration. Drawings provided by Piper were used to estimate the pilots' occupiable volume (see figure 8).

**Figure 8.** Piper Cub line drawing with distances estimated off other drawings.

The length of the nominal lap belt was estimated (see table 2) by using the length in the drawings from the anchor point of the belt to the top of the thigh of the occupant (12.8 inches), multiplying it by two and adding the length of the occupant's hip breadth from table 1. The stretched length was calculated with the addition of the 12 inches allowed in 8043B.

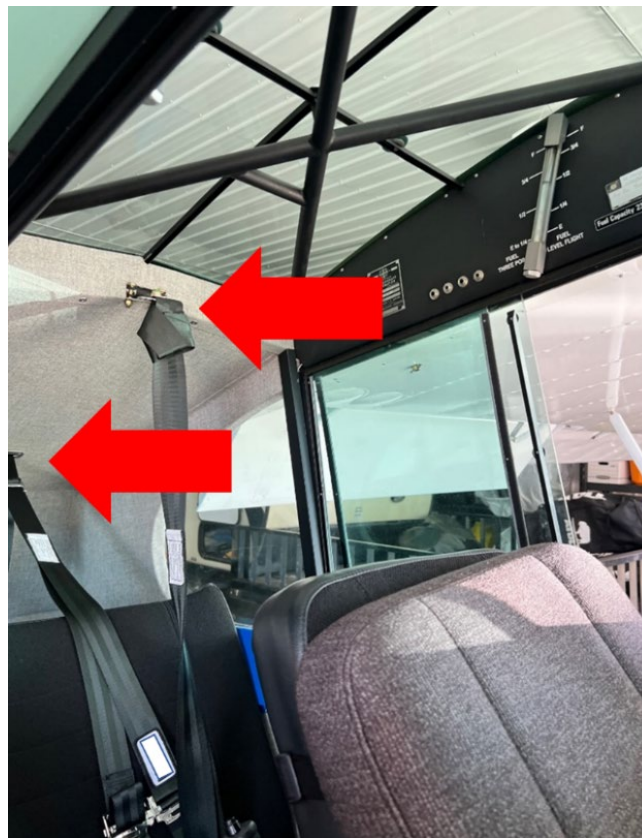
To estimate the difference in head path the occupants would have had with upper torso restraints, an approved restraint system<sup>5</sup> for a Piper cub was used for comparison purposes. This system did not include an inertia reel. The length for a nominal two-strap upper torso belt was estimated (see table 3) by using an anchor point aft of the occupant secured on overhead structure as shown in an exemplar Piper cub (figure 9). The length was from the anchor point to the top of the shoulders, which was then added to the waist front length from the torso length from table 1 which ends at the waist. This is where the webbing would end, and the buckle would start.

**Figure 9.** Mounting position for a set of upper torso restraints in an exemplar Piper Cub.

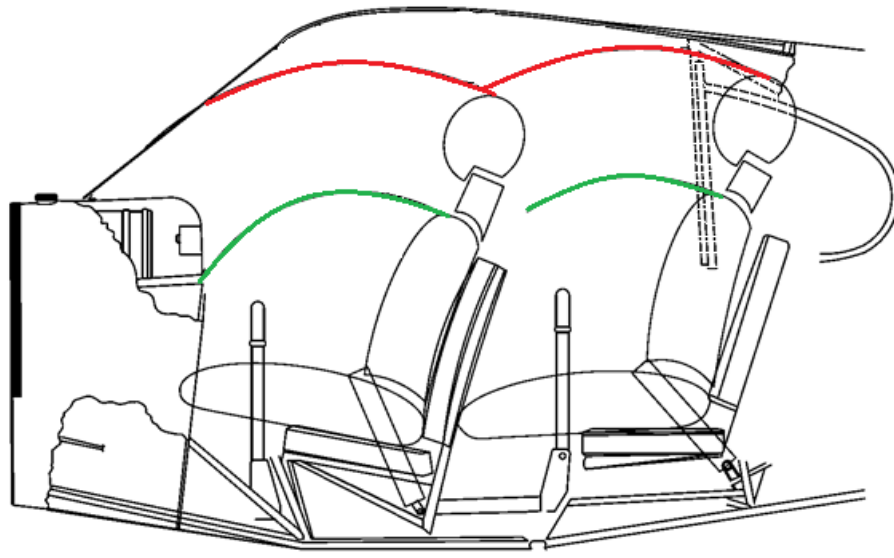
The head paths for the two occupants for the lap belt with no stretch are shown in figure 10. If the lap belt was stretched to the full length allowed per the regulations the occupants would impact in a different manner with more of the torso and head impacting the surfaces in front of them as shown in figure 11, which is consistent with the injuries seen.

**Figure 10.** Occupant head and shoulder path arcs with a lap belt only restraint and no stretch, head paths are in red, shoulder paths in green.

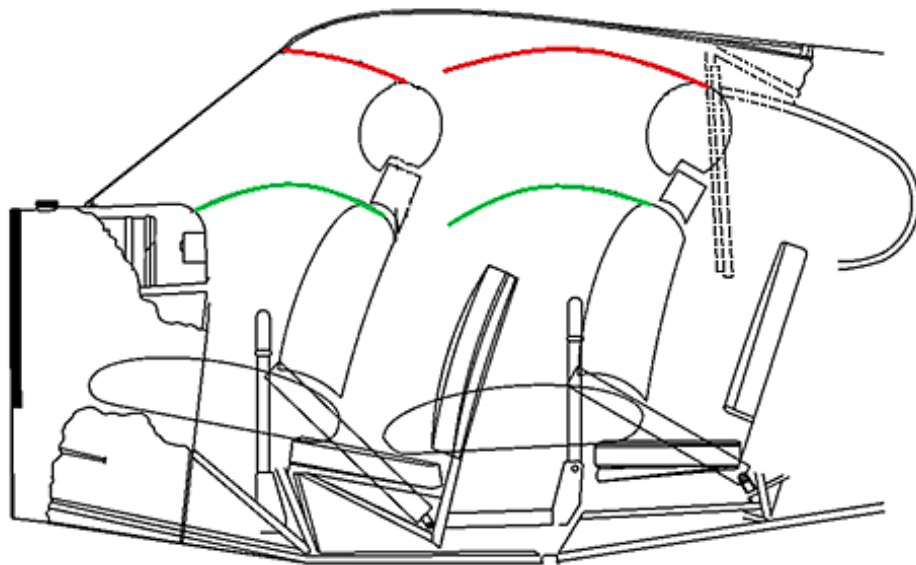
**Figure 11.** Occupant head and shoulder path arcs with a lap belt only restraint and 12 inches of stretch, head paths are in red, shoulder paths in green.

The current study used approximated anthropometric measurements of the two occupants in order to estimate their head paths during the impact and to determine what their bodies might have struck. The study also assumed a worst-case situation where the belts stretched to their full length allowed in the SAE standards. The results showed that the occupants were likely to impact much of their head and

upper torso on structures located within the cabin interior when restrained only by a lap belt; and the addition of an upper torso restraint would likely have lessened the severity of the blunt force injuries sustained by either keeping the occupant away from structure in front of them or lessening the force of impact with those objects.

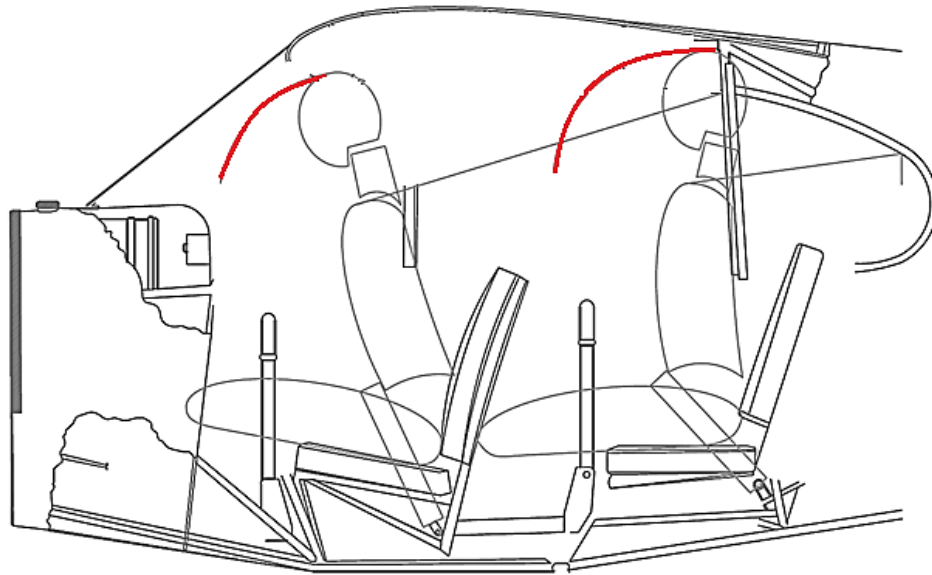
The upper torso restraint described in 5.4.2 was added to the AutoCAD model to show the head path that would have occurred had the occupants been wearing one. The occupant's upper torso was then rotated forward about the lap belt until the full calculated length, including 20% of stretch, was taken up. The occupant head

path arc was then based upon rotation about the upper torso belt contact of the shoulder and is shown in figure 12.

**Figure 12.** Occupant head path arcs after the forward rotation was stopped by their upper torso restraints, head path in red. Note the shoulder path is not depicted on this figure since the torso has already been rotated forward.
