**NATIONAL TRANSPORTATION SAFETY BOARD**

**Cockpit Displays & Other Device – Recorded Flight Data**

**Specialist's Factual Report  
By Kyle Garner**

Location: Lake Elmo, MN  
Date: October 02, 2020  
Vehicle: Piper PA-46-500TP  
Registration: N62ZM  
Operator: Private  
NTSB Number: CEN21LA004

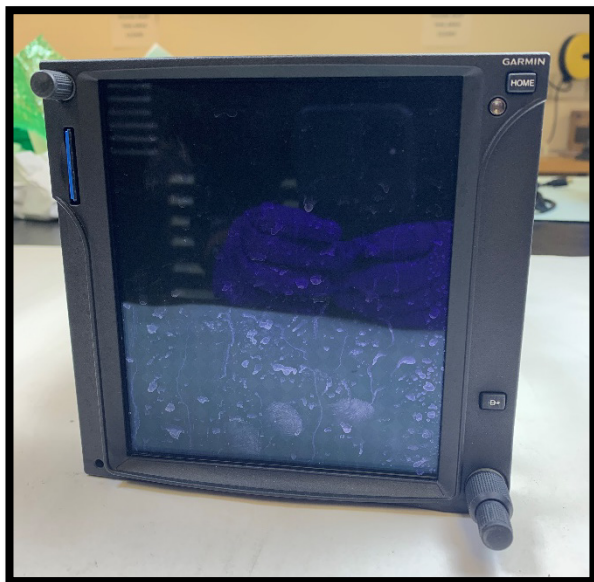
Figure 1. Garmin GTN 750, S/N 1ZA020634, as received.

Both Garmin GTN 750 devices from the accident aircraft arrived at the Vehicle Recorder Division in good condition, with no visible damage as shown in Figures 1 and 2. Detailed information about each device is shown in Table 1.

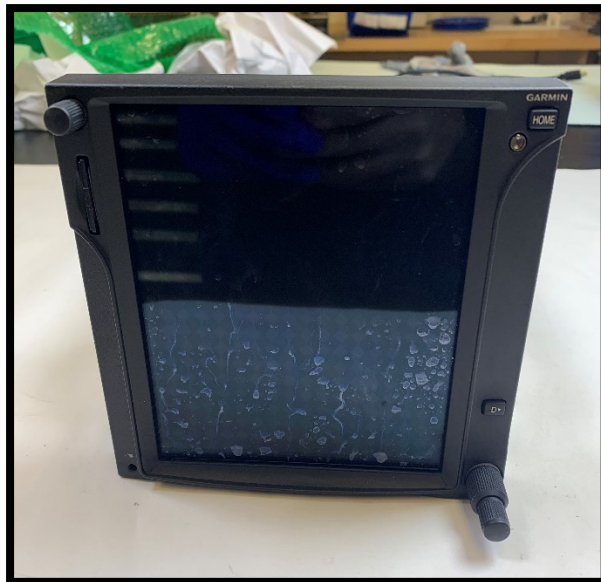
Figure 2. Garmin GTN 750, S/N 1ZA020761, as received.

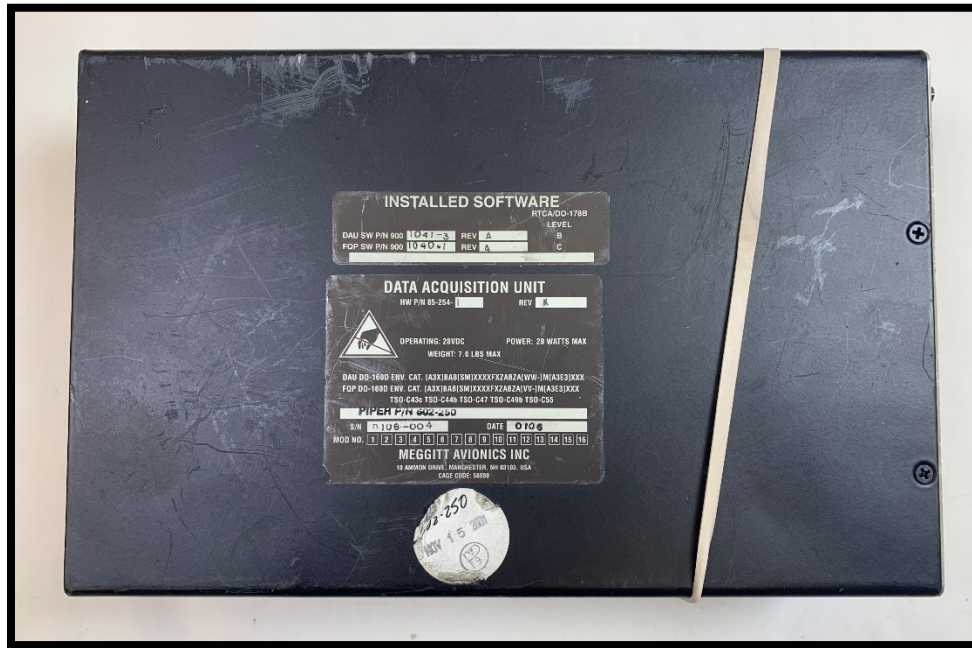
Figure 3. Top view of Meggitt DAU, as received.

The Meggitt DAU arrived at the NTSB's Vehicle Recorders Laboratory in good condition with no visible damage, as shown in Figures 3 and 4.

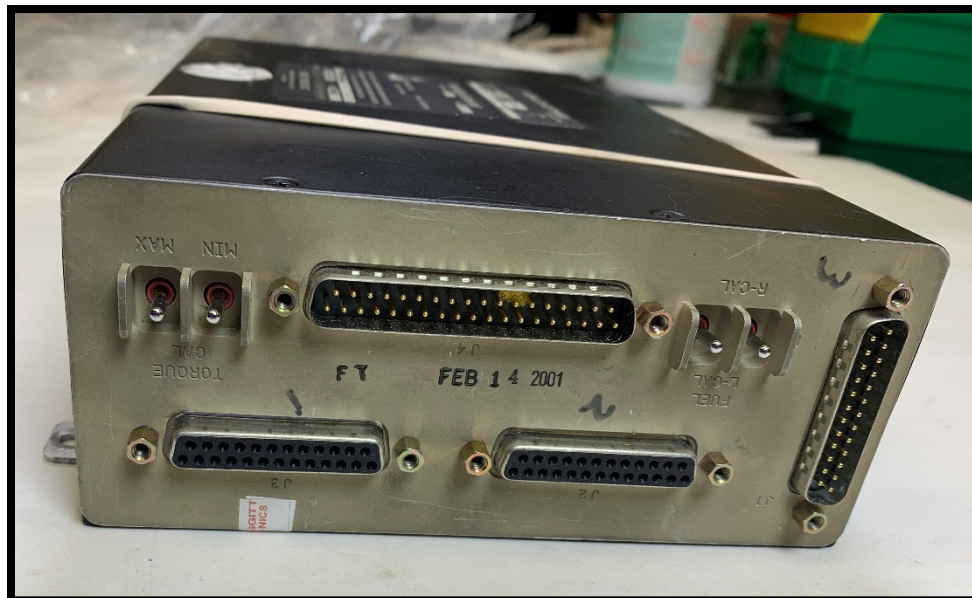
Figure 4. Side view of Meggitt DAU, as received.

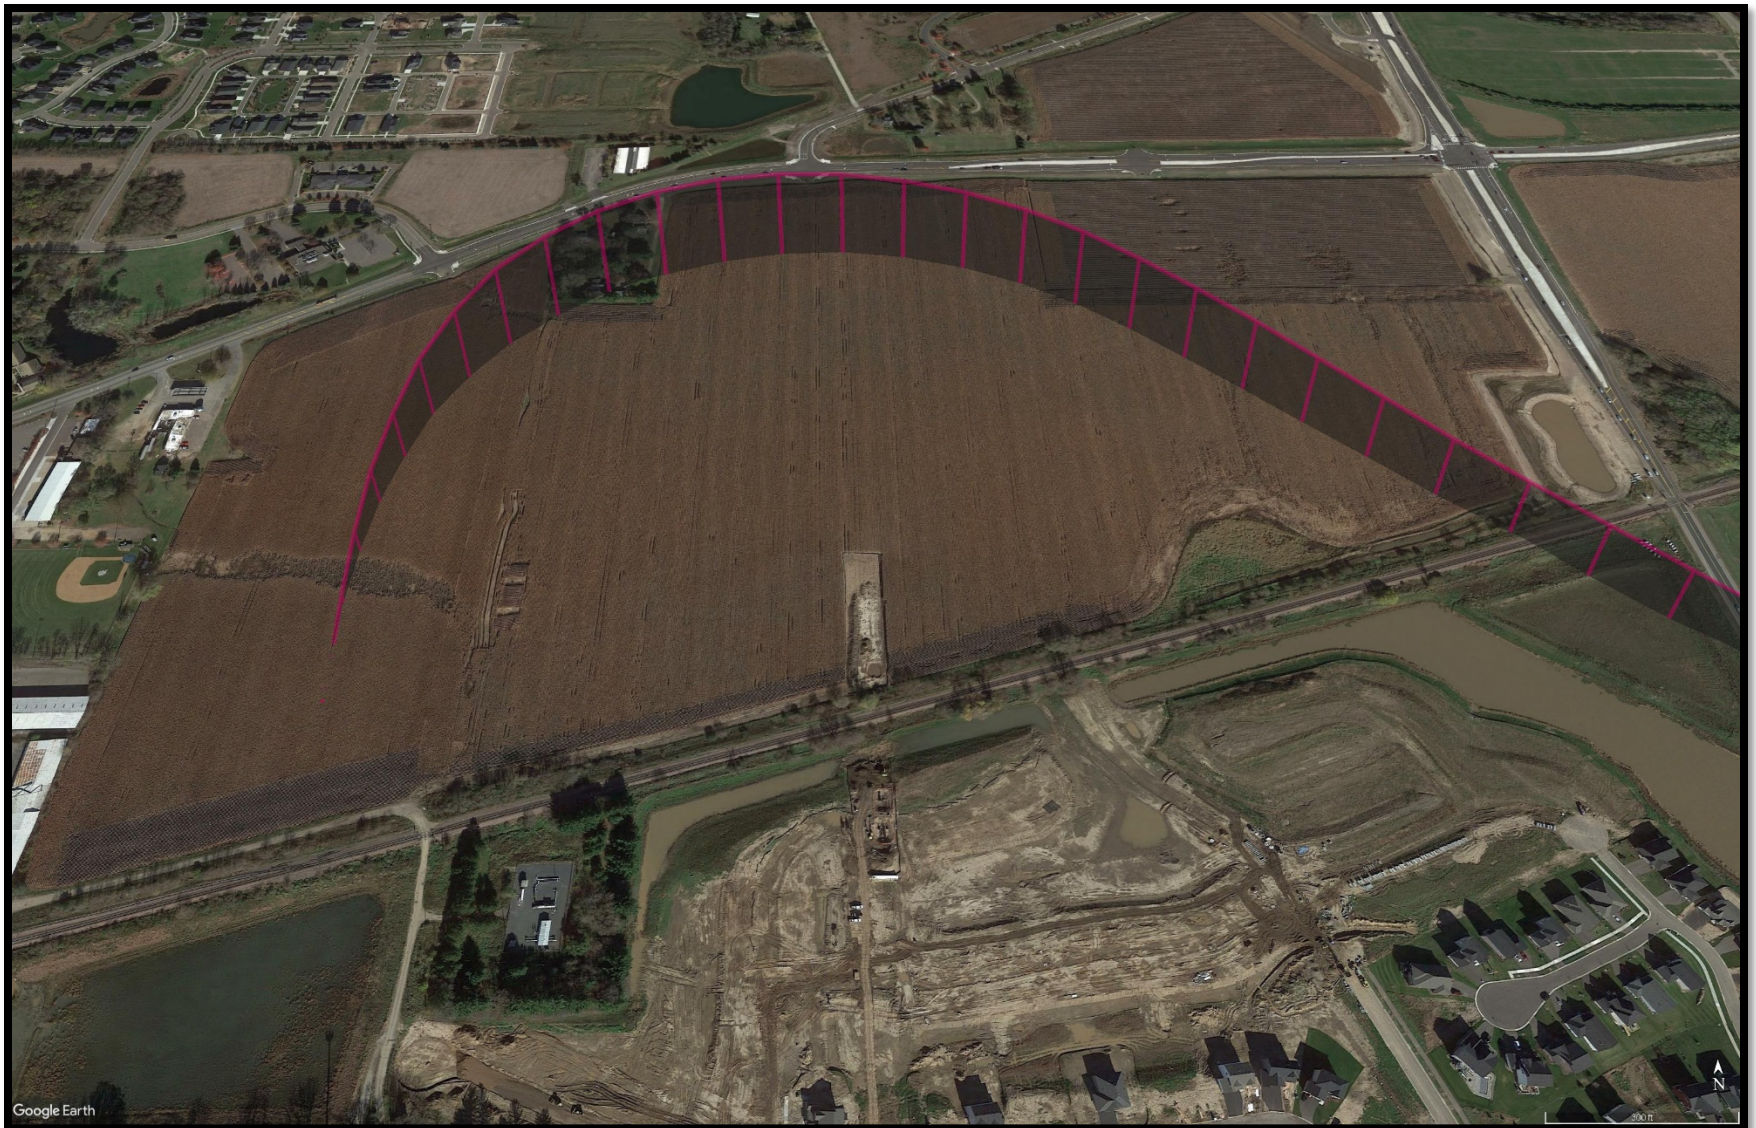
**Figure 6. Google Earth overview of the end of accident flightpath.**

Figures 5 and 6 are Google Earth presentations of the track of the accident flight generated from latitude and longitude data recorded on the Garmin GTN 750. The weather, season, and lighting conditions in Google Earth are not representative of the conditions at the time of the accident.
