**NATIONAL TRANSPORTATION SAFETY BOARD**  
Vehicle Recorder Division  
Washington, D.C. 20594

## **Electronic Recorder Devices**

**Specialist's Factual Report**  
**By W. Deven Chen**

Location: Silt, Colorado  
Date: January 31, 2021  
Aircraft: Cessna 172  
Registration: N4376Q  
Operator: Private  
NTSB Number: CEN21LA119

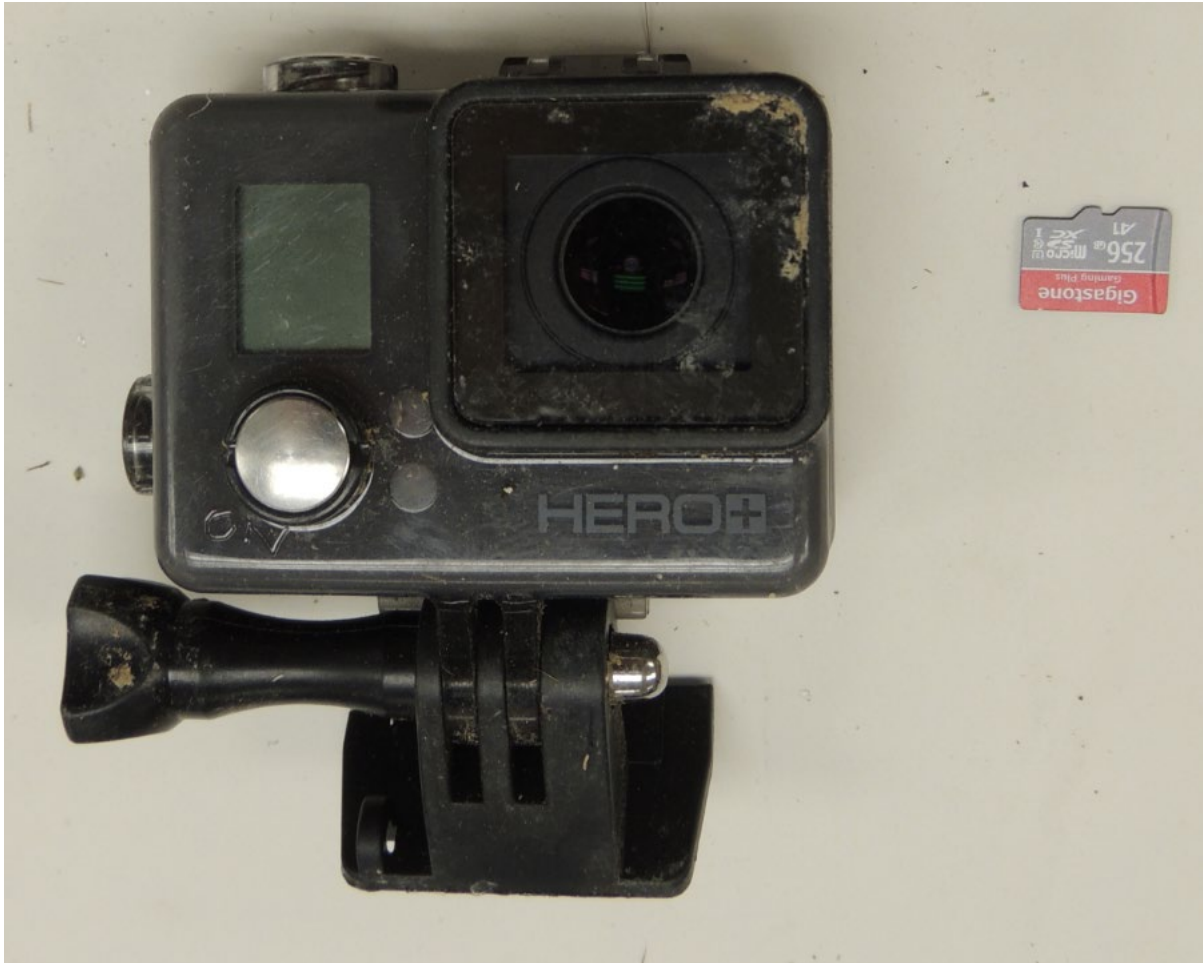
The device was in good condition upon arrival at the Vehicle Recorder Division, as shown in Figure 1. A 256 GB microSD card was installed in the device. The microSD card contained flight recordings, however, the accident event was not captured. Thus, no data pertinent to the investigation were recovered.

Figure 1: GoPro Hero+ as received.

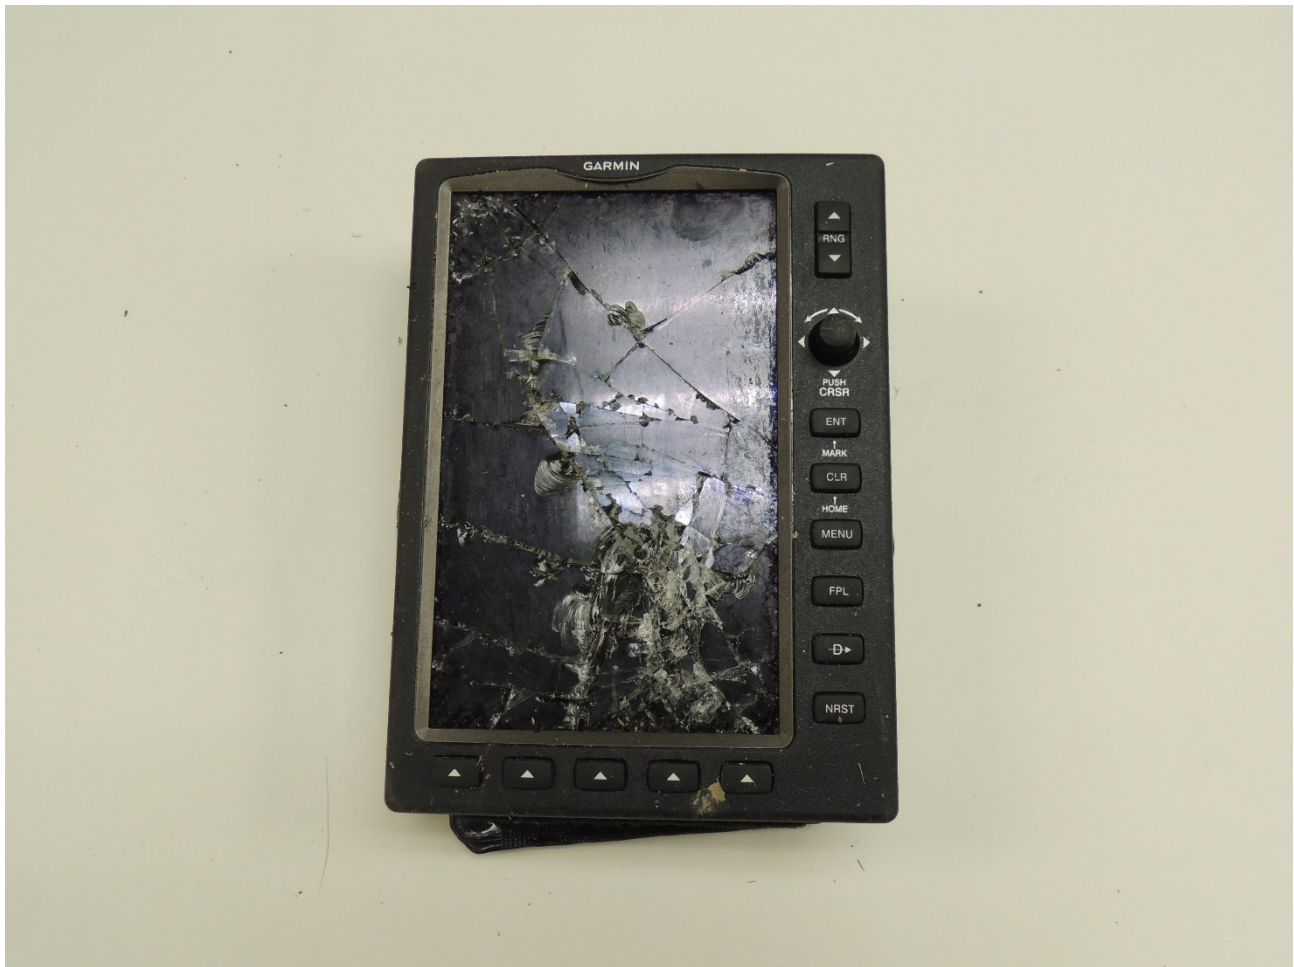
The device had sustained severe impact damage upon arrival at the Vehicle Recorder Division, as shown in Figure 2. An SD card was recovered from the device; however, it did not contain any flight data. The non-volatile memory chip was removed, read out and converted into engineering units using laboratory tools.

**Figure 2: Garmin GPSMAP 696 as received.**
