**NATIONAL TRANSPORTATION SAFETY BOARD**  
Vehicle Recorder Division  
Washington, D.C. 20594

## **Global Positioning System Device**

**Specialist's Factual Report**  
**By W. Deven Chen**

Location: Clayton Louisiana  
Date: May 18, 2021  
Aircraft: Air Tractor AT-520A  
Registration: N887LA  
Operator: Private  
NTSB Number: CEN21LA223

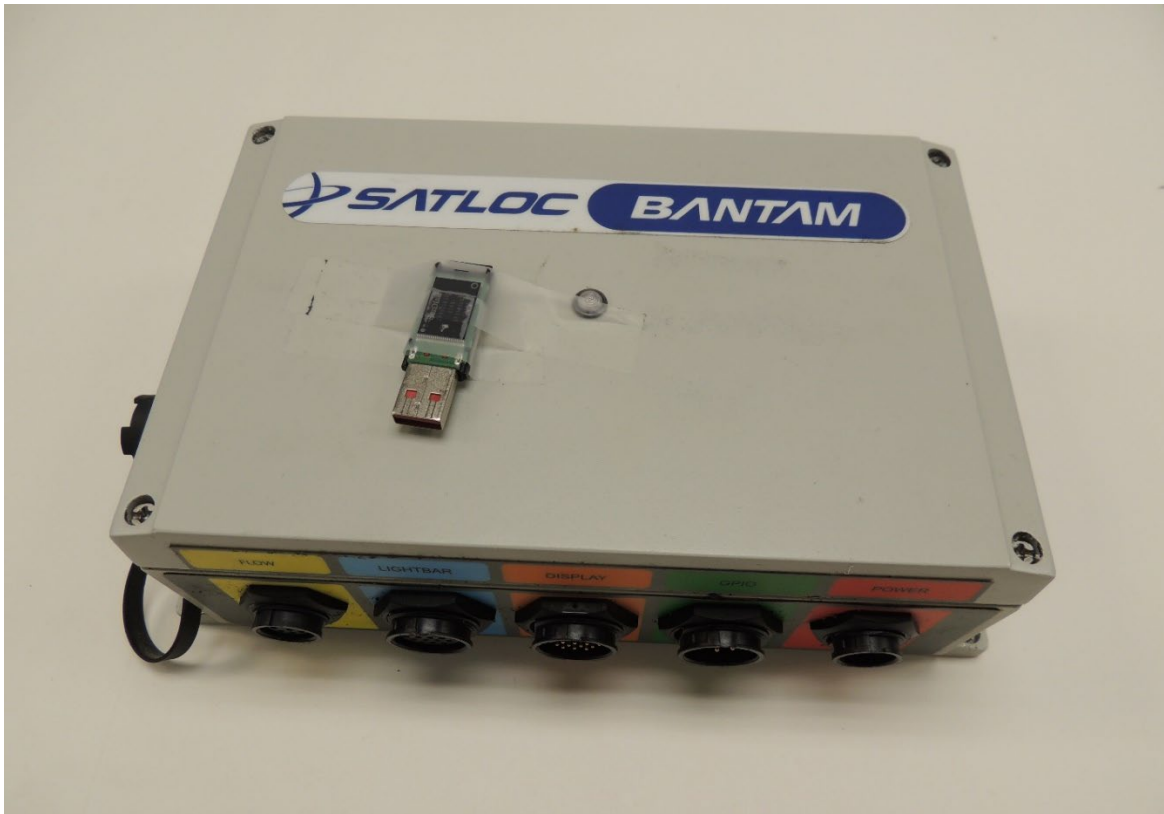
The device was undamaged upon arrival at the Vehicle Recorder Division, as shown in Figure 1. The USB thumb-drive attached on the top of the device could not be read due to damage. An internal compact flash (CF) card was recovered from the device, and data were extracted normally from the CF card using laboratory tools.

**Figure 1: SATLOT Bantam as received.**

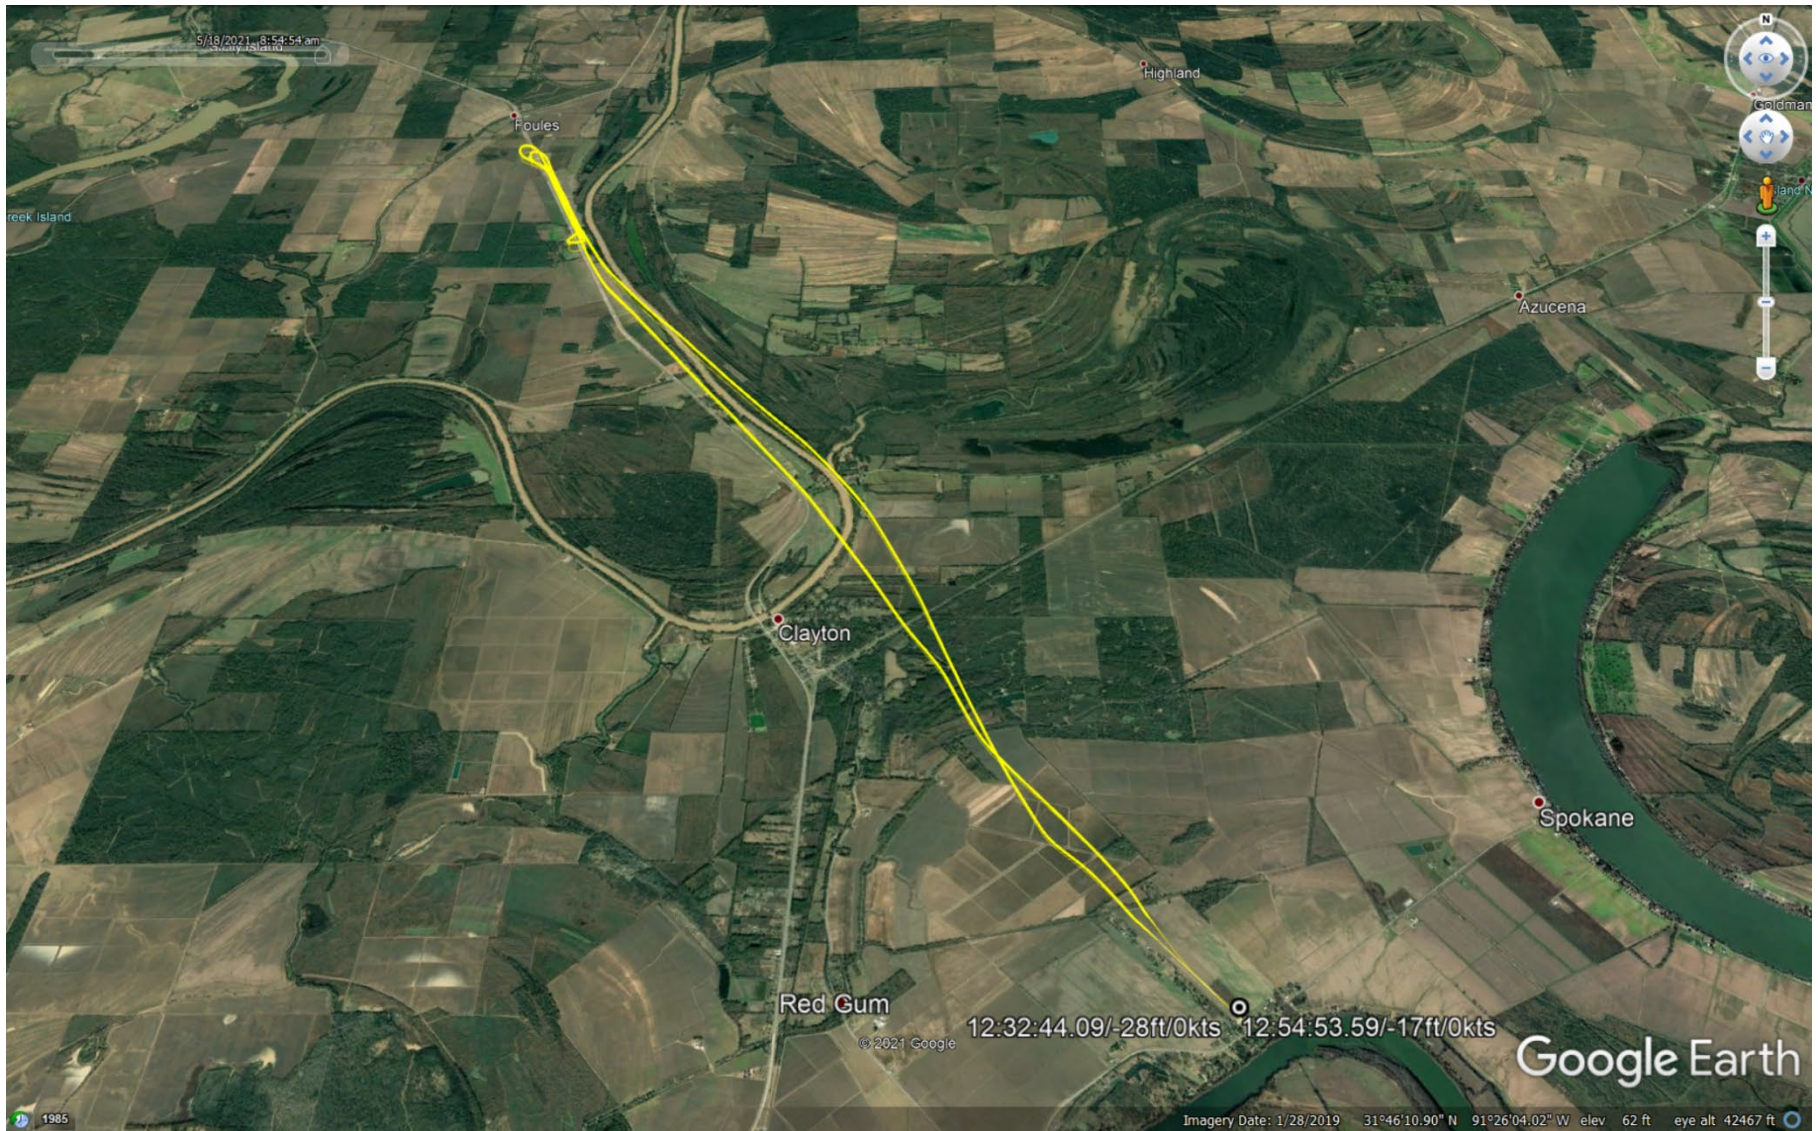
Figure 5: Google Earth overlay of the overview of the first flight.

Figures 5 - 9 are Google Earth overlays of the recorded flights. Figures 5 and 6 show the Google Earth overlays of the first and second flights. For those two flights, the accident aircraft returned to where it took off at the end of the flights. Figures 7 – 9 shows the Google Earth overlays of the accident flight. The aircraft took off around 13:10:00, and the last recorded data point was at 13:20:30.90 CDT. The reported wreckage location is shown with a red pin. Due to data buffering on the device, the data recording had ended before the crash occurred. According to the technical specialist from the manufacturer, the data recording could have ended as much as 30 seconds before the crash occurred. The weather and lighting conditions in Google Earth are not necessarily the weather and lighting conditions present at the time of the recording.

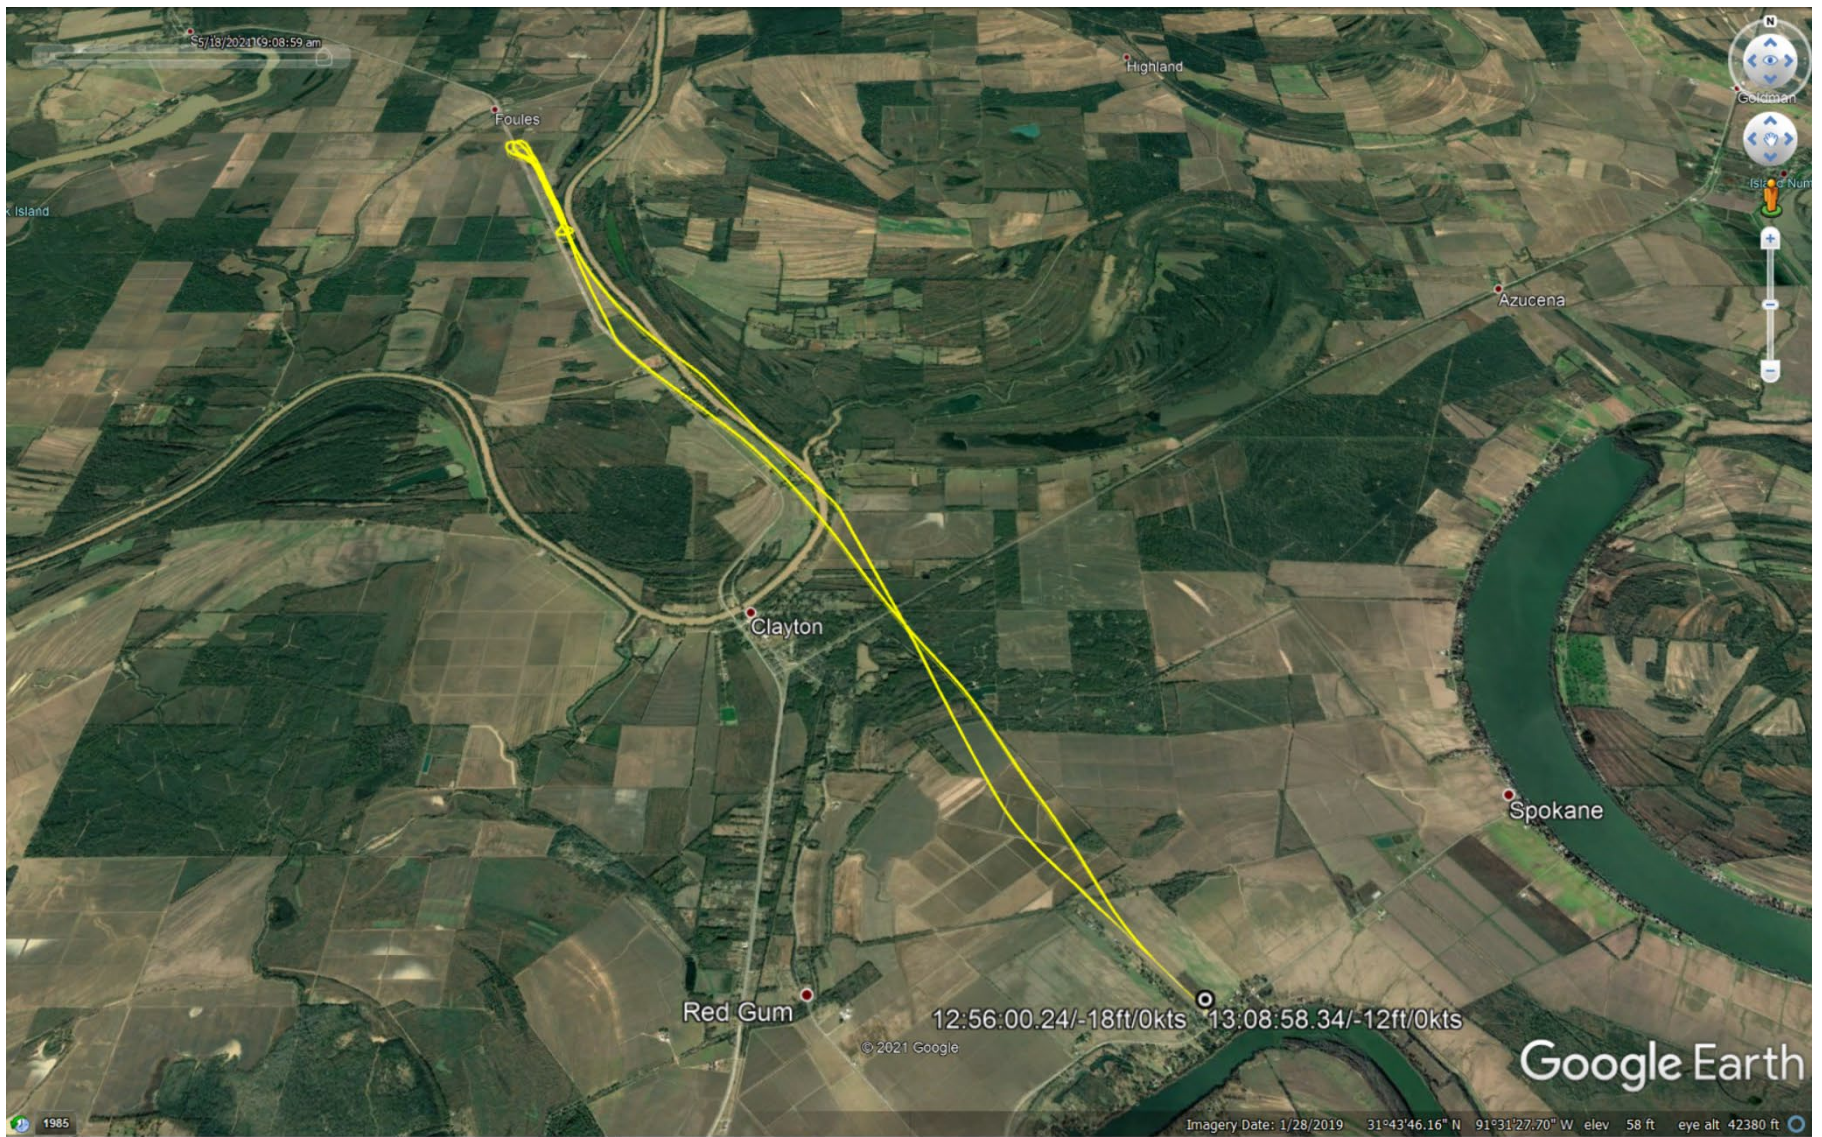
Figure 6: Google Earth overlay of the overview of the second flight.
