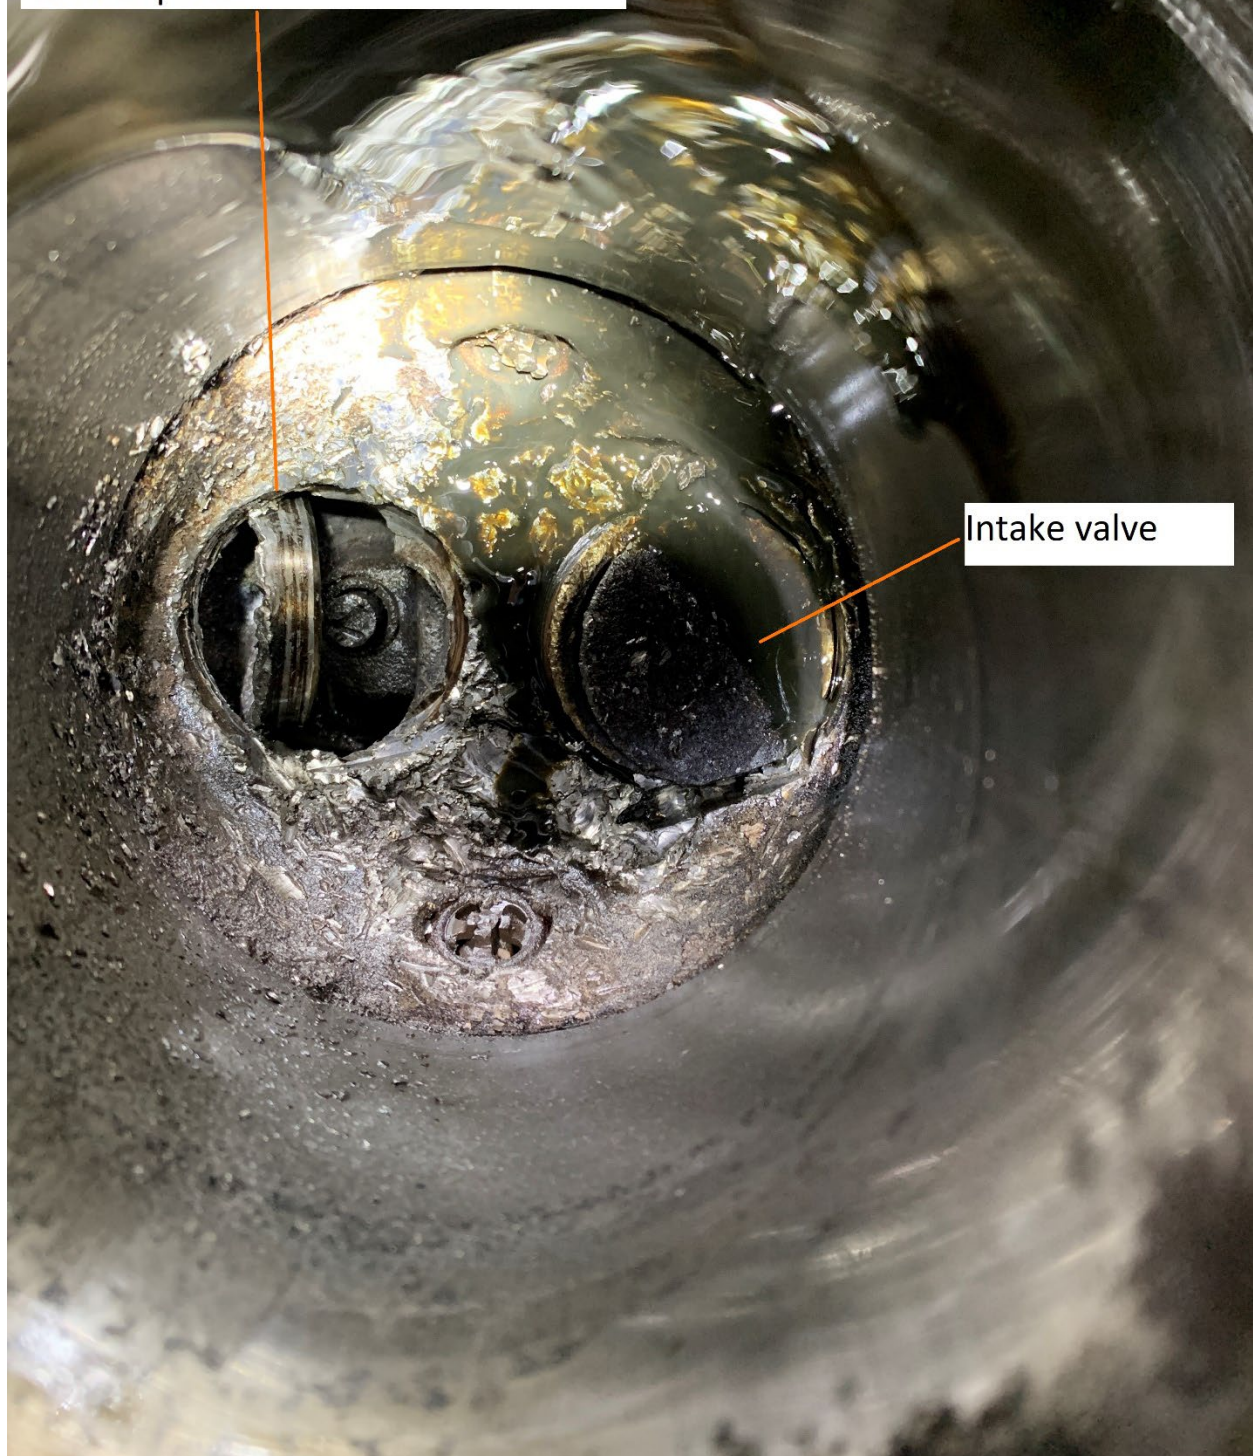
Photo 2: Exhaust Valve (Source – Federal Aviation Administration)

Inside view of #4 cylinder. looking down bore. Exhaust valve missing. Valve seat turned sideways in exhaust port.
