## **NATIONAL TRANSPORTATION SAFETY BOARD**

### **Specialist's Factual Report**

# **METEOROLOGY**

CEN22FA035

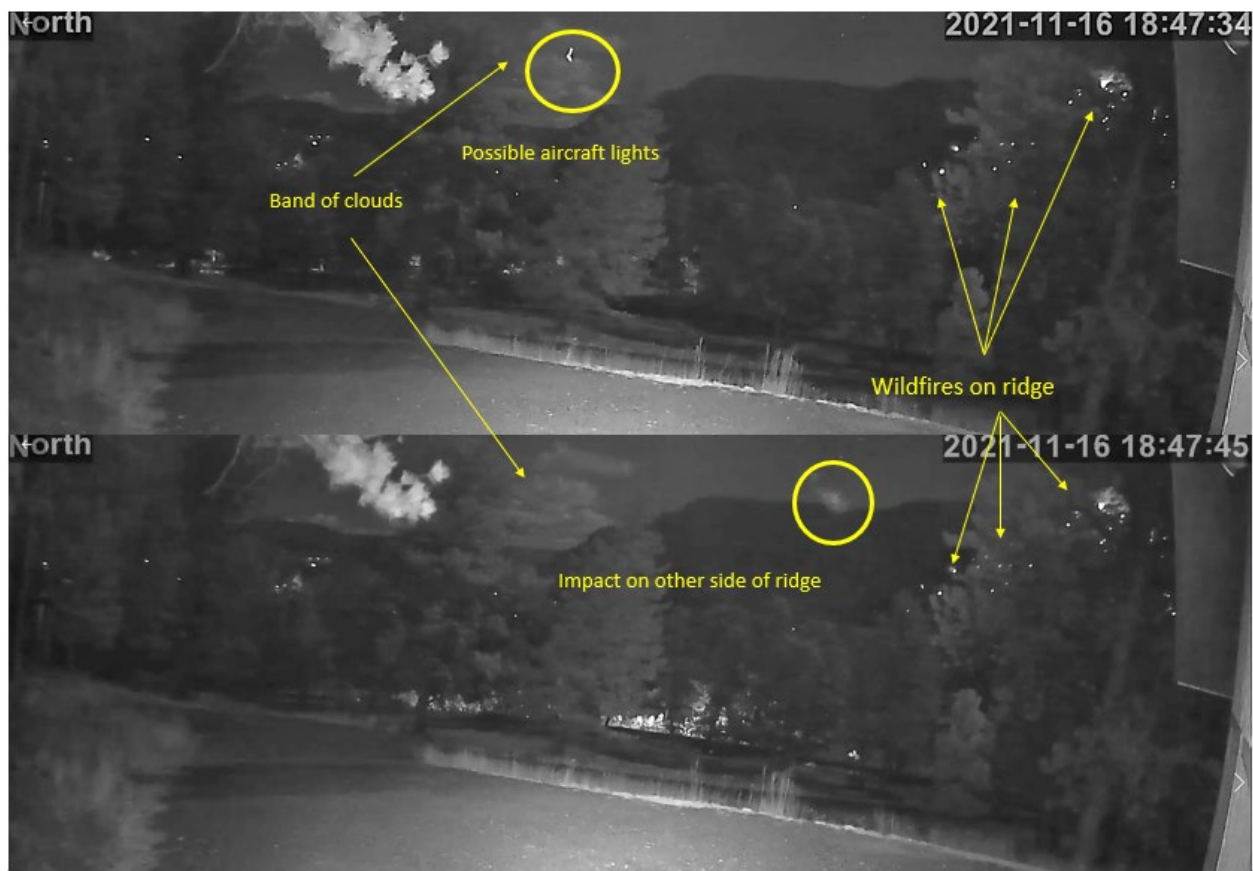
A security camera captured the fires burning on the ridge and the aircraft lights at the time stamp 1847:34 MST and the potential impact on the other side of the ridge at 1847:45 MST. Figure 33 is two still images from the security animation showing lights immediately below a low-layer of clouds, which are moving from left-to-right during the period, and a flash of the accident airplane hitting the ground on the opposite side of the ridge. Multiple wildfires can be seen on the right side of the image burning on the side of the ridge. The security camera was located on Rockwood Lane and facing east-northeast.

**Figure 33 - Security camera images at 1847:33 and 1847:45 MST capturing the aircraft.**
