# NATIONAL TRANSPORTATION SAFETY BOARD

## Multiple Electronic Devices

**Specialist's Factual Report**  
**by Sean Payne**

Location: Steamboat Springs, CO  
Date: December 10, 2021  
Aircraft: Piper PA-46-500TP  
Registration: N744Z  
Operator: Private  
NTSB Number: CEN22FA069

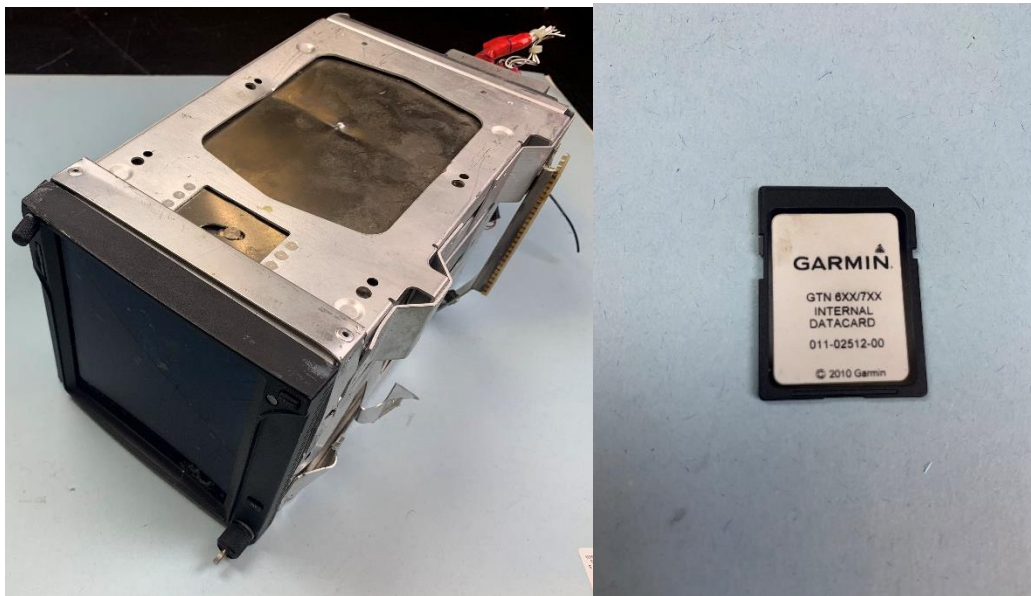
The second internally mounted, removable SD memory card from Unit B is pictured in figure 1 (right). The internally mounted, removable SD memory card from Unit B was in good condition, and was read out normally using a PC via a forensic write blocker.

**Figure 1.** The Garmin GTN-750 (Unit A), left, and the internally mounted, removable SD memory card from Unit B, right.

The lab received one full Garmin GTN-750 unit (hereinafter referred to as Unit A), and one internally mounted, removable data card from a second GTN-750 unit (hereinafter referred to as Unit B) installed in the accident airplane. Upon arrival at the Vehicle Recorder Division, an exterior examination revealed that Unit A had sustained impact damage. Unit A is pictured in figure 1 (left image). Unit A was inspected and its internally mounted, removable SD memory card was removed from the right side of the unit. The internally mounted, removable SD memory card was in good condition, and was read out normally using a PC via a forensic write blocker.

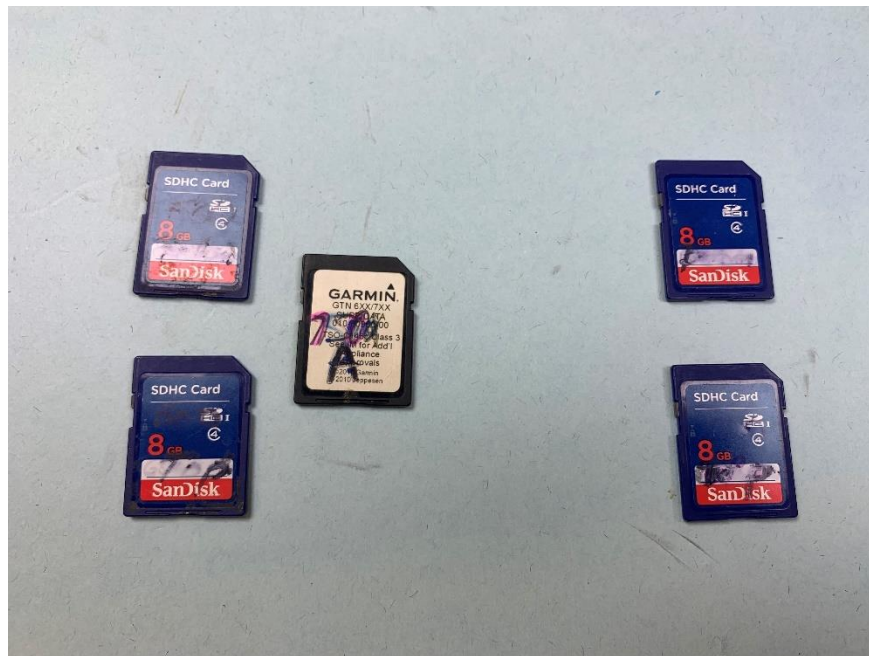
The accident aircraft contained two Garmin G500 devices. The laboratory was sent a set of 5 SD cards, each set of cards was labeled as being from either the left or right G500 unit. Figure 2 is a photograph of the SD cards received associated with the two G500 units.

**Figure 2.** The SD cards associated with both G500 units from the accident aircraft.

Each card was examined with a PC via a write blocker. Only one card appeared to have flight data. That flight data was in a format consistent with having been produced from a Garmin GTN series navigator, and not a G500. The data present on that card ranged in date from October 6, 2019, to January 27, 2021. The accident occurred in December 2021 and no data relevant to the accident was recorded on this SD card. The report does not discuss any data from this card.

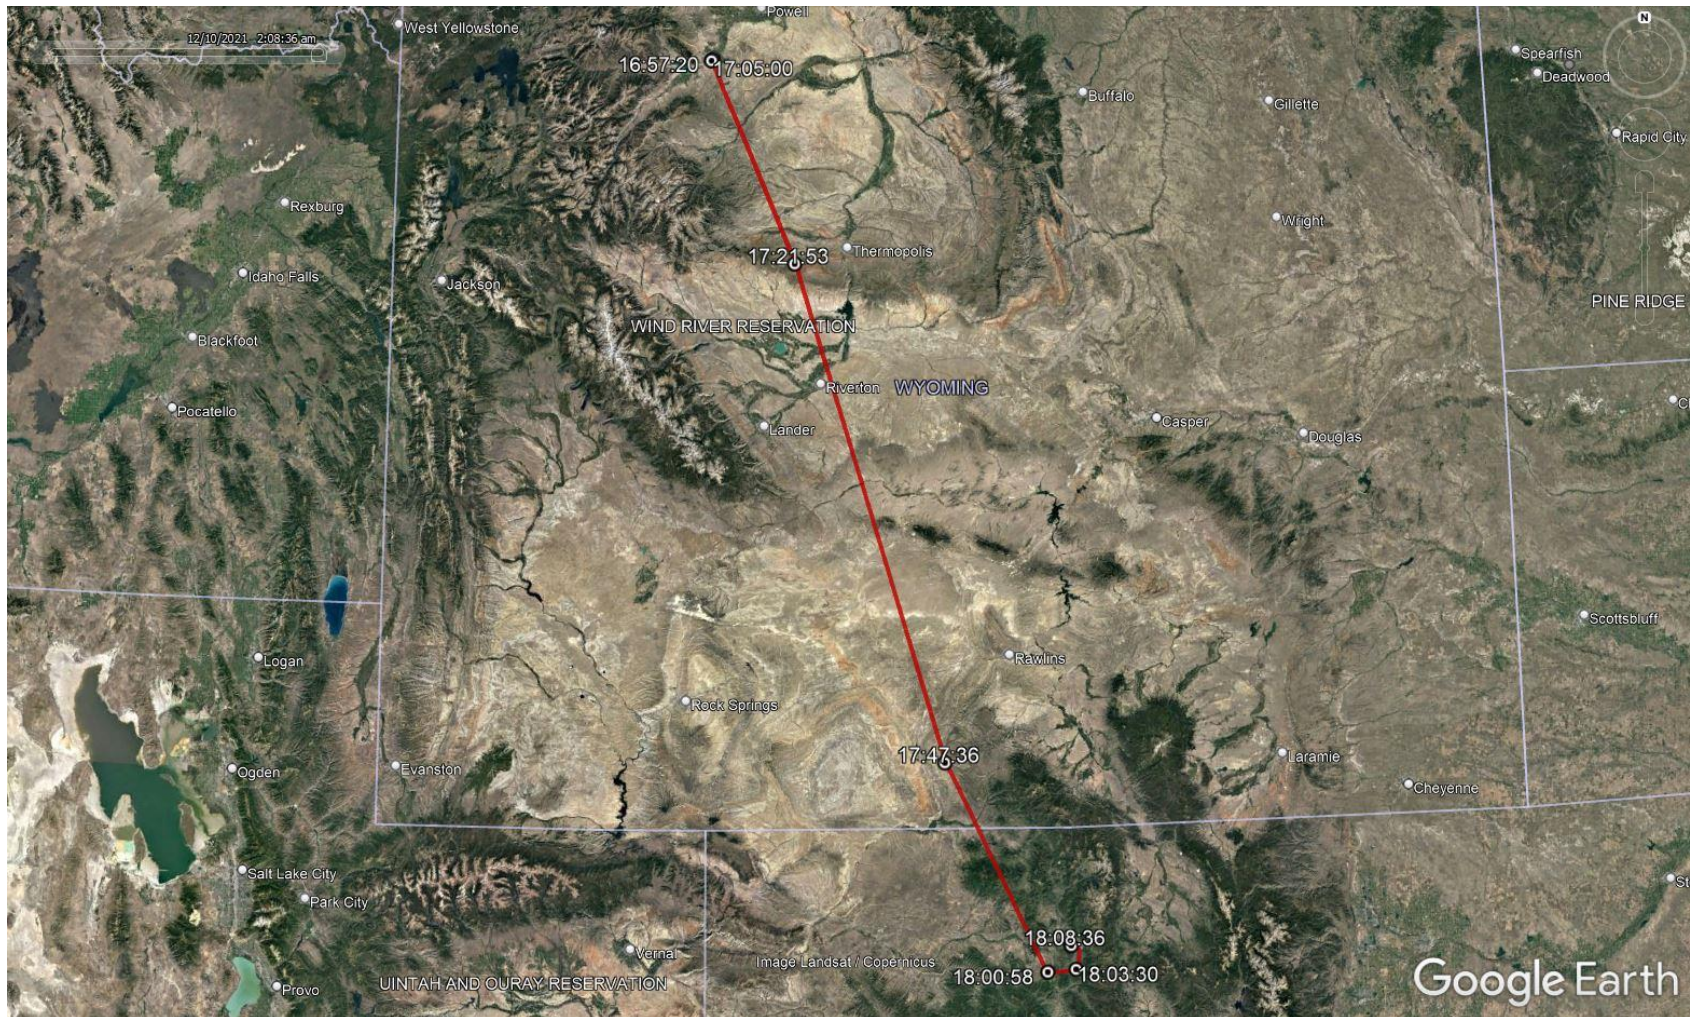
Figure 3 is a Google Earth plot showing the accident aircraft's ground track and recorded altitude data during the entire accident flight. The data show GPS began showing a position around 16:57 in the vicinity of a ramp area at Yellowstone Regional Airport (KCOD), Cody, Wyoming. Data show the aircraft had departed KCOD and began climbing on a south-easterly track around 17:05. The aircraft continued on a south-easterly track for the next approximately hour. Around 18:00, the aircraft was maneuvering in the vicinity on a ground track consistent with a published segment of the RNAV (GPS)-E approach for Steamboat Springs Airport (KSBS), Steamboat Springs, CO. Data continued be recorded showing the aircraft maneuvering in the vicinity of KSBS. Data ended at 18:08:36 in the vicinity of Quarry Mountain, west of the village of Steamboat Springs, CO. Note that additional figures and plots below discuss the aircraft's position on the RNAV (GPS)-E approach segment in further detail below.

**Figure 3.** A Google Earth plot showing the accident aircraft's ground track for the entire accident flight on December 10, 2021.

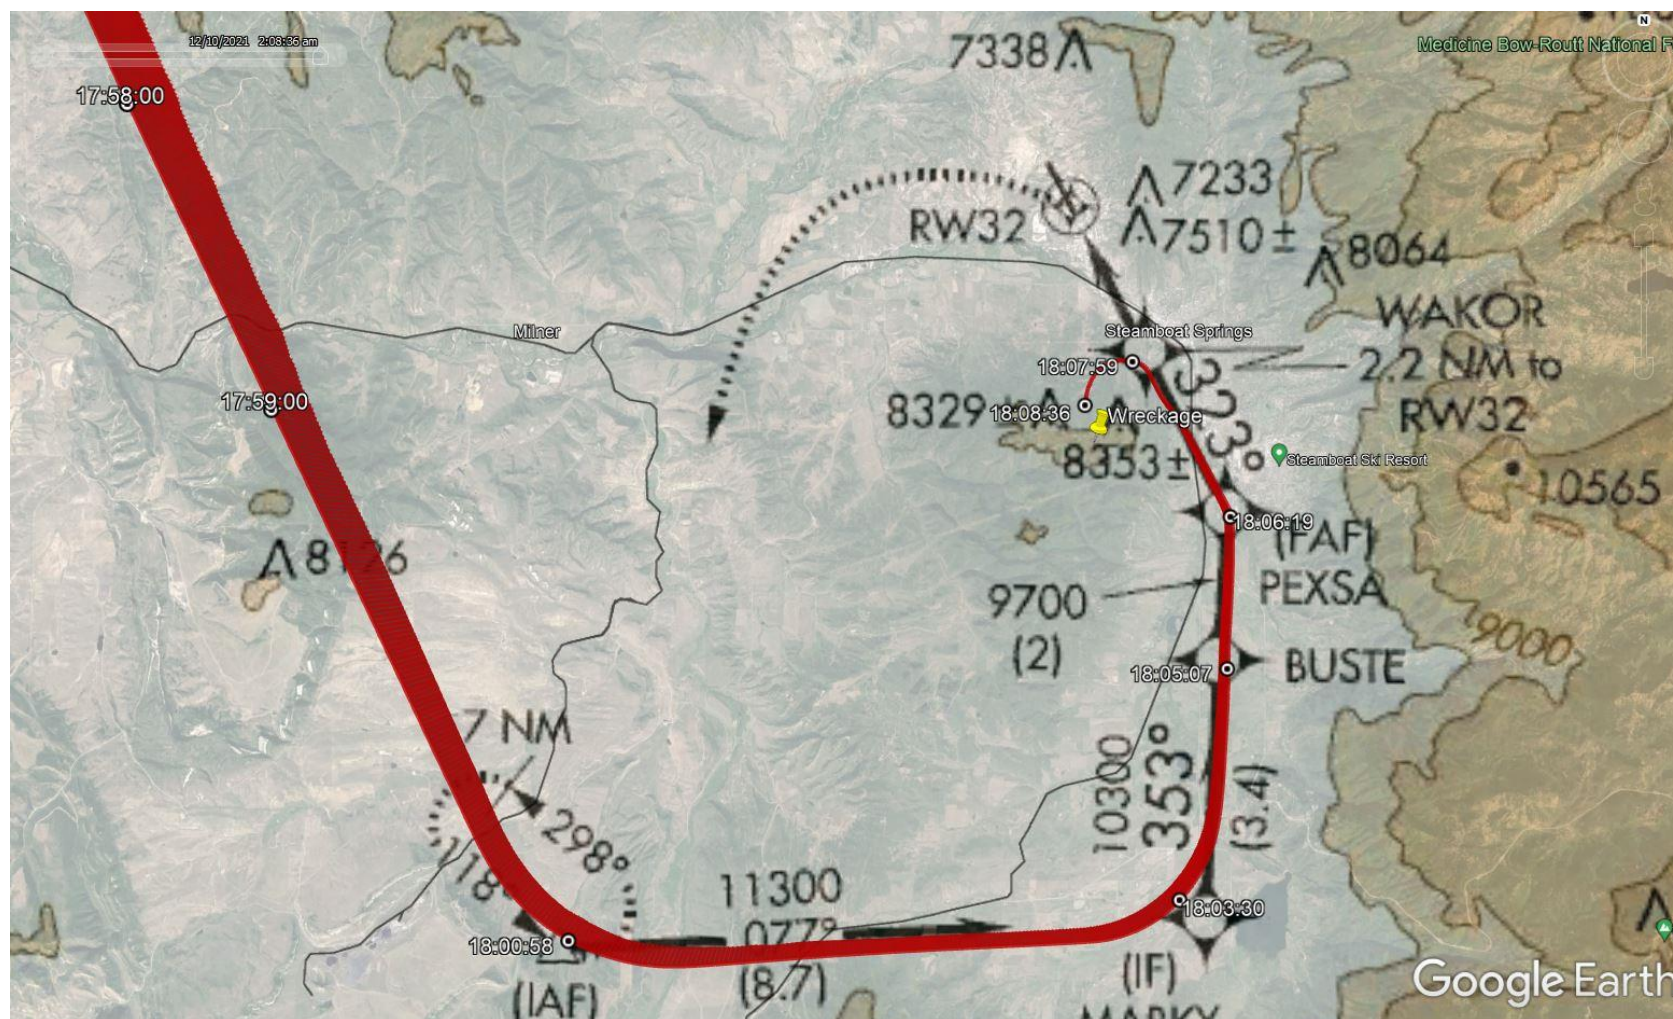
Figure 4 is a Google Earth plot showing the accident aircraft's ground track in the vicinity of the terminal area of KSBS. An FAA published approach plate is overlaid for the RNAV (GPS)-E approach into KSBS. Times are given in MST of the points in which the GTN-750 data sets showed sequencing of waypoints on the published approach. For reference to the attached data sets, the times are as follows: HABRO (IAF) - 18:00:58, MABKY (IF) - 18:03:30, BUSTE - 18:05:07, PEXSA (FAF) - 18:06:19, WAKOR - 18:07:59.

**Figure 4.** A Google Earth plot showing the accident aircraft's ground track in the vicinity of the KSBS terminal area. An FAA published approach plate for the RNAV (GPS)-E approach has been overlaid with a 50% opacity. A yellow pin has been added indicating the position of the wreckage.

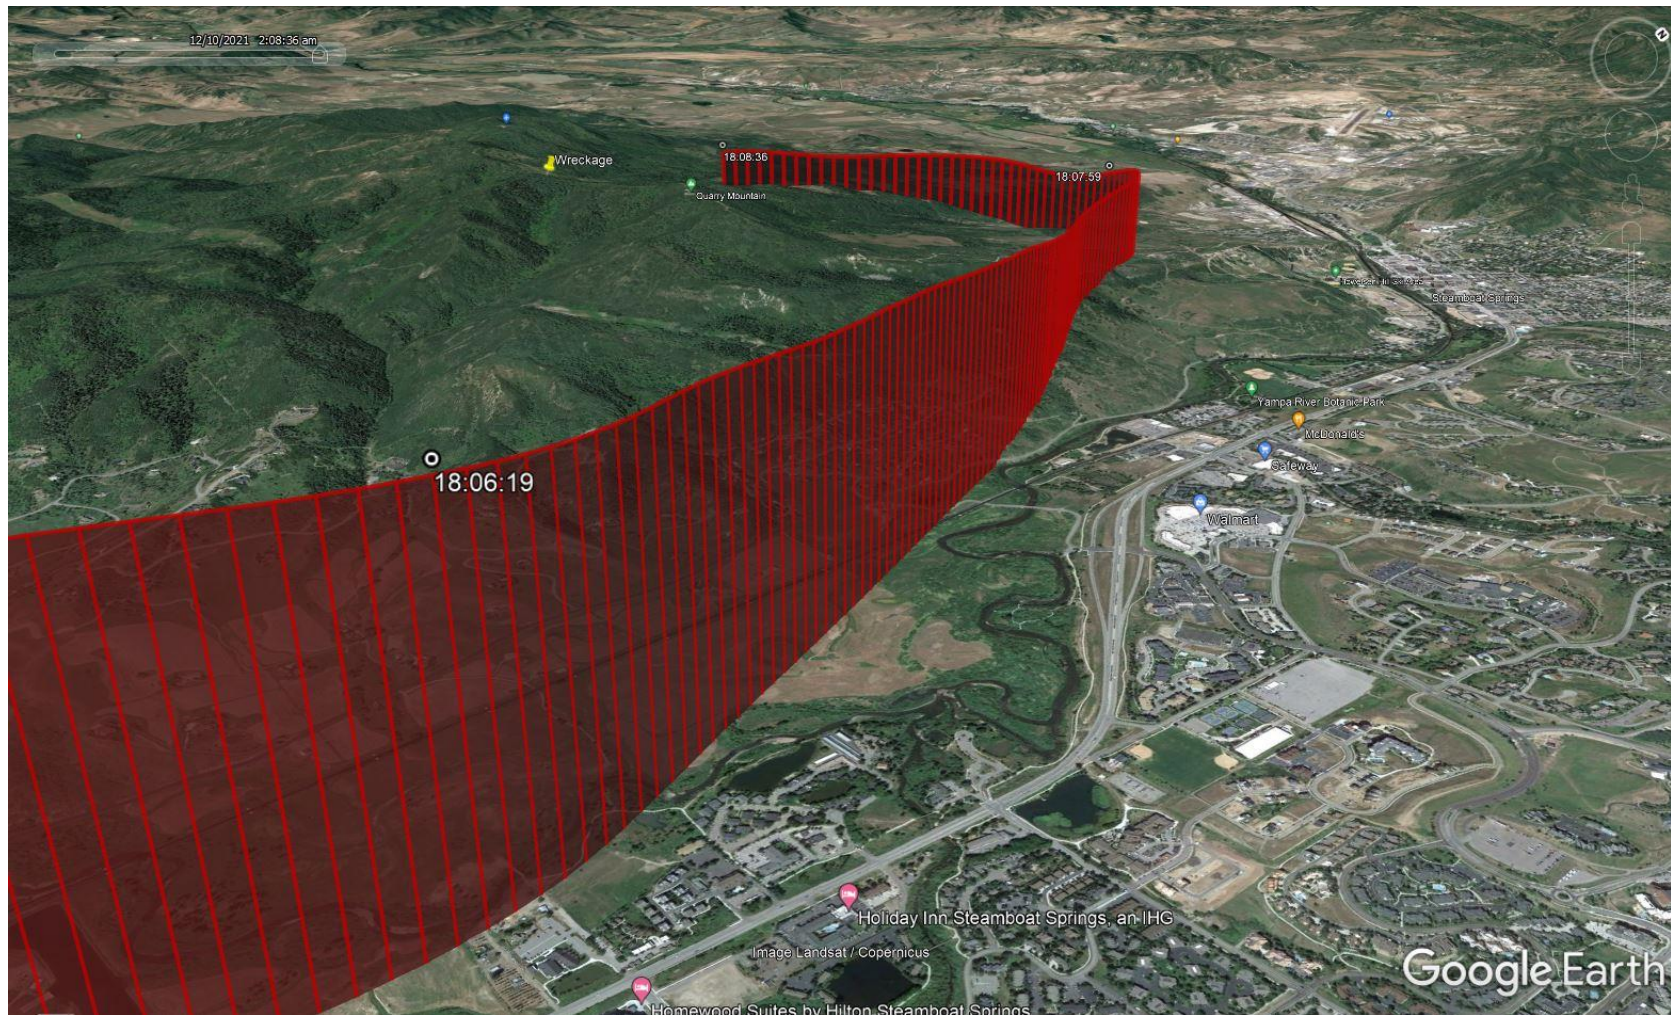
Figure 5 is a Google Earth plot showing the accident aircraft's ground track and recorded altitude data in the vicinity of KSBS. Just prior to 18:07:59 (sequence from WAKOR), the aircraft made a left turn into rising terrain west of the village of Steamboat Springs, CO. The wreckage location is denoted as a yellow pin. Note that the weather and lighting conditions represented in Google Earth do not depict the conditions of that day.

**Figure 5.** A Google Earth plot showing the accident aircraft's approach to KSBS. The wreckage location is indicated with a yellow pin.

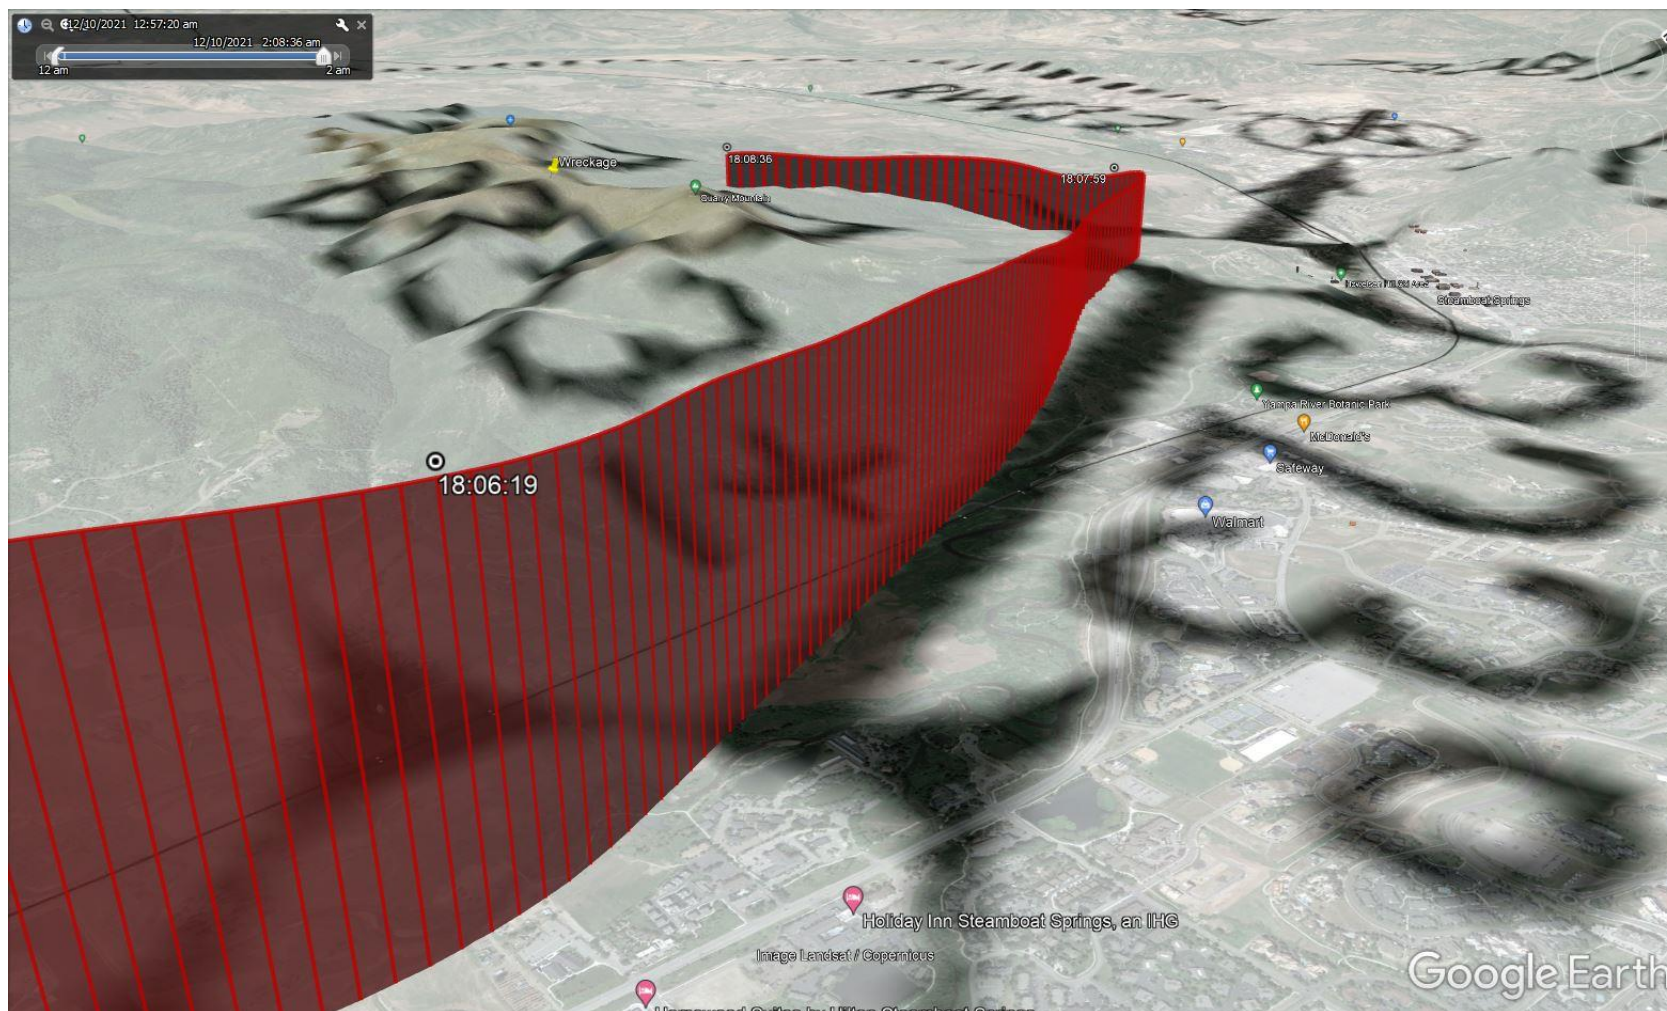
Figure 6 is a Google Earth plot showing the accident aircraft's ground track and recorded altitude data in the vicinity of KSBS. The orientation is similar to that of figure 5, except the FAA published approach plate for the RNAV (GPS)-E is overlaid in a 50% opacity. Note that the weather and lighting conditions represented in Google Earth do not depict the conditions of that day.

**Figure 6.** A Google Earth plot showing the accident aircraft's approach to KSBS. The wreckage location is indicated with a yellow pin. An FAA published approach plate for the RNAV (GPS)-E approach has been overlaid with a 50% opacity.

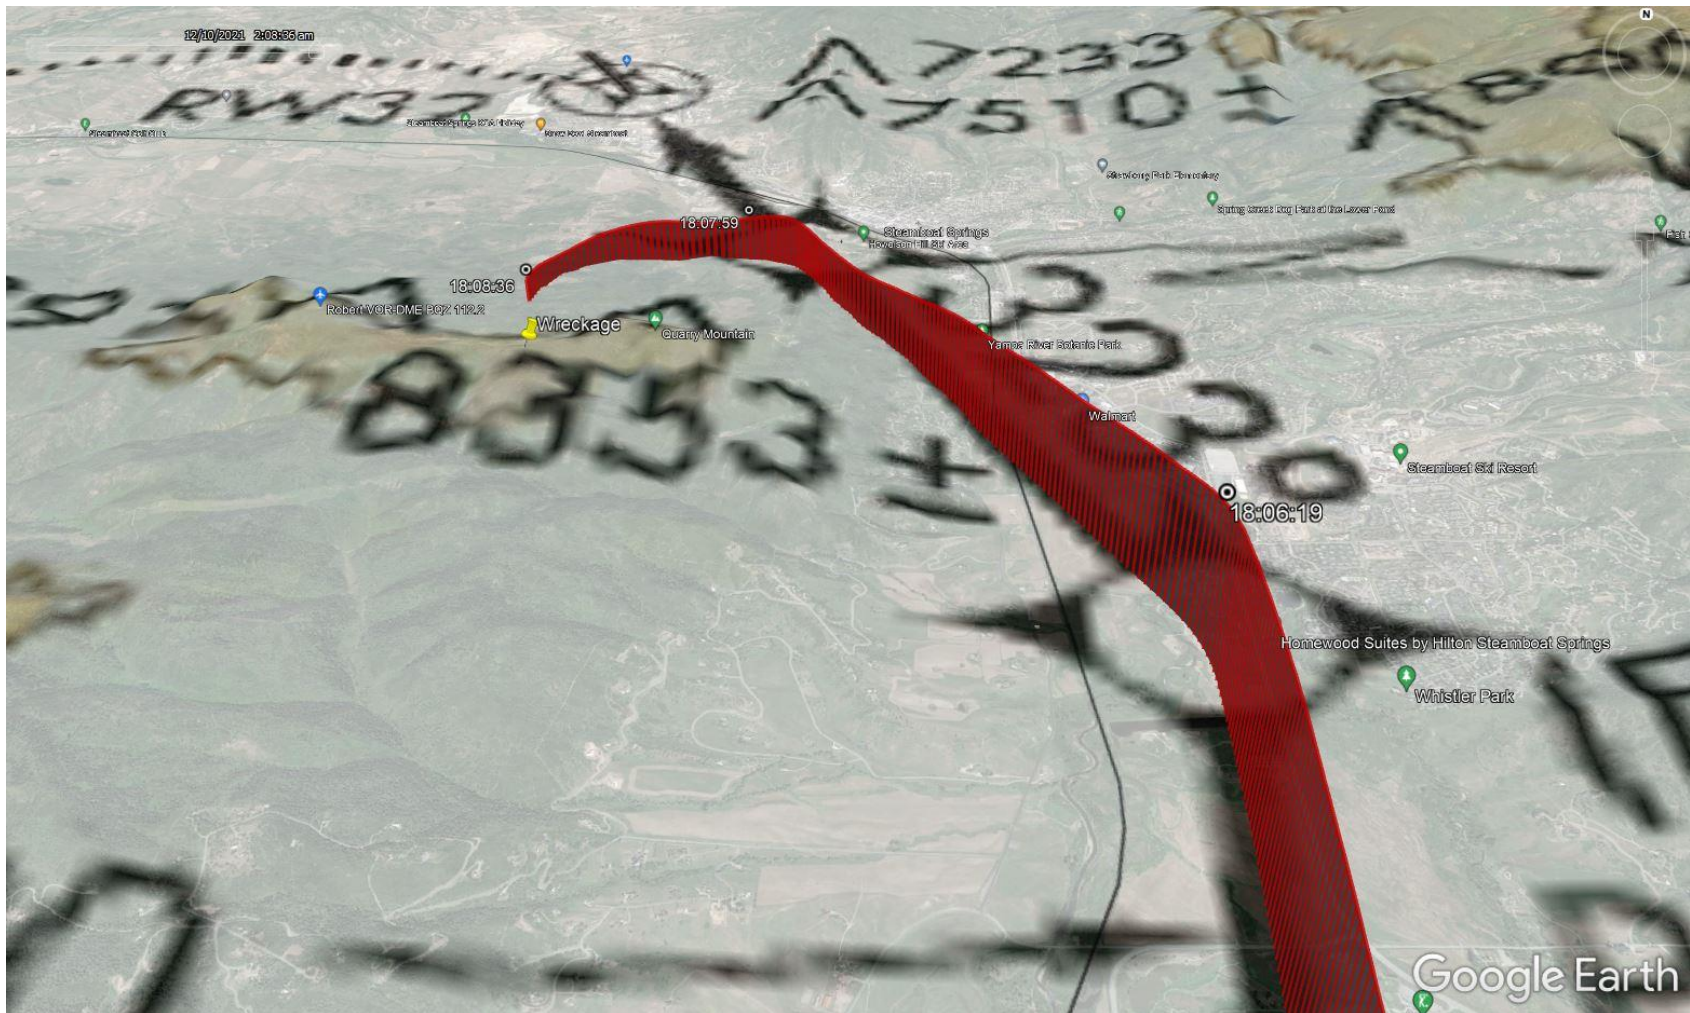
Figure 7 is a Google Earth plot showing a view of the aircraft's ground track centered around Quarry Mountain. The wreckage location is indicated with a yellow pin. An FAA approach plate for the RNAV (GPS)-E approach has been overlaid with a 50% opacity. Note that the weather and lighting conditions represented in Google Earth do not depict the conditions of that day.

**Figure 7.** A Google Earth plot showing a view of the aircraft's ground track centered around Quarry Mountain. The wreckage location is indicated with a yellow pin. An FAA approach plate for the RNAV (GPS)-E approach has been overlaid with a 50% opacity.

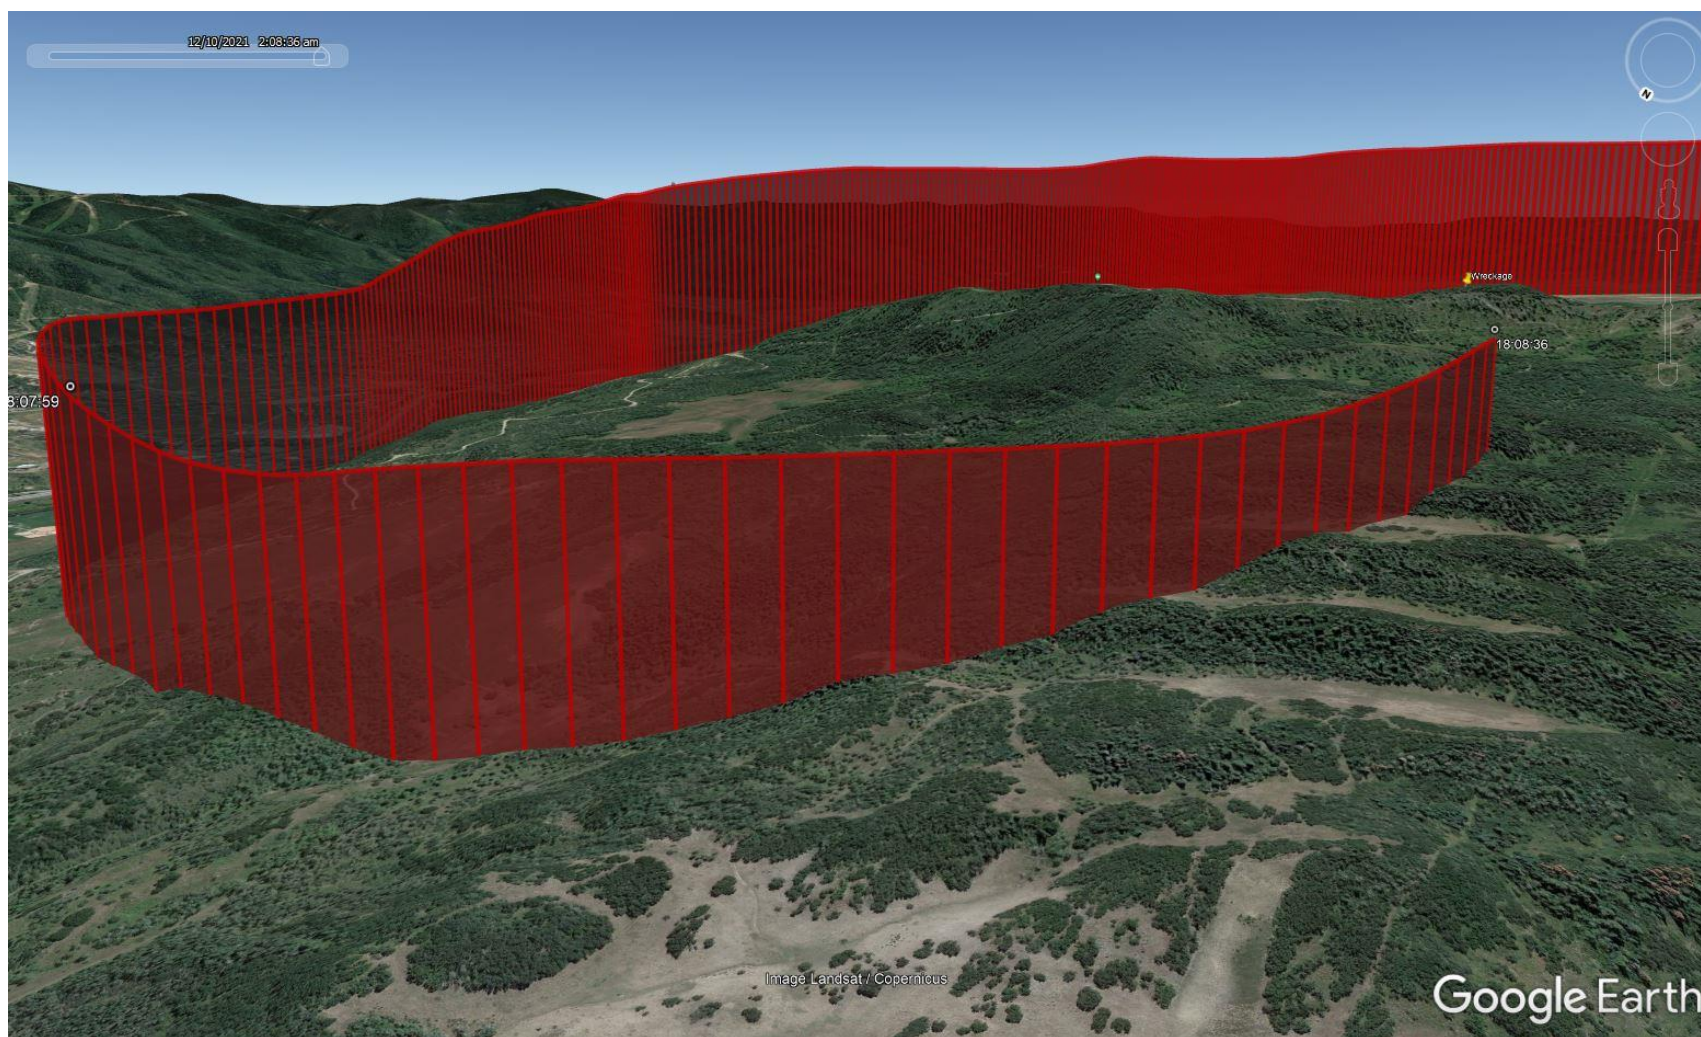
Figure 8 is a Google Earth plot showing an alternate view of the aircraft's tracklog in the vicinity of Quarry Mountain, west of Steamboat Springs, CO. The view of this image is oriented to the south-east (toward Quarry Mountain from the west side

**Figure 8.** A Google Earth plot showing an alternate view of the aircraft's tracklog in the vicinity of Quarry Mountain, west of Steamboat Springs, CO. The view of this image is oriented to the south-east (toward Quarry Mountain from the west side of the approach course to KSBS).

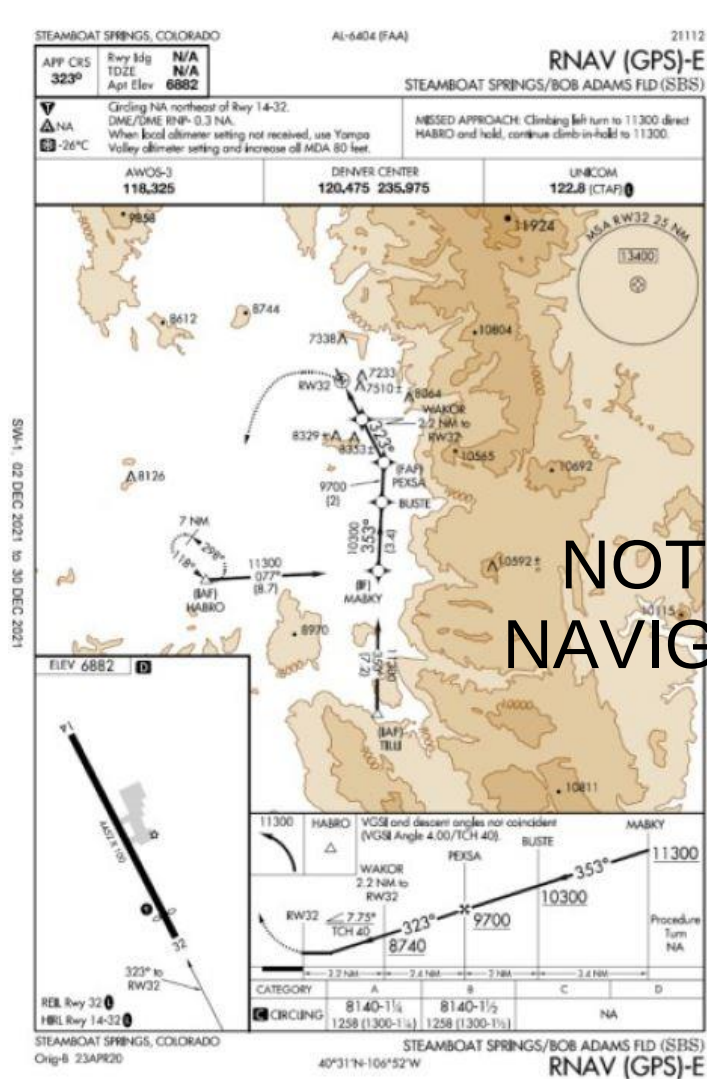
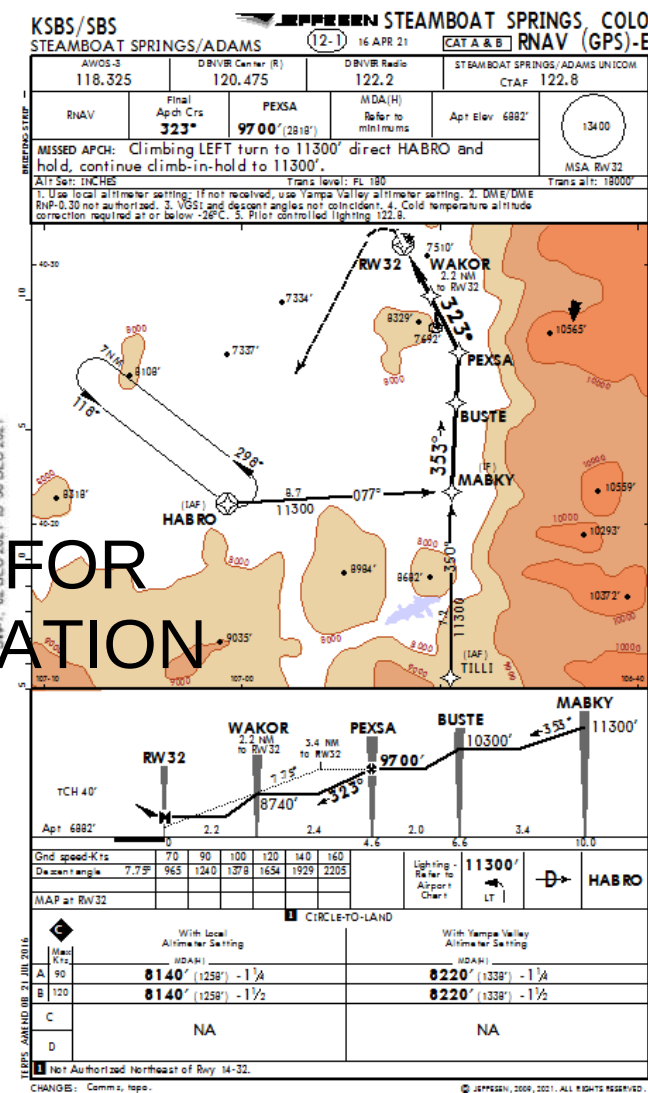
Figure 9 is the FAA published approach plate for the RNAV (GPS)-E approach at KSBS (pictured on the left of the figure) and the Jeppesen published approach plate for the same approach (pictured on the right of the figure). Both approach plates depicted in this figure were the versions current at the time of the accident. This figure is NOT TO BE USED FOR NAVIGATION.

**Figure 9.** The FAA published approach plate for the RNAV (GPS)-E approach at KSBS (left) and the Jeppesen published approach plate for the same approach. Both approach plates depicted here were the versions current at the time of the accident. NOT TO BE USED FOR NAVIGATION.

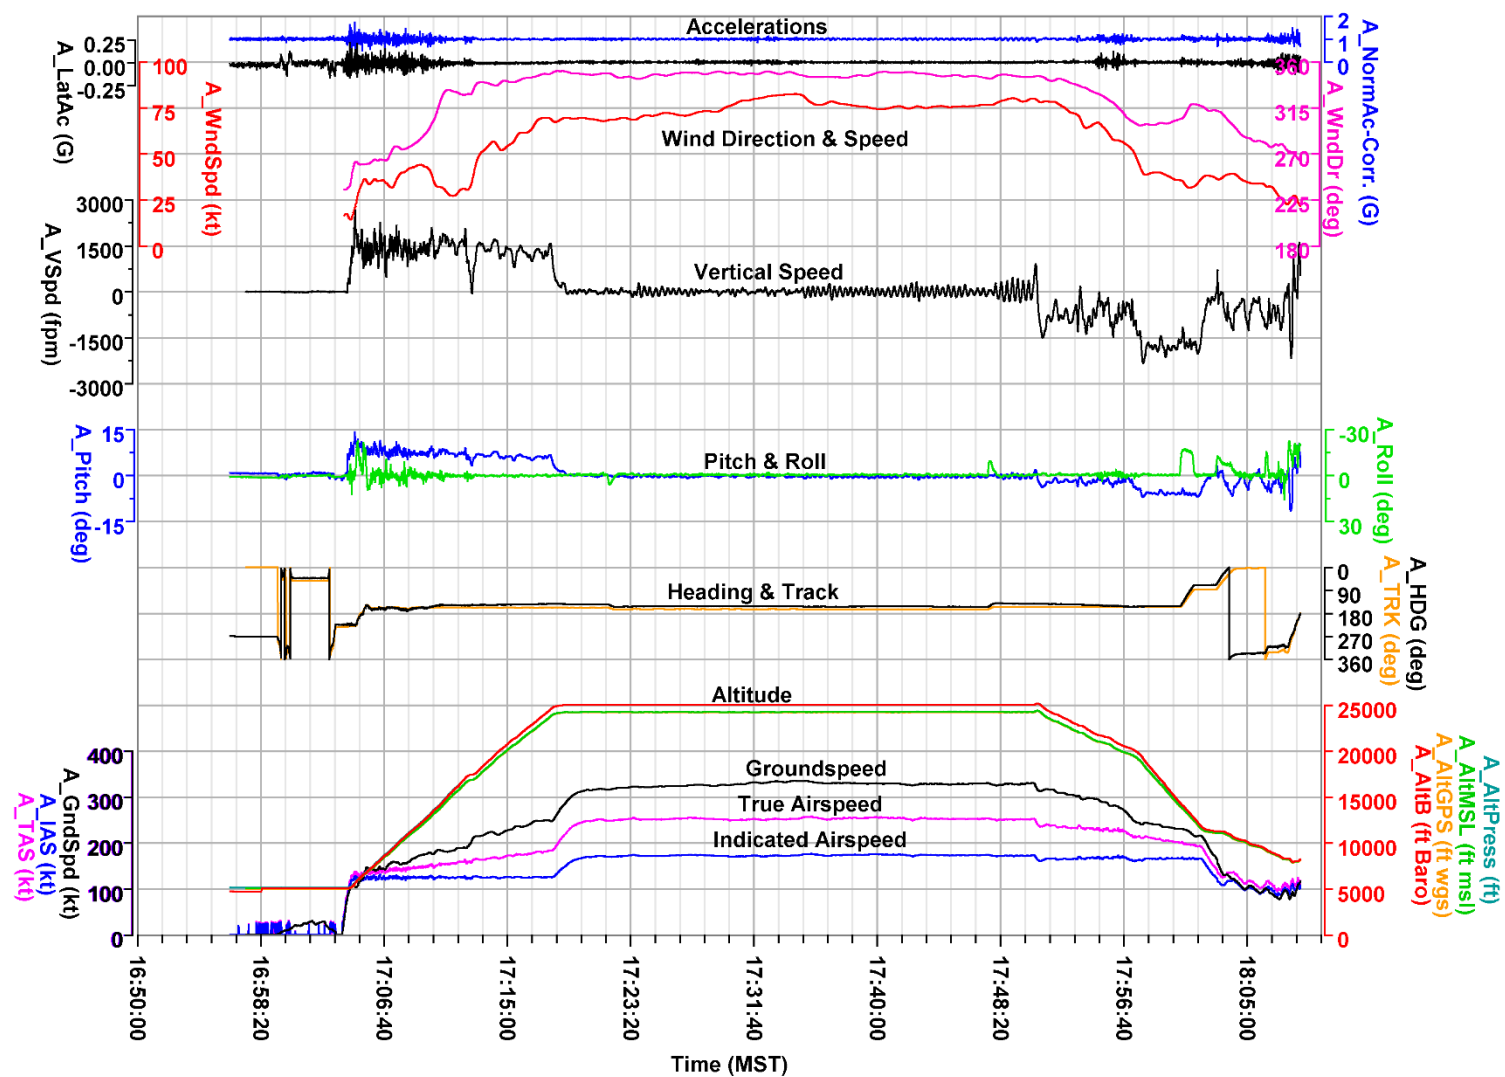
Figure 10 is a plot of select GTN-750 parameters for the entire accident flight. The data show the aircraft departed KCOD around 17:05 and began a climb to an altitude of 25,000 MSL (Barometric Altitude). The airplane reached 25,000 MSL around 17:19 and continued in an enroute/cruise phase for the next approximate 30 minutes. During cruise, the GTN-750 showed the aircraft's calculated true airspeed at around 250 knots. Around 17:51, the data show the aircraft began a descent into the KSBS terminal area. Details of the remainder of the flight are discussed below in further detail in the remaining figures.

**Figure 10.** A plot of relevant GTN-750 parameters for the entire accident flight.

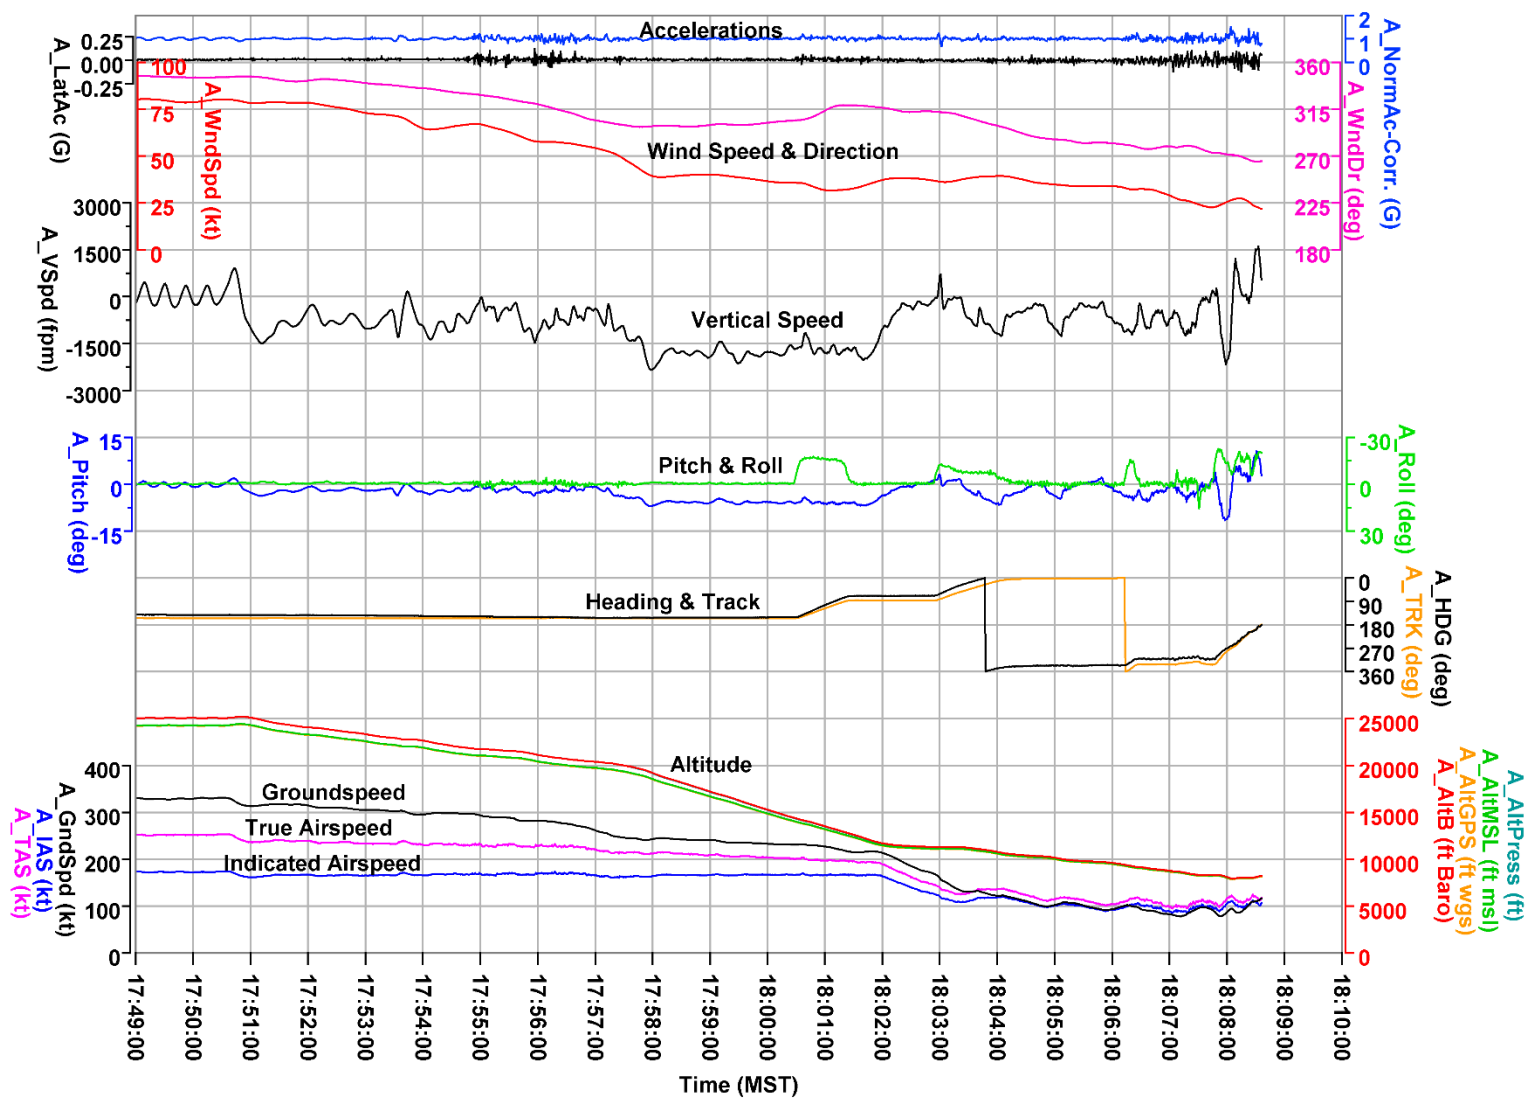
Figure 11 describes the last approximate 20 minutes of the aircraft's flight in the KSBS terminal area in greater detail. During the descent phase, the data show the aircraft had a varying descent rate. The maximum recorded descent rate was around -2,400 feet per minute as the aircraft was descending out of 19,000 feet (barometric altitude). Details of the remainder of the flight are discussed below in further detail in the remaining figures.

**Figure 11.** A plot of relevant GTN-750 parameters for the terminal portion of the accident flight.

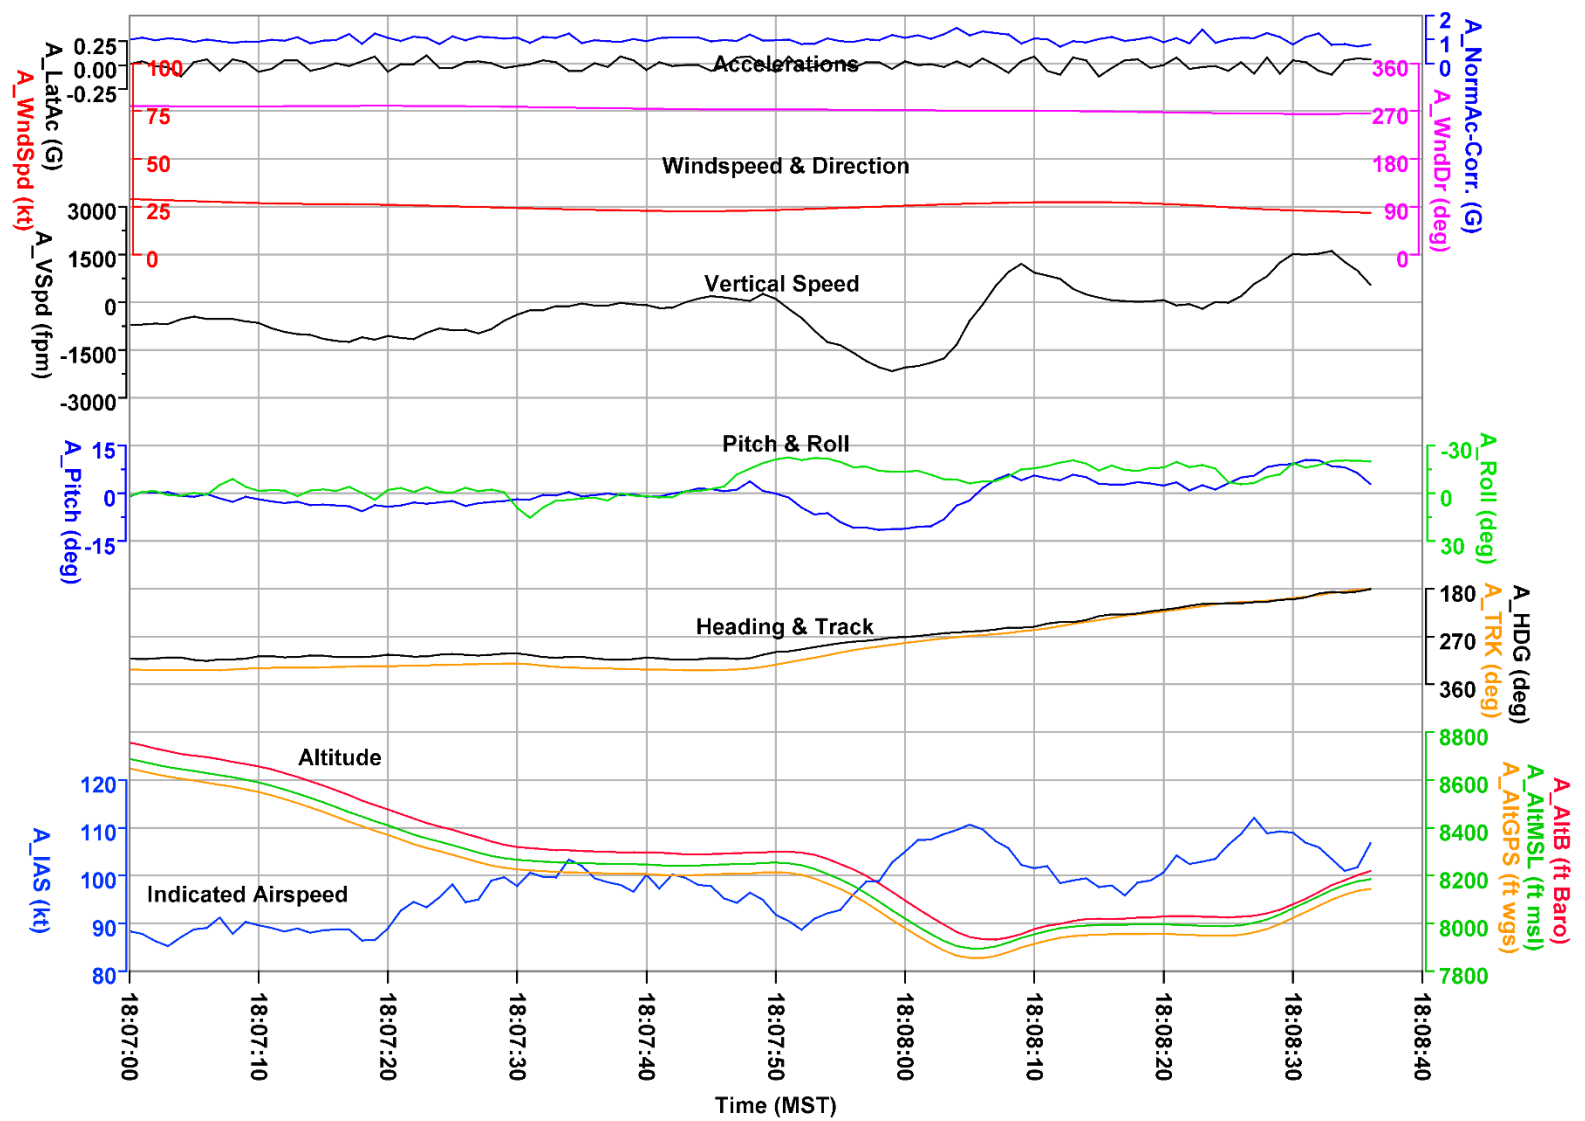
Figure 12 shows the last approximately one minute and 35 seconds of the accident flight. The plot begins with the aircraft descending from 8,700 feet on a heading of about 313 degrees magnetic and an airspeed of around 90 knots indicated. Around 18:07:40, the aircraft had descended to approximately 8,300 feet (barometric altitude). The aircraft continued at around 8,300 feet for the next 10 seconds, the indicated airspeed at this time varied between 103 knots indicated and 89 knots indicated. The aircraft then continued a descent to a minimum of around 7930 feet (barometric altitude), during this portion of the flight and during this descent, the indicated airspeed climbed from 89 knots indicated to around 111 knots indicated. At this time, altitude trend began increasing, the data show the aircraft was continuing in a left turn. Altitude roughly stabilized between 18:08:10 and 18:08:27 at around 8,000 feet (barometric altitude), the data show the aircraft's heading and groundtrack still changing to the left. The recorded data ended at 18:08:36. At this time, altitude and airspeed were in a slight increasing trend and the aircraft's pitch was decreasing to level. The last altitude record was 8,218 feet (barometric altitude).

**Figure 12.** A plot of relevant GTN-750 parameters for the final portion of the accident flight.

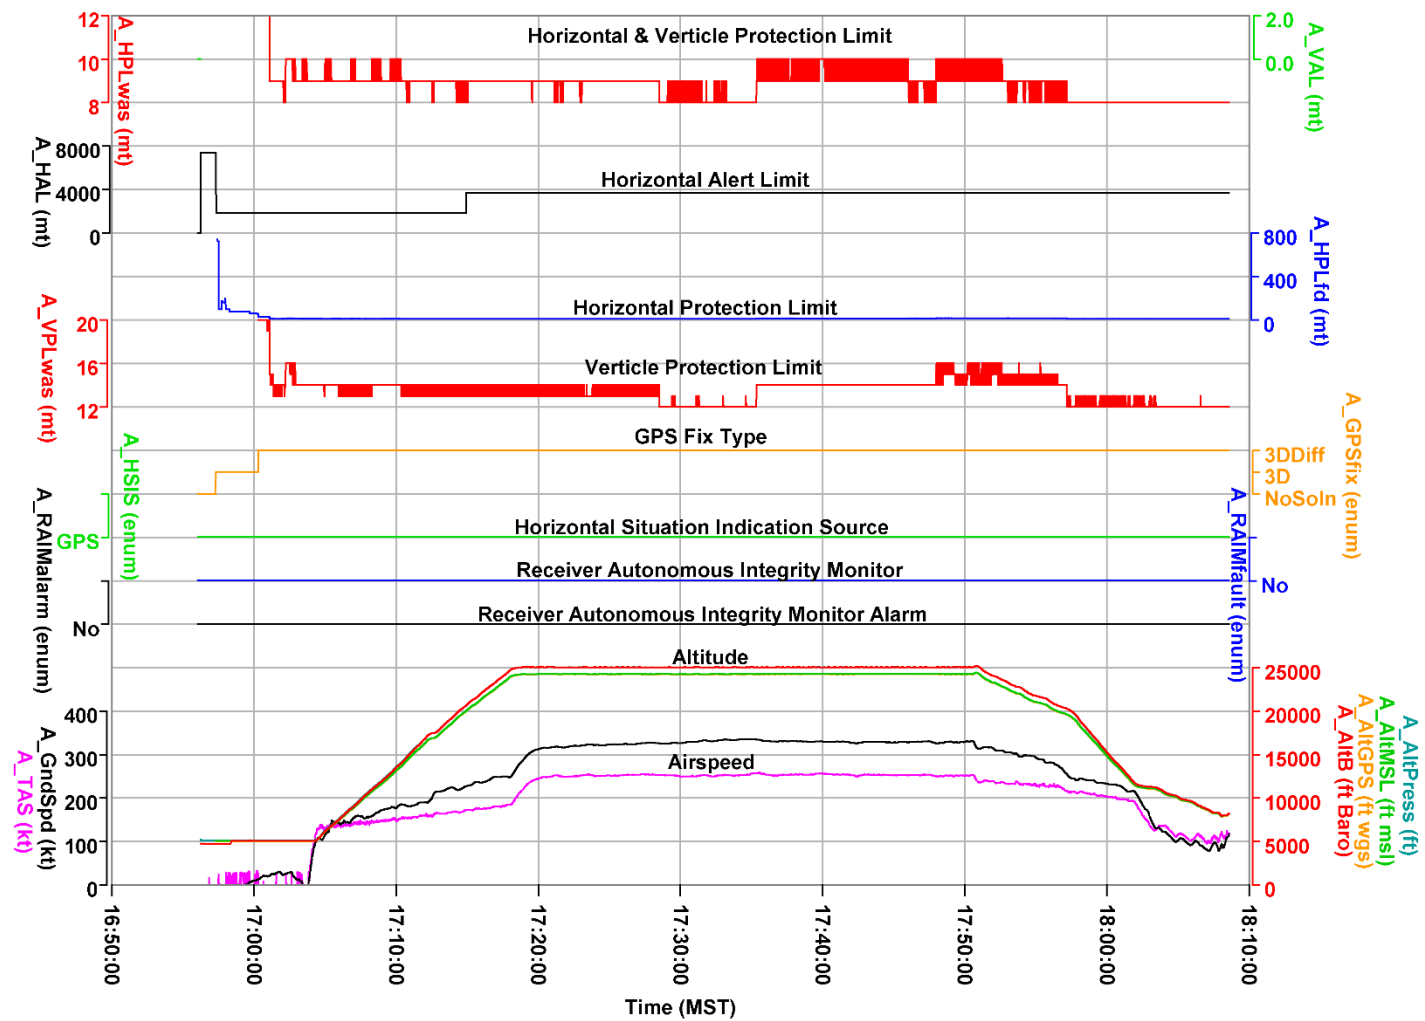
Figure 13 is a plot of GPS quality-related data from GTN-750 Unit A. Nothing anomalous was detected in the GPS quality dataset. Additionally, the data indicate that unit was set to "GPS" as the Horizontal Situation Indication Source (HSIS). This did not change for the duration of the flight.

**Figure 13.** A plot of GPS quality related data from GTN-750 Unit A.
