# NATIONAL TRANSPORTATION SAFETY BOARD

## Multiple Electronic Devices

**Specialist's Factual Report**  
**by Sean Payne**

Location: Steamboat Springs, CO  
Date: December 10, 2021  
Aircraft: Piper PA-46-500TP  
Registration: N744Z  
Operator: Private  
NTSB Number: CEN22FA069

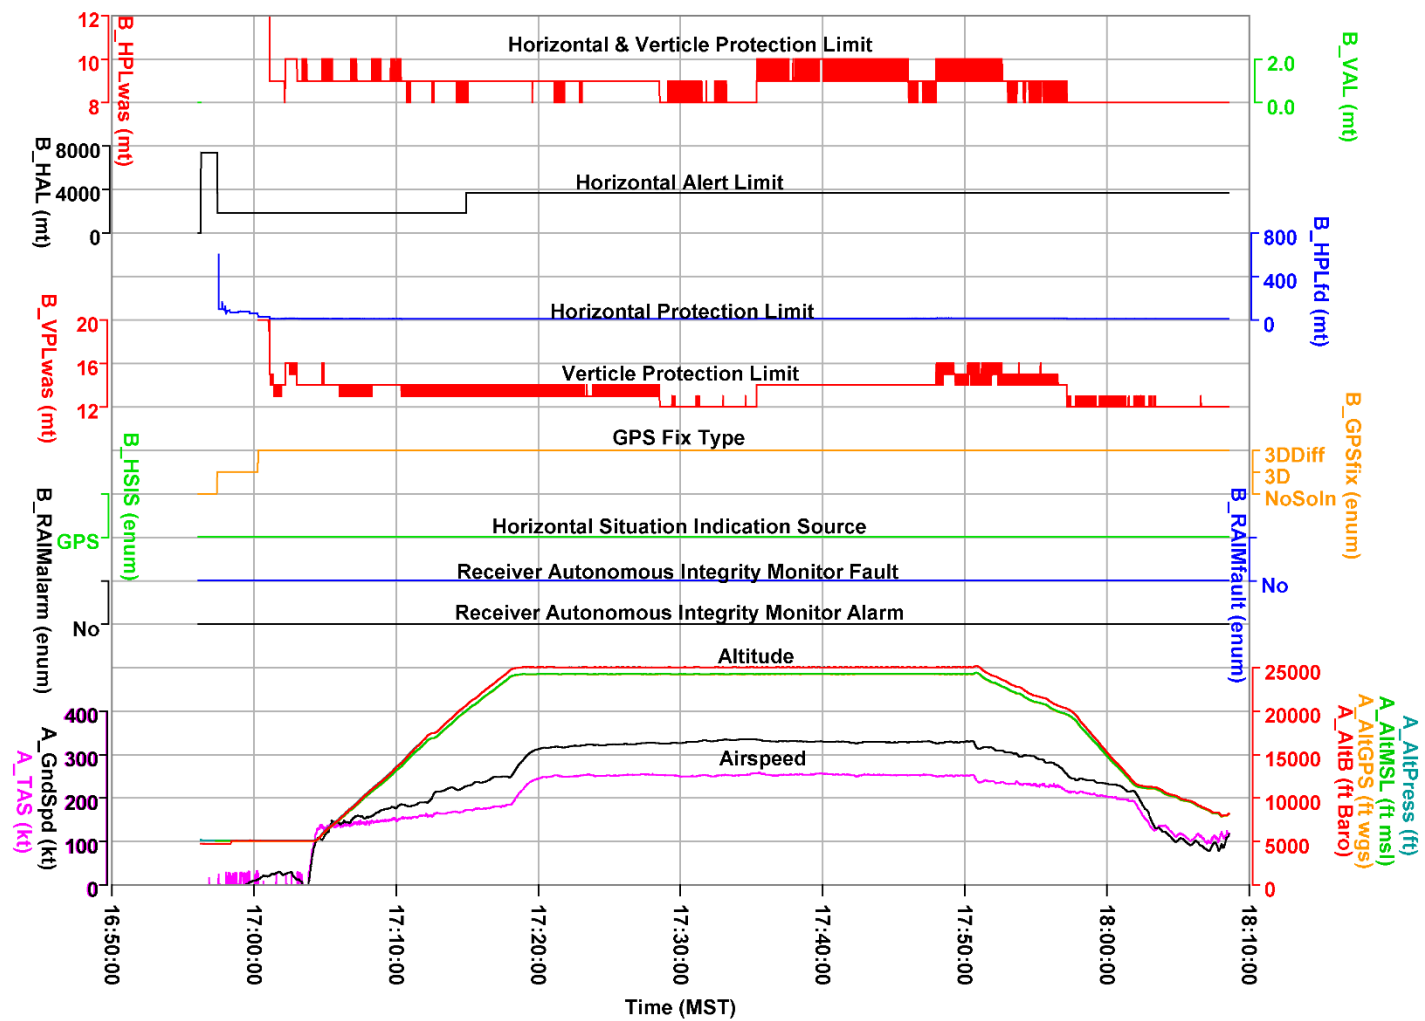
Figure 14 is a plot of GPS quality-related data from GTN-750 Unit B. Nothing anomalous was detected in the GPS quality dataset. Additionally, the data indicate that unit was set to "GPS" as the Horizontal Situation Indication Source (HSIS). This did not change for the duration of the flight.

**Figure 14.** A plot of GPS quality related data from GTN-750 Unit B.

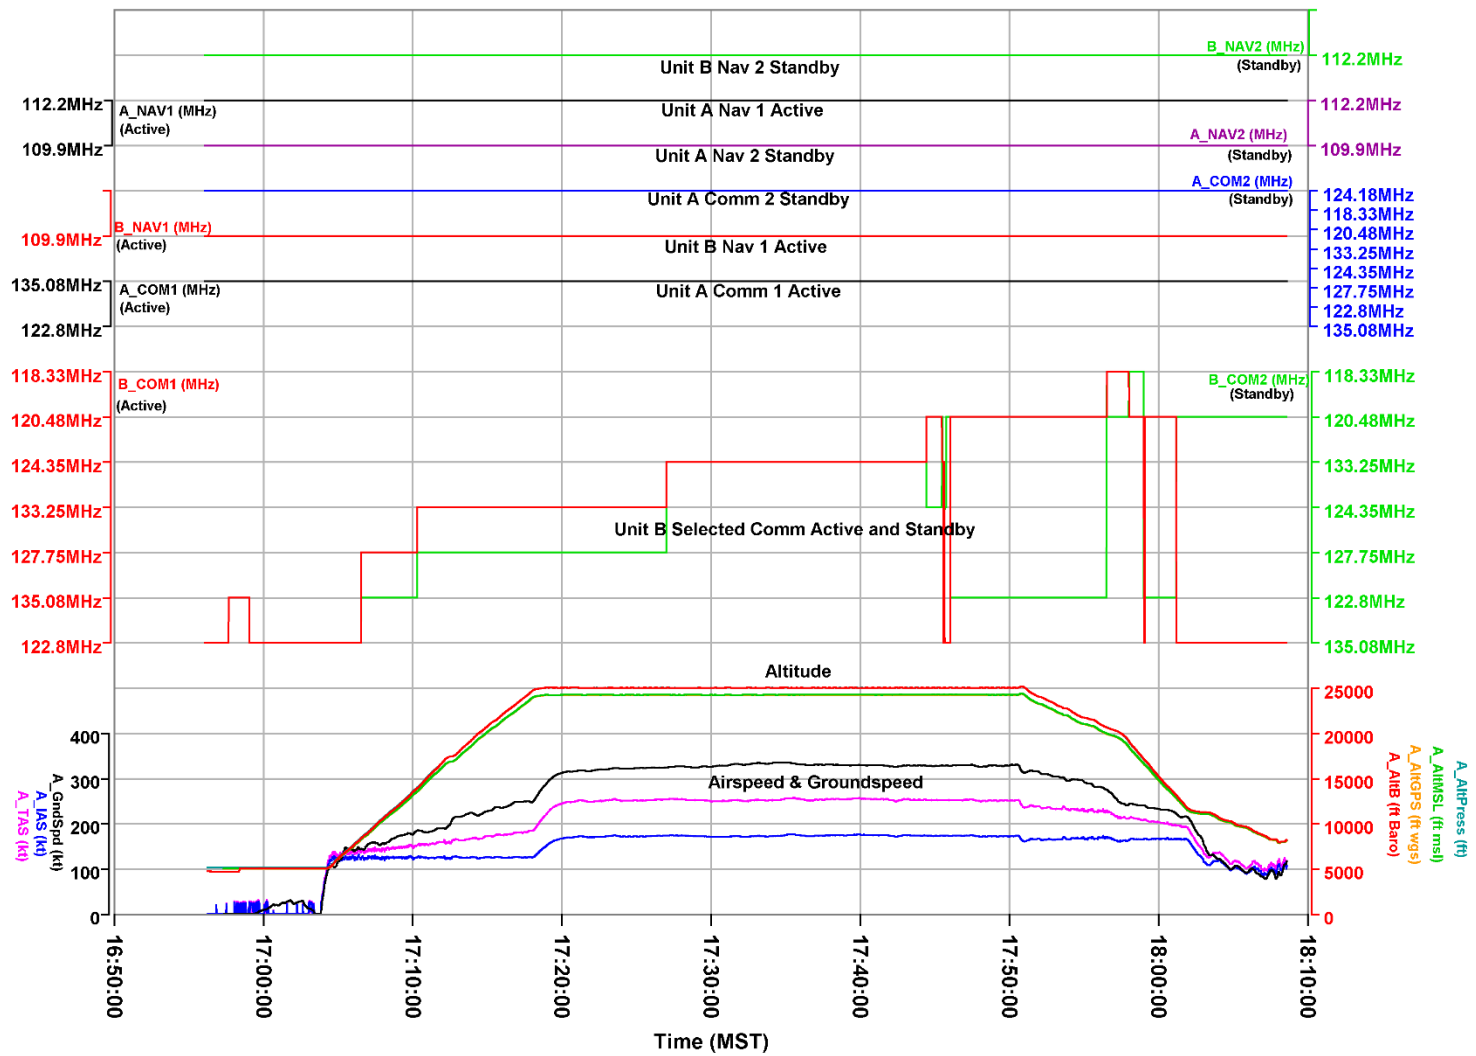
Figure 15 is a plot of communication and navigation frequency recorded data from both Unit A and Unit B. Note that communication and navigation frequencies in this plot are rounded to the nearest hundredth of a megahertz.

The data show that communications frequencies for Unit B were changed during the flight. As the aircraft approached KSBS, the active communication frequency for Unit B was set to 120.475 MHz (a published frequency for Denver Center). As the aircraft approached KSBS and was in a descent phase, the active communication frequency for Unit B was set to 118.325 MHz (a published frequency for the AWOS-3 at KSBS). Data show the active communications frequency for Unit B was then set back to 120.475 MHz. As the aircraft descended out of approximately 12,000 feet, Unit B's active communication frequency was recorded as 122.8 MHz (a published frequency for KSBS UNICOM).

Data show that communication frequencies for Unit A were unchanged for the duration of the accident flight.

Data show that Unit B's active navigational frequency was recorded as 109.9 MHz and remained unchanged for the entire flight.

Data show that Unit A's active navigational frequency was recorded as 112.2 MHz and remained unchanged for the entire flight.

**Figure 15.** A plot of communication and navigation frequency recorded data from both Unit A and Unit B.

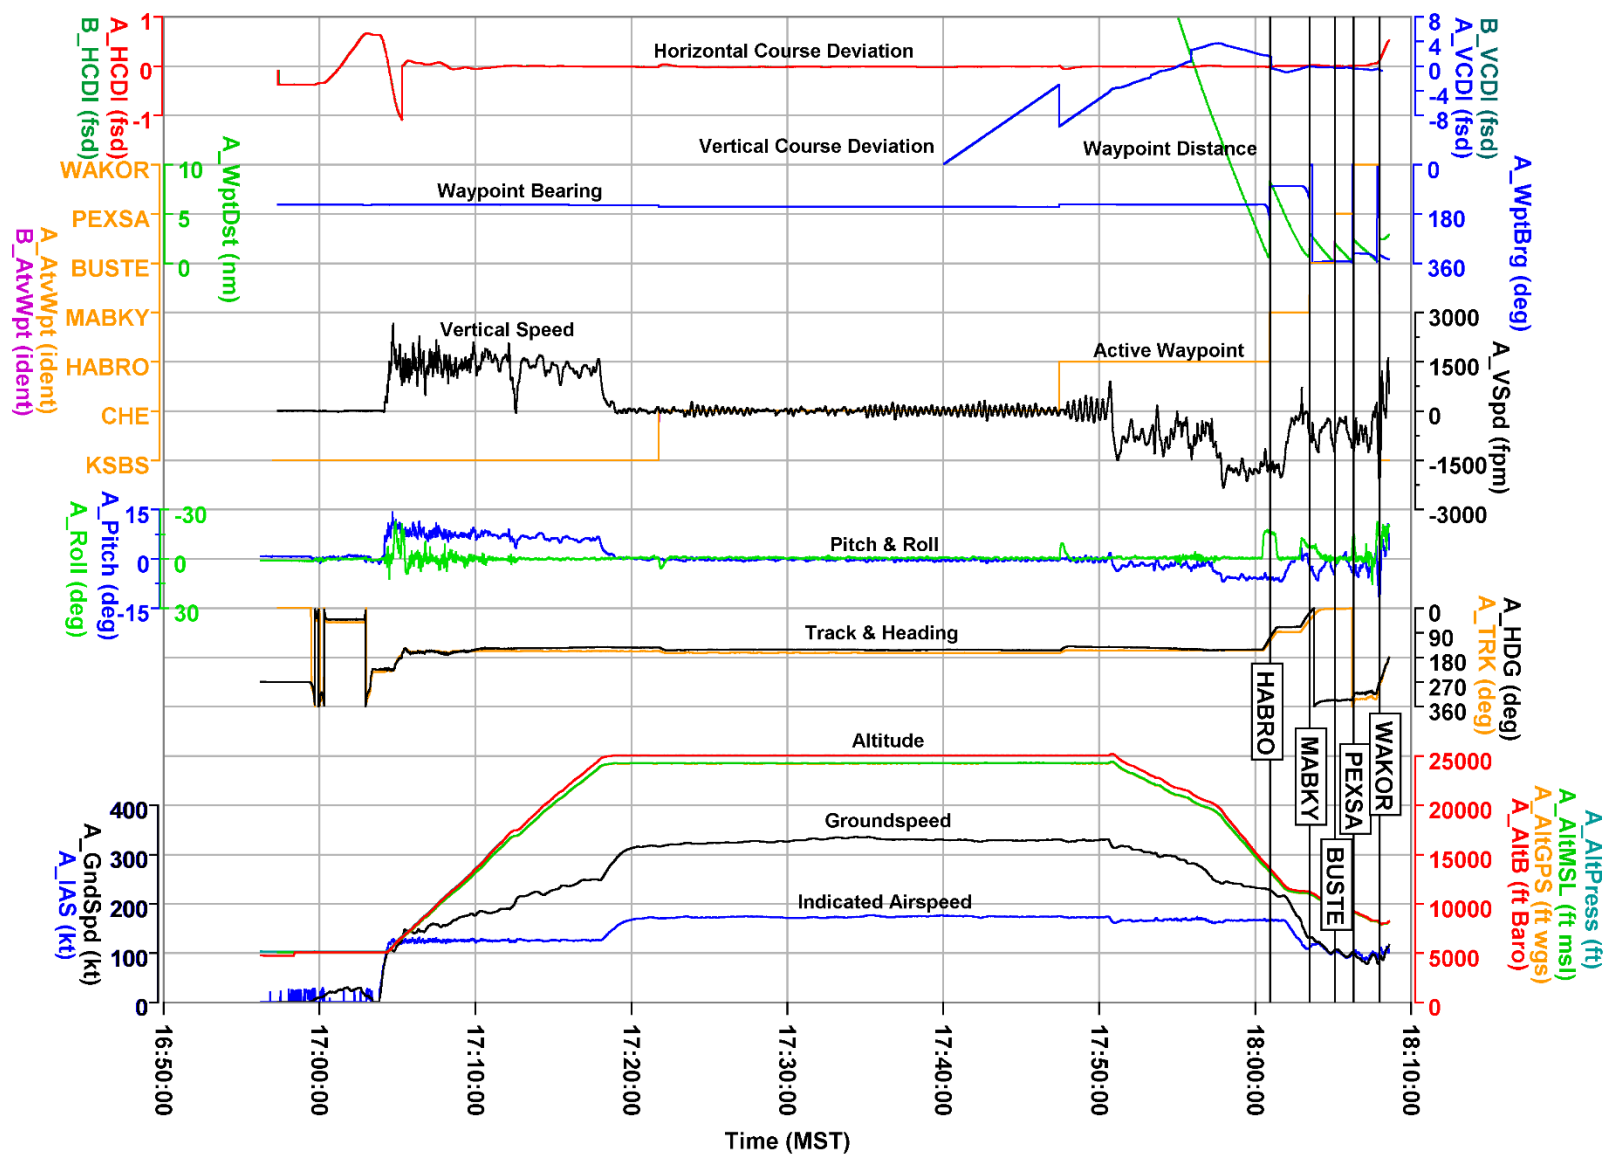
Figure 16 is a plot of select parameters related to IFR navigation for the entirety of the accident flight. Data for both Unit A and Unit B show the following selected waypoints were recorded as "AtvWpt" (Active Waypoint) throughout the flight. The waypoints are listed in chronological order as follows: KSBS, CHE (Hayden VOR), HABRO, MABKY, BUSTE, PEXSA, WAKOR, KSBS. Note that the RNAV (GPS)-E approach terminates as KSBS, and not a runway. Data does not show any other active waypoints captured by the dataset.

**Figure 16.** Parameters related to IFR navigation recorded by the GTN-750 for the entire flight.

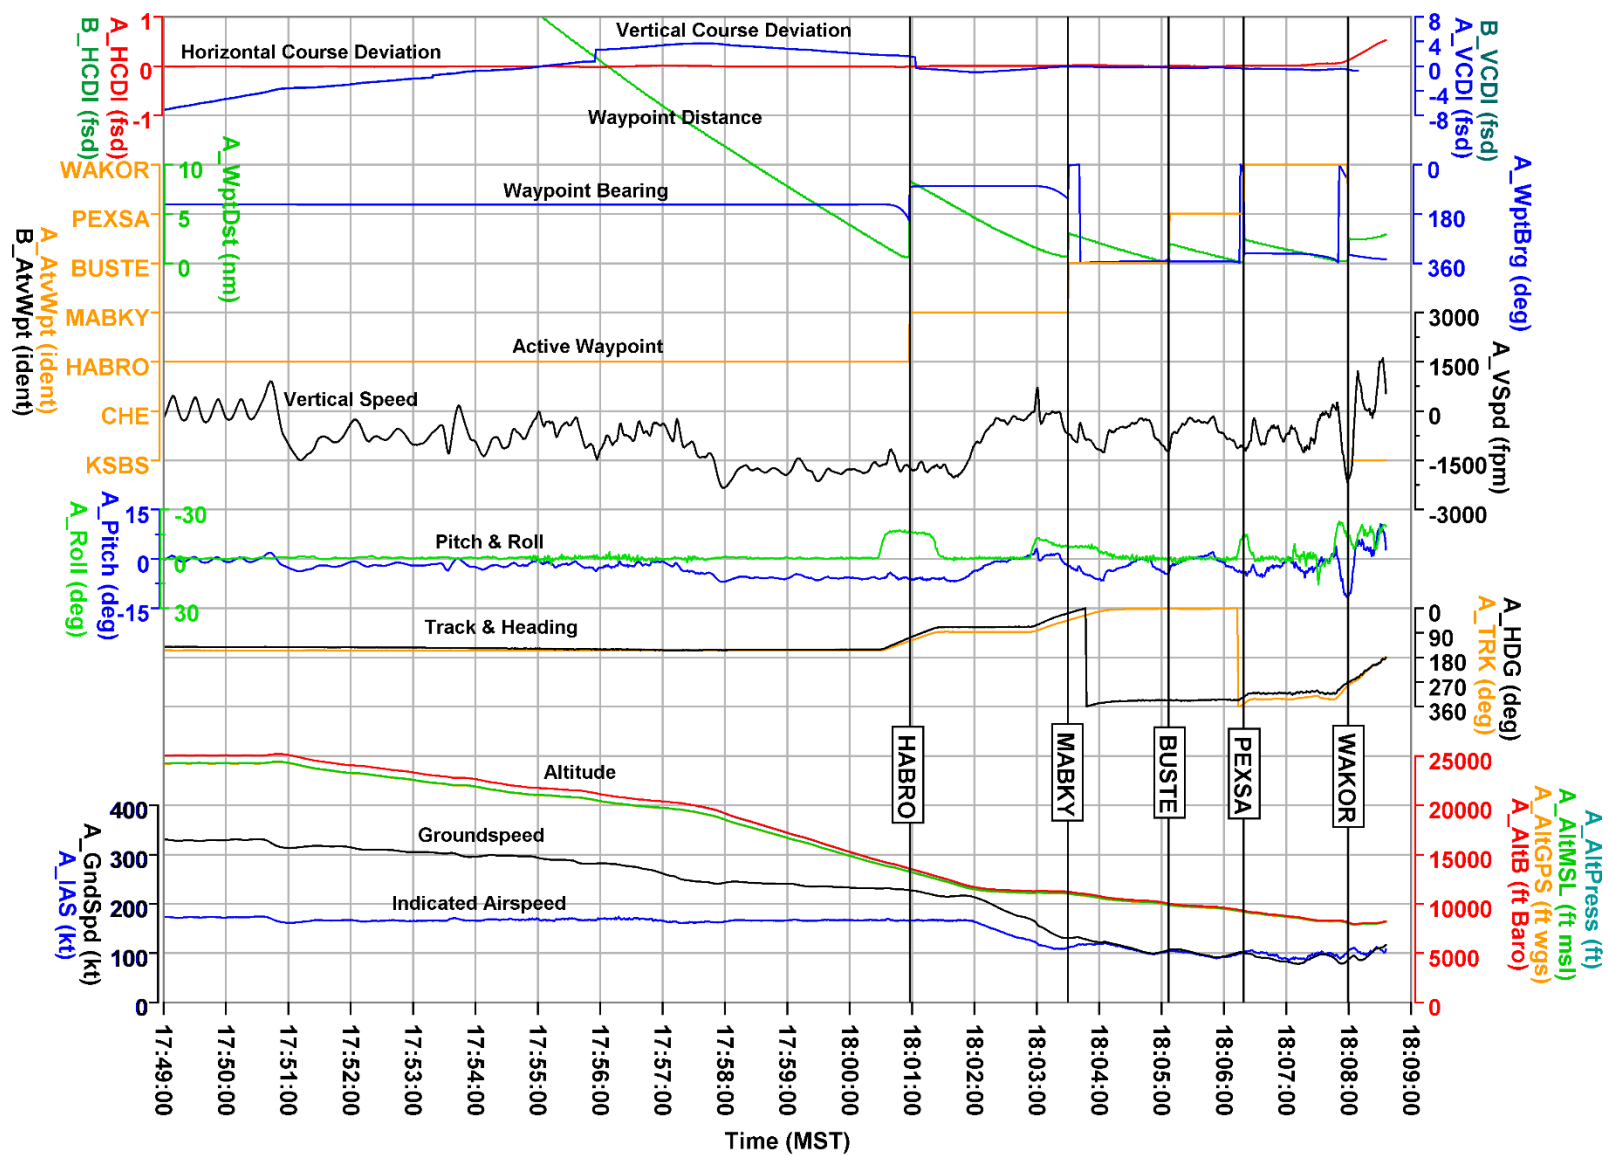
Figure 17 is a plot of select parameters related to IFR navigation for the last approximate 20 minutes of the accident flight. Table 1 shows altitudes related to each fix and are displayed as follows: Fix Name (Published Altitude), (Recorded Barometric Altitude), (Recorded GPS Altitude).

**Figure 17.** Parameters related to IFR navigation recorded by the GTN-750 for the descent phase and terminal area of the flight.

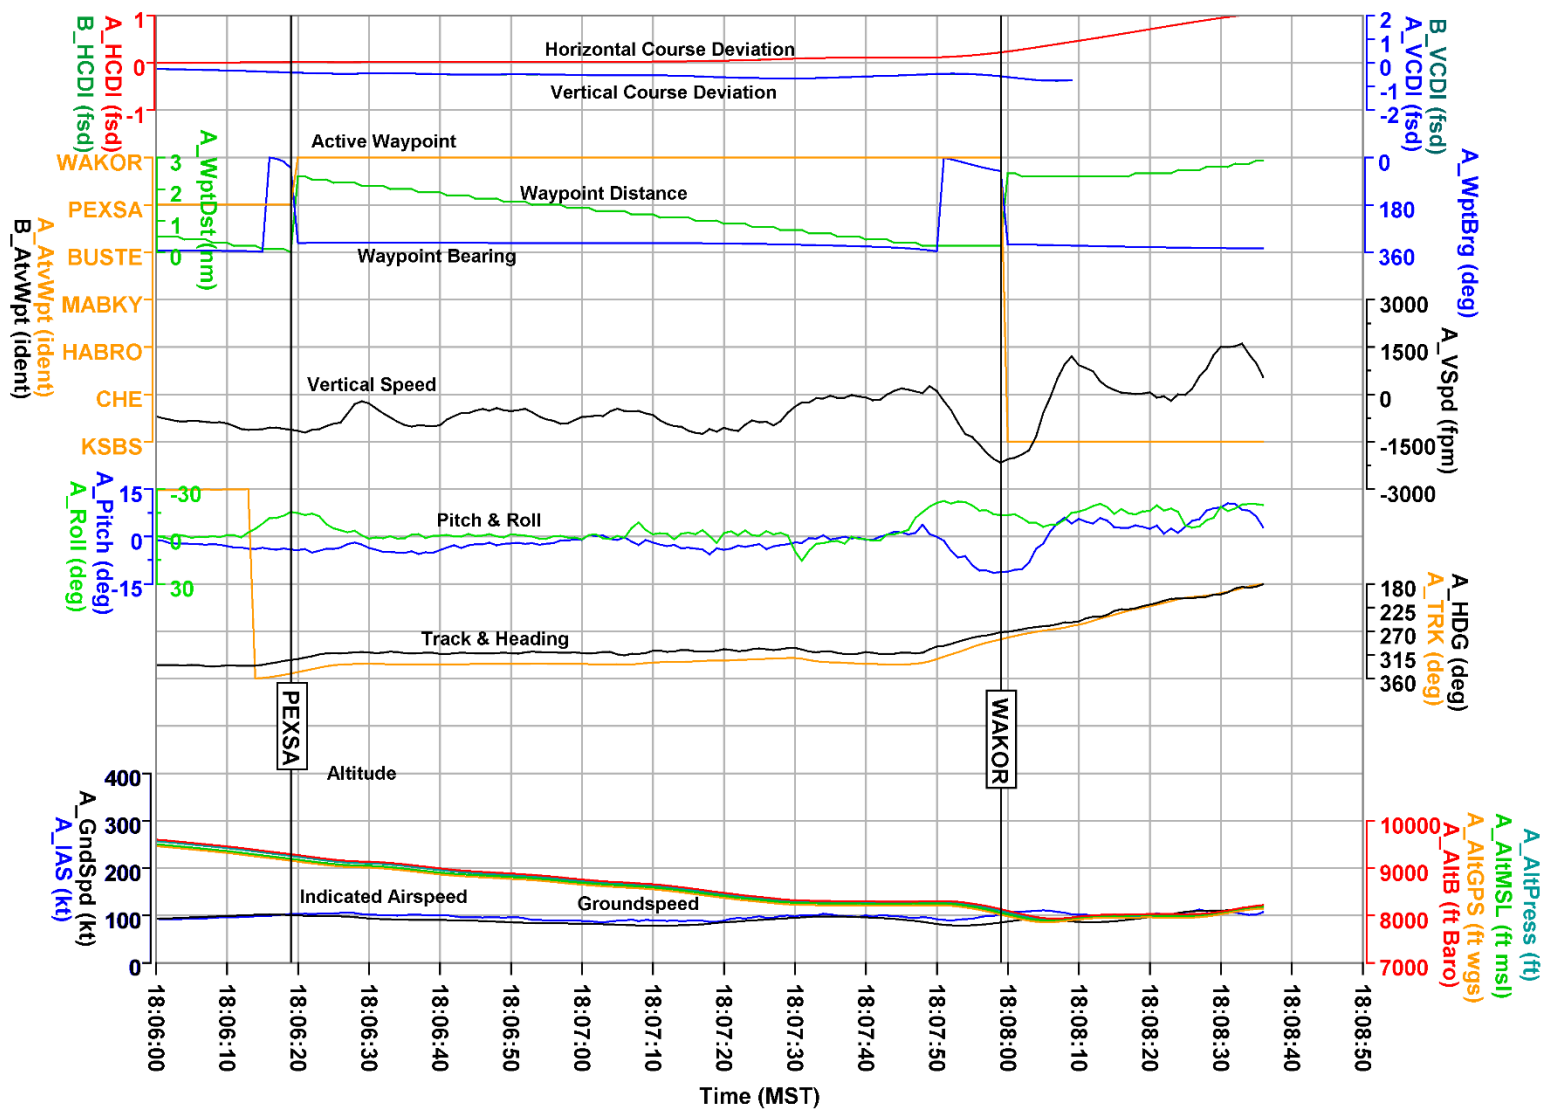
Figure 18 is a plot of select parameters related to IFR navigation for the last approximate 13 minutes of a flight conducted on November 12, 2021, in which the aircraft also flew an RNAV approach to KSBS. Table 2 shows altitudes related to each fix and are displayed as follows: Fix Name (Published Altitude), (Recorded Barometric Altitude), (Recorded GPS Altitude).

**Figure 18.** Parameters related to IFR navigation recorded by the GTN-750 for the final portion of the flight.

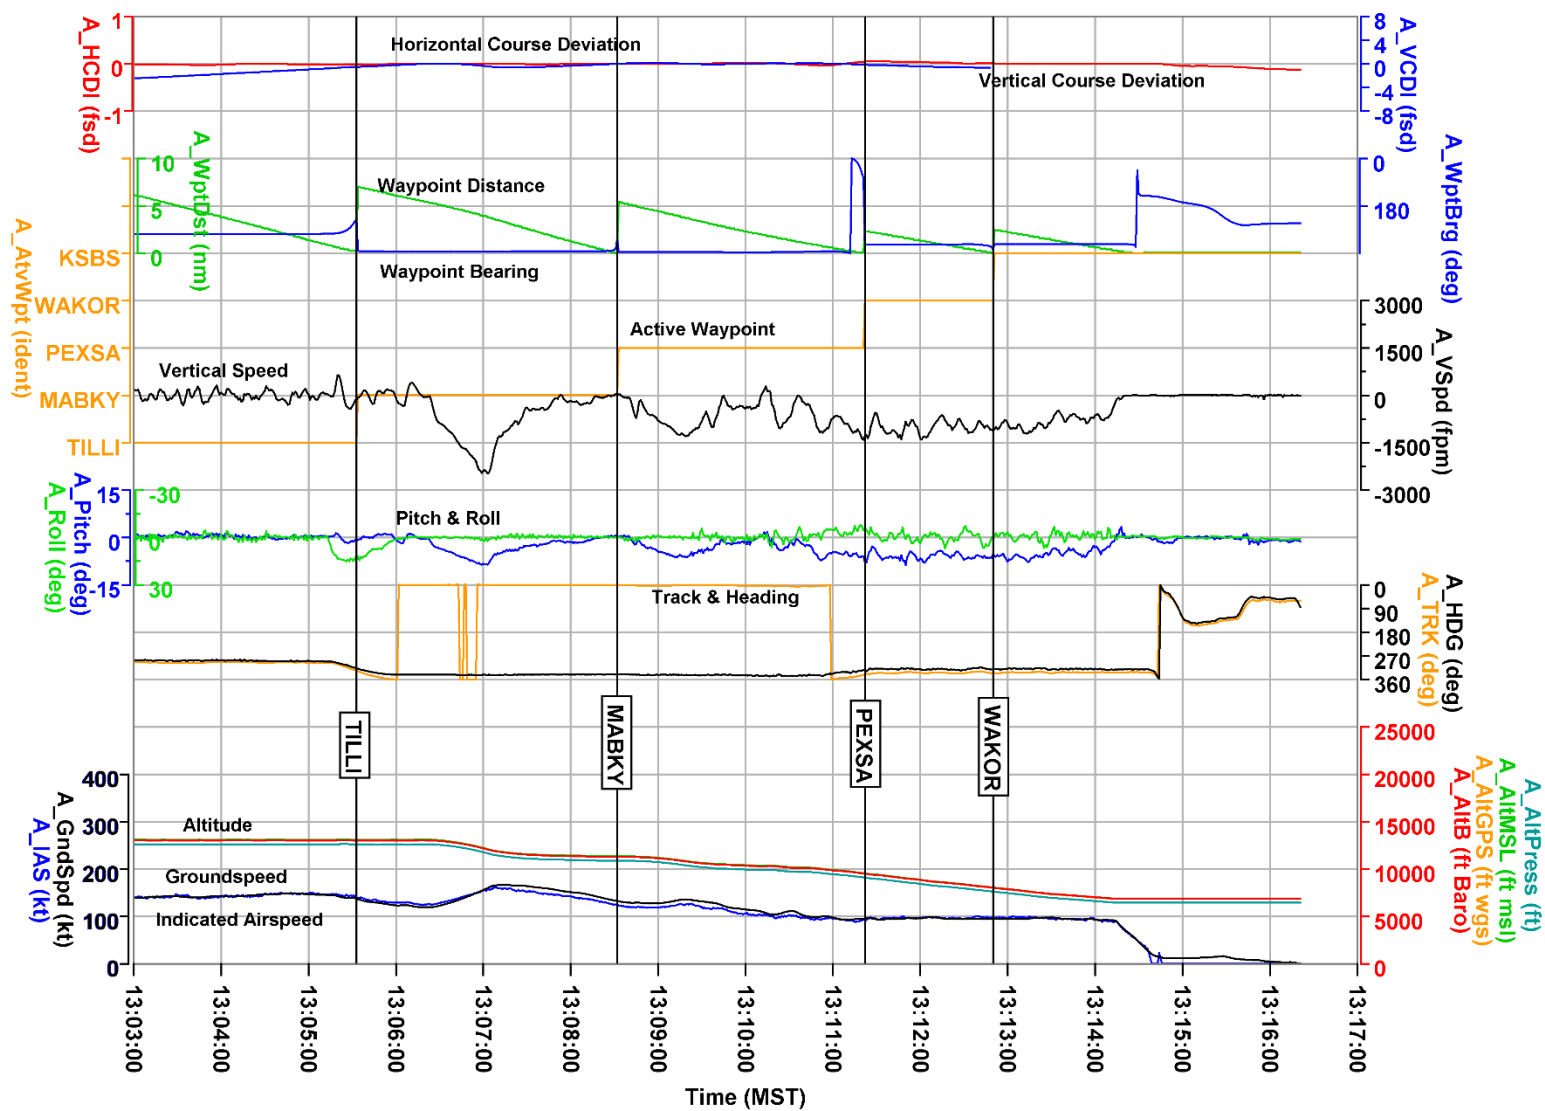
Figure 19 is a plot of select parameters related to IFR navigation for the last approximate 10 minutes of a flight conducted on December 4, 2021, in which the aircraft also flew an RNAV approach to KSBS. Table 3 shows altitudes related to each fix and are displayed as follows: Fix Name (Published Altitude), (Recorded Barometric Altitude), (Recorded GPS Altitude).

**Figure 19.** Parameters related to IFR navigation recorded by the GTN-750 for a previous approach to KSBS on November 11, 2021.

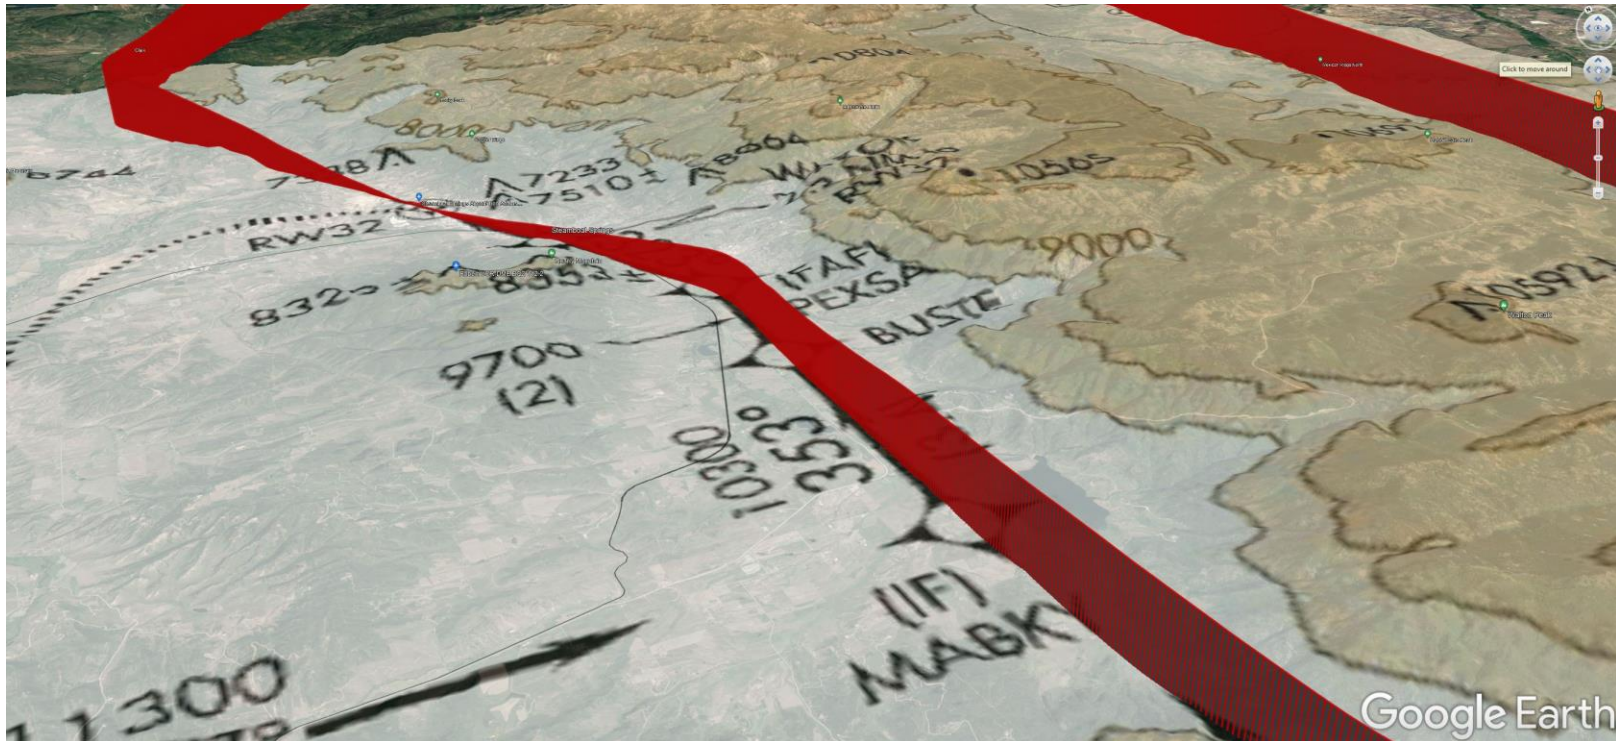
Figure 20 is a Google Earth plot showing the accident aircraft's ground track in the vicinity of the terminal area of KSBS for a flight conducted on November 11, 2021. An FAA published approach plate is overlaid for the RNAV (GPS)-E approach into

KSBS. Note that the aircraft's departure profile is also shown in this image. The flight's origin was KSBS and the aircraft completed the flight returning to KSBS.

**Figure 20.** The aircraft's groundtrack recorded by the GTN-750 for a previous approach to KSBS on November 11, 2021. An FAA approach plate for RNAV (GPS)-E has been overlaid on the plot.

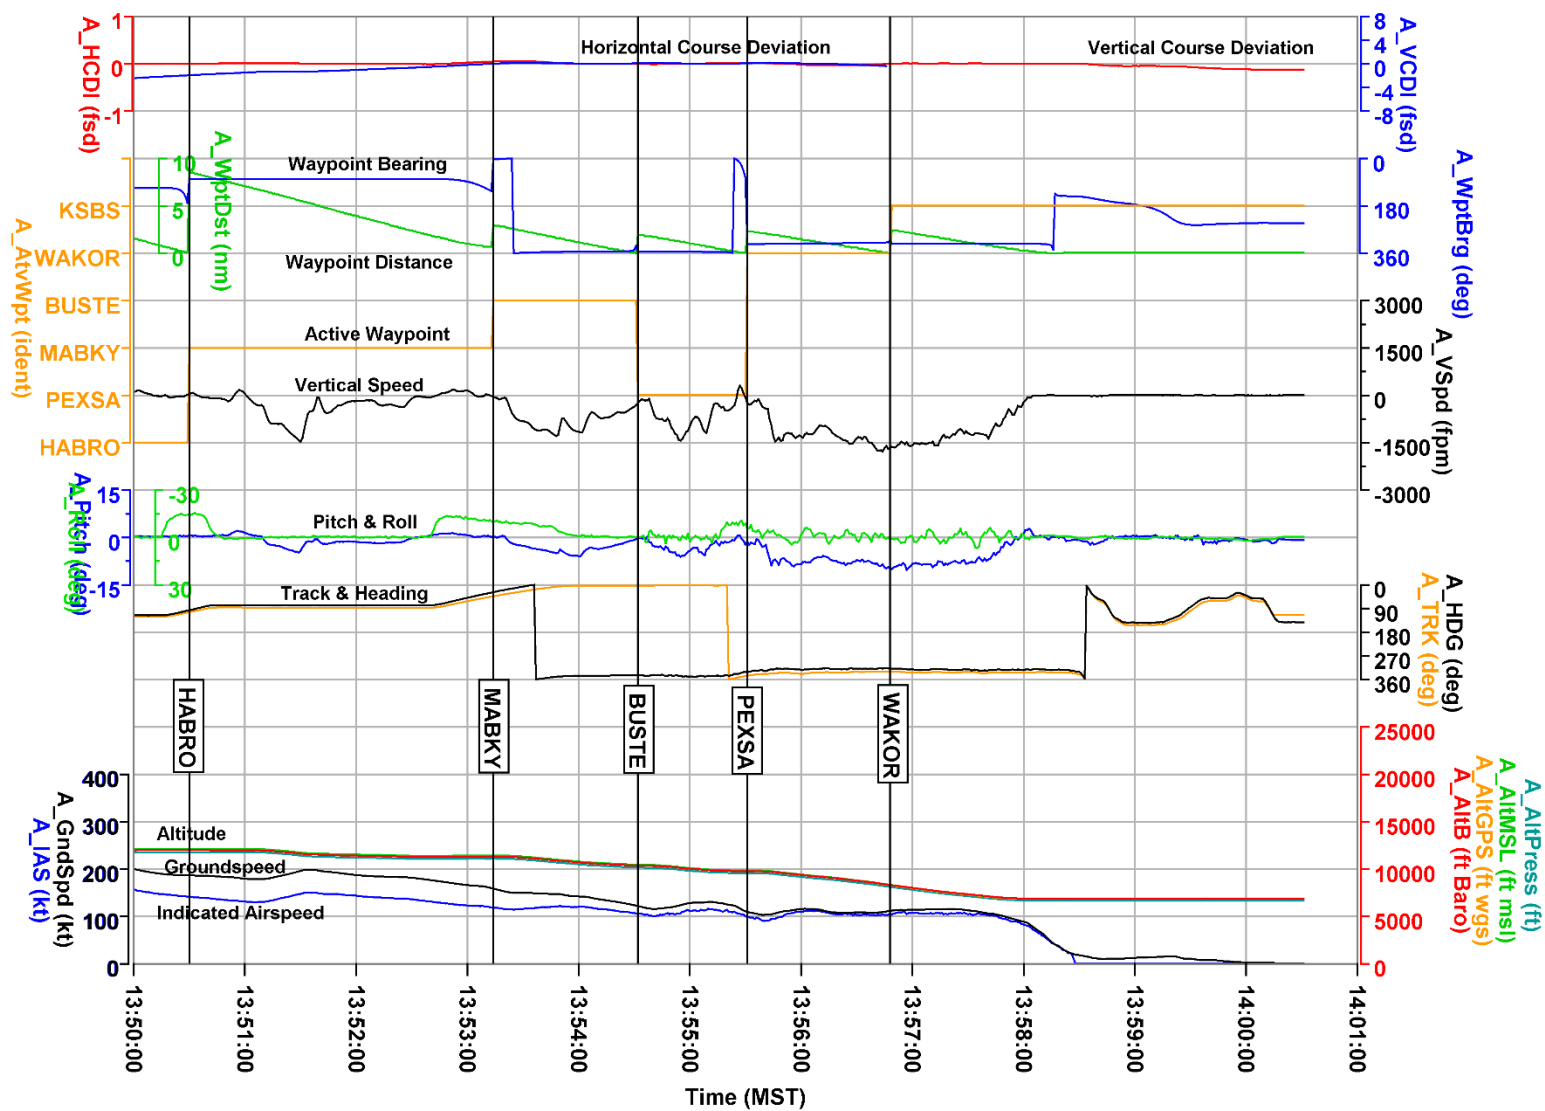
**Figure 21.** Parameters related to IFR navigation recorded by the GTN-750 for a previous approach to KSBS on December 4, 2021.

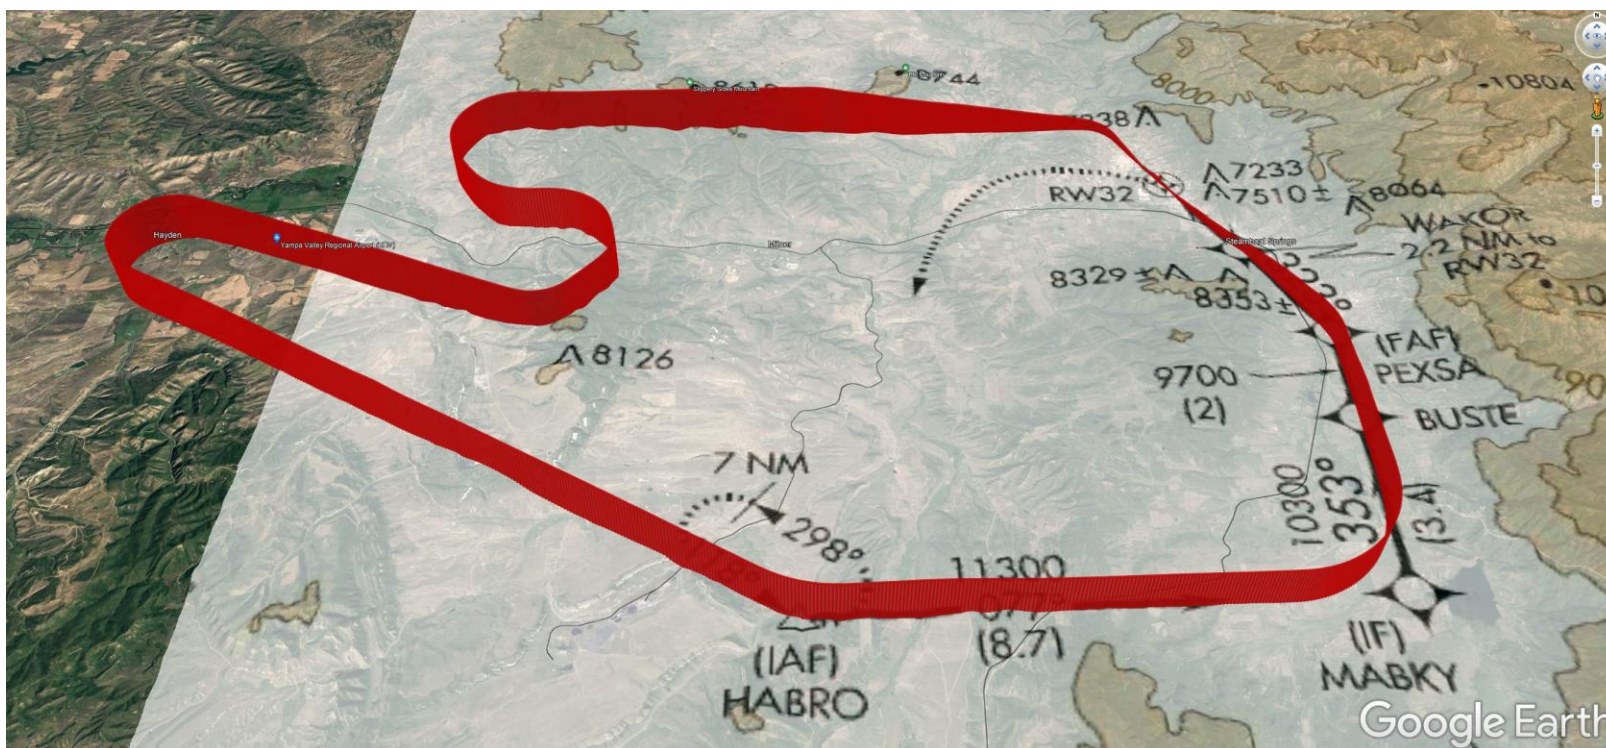
Figure 21 is a Google Earth plot showing the accident aircraft's ground track in the vicinity of the terminal area of KSBS for a flight conducted on December 4, 2021. An FAA published approach plate is overlaid for the RNAV (GPS)-E approach into KSBS. Note that the aircraft's departure profile is also shown in this image. The flight's origin was KSBS and the aircraft completed the flight returning to KSBS.

**Figure 22.** The aircraft's groundtrack recorded by the GTN-750 for a previous approach to KSBS on December 4, 2021. An FAA approach plate for RNAV (GPS)-E has been overlaid on the plot.

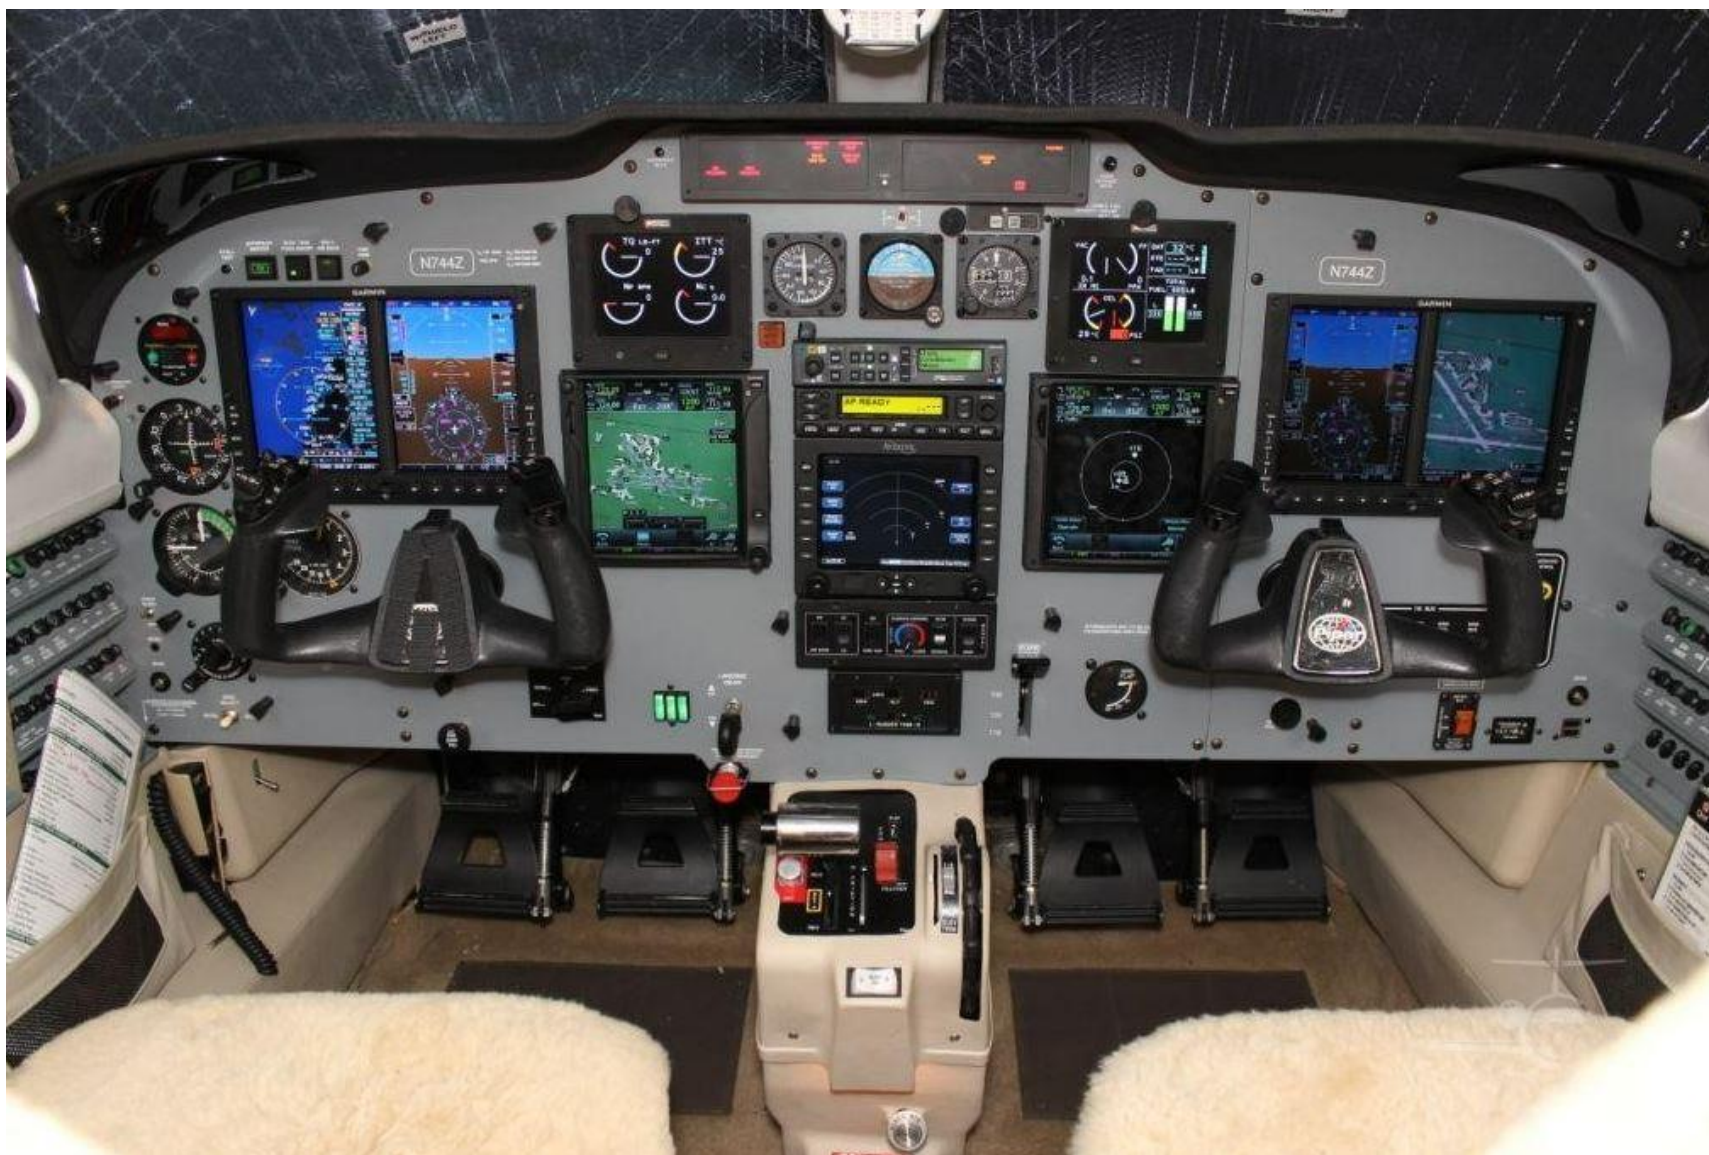
Figure 22 is a photograph of the accident aircraft's instrument panel as described in an undated sales listing. The advertisement states, "New dual Garmin 500 glass package New pilot side synthetic vision."

**Figure 23.** The instrument panel of N744Z. The photo was taken from an online sales posting for the accident aircraft was undated. The sales listing advertised *"New dual Garmin 500 glass package New pilot side synthetic vision."*
