## **NATIONAL TRANSPORTATION SAFETY BOARD**

### **Specialist's Factual Report**

# **METEOROLOGY**

CEN22FA145

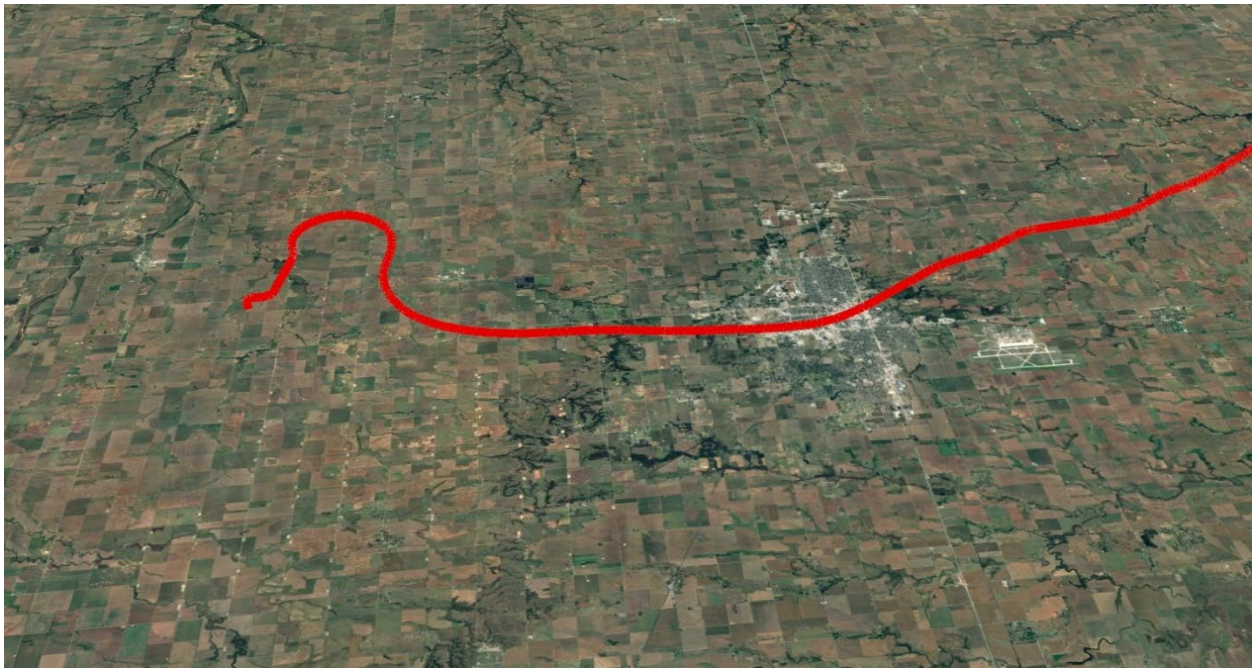
**Figure 4** - Accident aircraft flight path without weather radar data depicted.

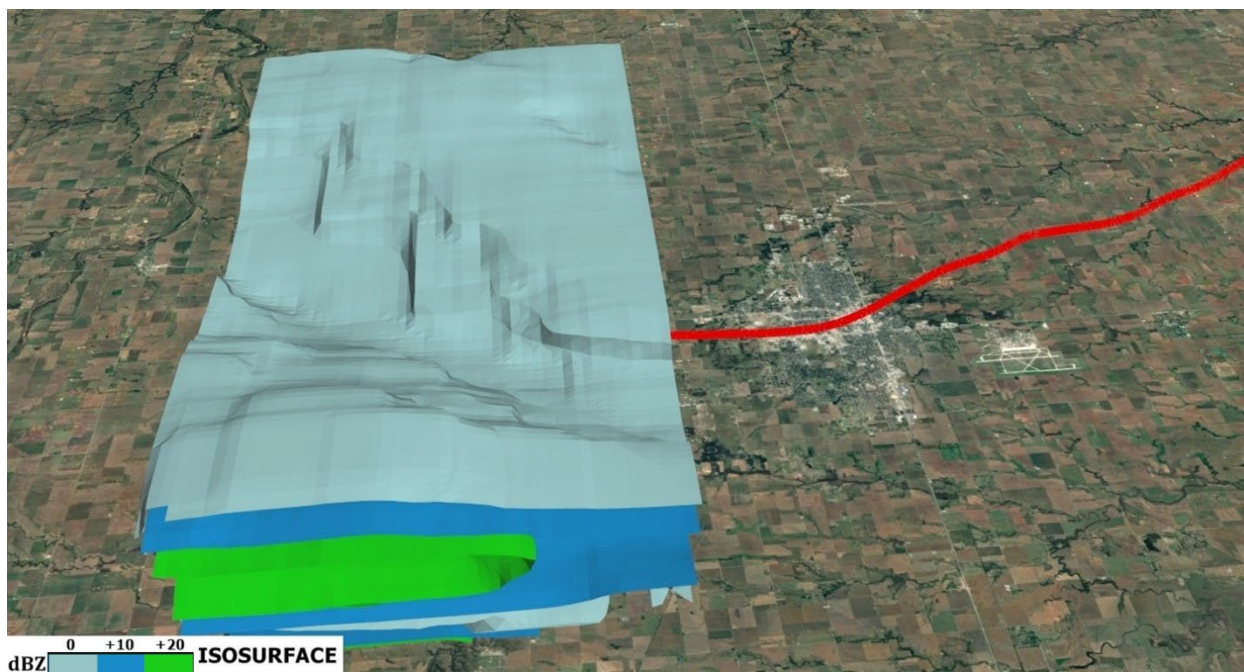
**Figure 6** - Accident aircraft flight path with 3D 0, +10 and +20 dBZ isosurfaces overlaid.

Figures 5-7 present a 3D “volume” of KRGX radar data<sup>7</sup> from about 1635 CDT, which considers all tilts available. The isosurfaces depicted are 0, +10 and +20 dBZ, which would generally identify light values of precipitation or suspended hydrometeors. The volumes presented in figures 5-7 do not explicitly depict cloud boundaries. Generally speaking, reflectivity values (expressed in units of dBZ) express the amount of transmitted power returned to the radar receiver after hitting objects, as compared to a reference power density. According to these figures, the entire portion of the flight that occurred within the inspected volume of radar data took place within the 0 dBZ volume, and a portion of that did occur within the +10 dBZ volume.
