# National Transportation Safety Board

CEN22FA424

## **METEOROLOGY**

Specialist's Factual Report

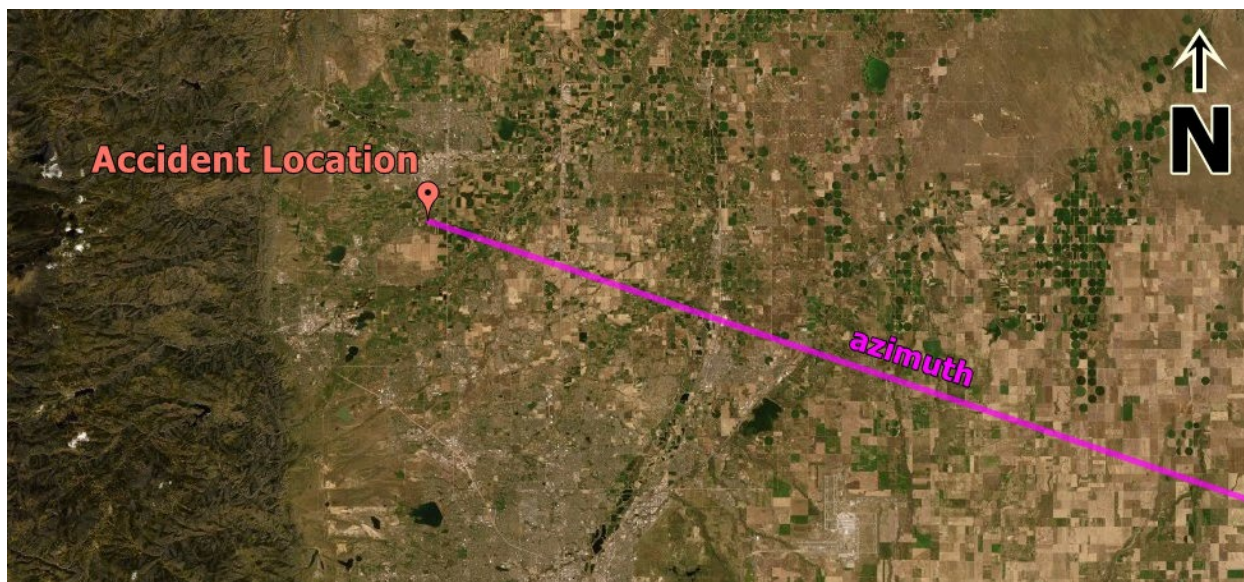
**Figure 1** - Depiction of solar azimuth relative to the accident location.

At the time of the accident and relative to the accident location, the sun was at an azimuth<sup>2</sup> of 108.38° and an elevation<sup>3</sup> of 23.62°. <sup>4</sup>
