# National Transportation Safety Board

CEN22FA433

## **ELECTRONIC DEVICES**

Specialist's Factual Report

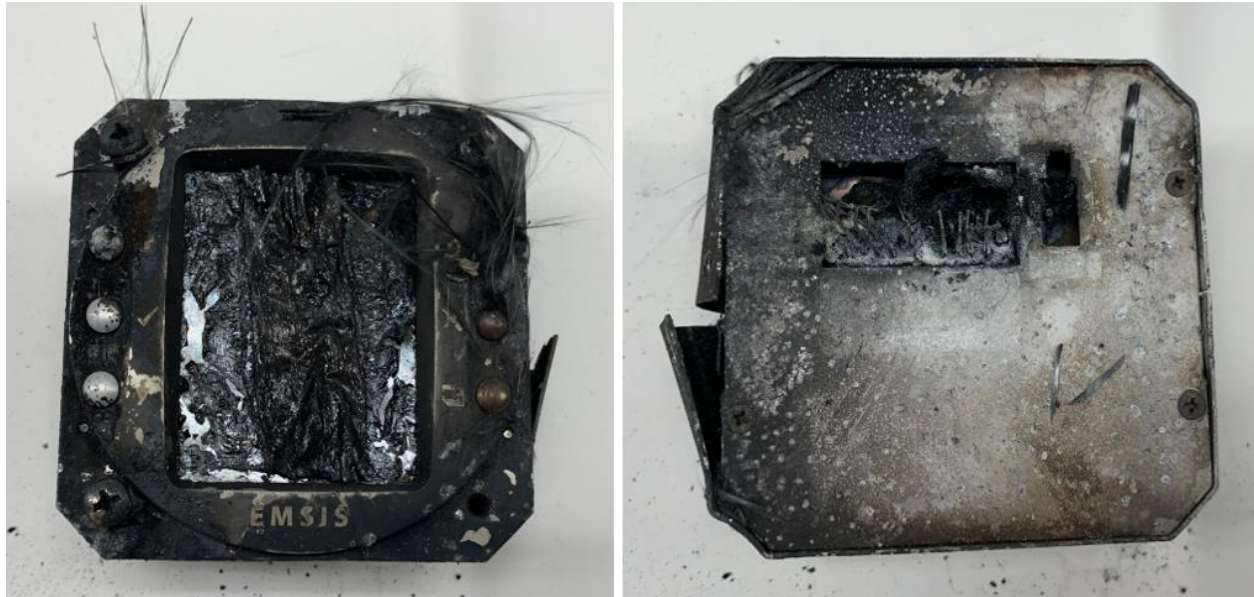
The Kanardia Emsis 80mm had sustained severe fire damage as shown in figures 1 and 2. There was no microSD card presented in the front card slot. The extent of the damage precluded normal and advanced recovery procedures, and

**Figure 1.** Front and back views of the Kanardia Emsis 80mm as received.

additional attempts were unsuccessful in yielding usable data. No data pertinent to the event were recovered.

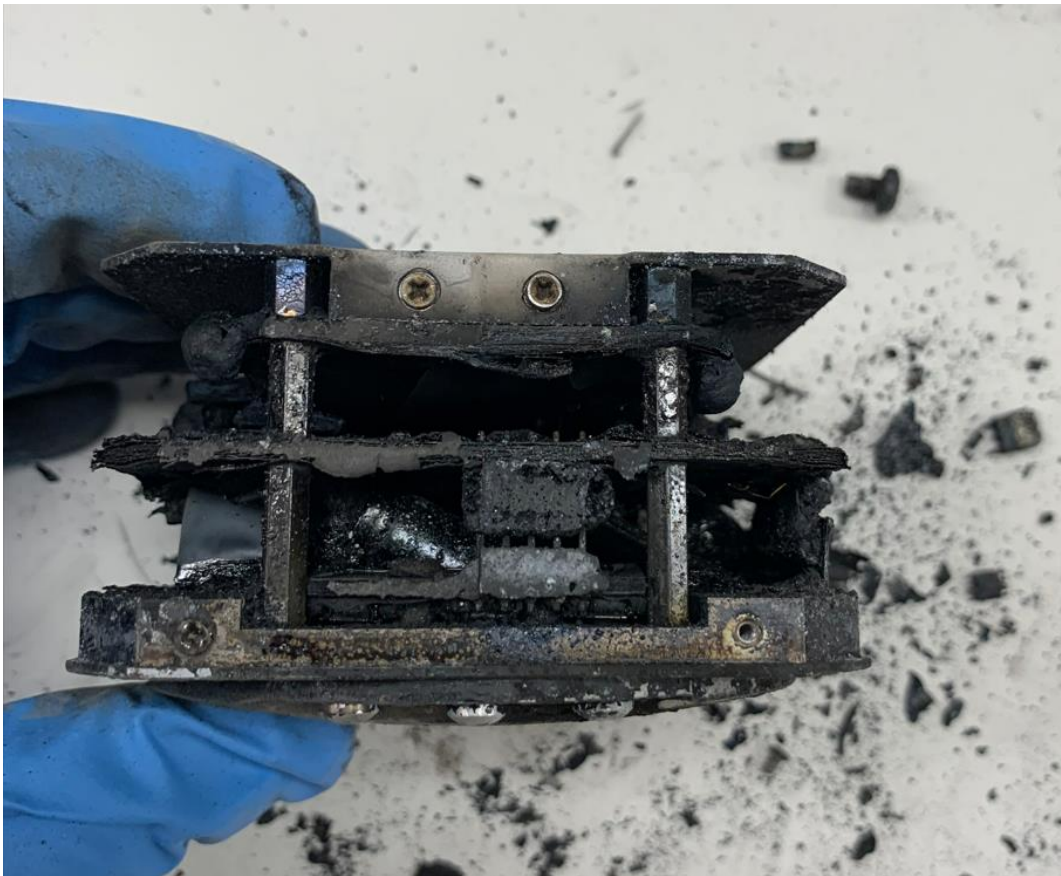
**Figure 2.** Internal view of the Kanardia Emsis 80mm as received.

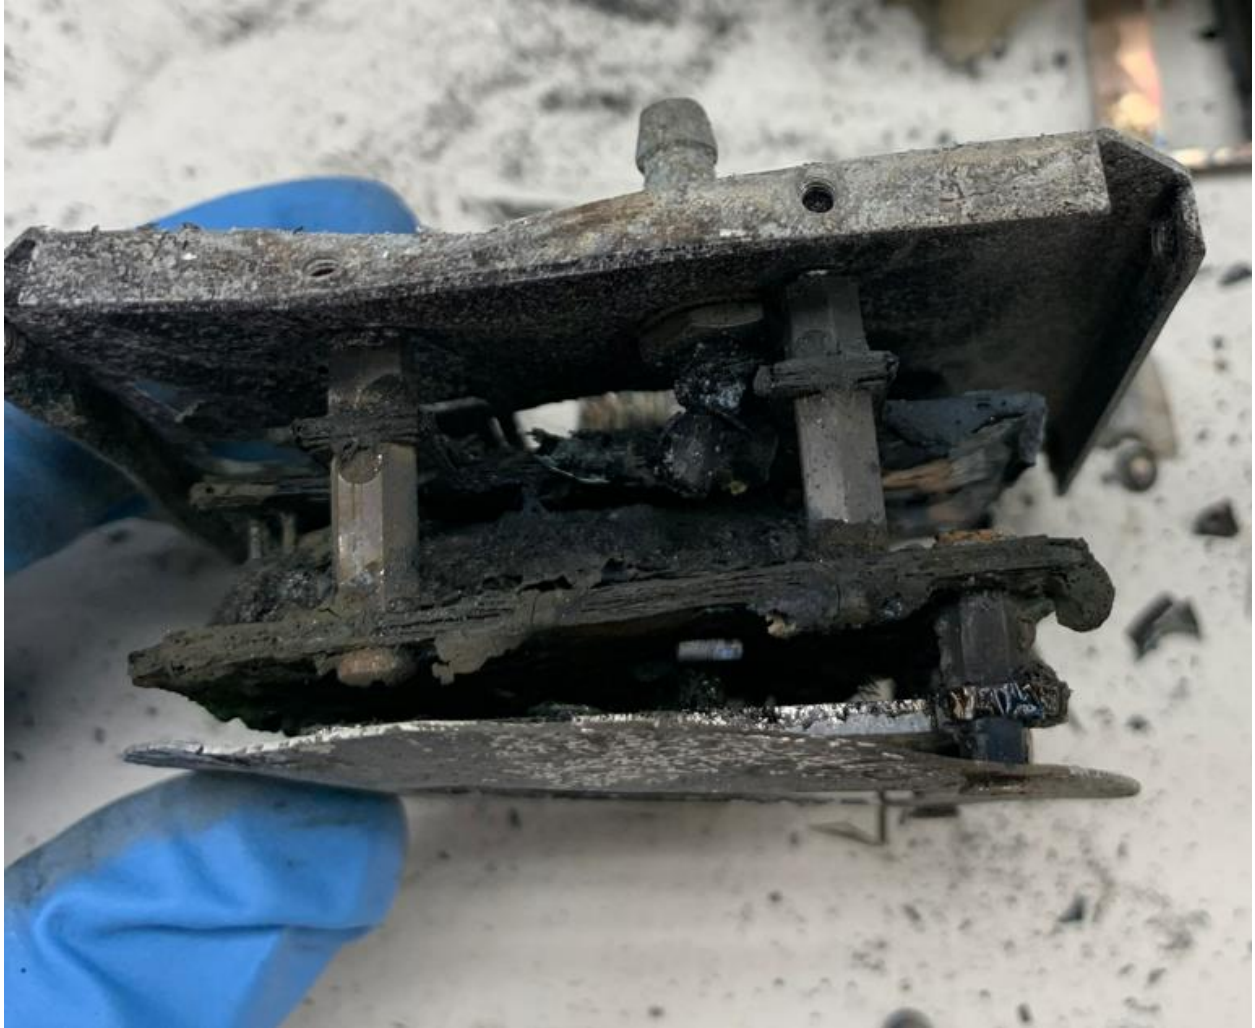
The unknown VSI had sustained severe fire damage, as shown in figures 3 and 4. The extent of the damage precluded normal and advanced recovery procedures, and additional attempts were unsuccessful in yielding usable data. No data pertinent to the event were recovered.

**Figure 4.** Internal view of the unknown VSI as received.
