**From:** Budinski Michael  
**Sent:** Wednesday, October 6, 2021 4:48 PM  
**To:** Fox Todd  
**Subject:** CEN22LA004, Watkins, CO, Cessna 195B (N3027B) Materials Laboratory Email Report  
**Attachments:** CEN22LA004 Left Main Landing Gear Leg Fracture.jpg

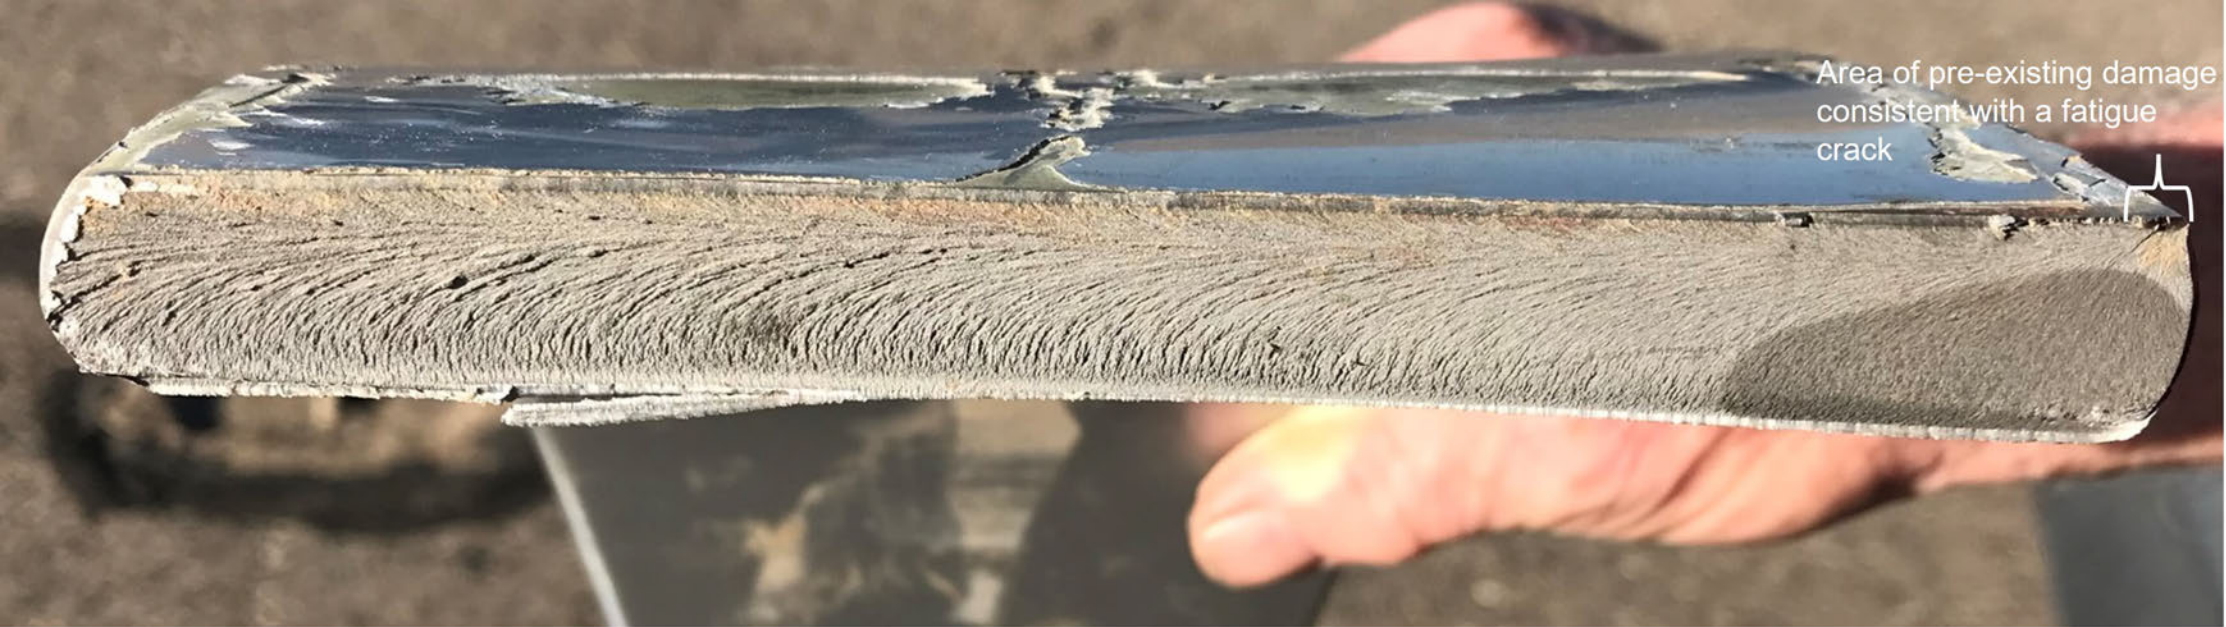
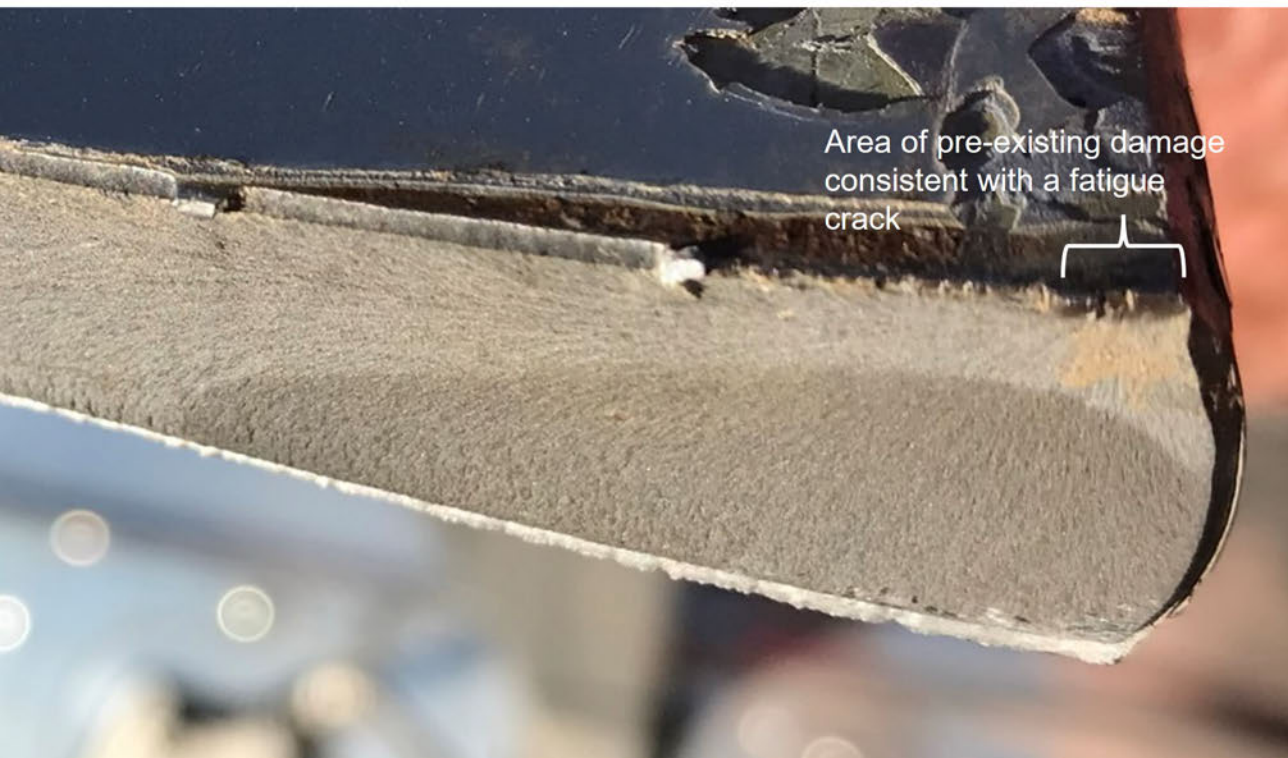
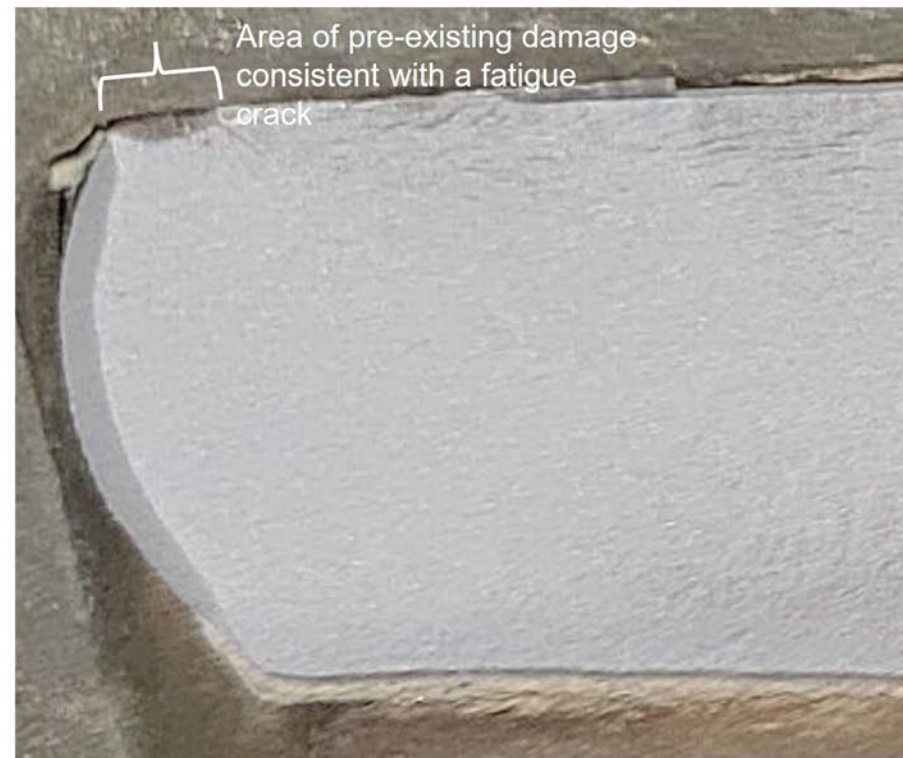
Based on photographic evidence (see attached images) only, a small thumbnail-shaped crack is present in the upper forward portion of the left main landing gear leg adjacent to the fuselage. The oxidation and general morphology of the thumbnail-shaped crack is consistent with a pre-existing fatigue crack. The balance of the fracture surface on the landing gear leg exhibits chevron features and shear lips along the upper and lower edges, consistent with instantaneous overstress fracture.
