# NATIONAL TRANSPORTATION SAFETY BOARD

## Cockpit Display – Recorded Flight Data

Specialist's Factual Report

Location: Montrose, Colorado  
Date: January 2, 2022  
Aircraft: Zenith CH750  
Registration: N750DP  
Operator: Private  
NTSB Number: CEN22LA093

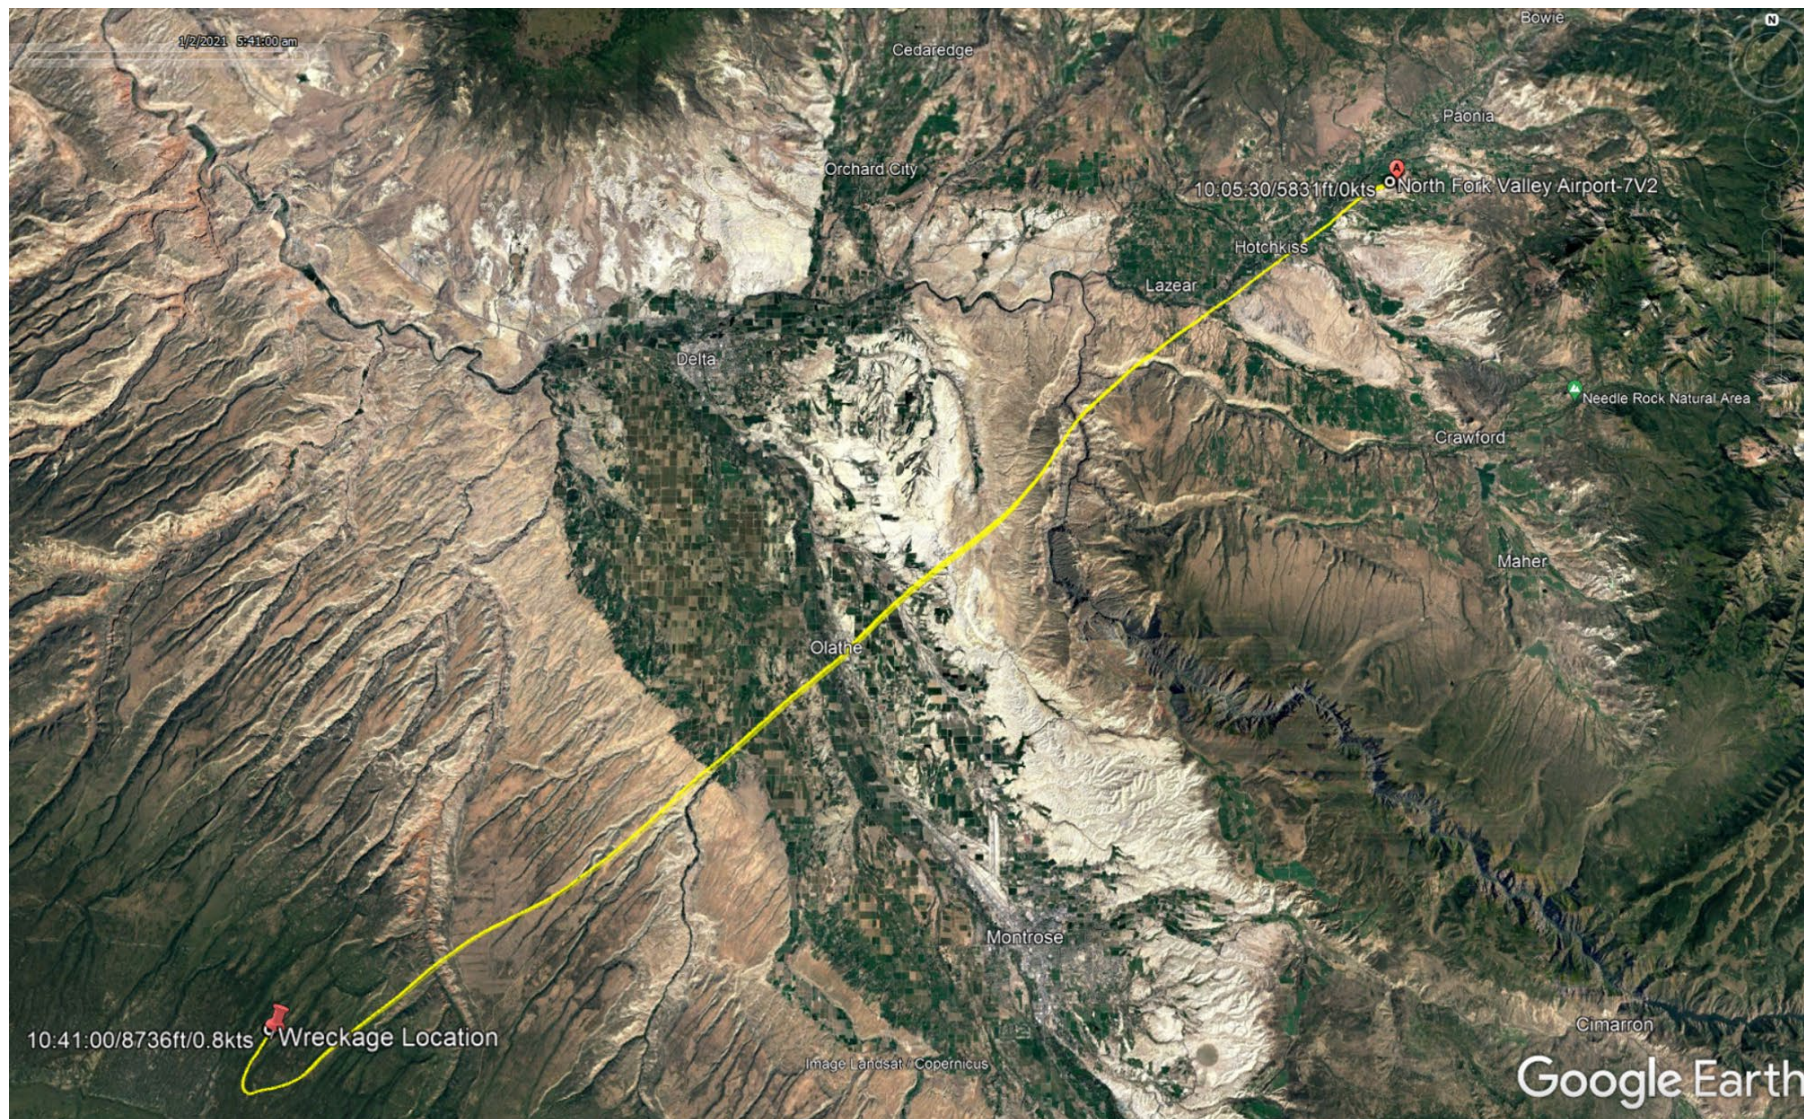
Figure 7: Google Earth overlay of the entire event flight.

Figure 7 is a Google Earth overlay of the entire event flight. The weather and lighting conditions in Google Earth are not necessarily the weather and lighting conditions present at the time of the recording.

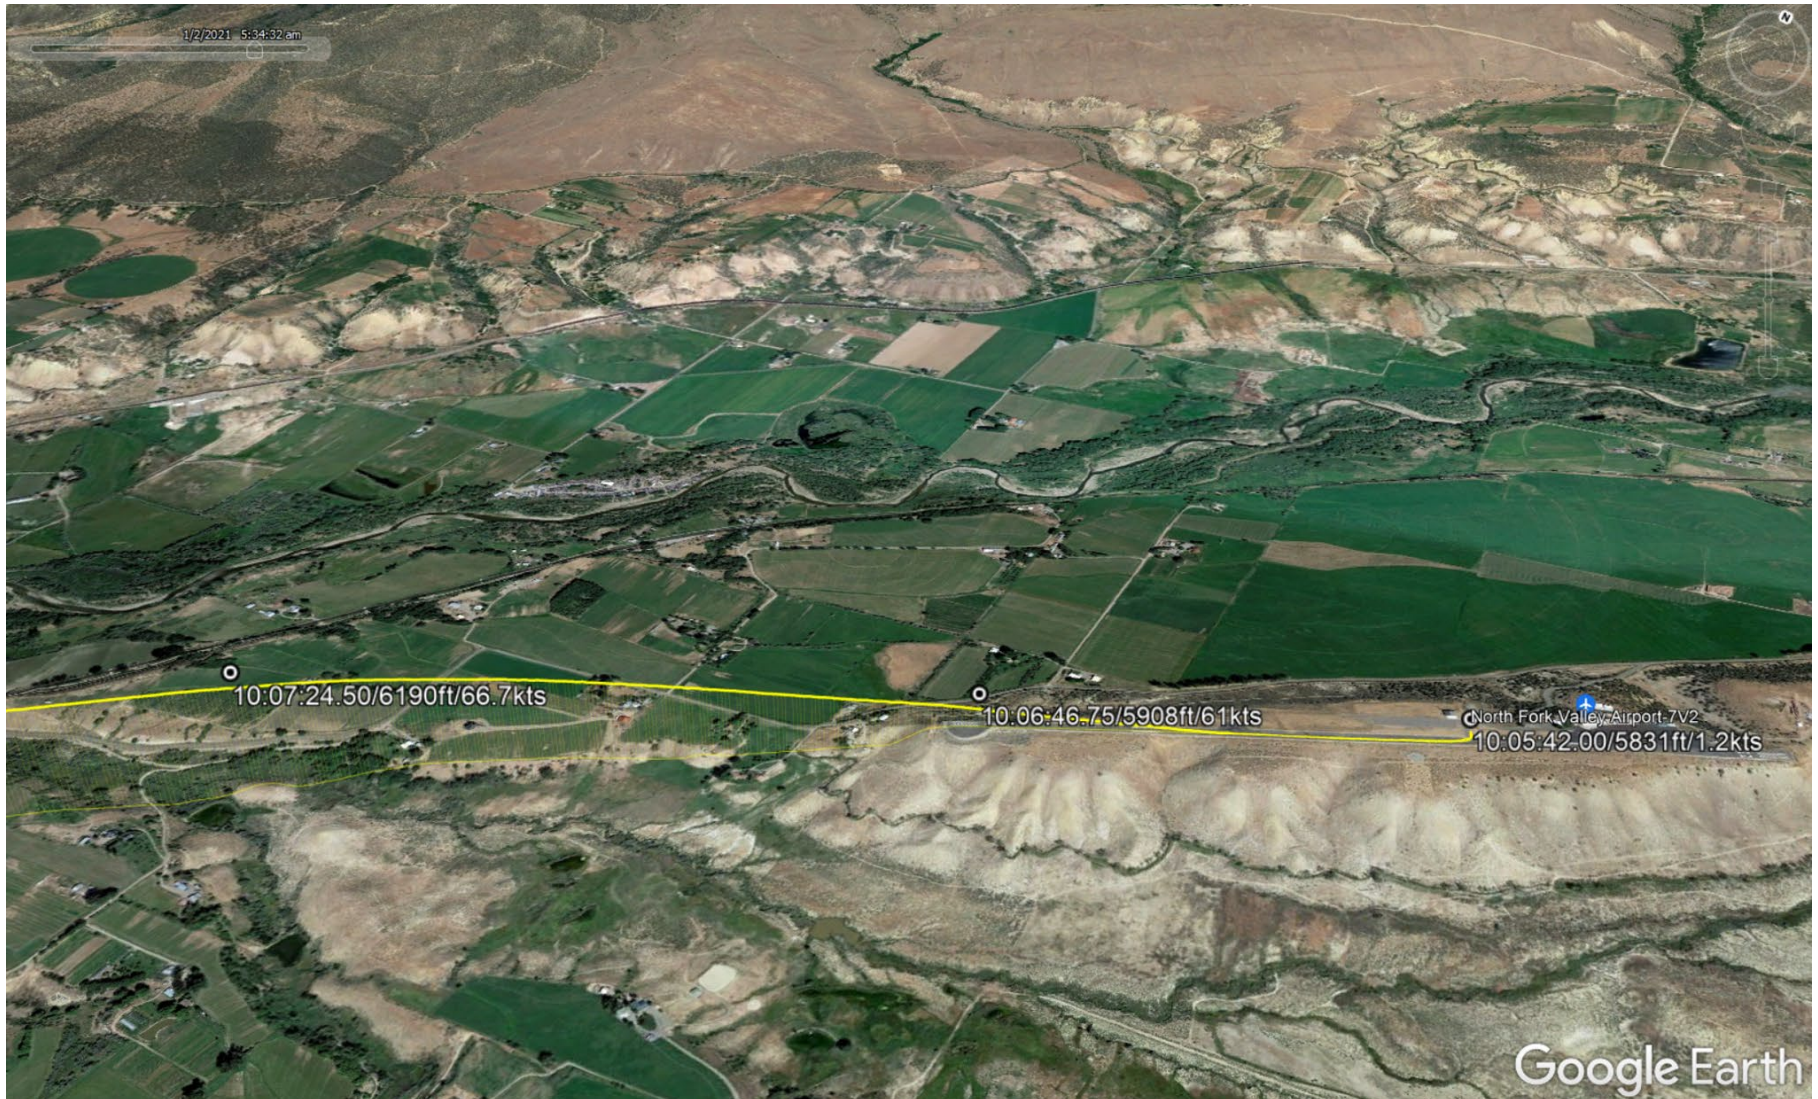
Figure 8: Google Earth overlay showing the takeoff portion of the event flight.

Figure 8 is a Google Earth overlay of the beginning of the flight. It shows the aircraft took off at the North Fork Valley Airport (7V2) at around 10:05:00 MST.

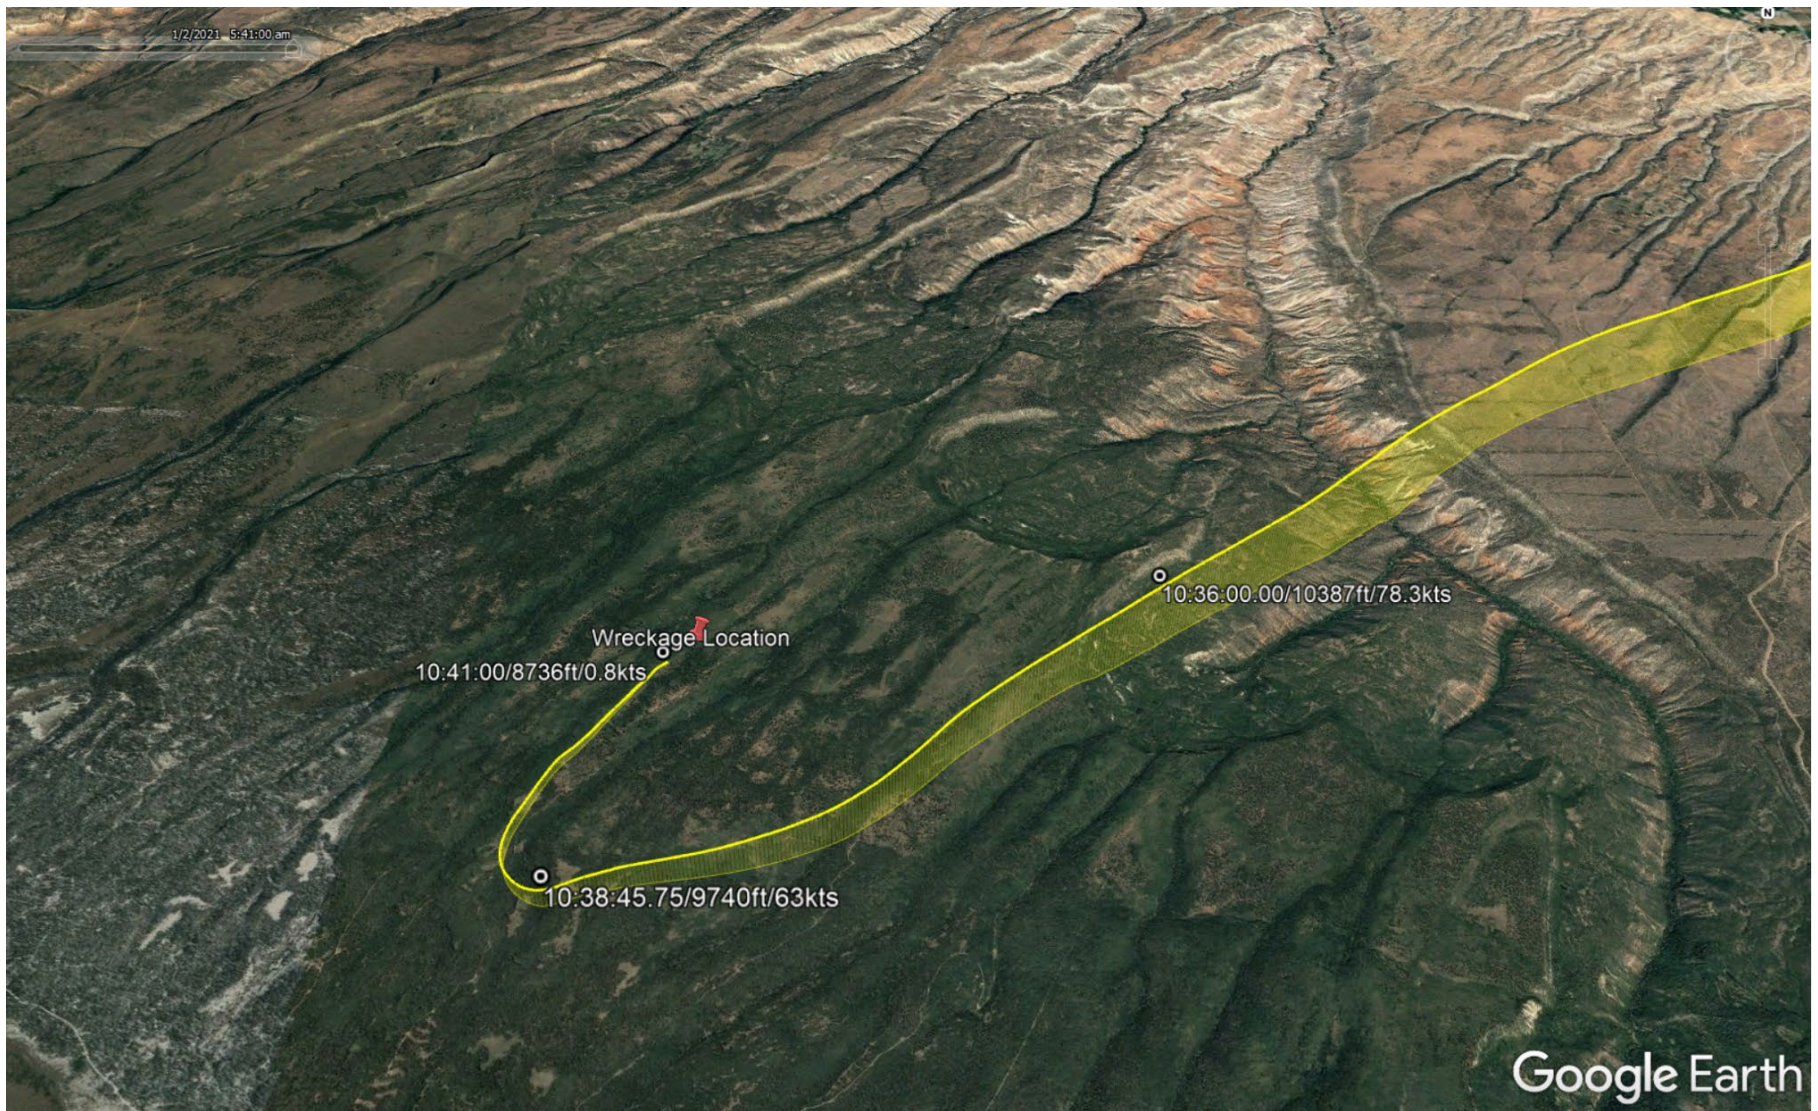
**Figure 9:** Google Earth overlay showing the final portion of the event flight.

Figure 9 is a Google Earth overlay of the final portion of the event flight. The reported wreckage location is shown with a red pin.

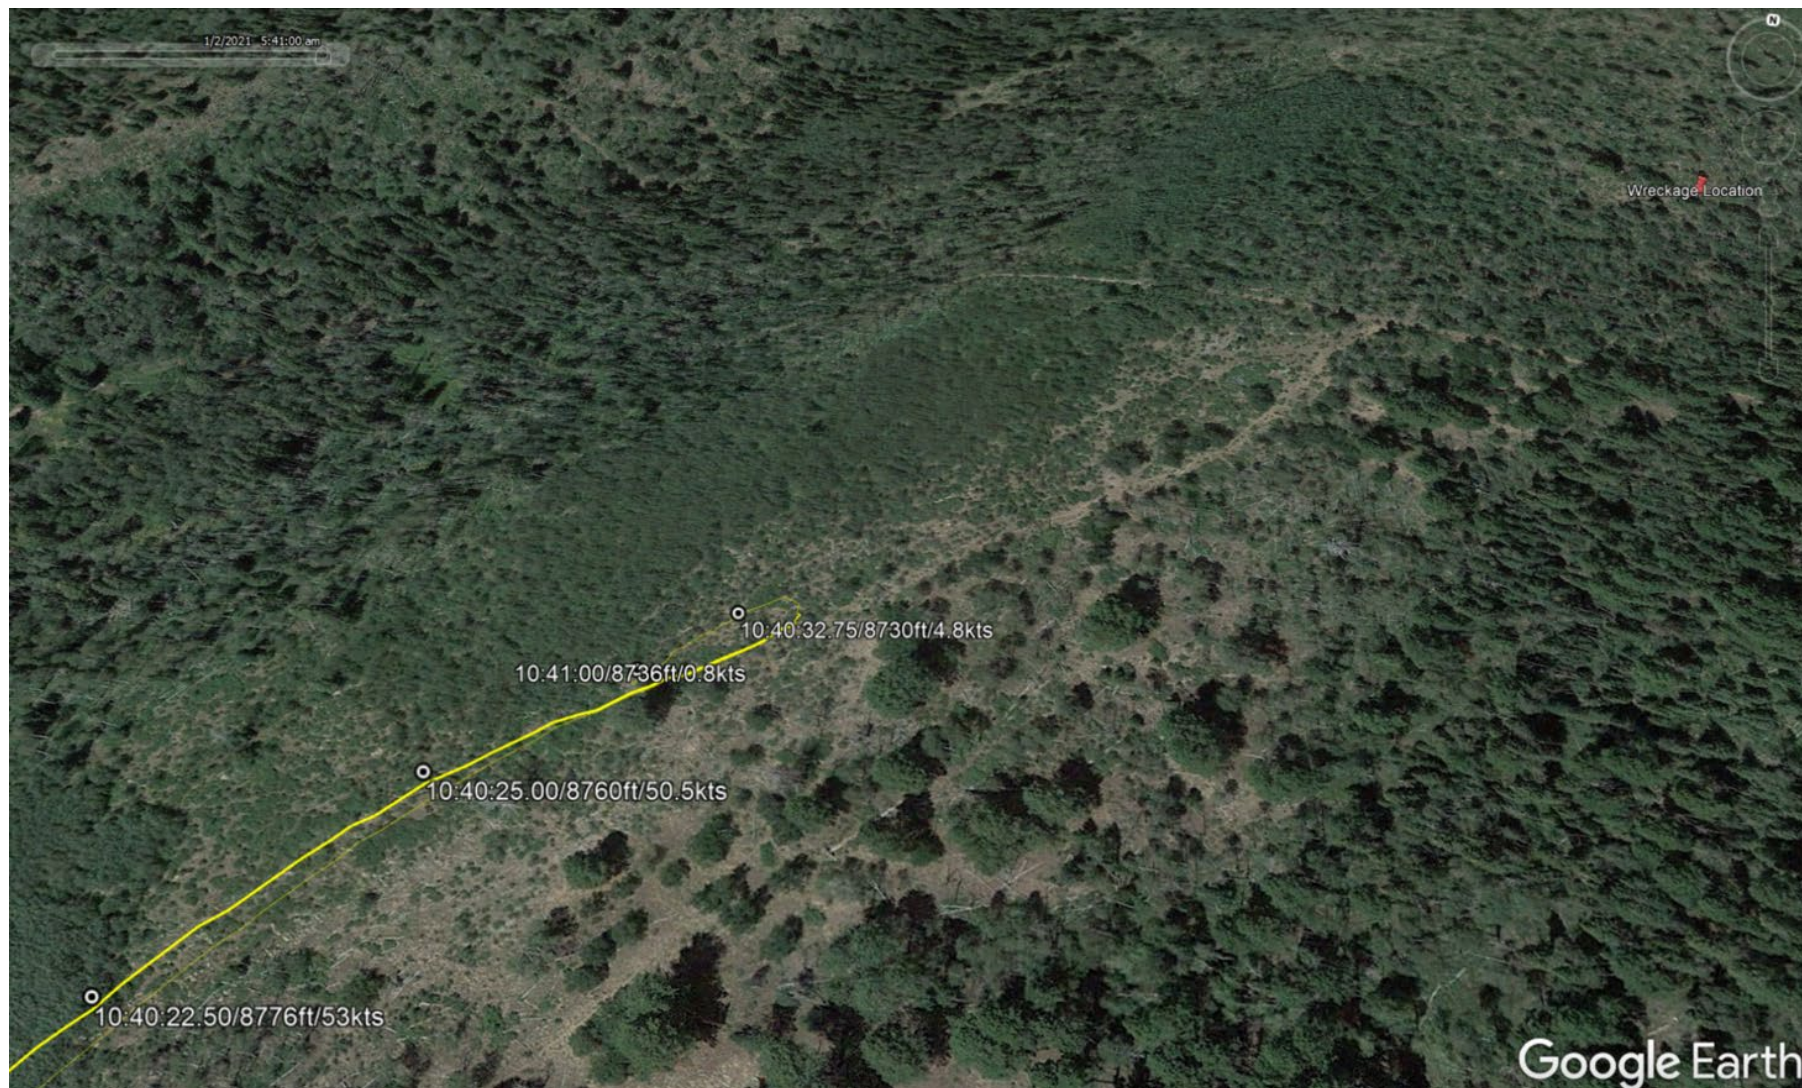
Figure 10: Google Earth overlay showing the final portion of the event flight when zoomed in.

Figures 10 and 11 are Google Earth overlays zoomed in on the final portion of the event flight.
