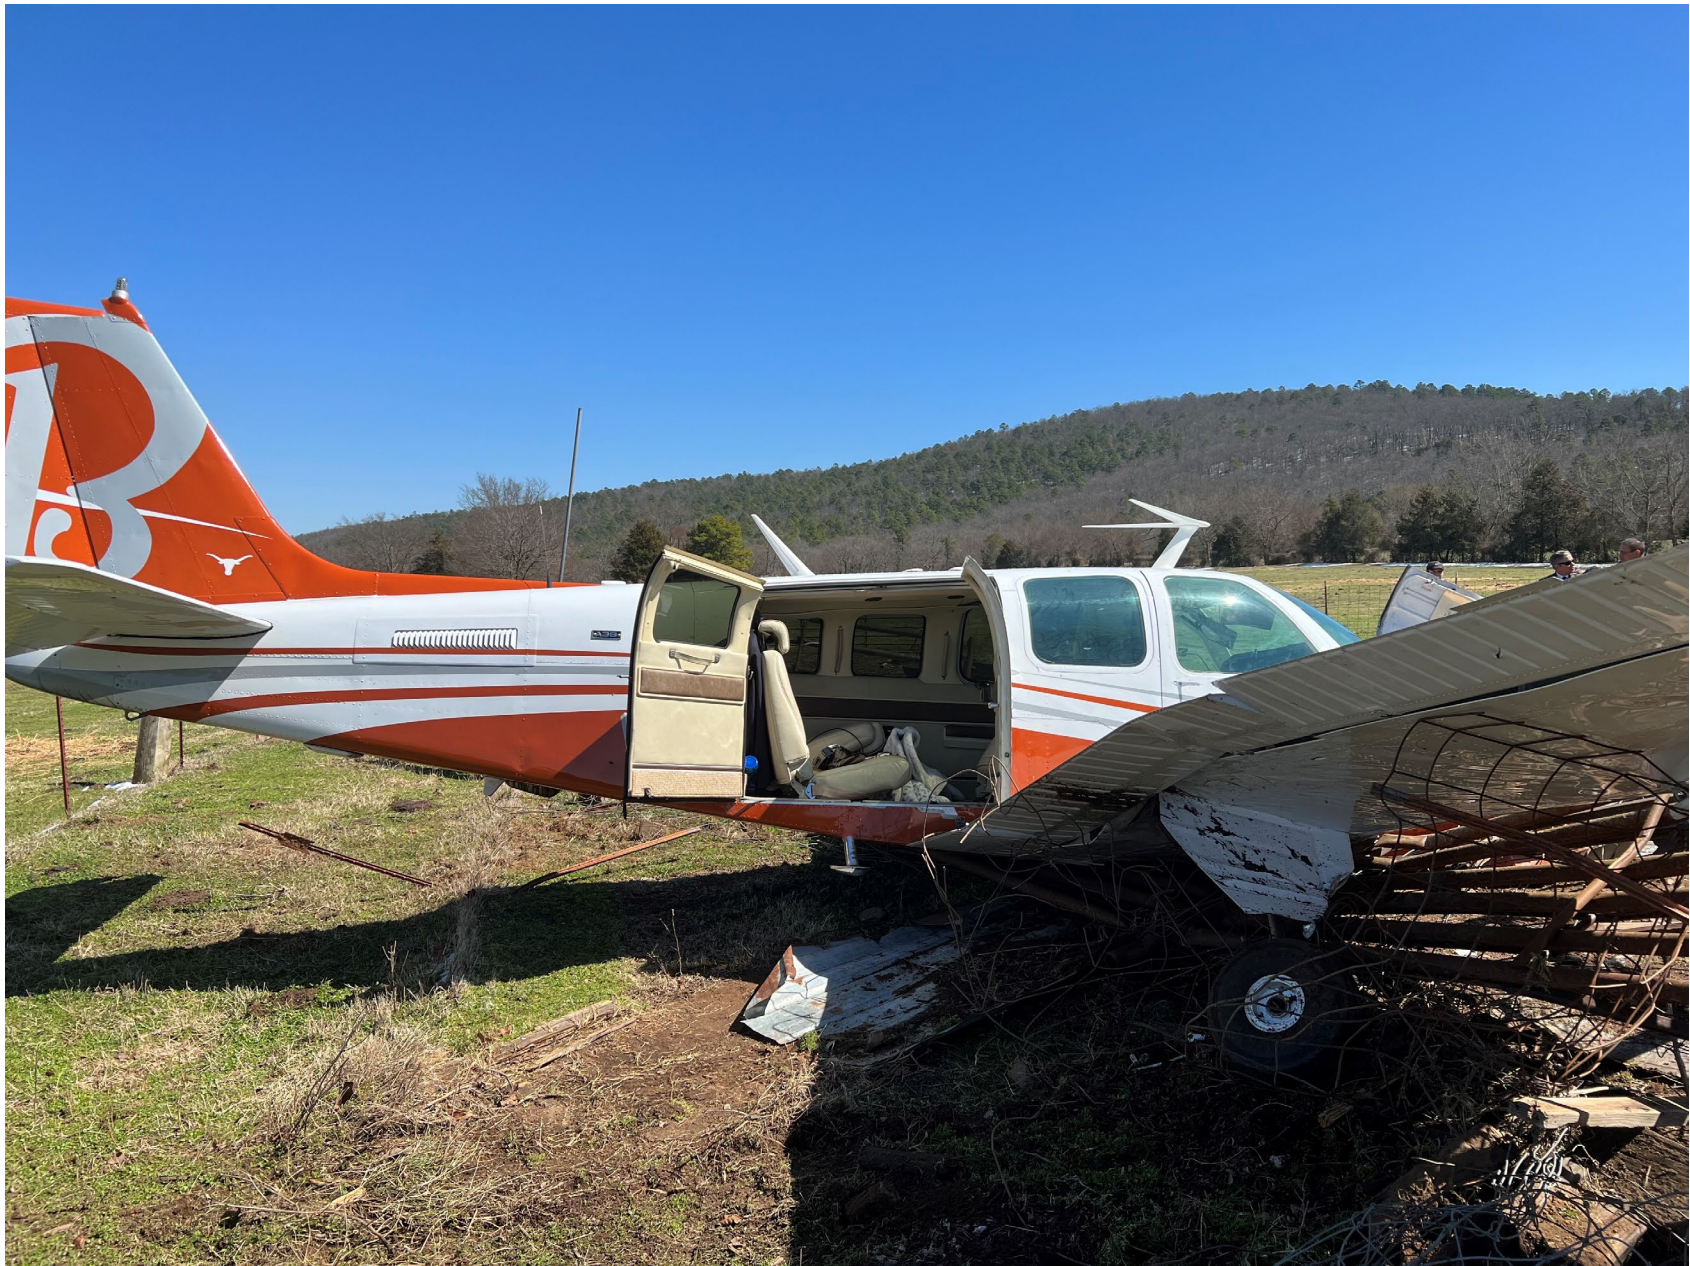
**Photo 1 – View of airplane from right side (FAA Photo)**

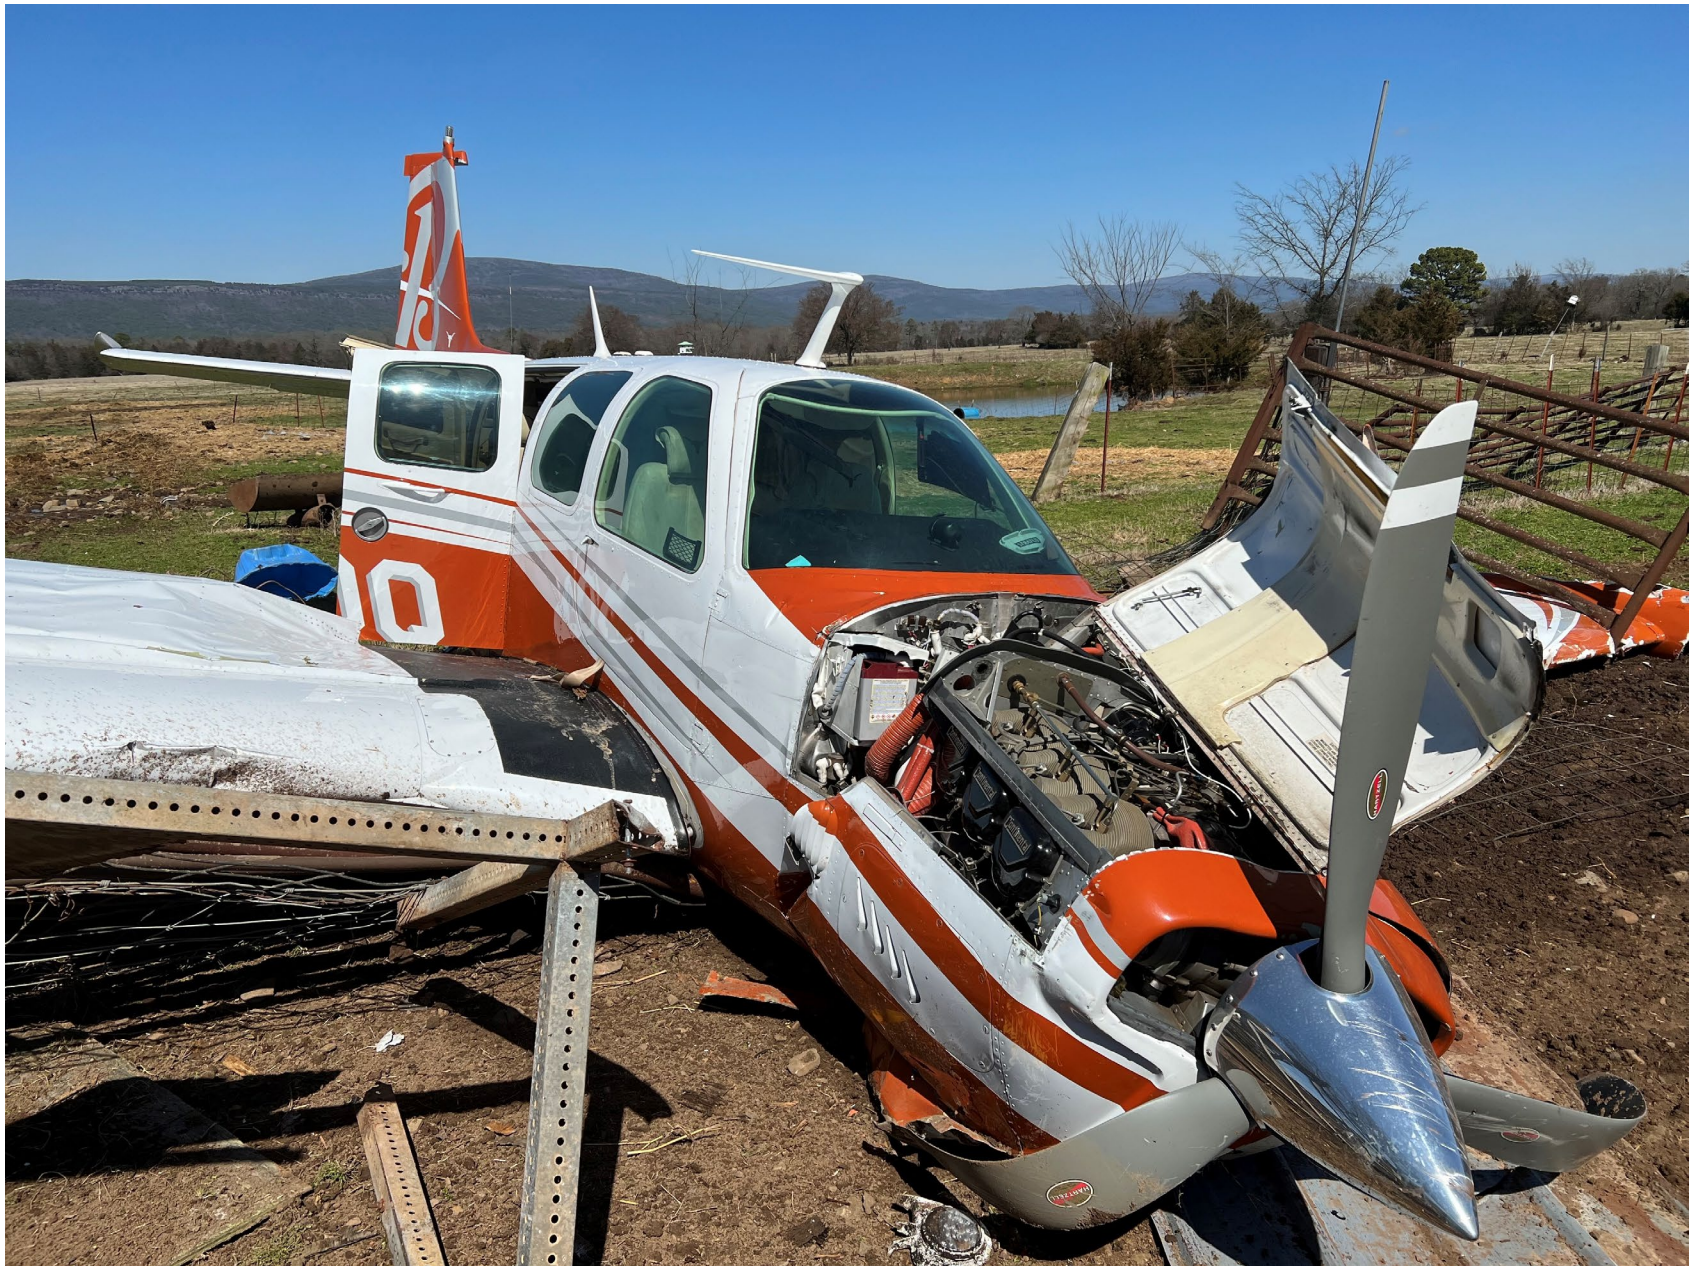
**Photo 2 – View of airplane from front right side (FAA Photo)**

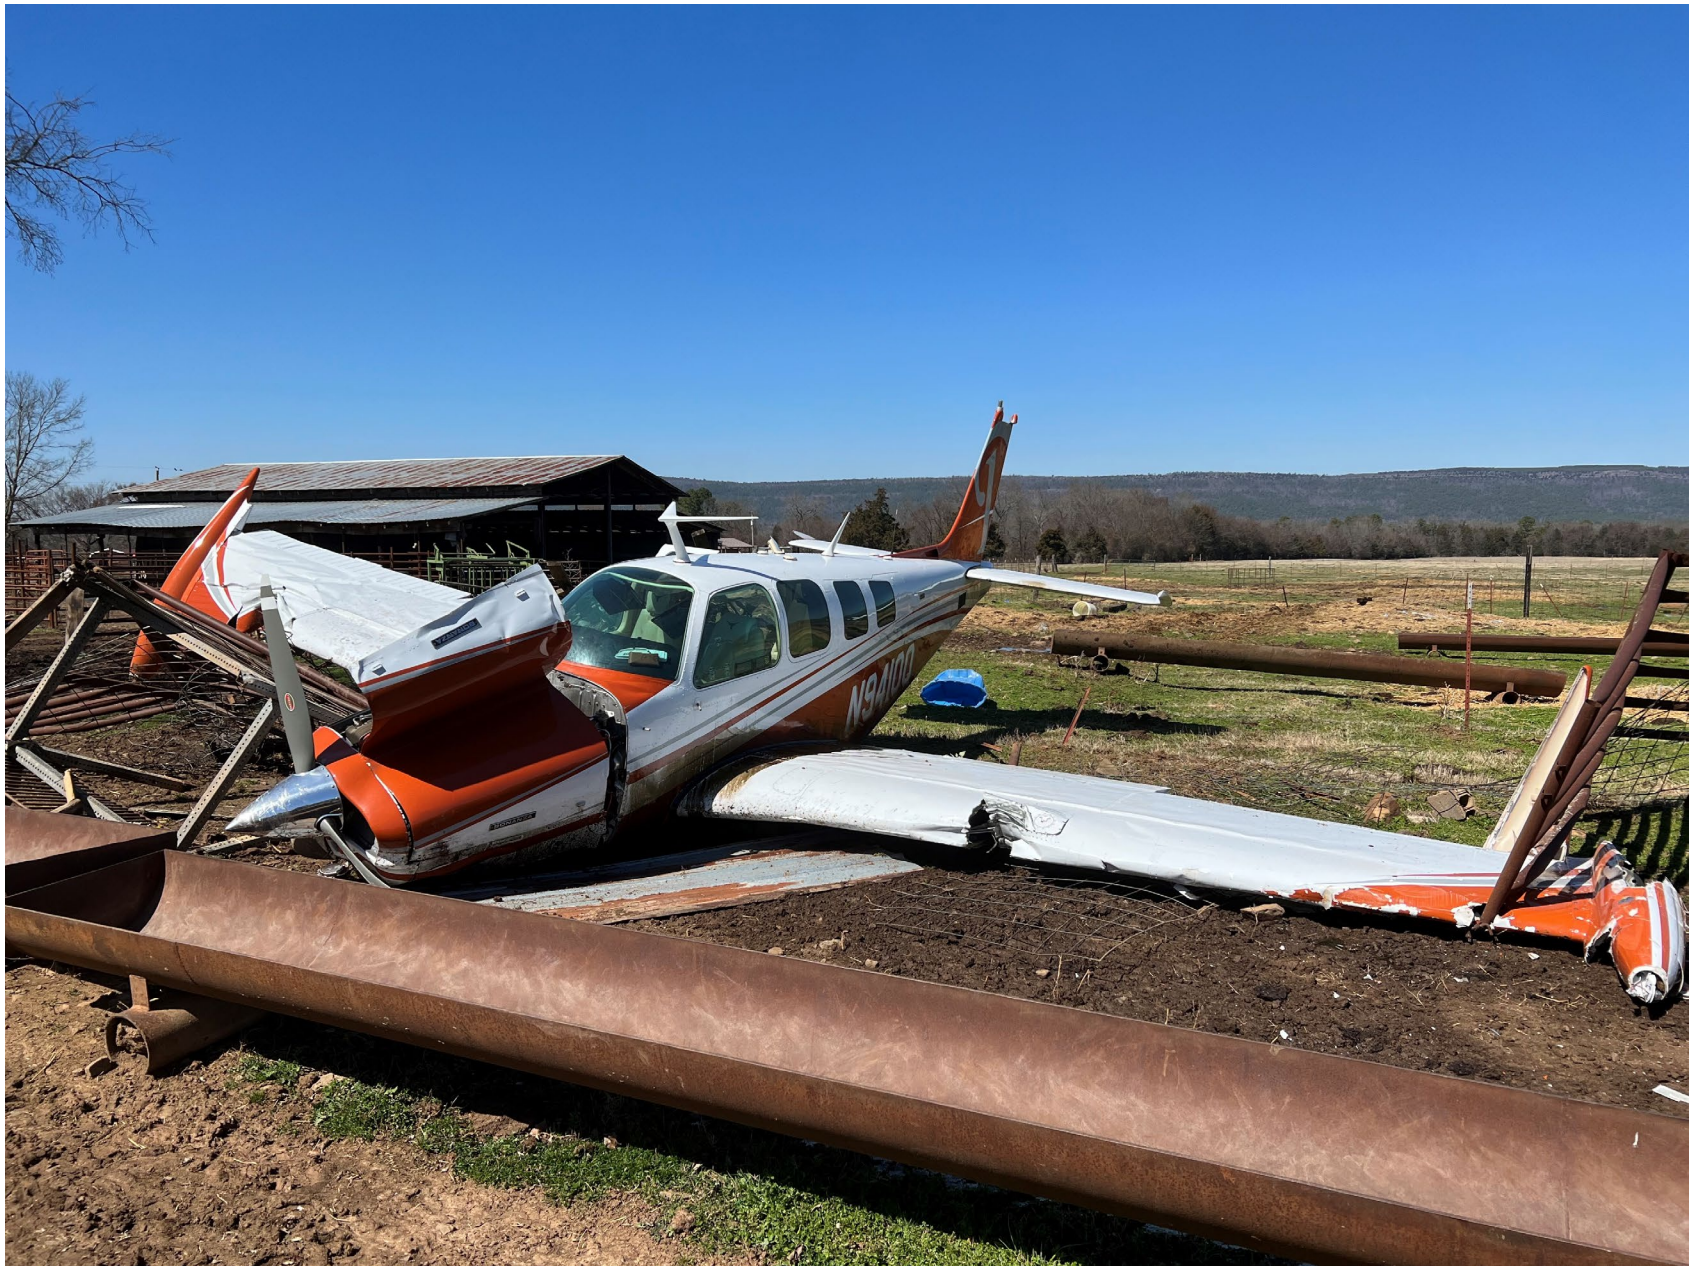
**Photo 3 – View of airplane from front left side (FAA Photo)**

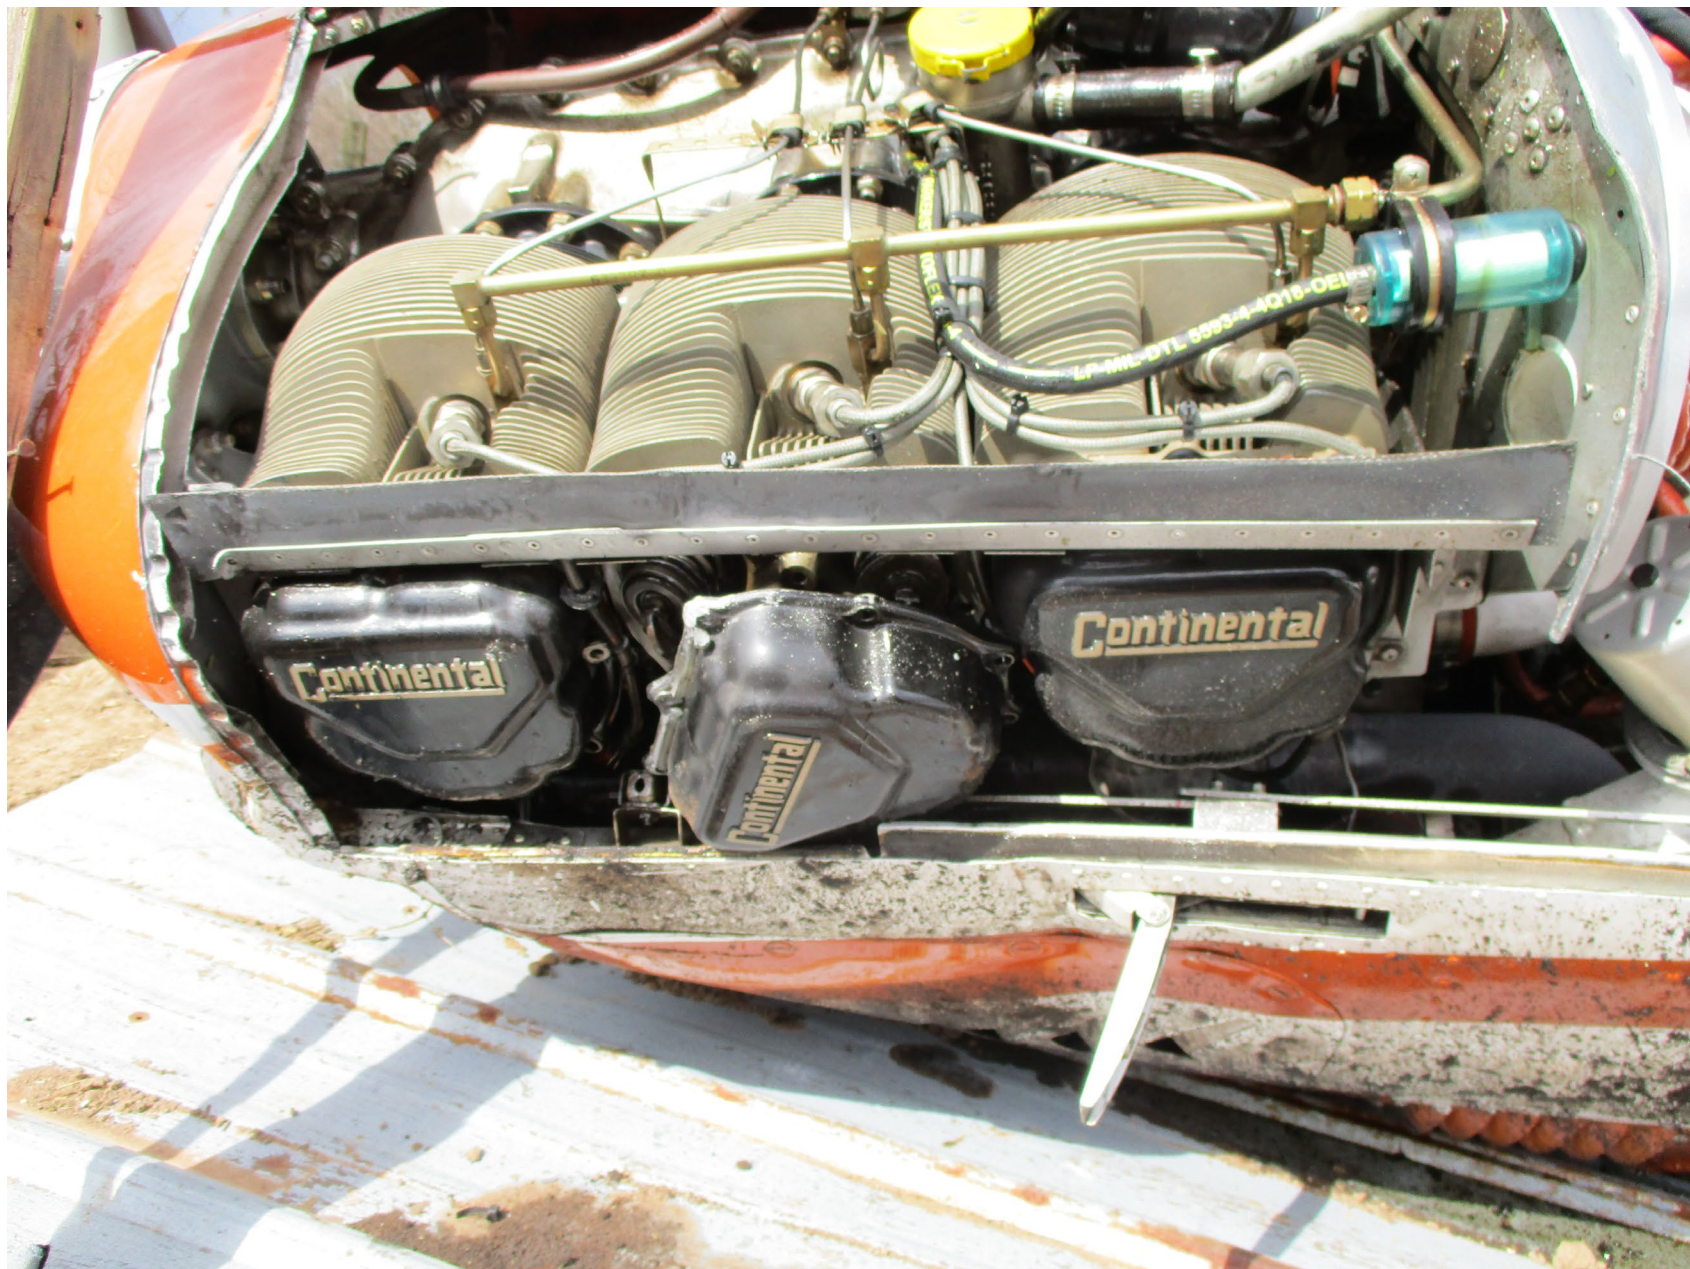
**Photo 4 – View of engine left side showing loose No. 4 rocker cover (FAA Photo)**

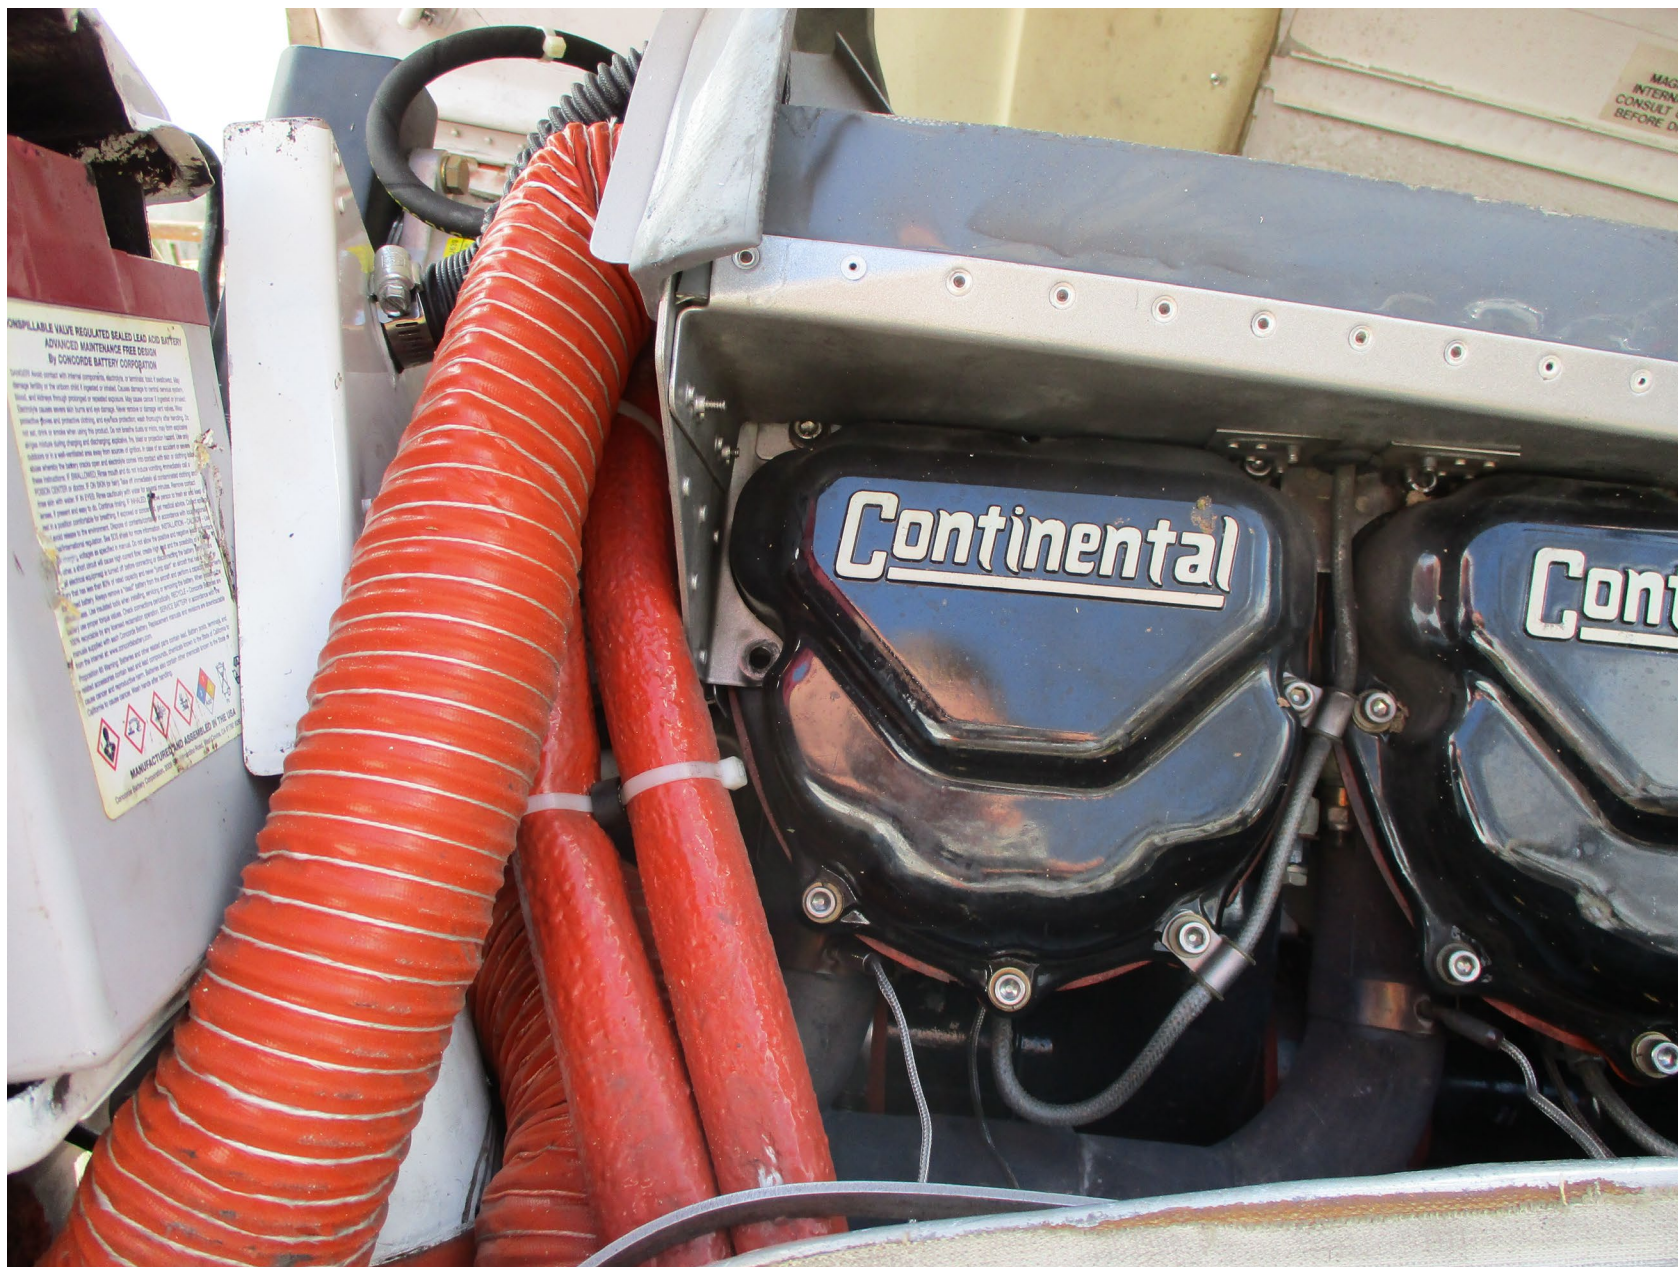
**Photo 5 – View of No. 5 rocker cover showing missing bolt (FAA Photo)**

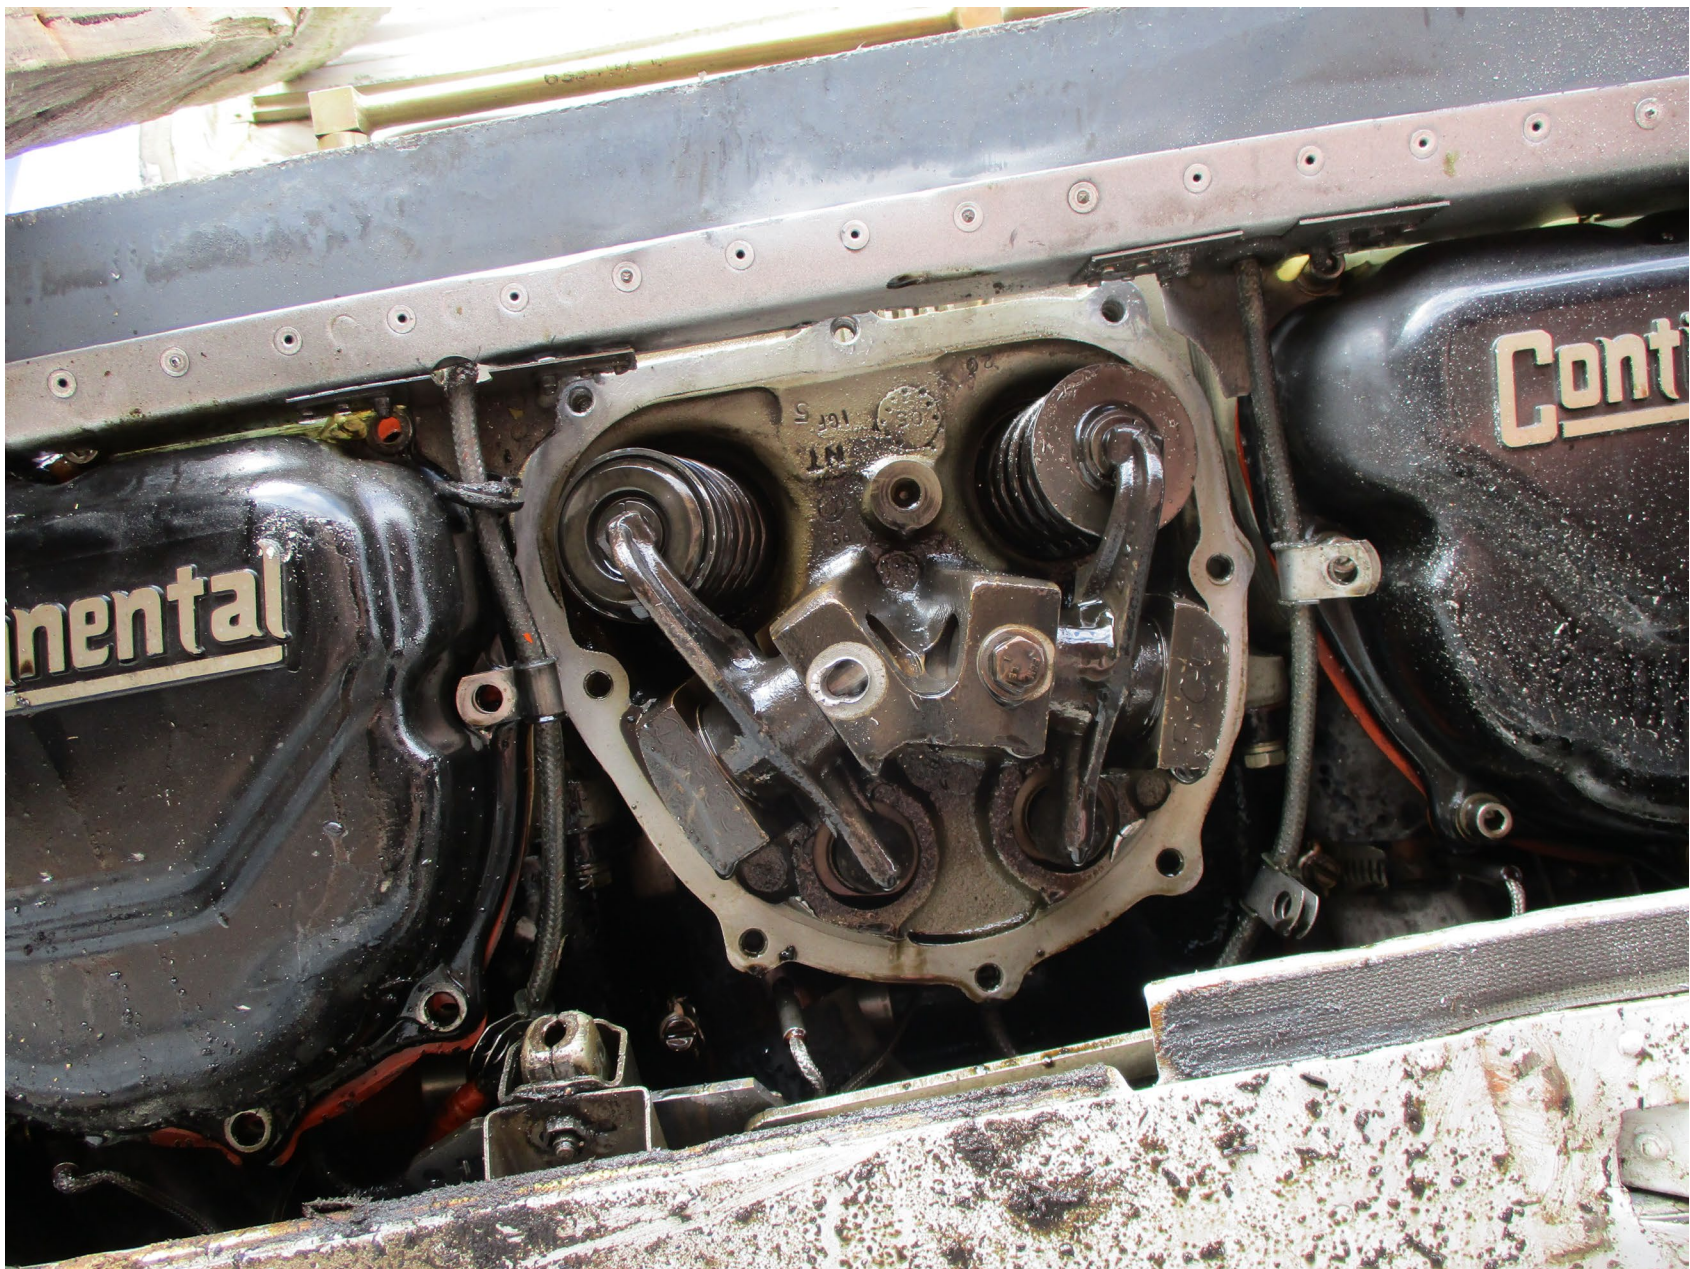
**Photo 6 – View of No. 4 cylinder head (FAA Photo)**

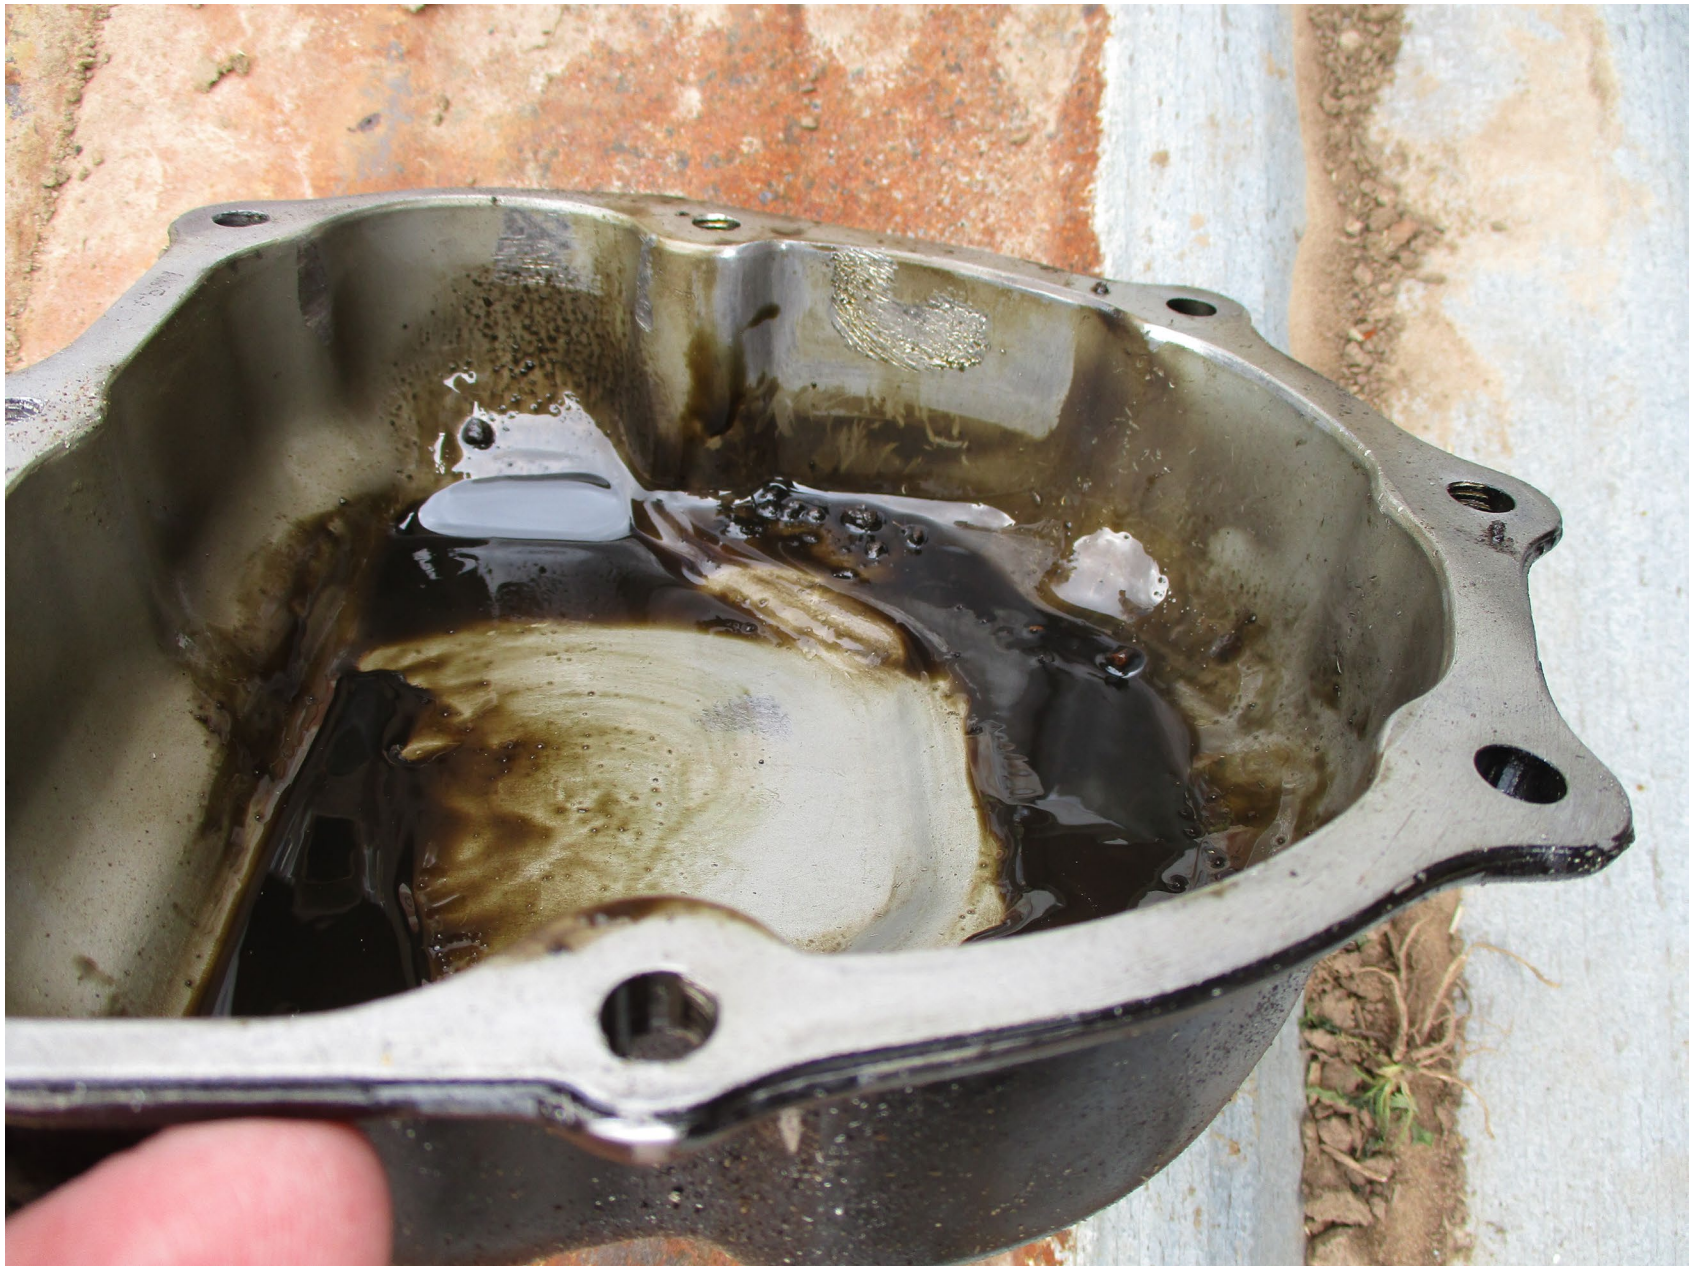
**Photo 7 – Contaminated oil in rocker cover (FAA Photo)**

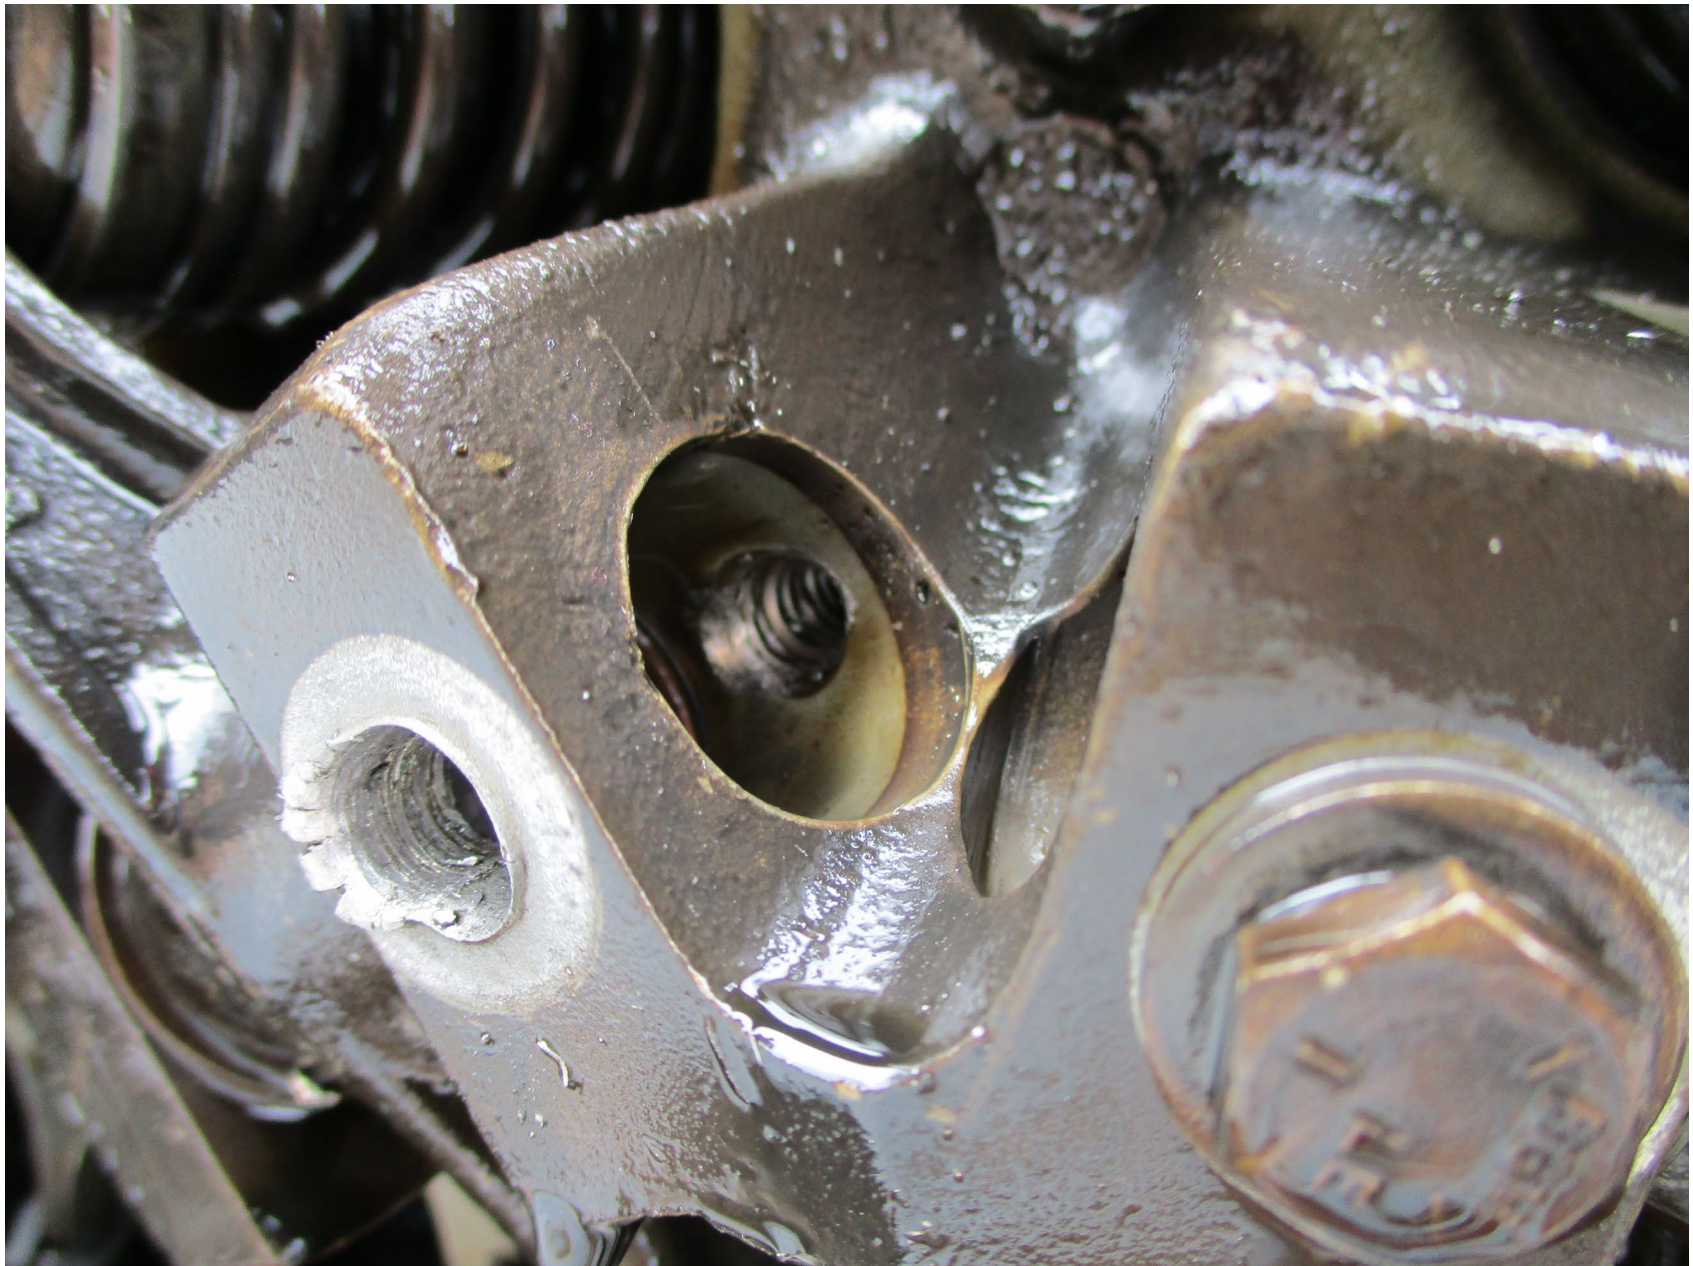
**Photo 8 – No. 4 rocker arm shaft boss (FAA Photo)**
