# National Transportation Safety Board

CEN23FA057

## **AIRCRAFT PERFORMANCE STUDY**

Location:     Cleburne, Texas  
Date:         December 4, 2022  
Time:         20:56 central standard time  
                  02:56 UTC (December 5, 2022)  
Airplane:     Cessna 210-5 (205), N8149Z

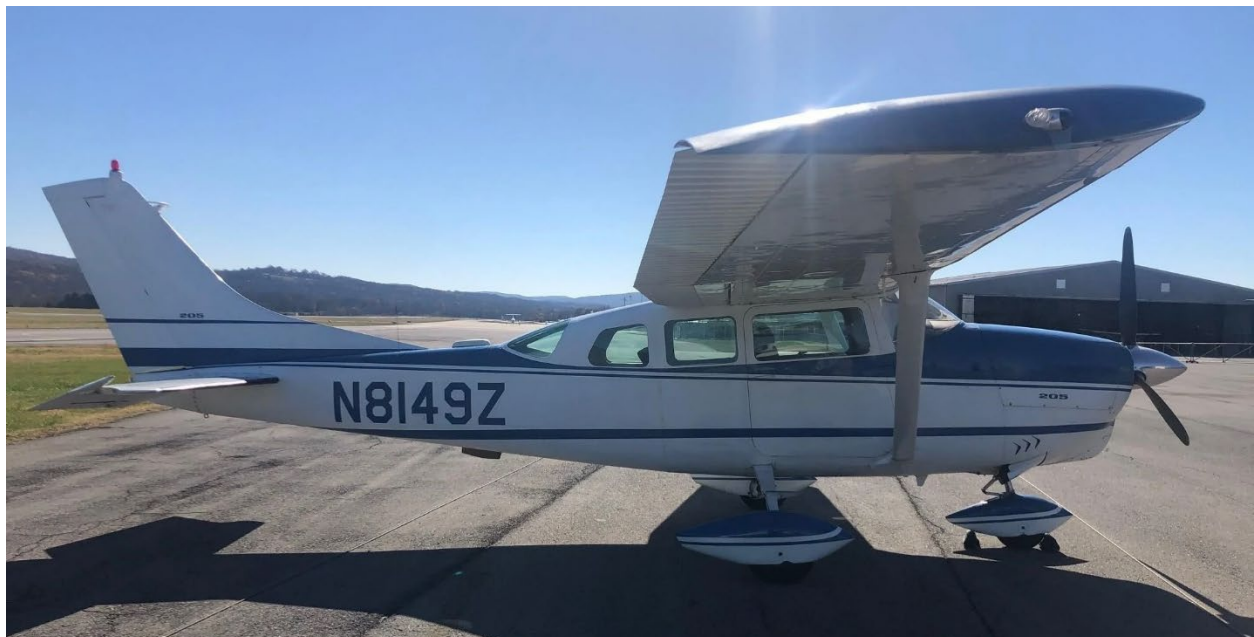
Figure 1. The accident airplane, N8149Z, a Cessna 210-5 (205).

The airplane was a Cessna 210-5, also known as a Cessna 205, a high-wing, single-engine airplane with fixed landing gear that seats six. Figure 1 is a photograph of the accident airplane, which was manufactured in 1962.

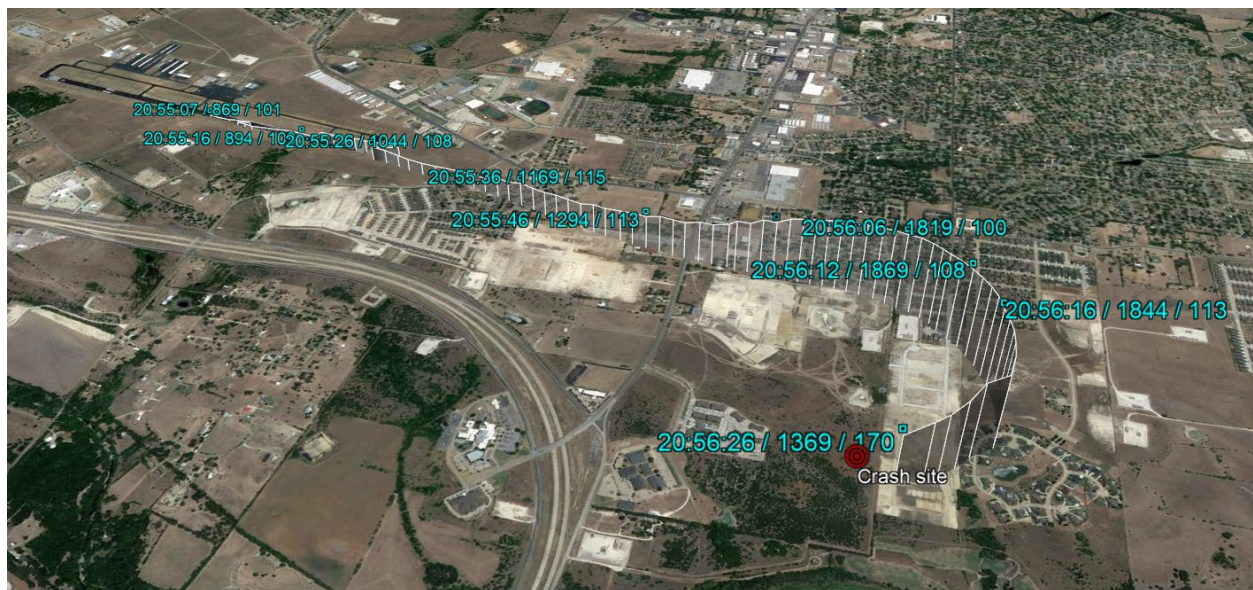
Figure 2 shows a Google Earth image of the flight path using the GNSS position data and the GNSS altitude corrected to msl. Points are annotated with the time, altitude msl and calculated calibrated airspeed in kts. The crash site was reported as 32.323764° North, 97.431479° West.

The first ADS-B data point was at 20:55:06. Based on the GNSS altitude corrected to msl and the reported overcast ceiling at 300 ft agl, the airplane entered the clouds at about 20:55:35. The airplane reached a maximum rate of climb of about 1,900 ft/min at 20:55:53, and reached a maximum altitude of about 1,870 ft msl at 20:56:13, after which it began to descend steeply, reaching a descent rate of over 11,000 ft/min. The airplane's ground track was generally aligned with the extended centerline of the runway until 20:56:00, when it began a right turn that averaged about 6°/s until the data ended.

Figure 2. Google Earth image of the flight path, with selected times, msl altitude and calibrated airspeeds indicated.
