# National Transportation Safety Board

CEN23FA142

## **ELECTRONIC DEVICES**

Location: Port Allen, Louisiana  
Date: March 26, 2023  
Time: 02:38 central daylight time (CDT)  
Helicopter: Robinson R44 II, Baton Rouge Police Department, N441PD

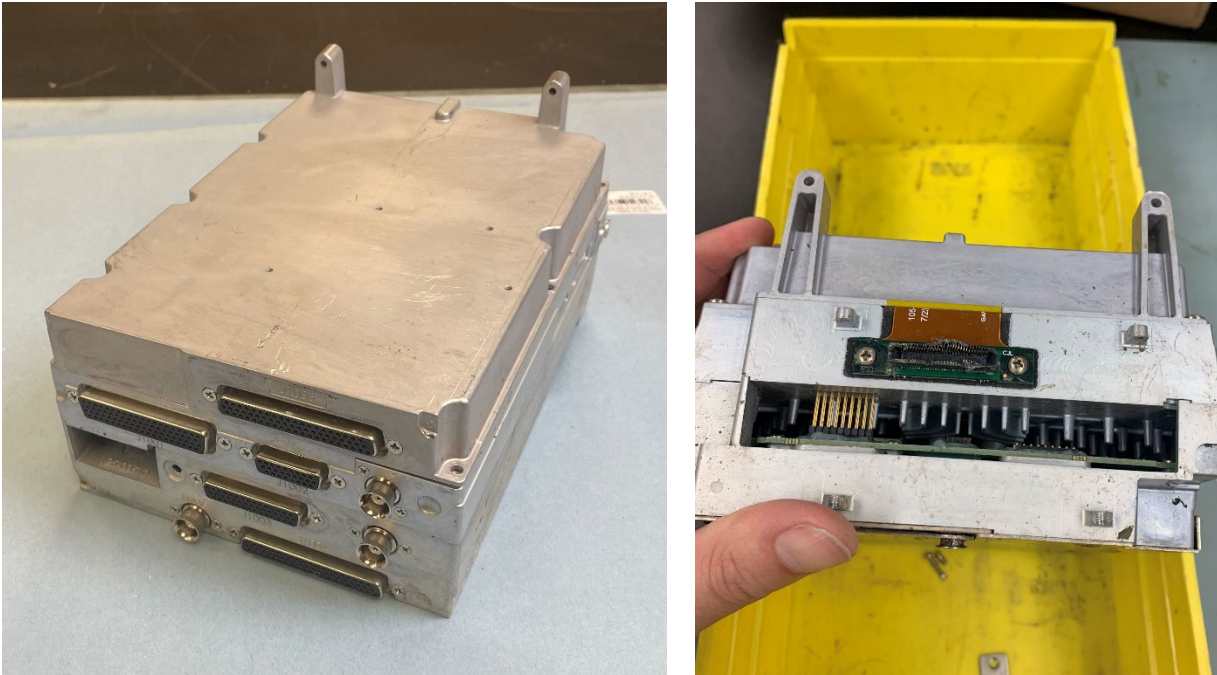
The Garmin GTN 750Xi arrived without a display and minor exterior damage, as shown in figure 1. The device was opened, the circuit boards were examined, and it was determined that the device did not contain an internally mounted SD card.

**Figure 1.** Garmin GTN 750Xi, as received. Rack-mounted computer unit (left) and damage to display connector (right).

Due to the minor damage, missing display, and lack of an internally mounted SD card, the manufacturer was contacted for additional support. The manufacturer indicated that the GTN 750Xi has an eMMC chip on the main circuit board that stores limited GPS data, but no AHRS or ADC data.<sup>2</sup>

After consultation with the Investigator-in-Charge, it was determined that due to the existence of ADS-B data for the accident, further recovery attempts of the data contained on the GTN 750Xi would not be pursued. No data were recovered from the device.

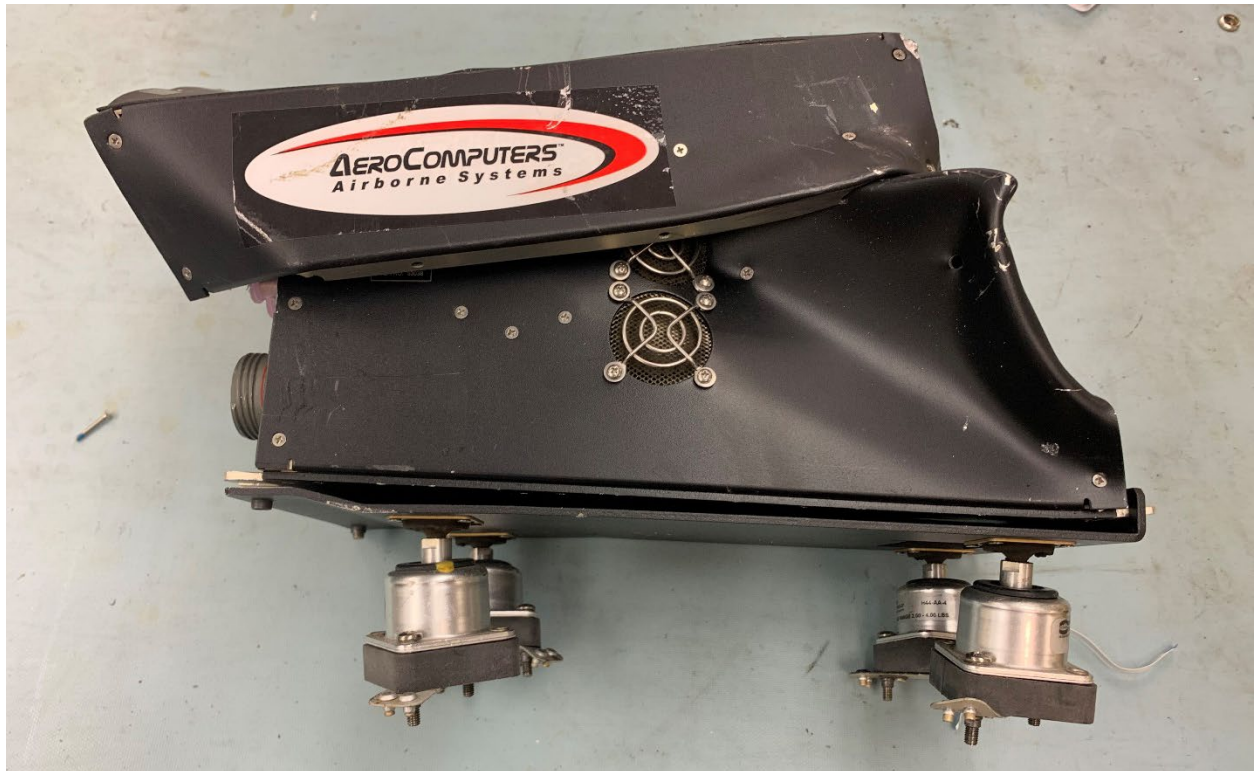
The AeroComputers UC-5300 was damaged in the accident. The extent of the damage is shown in figure 2.

**Figure 2.** AeroComputers UC-5300 device, as received.

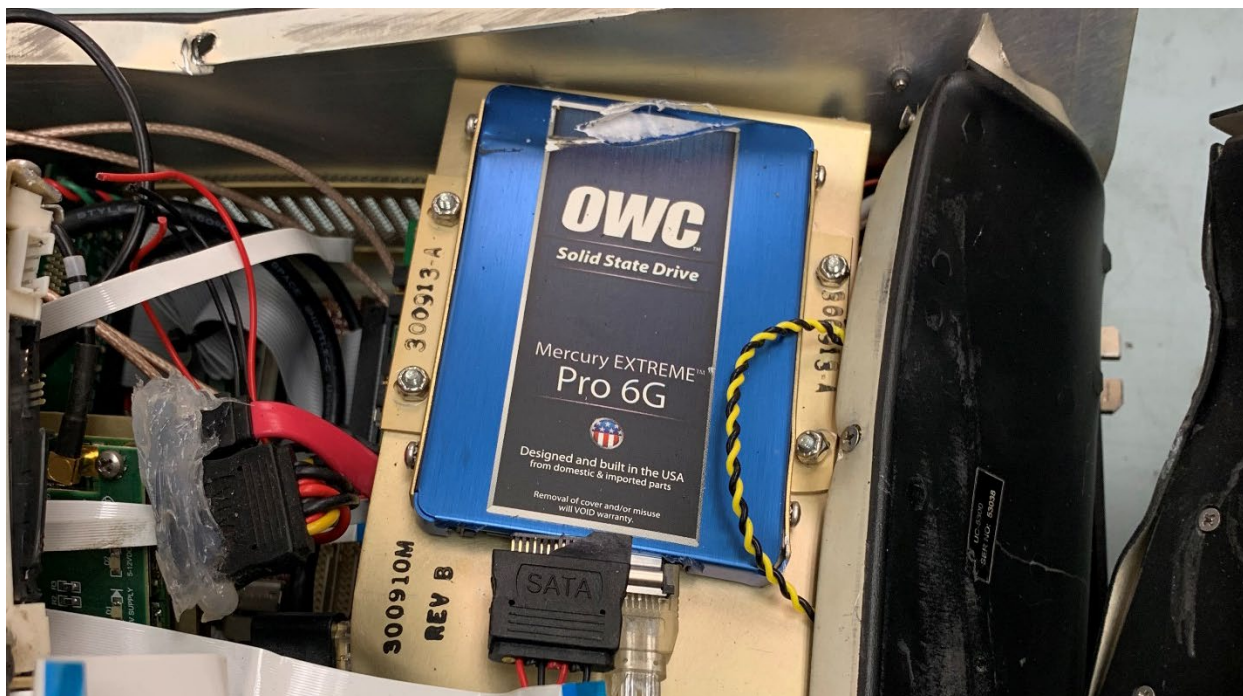
The outer casing was opened, and the internal SSD was located as shown in figure 3.

**Figure 3.** AeroComputers UC-5300 internal SSD, as received.

The SSD had signs of impact damage. When attached to a lab computer via a write blocker device, the SSD did not have a recognizable filesystem.

Due to the extent of the damage, the SSD was sent to a third-party lab that specializes in recovering data from solid-state memory devices. The third-party lab indicated that their recovery attempts were also unsuccessful. Techniques employed by the third-party lab can include but are not limited to board rework and reading of individual memory chips, and the use of virtual NAND<sup>3</sup> reconstruction software.

Despite multiple recovery attempts by the NTSB and a third-party lab, no data were recovered from the device.
