# National Transportation Safety Board

CEN23FA314

## VIDEO STUDY

Location: Kearney, Missouri  
Date: July 20, 2023  
Time: 0934 CDT (central daylight time)  
Aircraft: Piper PA-31P

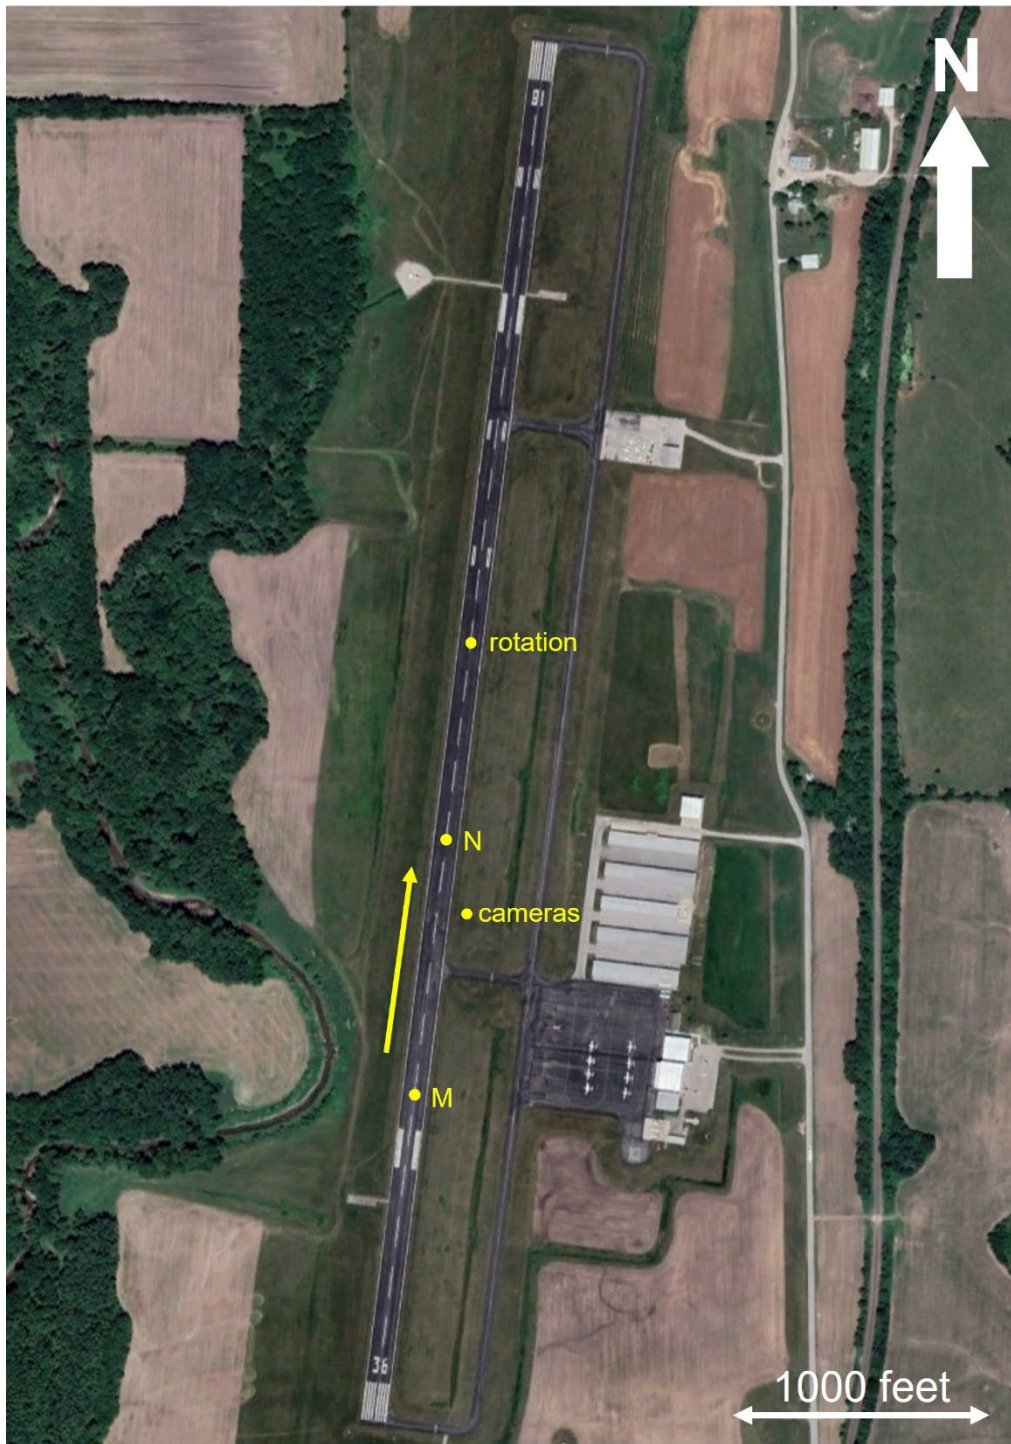
**Figure 1.** Aerial view of the accident area

Figure 1 is an aerial view of the accident area. The location where the two cameras were located is marked in the figure. During the ground roll, the airplane was initially approaching the cameras, resulting in the sound frequencies recorded by the cameras being higher than the frequencies emitted by the airplane due to the Doppler

The objective of this Video Study was the estimation of the ground speed of the airplane during its ground roll, the ground speed at the time of rotation, and the speed of the two airplane engines and propellers. Analysis was based on the visual and sound information in two videos recorded with hand-held phones. The two phones were at about the same location along the runway (see Figure 1).

Video 1 recorded the airplane past the time of liftoff. The centerline of runway 36 is marked with white stripes that are 120 feet in length. The gaps in between the stripes are 80 feet long. It was possible to estimate the locations of the airplane using the white stripes as a ruler. The estimated locations were those where the shadow of the left wing first touched a white stripe. The first location where it was possible to accurately estimate the location of the airplane is marked as M in Figure 1. The last location where it was possible to accurately estimate the location of the airplane is marked as N in Figure 1. Accurate estimation of airplane locations before M and past N was not possible because the hand-held camera was aimed parallel to the runway surface on which were the stripes.

A total of six locations were estimated with a total length of  $5 \times (120 + 80) = 1000$  feet. The time elapsed between when the airplane was at location M and location N was 8.37 seconds, based on the frame rate of video 1. Analysis showed that the speed was constant at 119.5 feet/second (70.8 knots) during the 8.37 seconds.

The visual information in video 1 showed that the airplane was moving at a constant speed at least up to location N marked in Figure 1, corresponding to video 1 time 35.14 seconds. If it could be shown that the speed remained constant at 119.5 feet/second (70.8 knots) up to rotation at video 1 time 41.71 seconds, then the rotation speed would be known, and the rotation location could be estimated by integration of the known speed. The strategy was to use the Doppler effect, as described next.

The assumed rotation speed of 70.8 knots resulted in close agreement between the estimated propeller speeds based on visual and sound information in the videos. The alternative assumption of 78 knots did not result in a close agreement. Therefore, it was concluded that rotation occurred at the ground speed of about 70.8 knots. Winds at a location that is 2 NM from the accident site were reported as 4 knots from 330°. Under the extreme assumption that the air speed was the ground speed with 4 knots added to it, the resulting estimated air speed of 74.8 knots was significantly lower than the rotation speed of 83 knots recommended by Piper. Since the time between when the airplane was at location N in Figure 1 and the time of rotation was known, and assuming constant ground speed of 70.8 knots, rotation location was estimated as 3080 feet from the beginning of the paved surface of runway 36. This location is marked in Figure 1.

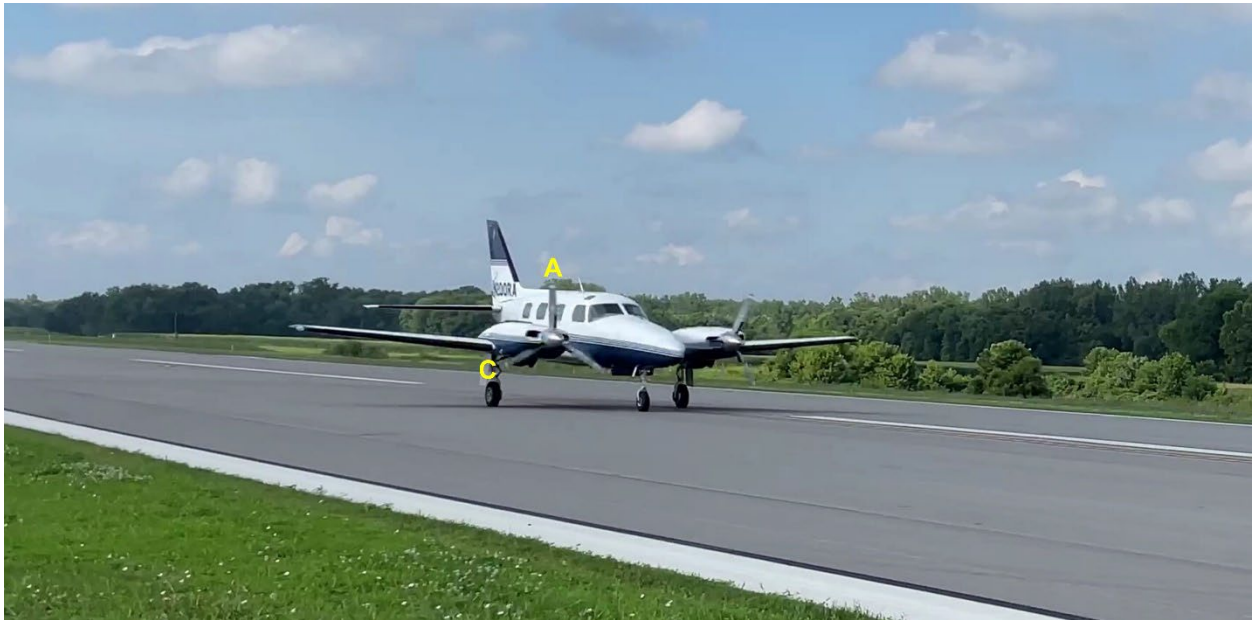
**Figure 2.** The airplane at time 55.572 seconds (video 2)

Video 1 had frame rate of 30 fps, which was too low to be usable for estimation of the propeller speeds based on the visual information in the video. Video 2 had frame rate of 60 fps, which made it possible to estimate the speed of the propellers. Figure 2 shows a frame from video 2 recorded at video 2 time 55.572 seconds. Note that blade A of the right propeller points up. Figure 3 shows the next frame of video 2. A blade on the right propeller is marked with B. The propeller was rotating clockwise when viewed from the front. The angle of blade B in Figure 3 is at an angle that is estimated at about  $83^\circ$  rotated clockwise with respect to blade A in Figure 2.

If it is assumed that blade B in Figure 3 is the same blade as blade A in Figure 2, the propeller rotational speed can be estimated as  $(83^\circ/360^\circ)/(1/60) \times 60$  where  $83^\circ/360^\circ$  is the fraction of one rotation corresponding to  $83^\circ$  rotation,  $1/60$  is the frame spacing corresponding to the frame rate of 60 fps, and multiplying by 60 converts rotations/second to rpm. The formula simplifies to  $10 \times 83 = 830$  rpm. This propeller speed is, obviously, too low considering that the airplane was able to take off. Therefore, the assumption that blade B in Figure 3 is the same blade as blade A in Figure 2 is incorrect.

If blade B in Figure 3 is not the same blade as blade A in Figure 2, blade B in Figure 3 must be the next blade that is located  $120^\circ$  counterclockwise from blade A, marked as C in Figure 2. Therefore, the propeller rotation during one frame spacing was  $120^\circ + 83^\circ = 203^\circ$  rather than  $83^\circ$ . Using the simplified expression from above, the estimated propeller speed was  $10 \times 203 = 2030$  rpm. It is estimated that the uncertainty of the  $83^\circ$  rotation was  $\pm 2^\circ$ . Therefore, the estimated right propeller speed was  $2030 \pm 20$  rpm. The speed of the geared Lycoming TIGO-541-E1A engine corresponding to a propeller speed of 2030 rpm is  $2030 \times 1.5 = 3045$  rpm. With the uncertainty added, it is  $3045 \pm 30$  rpm.

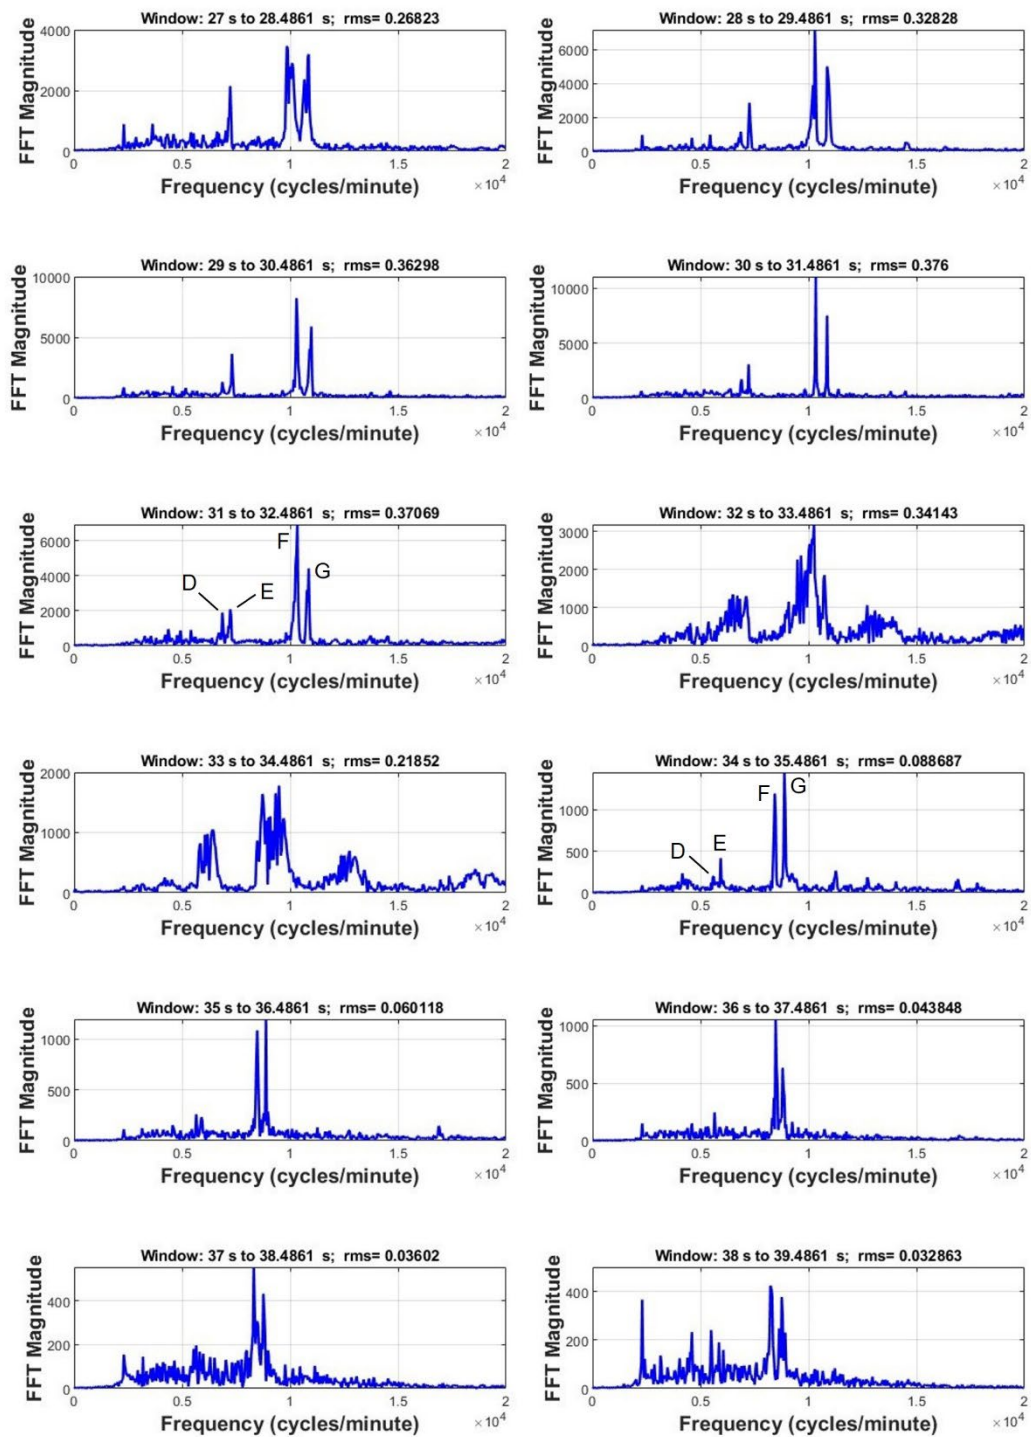
**Figure 4.** Sound spectra in windows starting at time 27 seconds (video 1)

Figure 4 shows 12 spectra with windows starting at video 1 times from 27 seconds to 38 seconds. The airplane was in front of camera 1 at time 33.07 seconds. This is the reason why the spectra starting at 32 seconds and at 33 seconds look different from the other spectra. The two windows of interest were those starting at 31 seconds and 34 seconds. Four spectral peaks, D, E, F and G are marked on the spectrum that starts at 31 seconds. Their frequencies are 6864 cpm, 7227 cpm, 10336 cpm and 10861 cpm, respectively. Spectral peaks D and E are the blade passage frequencies of the two 3-bladed propellers. Spectral peaks F and G are the third harmonics of the engine rotational speed.

At the rated propeller speed of 2133 rpm, the blade passage frequency is  $2133 \times 3 = 6399$  cpm. The two Lycoming TIGO-541-E1A engines on the PA-31P are geared. The engines rotate at 3200 rpm when the propellers rotate at 2133 rpm. Six cylinder, horizontally opposed engines usually generate sound signals at a frequency that is three times their rotational speed. At the rated engine speed, it is  $3200 \times 3 = 9600$  cpm. Peaks D, E, F and G in the window starting at 31 seconds in Figure 4 are at frequencies higher than the frequencies corresponding to the rated propeller and engine speed. It is so because of the Doppler effect caused by the airplane approaching the camera.

Since the analysis based on video 2 showed that the left engine was rotating faster than the right engine, spectral peaks E and G correspond to the left propeller and engine and peaks D and F correspond to the right propeller and engine.

Four spectral peaks, D, E, F and G are also marked on the spectrum that starts at 34 seconds. Their frequencies are 5571 cpm, 5935 cpm, 8438 cpm and 8882 cpm, respectively. Peaks D, E, F and G in the window starting at 34 seconds in Figure 4 are at frequencies lower than the frequencies corresponding to the rated propeller and engine speed. It is so because of the Doppler effect caused by the airplane moving away from the camera.

The spectral peaks corresponding to the engine sound, peaks F and G, were tracked up to the window starting at video 1 time 48 seconds, past the time of rotation. Table 1 shows the frequencies. Since peaks F and G are due to combustion noise, this indicates that both engines were operating at least till that time and that the right engine was rotating more slowly than the left engine.
