Andrew Finne  
Air Safety Investigator  
Office of Aviation Safety

**Subject:** CEN23FA314 - White Deposit NTSB Material Lab Email Report

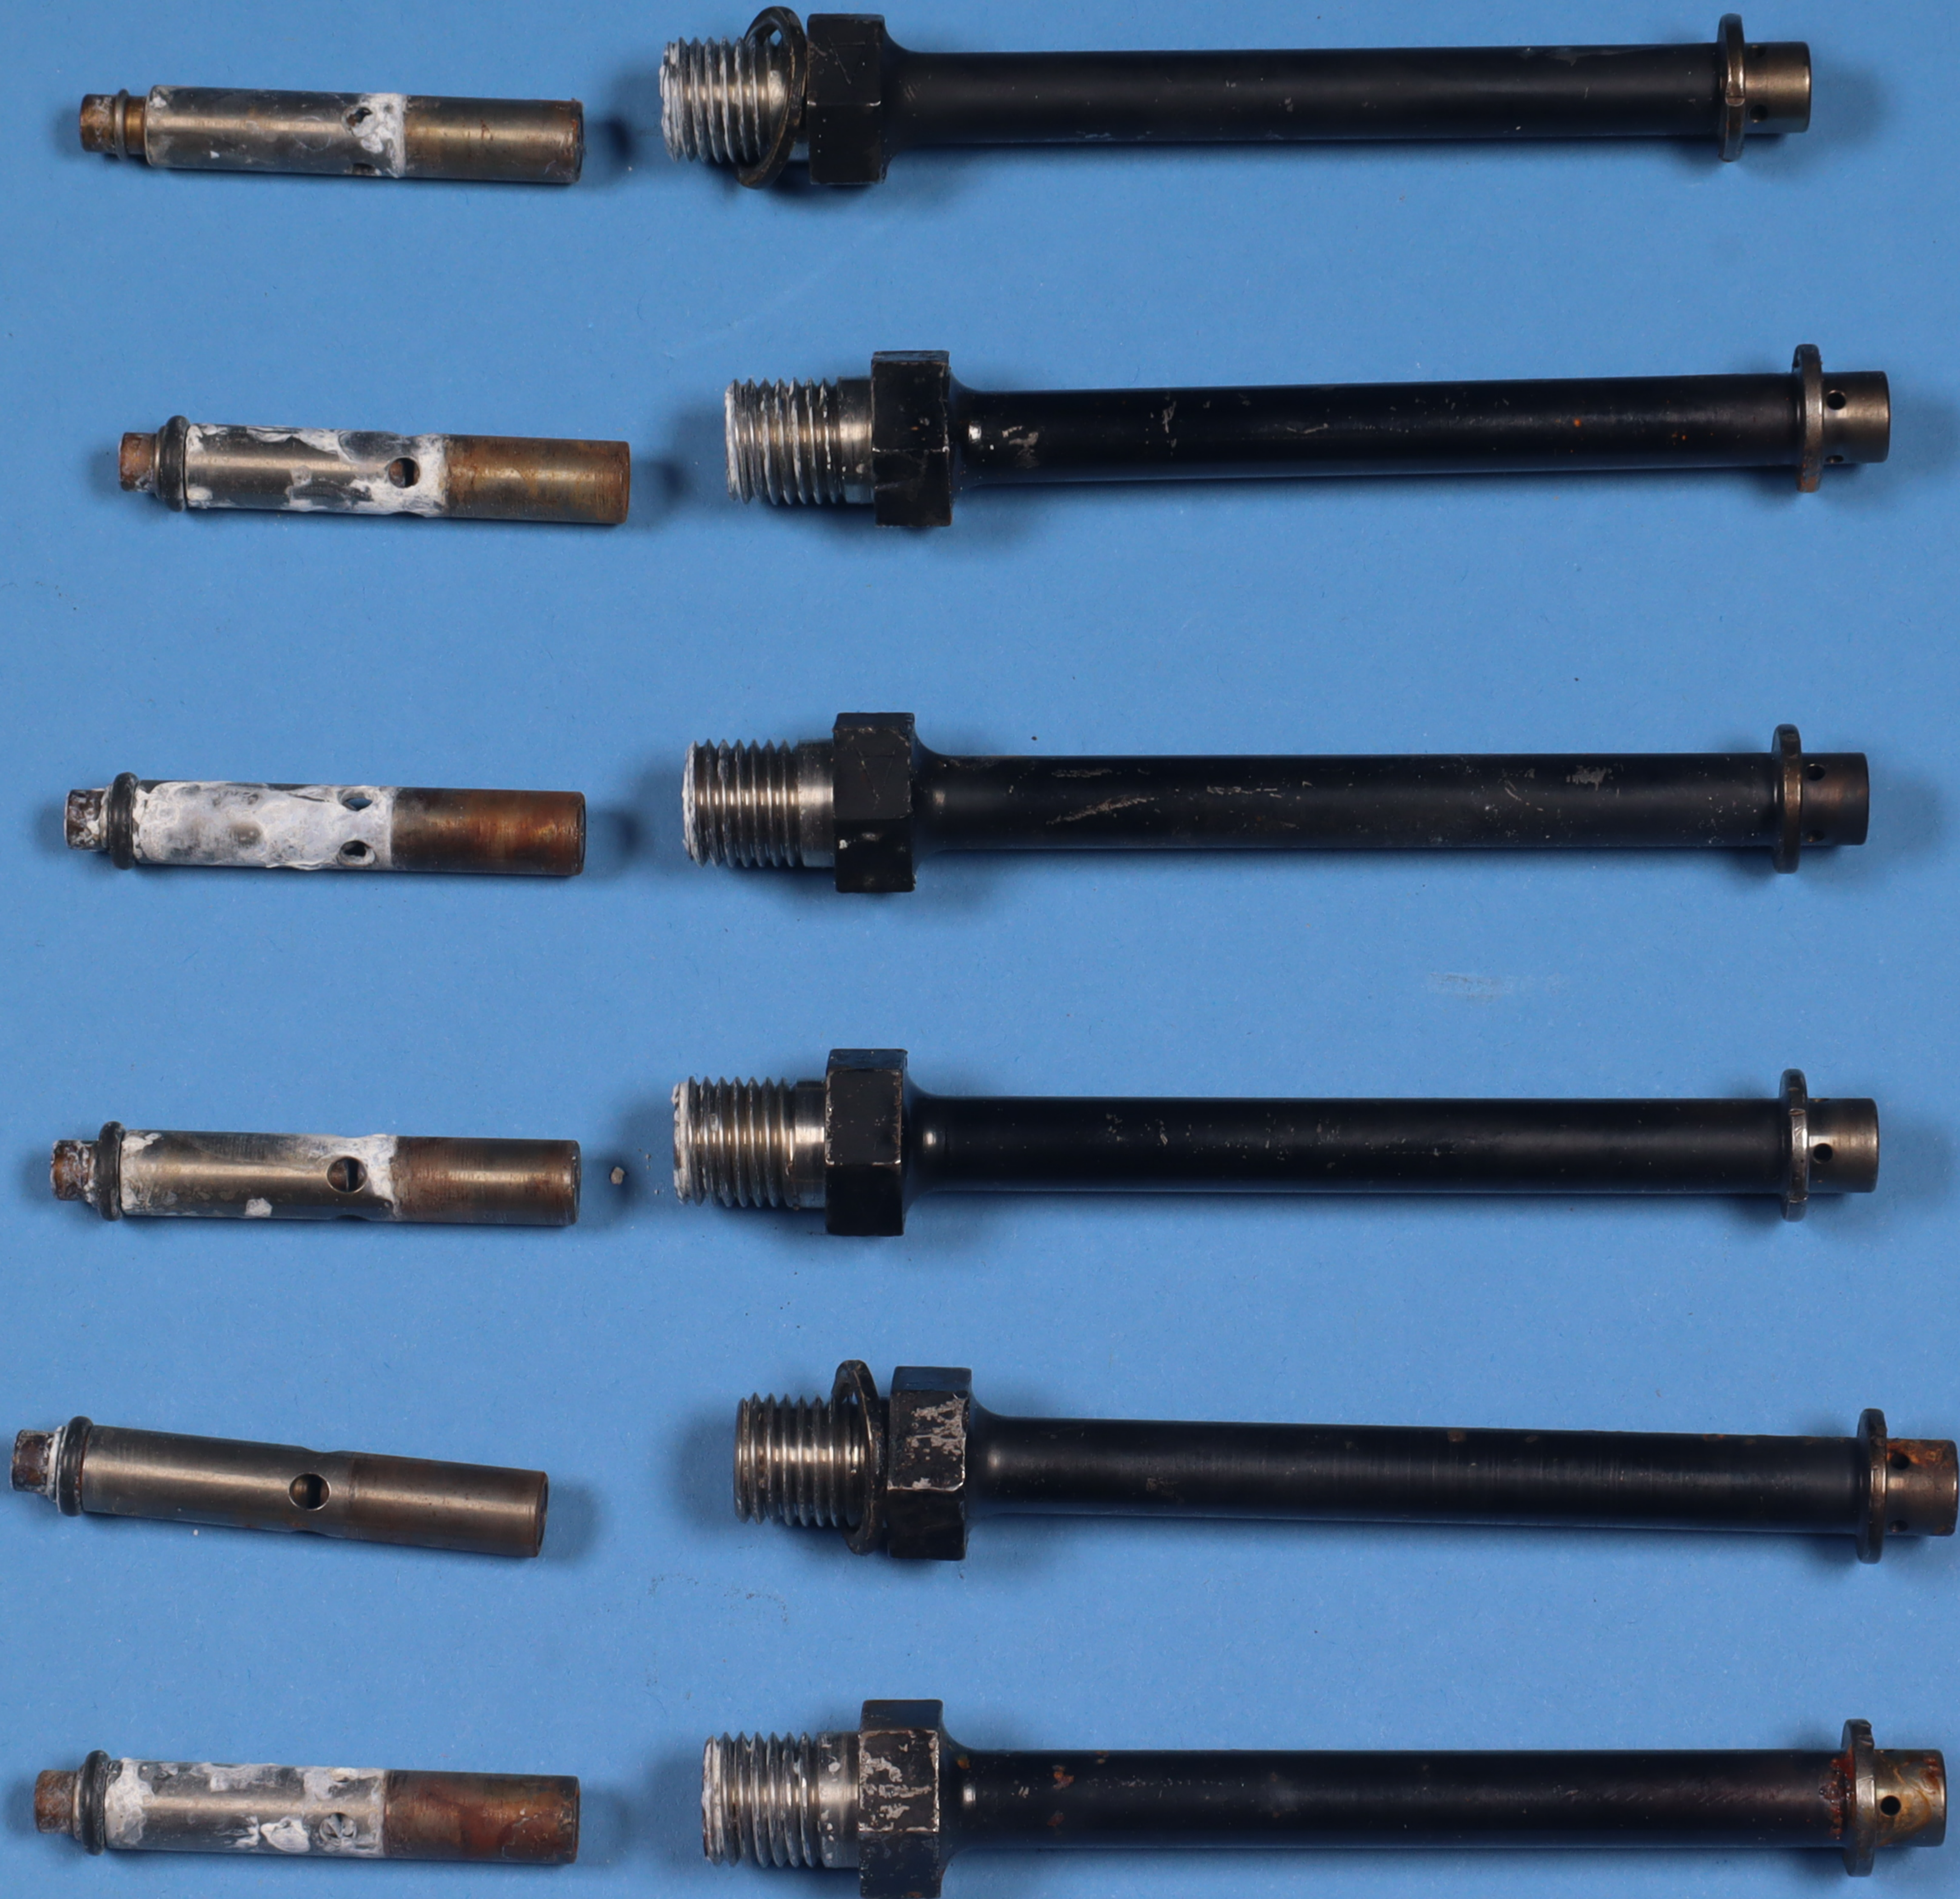
The right engine fuel injectors with extension tubes from the subject investigation were received as shown in the attached image. One of the injectors was placed in the scanning electron microscope, and the white deposits on the surface were analyzed using energy-dispersive x-ray spectroscopy (EDS). The EDS spectrum, included as an attachment, showed high peaks of magnesium and oxygen consistent with magnesium oxide.

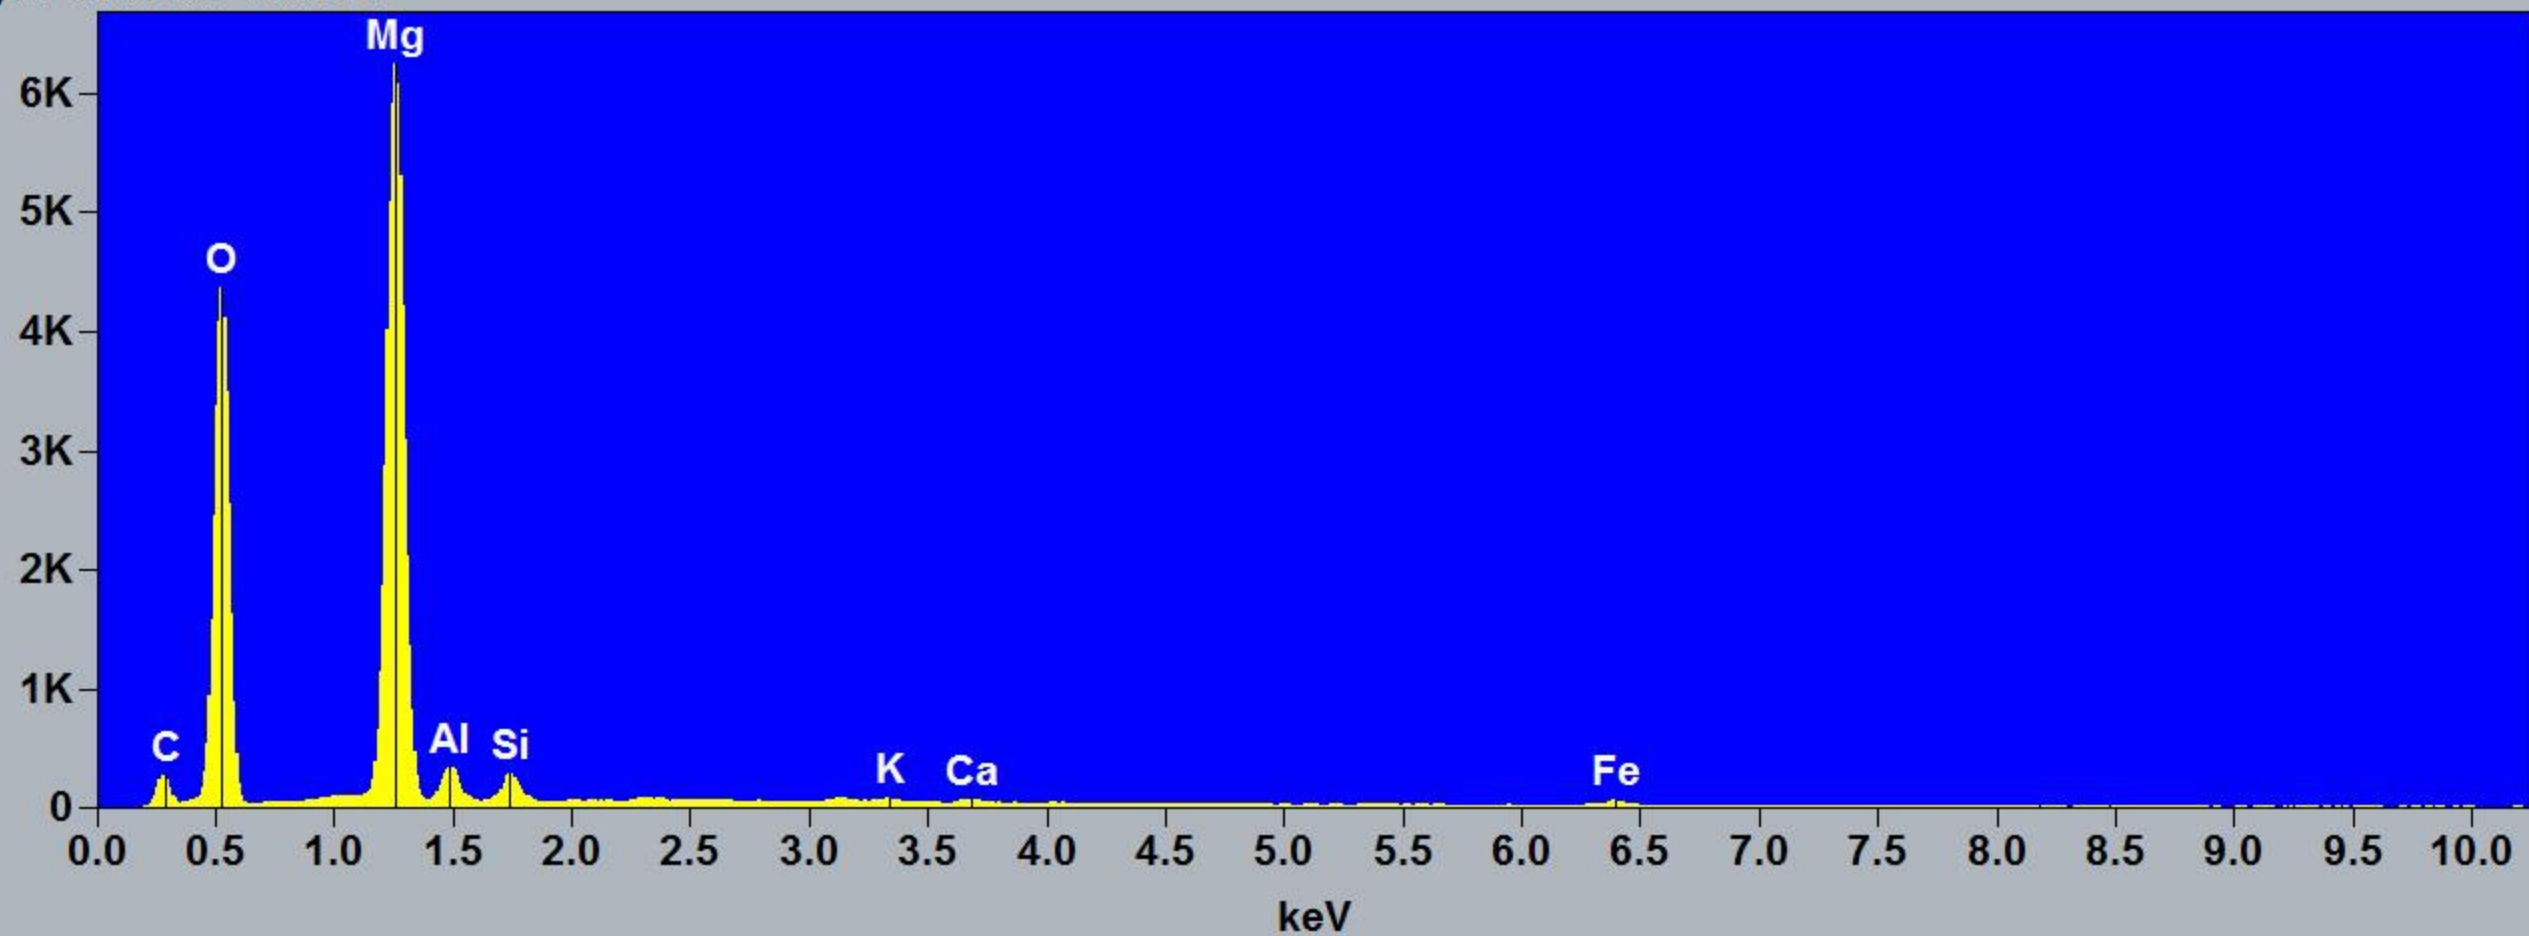
white deposits(1)

Full scale counts: 6257

Integral Counts: 120110
