# National Transportation Safety Board

CEN23FA340

## **GLOBAL POSITIONING SYSTEM DEVICES**

Location: Oakdale, Illinois  
Date: July 31, 2023  
Time: 1310 central daylight time (CDT)  
1810 coordinated universal time (UTC)  
Helicopter: UH-1H, Kash Helicopter Services LLC, N567VF

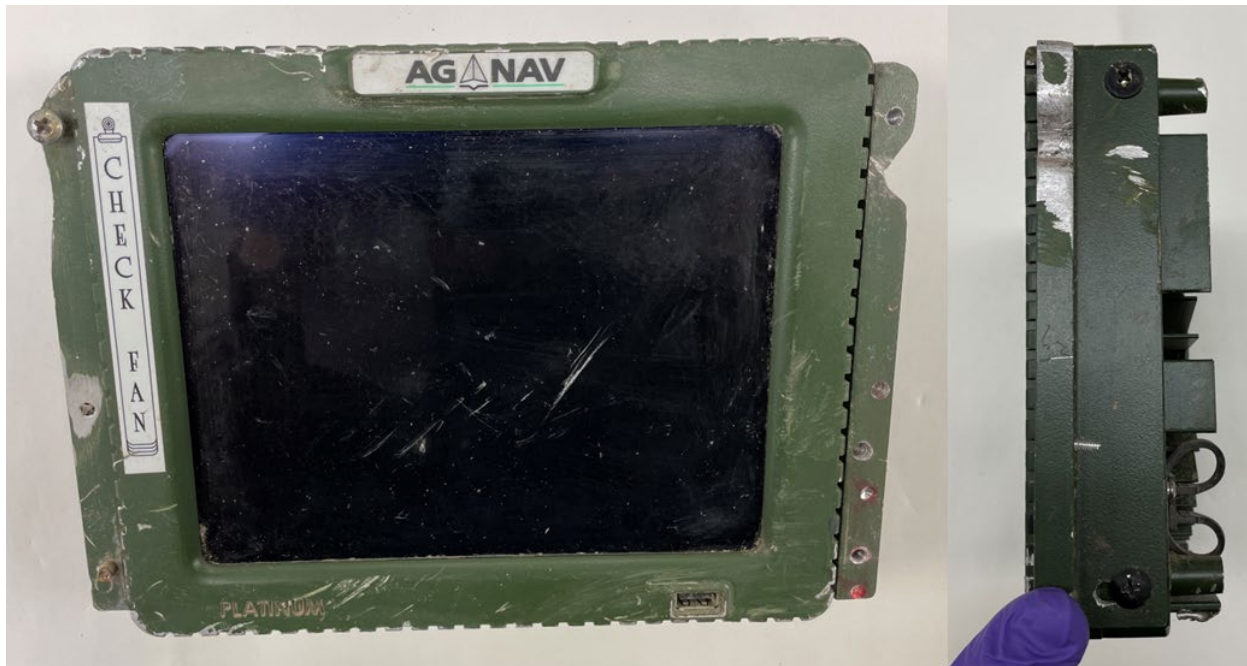
**Figure 1.** Photo of front and side view of Ag-NAV GUIA Platinum P771, as received.

The Ag-NAV GUIA Platinum P771 was in good condition and data were downloaded normally using the manufacturer's procedure. Figure 1 is the front and side view of the Ag-NAV device, as received.

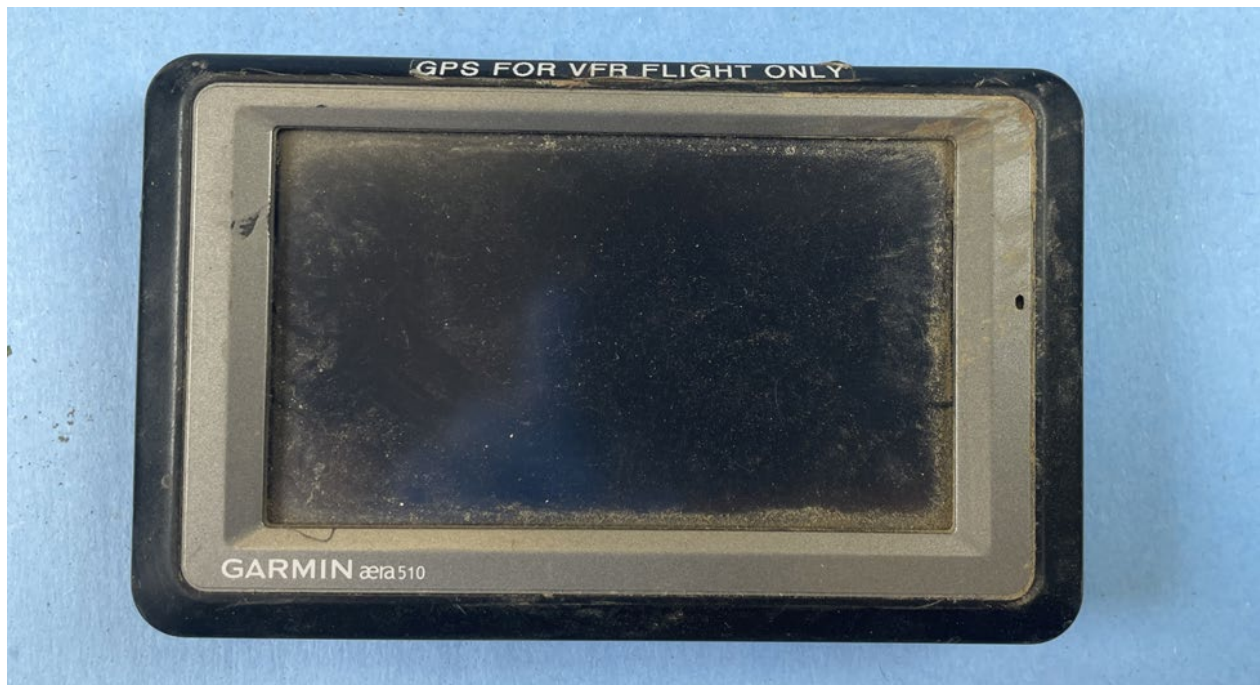
**Figure 2.** Photo of front view of Garmin Aera 510, as received.

The Garmin Aera 510 was in good condition and the data were downloaded normally using the manufacturer's procedure. Figure 2 is the front view of the Garmin Aera 510 device, as received.
