# National Transportation Safety Board

## **MATERIALS LABORATORY**

Factual Report 24-008

Location: Waunakee, WI  
Date: June 21, 2023  
Vehicle: Champion 7EC, N80461  
Investigator: Michael Hodges

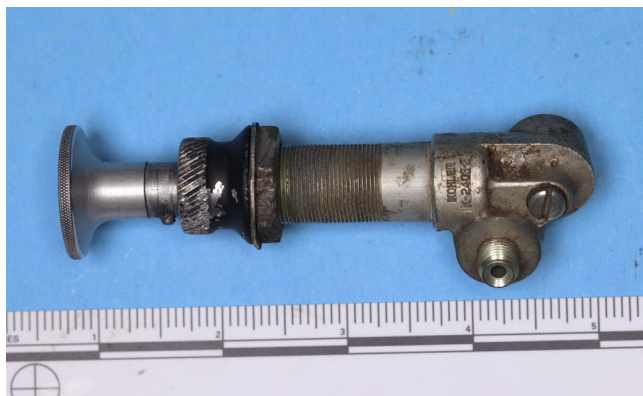
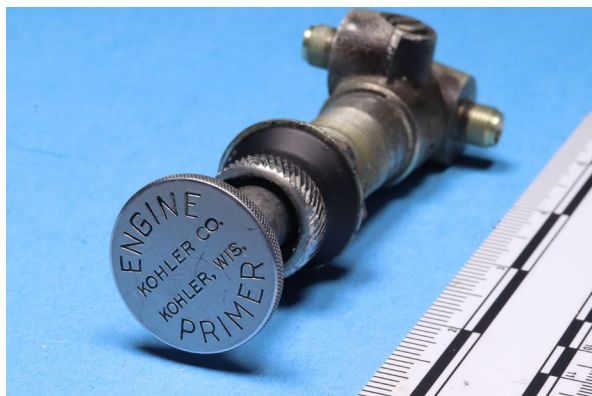
**Figure 1.** Fuel primer pump as received.

A fuel primer pump (Kohler K-2406-2) was submitted for examination. This fuel primer pump was a manually operated piston type pump for priming the engine (Figure 1). The pump's piston had a cylindrical pin perpendicular to the piston's axis which was used to lock the piston in the fully inserted position when not in use (Figure 2). The locking pin was approximately 0.093" diameter. The locking pin would be kept captive by a retention lip on the pump housing end cap when the piston was fully inserted and turned either to the left or right. Examination of the end cap (Figures 3, 4) revealed that the retention lip on the end cap was worn away around most of its circumference leaving only a 0.143" long section of the retaining lip.

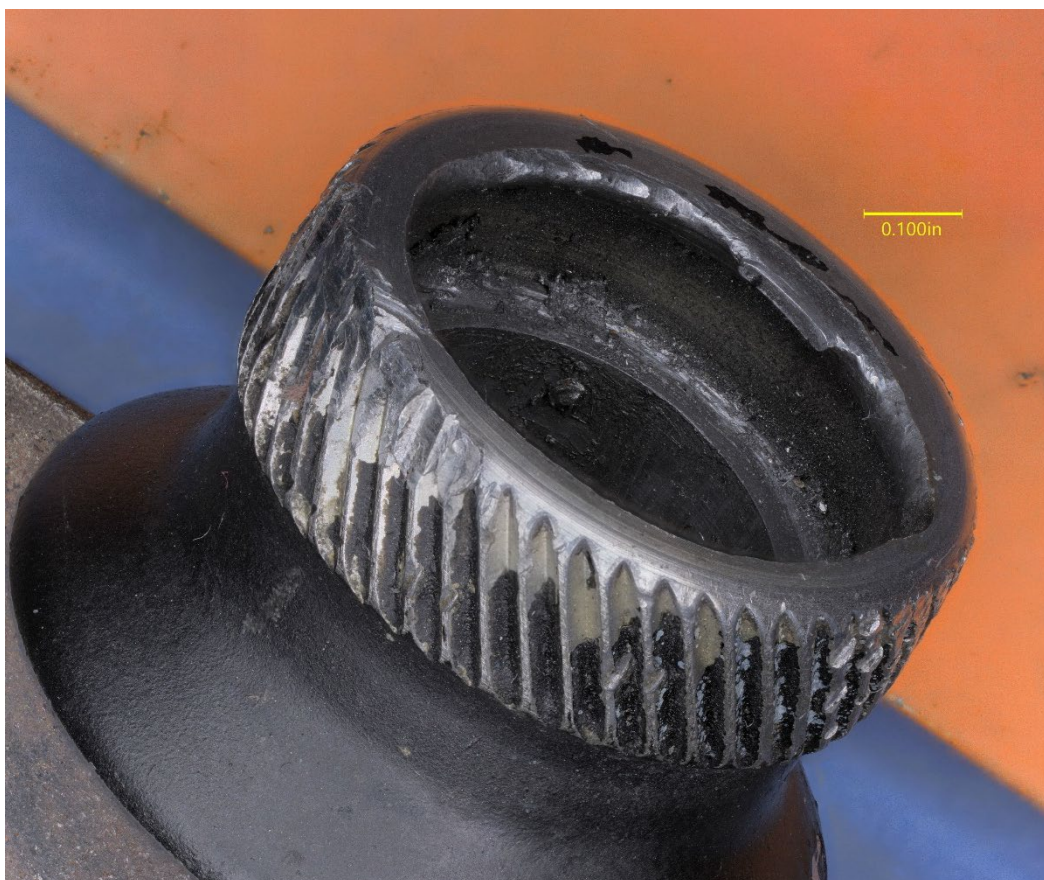
**Figure 4.** End cap exhibiting worn retention lip.

Wear of the end cap's retaining lip reduced the area of overlap between the retention pin and retention lip.
