# National Transportation Safety Board

CEN23LA337

## VIDEO FILE

Specialist's Factual Report

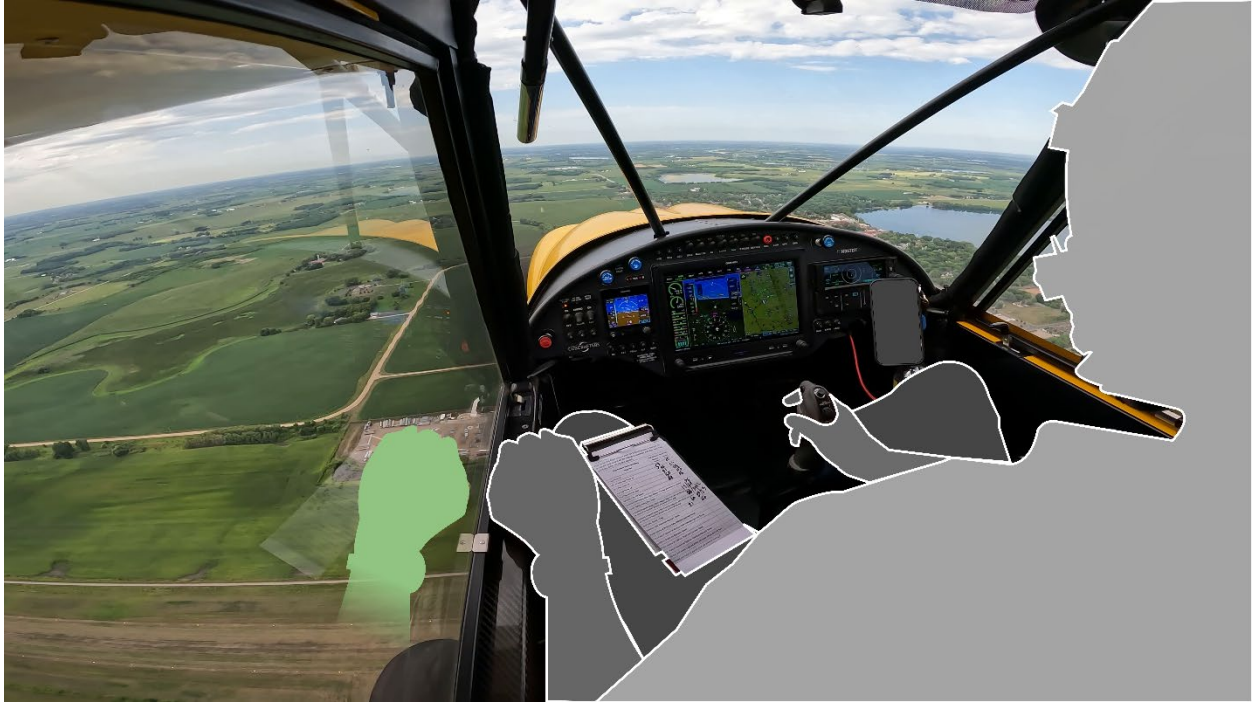
**Figure 1.** Image showing typical field of view (pilot and reflection on canopy and cell phone redacted).

The accident recording was made at a resolution of 3840 x 2160 pixels at a frame rate of 29.97 frames per second (fps). The length of the recording is 2 minutes and 32 seconds and captured the accident. An associated audio track was also recorded from the pilot's headset adapter. This audio track did not include sounds from the engine. The camera was mounted to the frame of the aircraft behind the pilot on the left side and was oriented to show a forward-facing field of view that included a view of the instrument panel, the pilot, and an external view forward and to the left of the airplane. The field of view of the accident recording is digitally illustrated in figure 1 below.

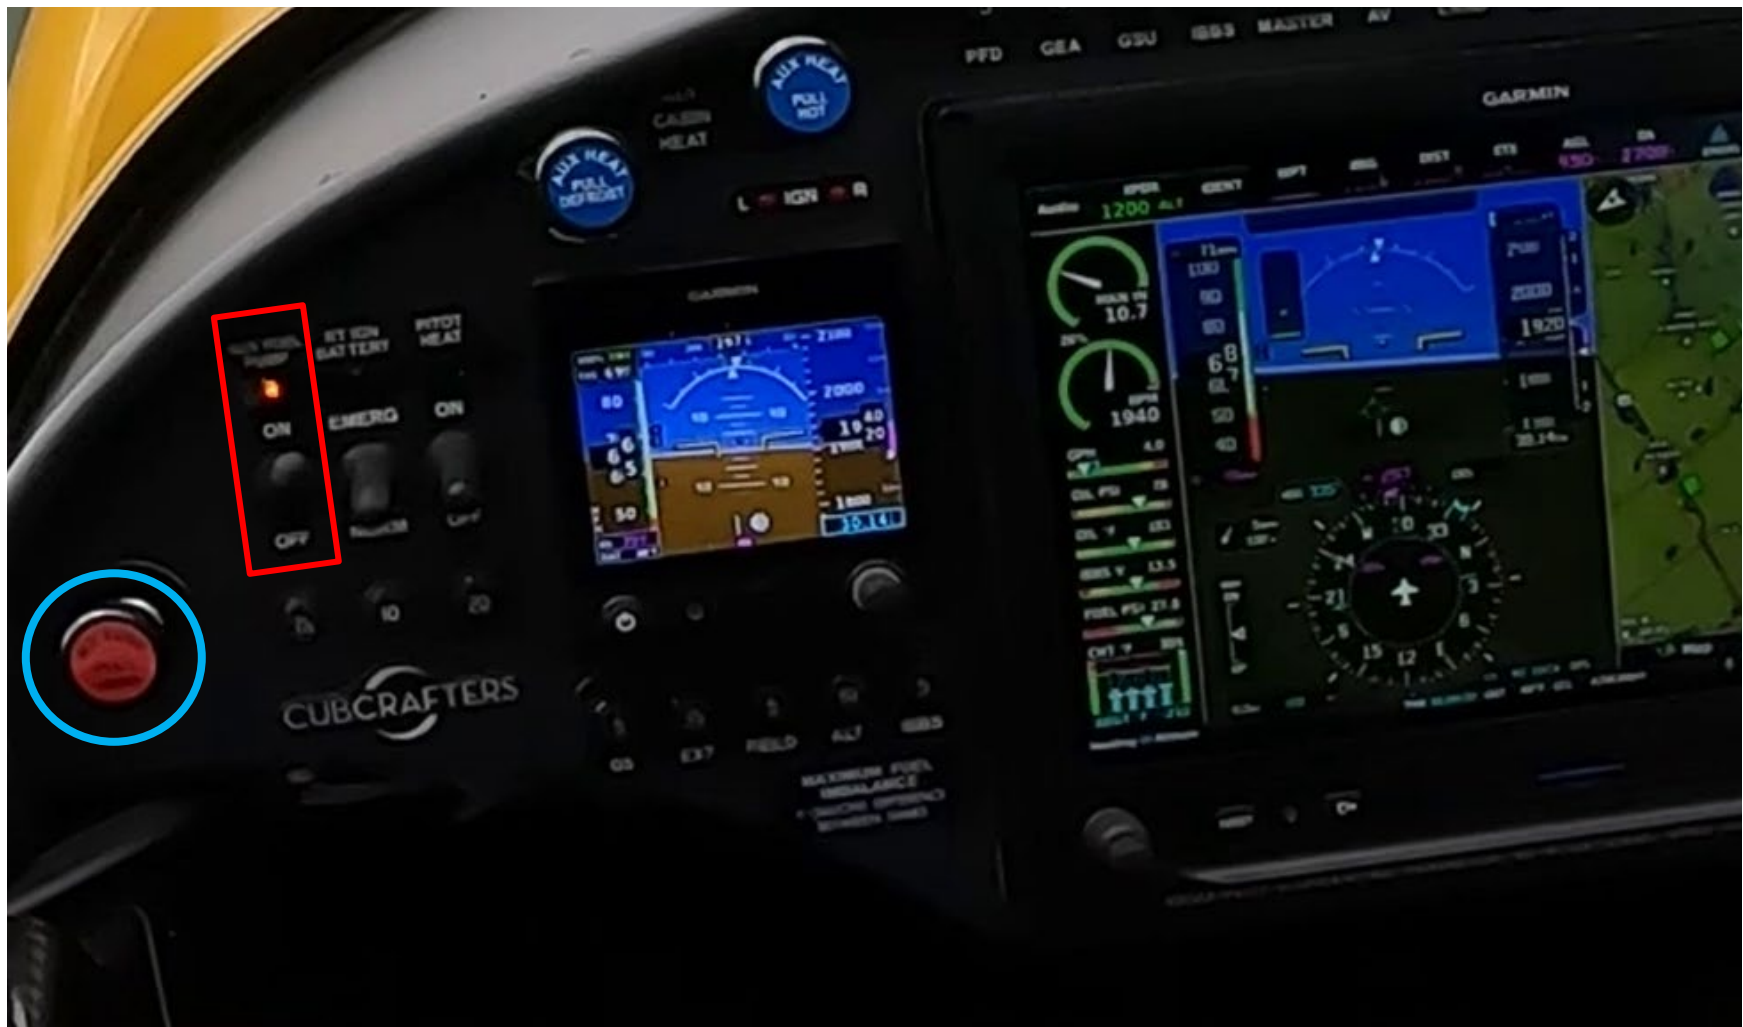
**Figure 2.** Aux fuel pump (red rectangle) and mixture control knob (blue circle). Screenshot taken at 16:54:17 CDT.

| Time CDT (HH:MM:SS) | Observation |
|---|---|
| <b>16:54:17</b> | <p>The pilot performed a before landing checklist. Noted items were:</p> <ul style="list-style-type: none"><li>• "we've got the boost on," and the pilot checked the aux fuel pump. The orange light was already on, as shown in figure 2.</li><li>• "gas set to both," and the pilot toggled a switch below the throttle.</li><li>• "undercarriage," was stated, and no action was taken.</li><li>• "carb heat," was stated, and no action was taken.</li><li>• "mixture extra full rich," and the pilot pressed the mixture red knob, as shown in figure 2.</li><li>• "prop fully forward," and the pilot checked the prop lever.</li><li>• "safety belts," was stated, and no action was taken. The pilot had the safety belt on and was visible in the frame.</li></ul> |

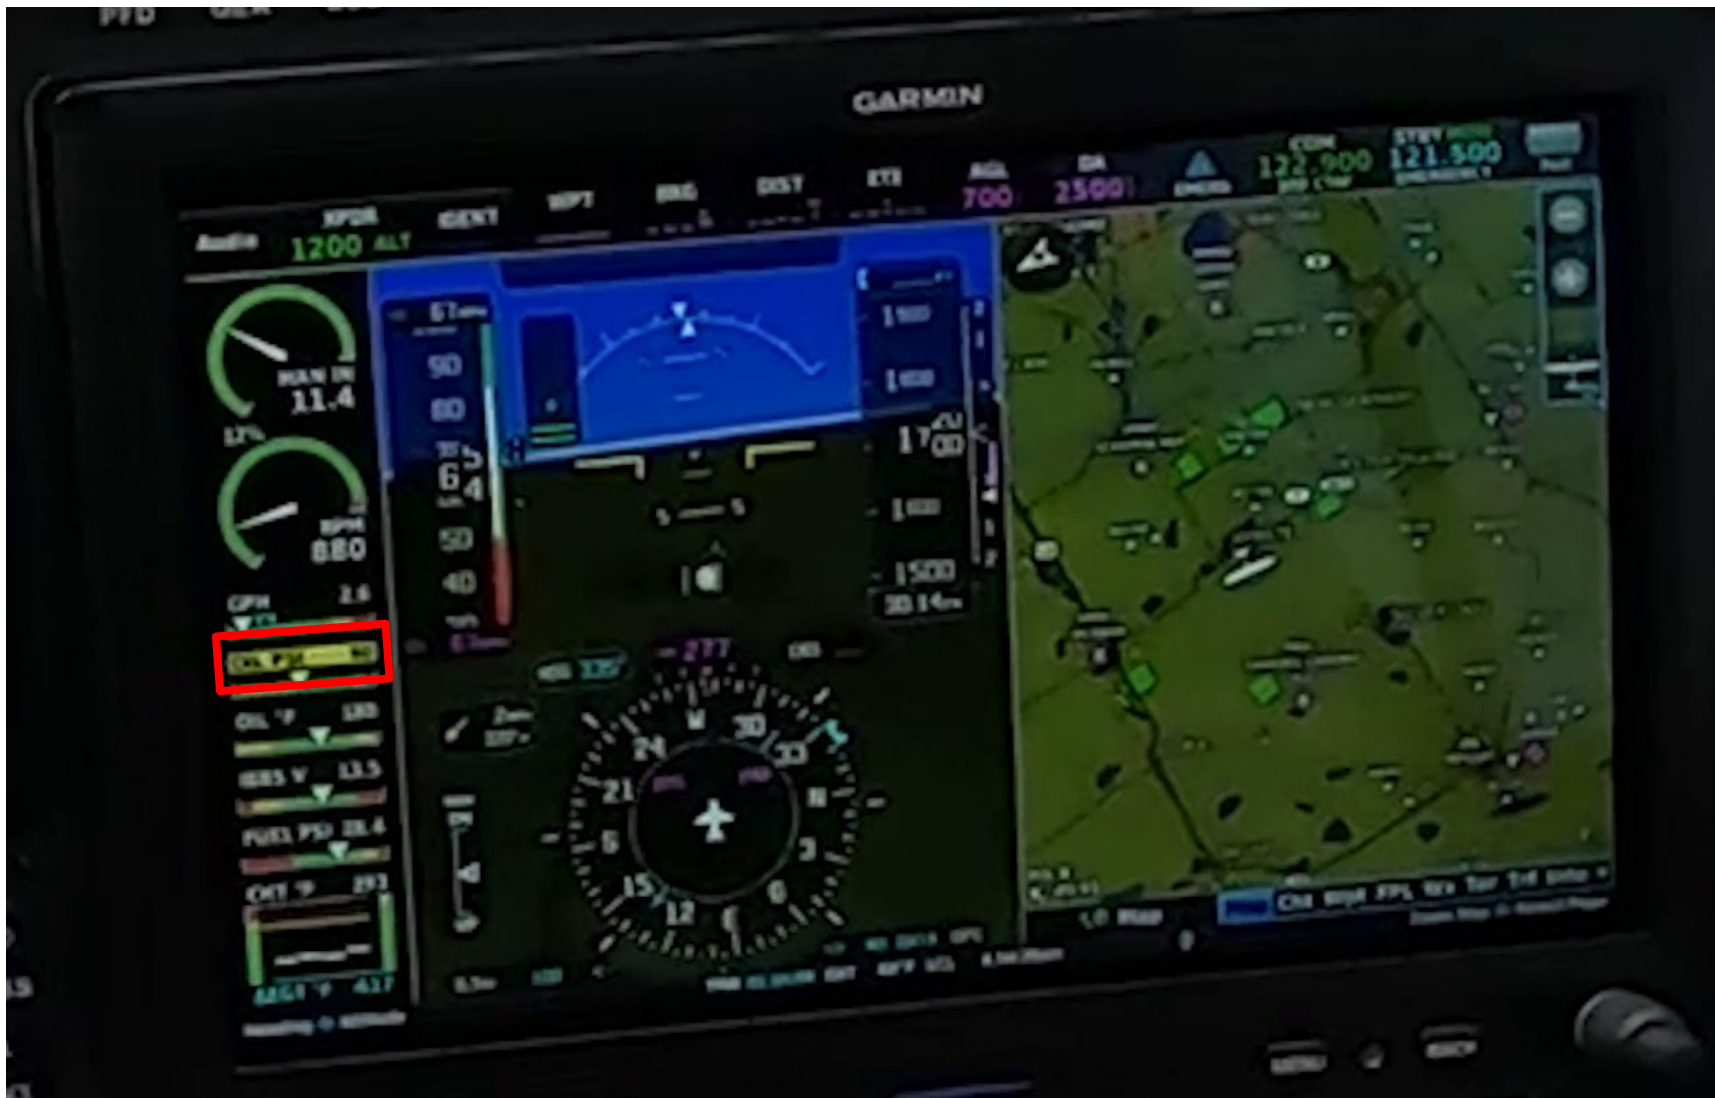
**Figure 3.** Garmin G3X PFD display with oil pressure yellow caution (red rectangle). Screenshot taken at 16:54:40 CDT.

| Time CDT (HH:MM:SS) | Observation |
|---|---|
| <b>16:54:40</b> | The oil pressure yellow caution first illuminated on the Garmin G3X, as shown in figure 3. The oil pressure displayed was 60 psi. |

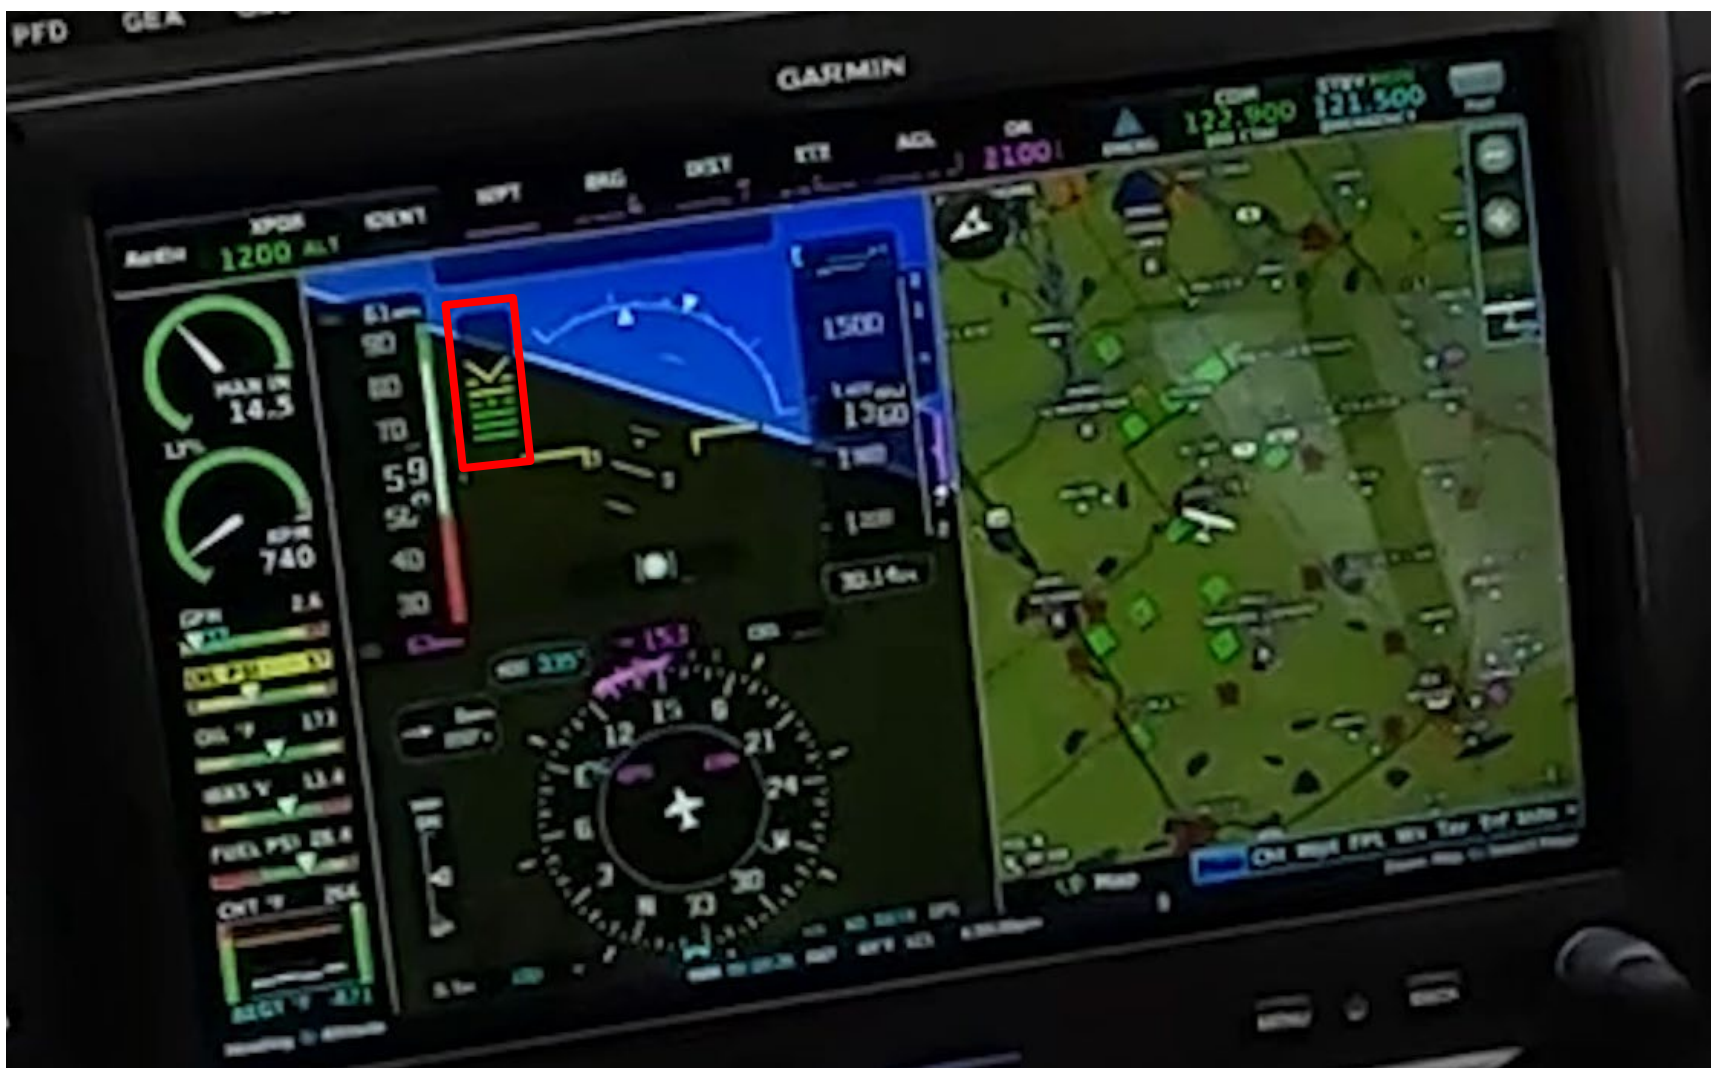
**Figure 4.** Garmin G3X AOA visual alert for pilots (red rectangle). Screenshot taken at 16:55:06 CDT.

| <b>Time CDT (HH:MM:SS)</b> | <b>Observation</b> |
|---|---|
| <b>16:55:06</b> | The angle of attack (AOA) aural alert activated and beeped for 6 seconds. Figure 4 shows the AOA visual warning on the Garmin G3X PFD. Figure 5 shows the pilot guidance on the AOA aural and visual warning on the PFD. |

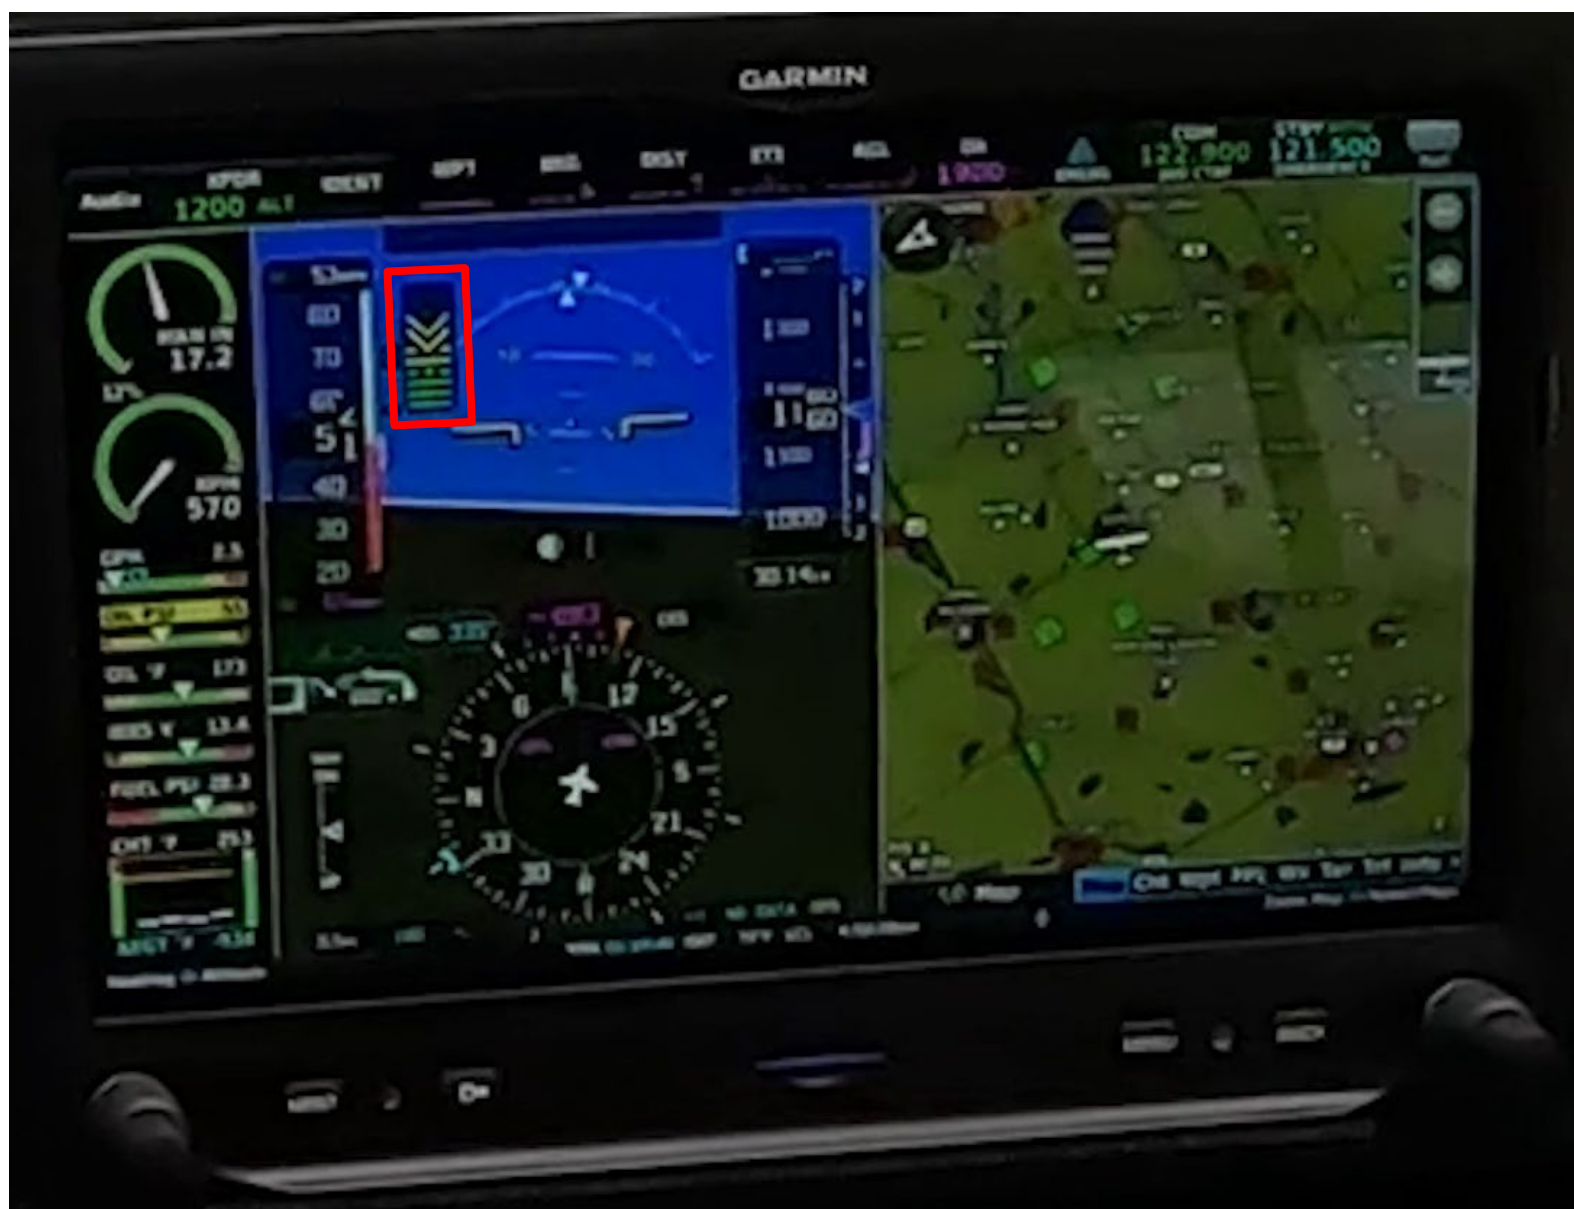
**Figure 6.** AOA visual alert on Garmin G3X with two chevrons (red rectangle). Screenshot taken at 16:55:20 CDT.

| <b>Time CDT (HH:MM:SS)</b> | <b>Observation</b> |
|---|---|
| <b>16:55:20</b> | The pilot continued to hold the stick aft and a faster persistent AOA aural beeping with two visual yellow chevrons were observed for 7 seconds (as seen in figure 6). |

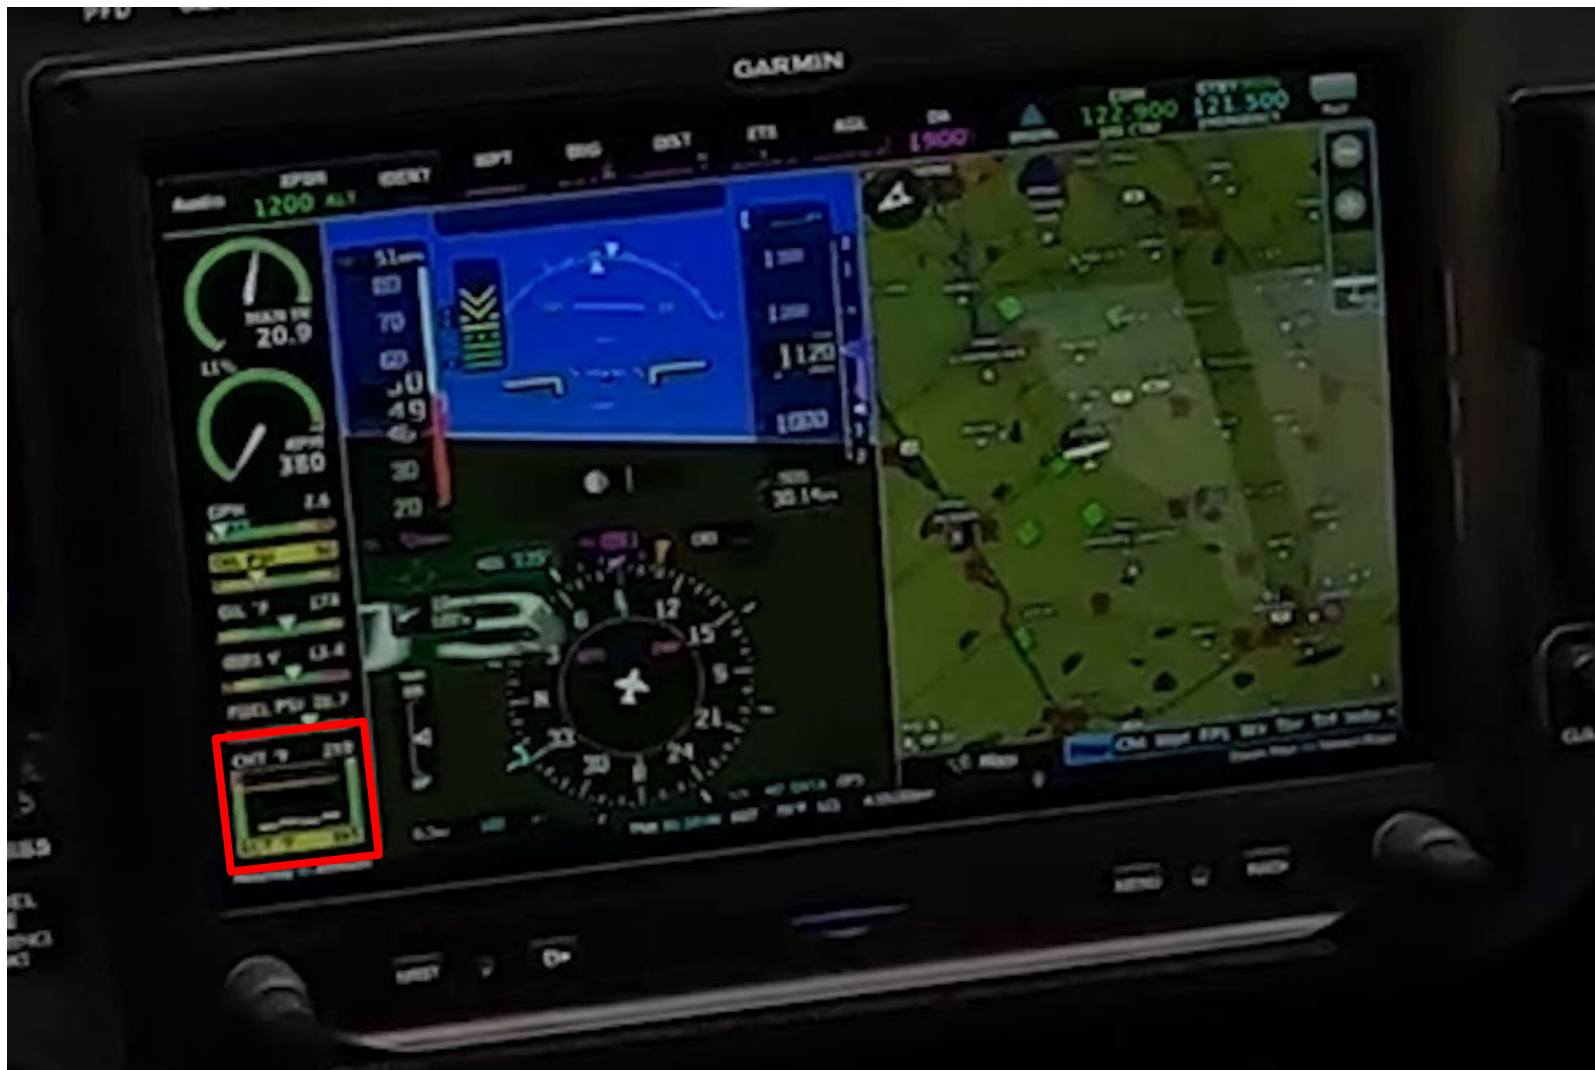
**Figure 7.** Garmin G3X PFD display with EGT yellow caution (red rectangle). Screenshot taken at 16:55:23 CDT.

| <b>Time CDT (HH:MM:SS)</b> | <b>Observation</b> |
|---|---|
| <b>16:55:23</b> | The EGT yellow caution illuminated on the Garmin G3X, as shown in figure 7. The airspeed was 49 mph and the altitude was 1120 ft (approximately 105 ft AGL). |

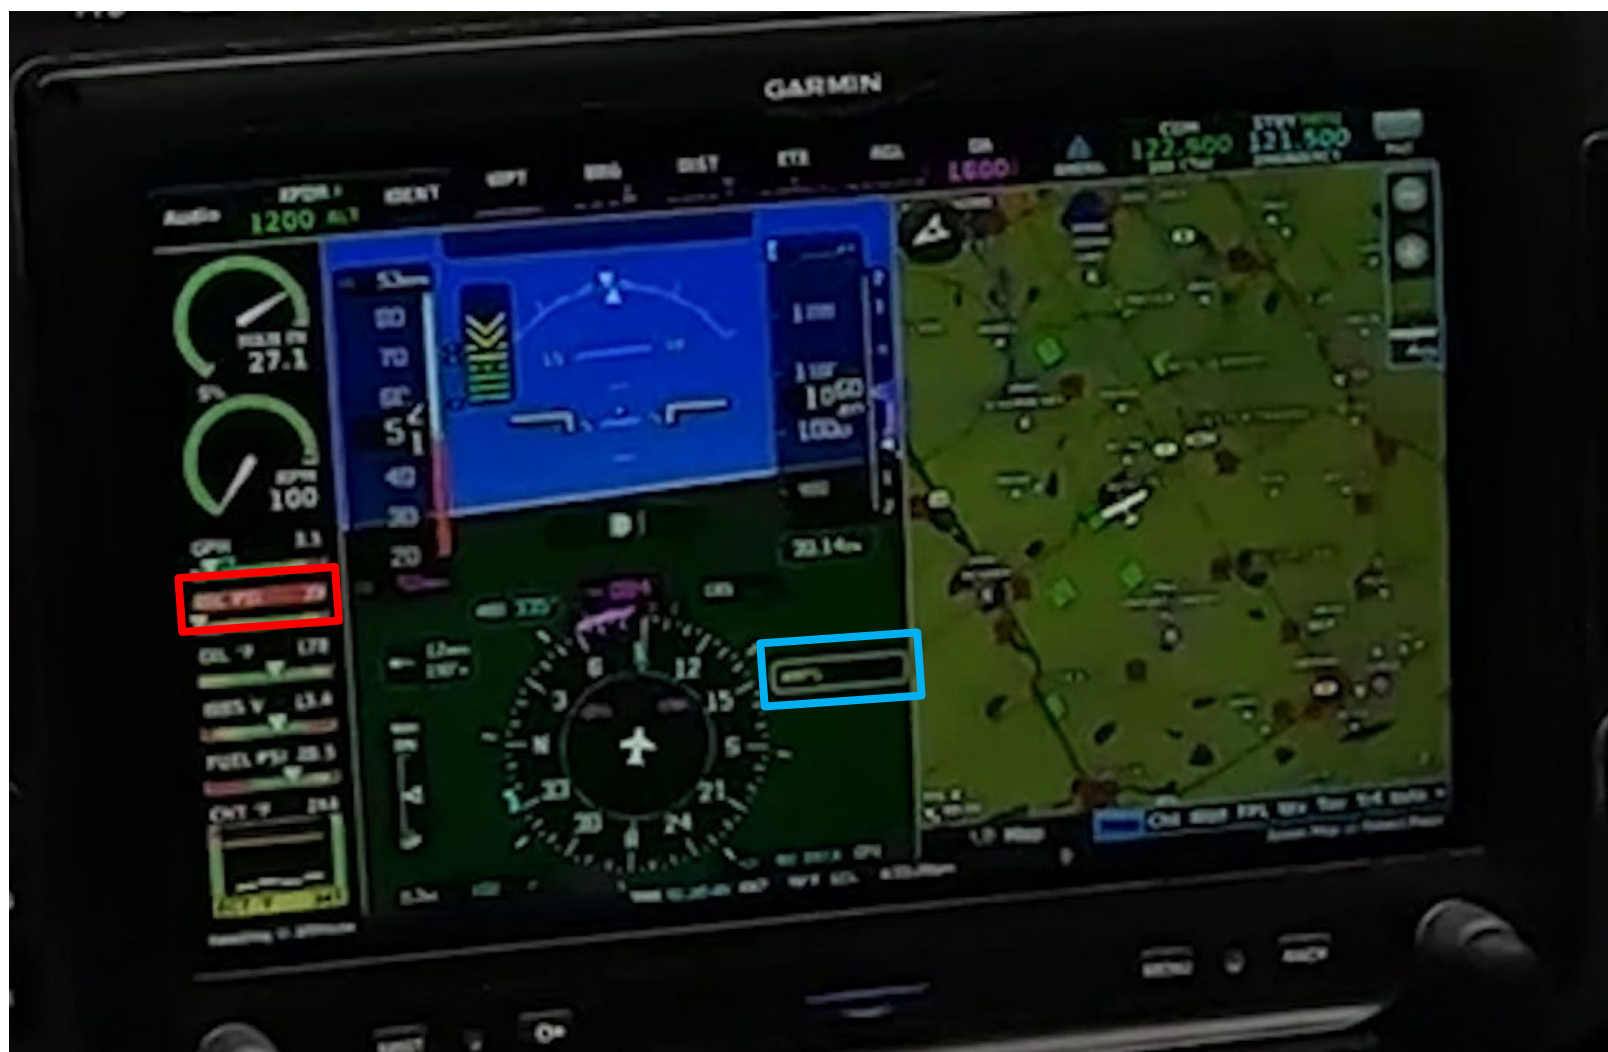
**Figure 8.** Garmin G3X PFD display with oil pressure red warning (red rectangle) and CAS AMPS yellow caution (blue rectangle). Screenshot taken at 16:55:29 CDT.

| <b>Time CDT (HH:MM:SS)</b> | <b>Observation</b> |
|---|---|
| <b>16:55:29</b> | The propeller stopped rotating and the oil pressure red warning illuminated on the Garmin G3X, as shown in figure 8. In addition, a crew alerting system (CAS) "AMPS" yellow caution message was displayed. Faster persistent AOA aural beeping and two visual yellow chevrons were observed. |

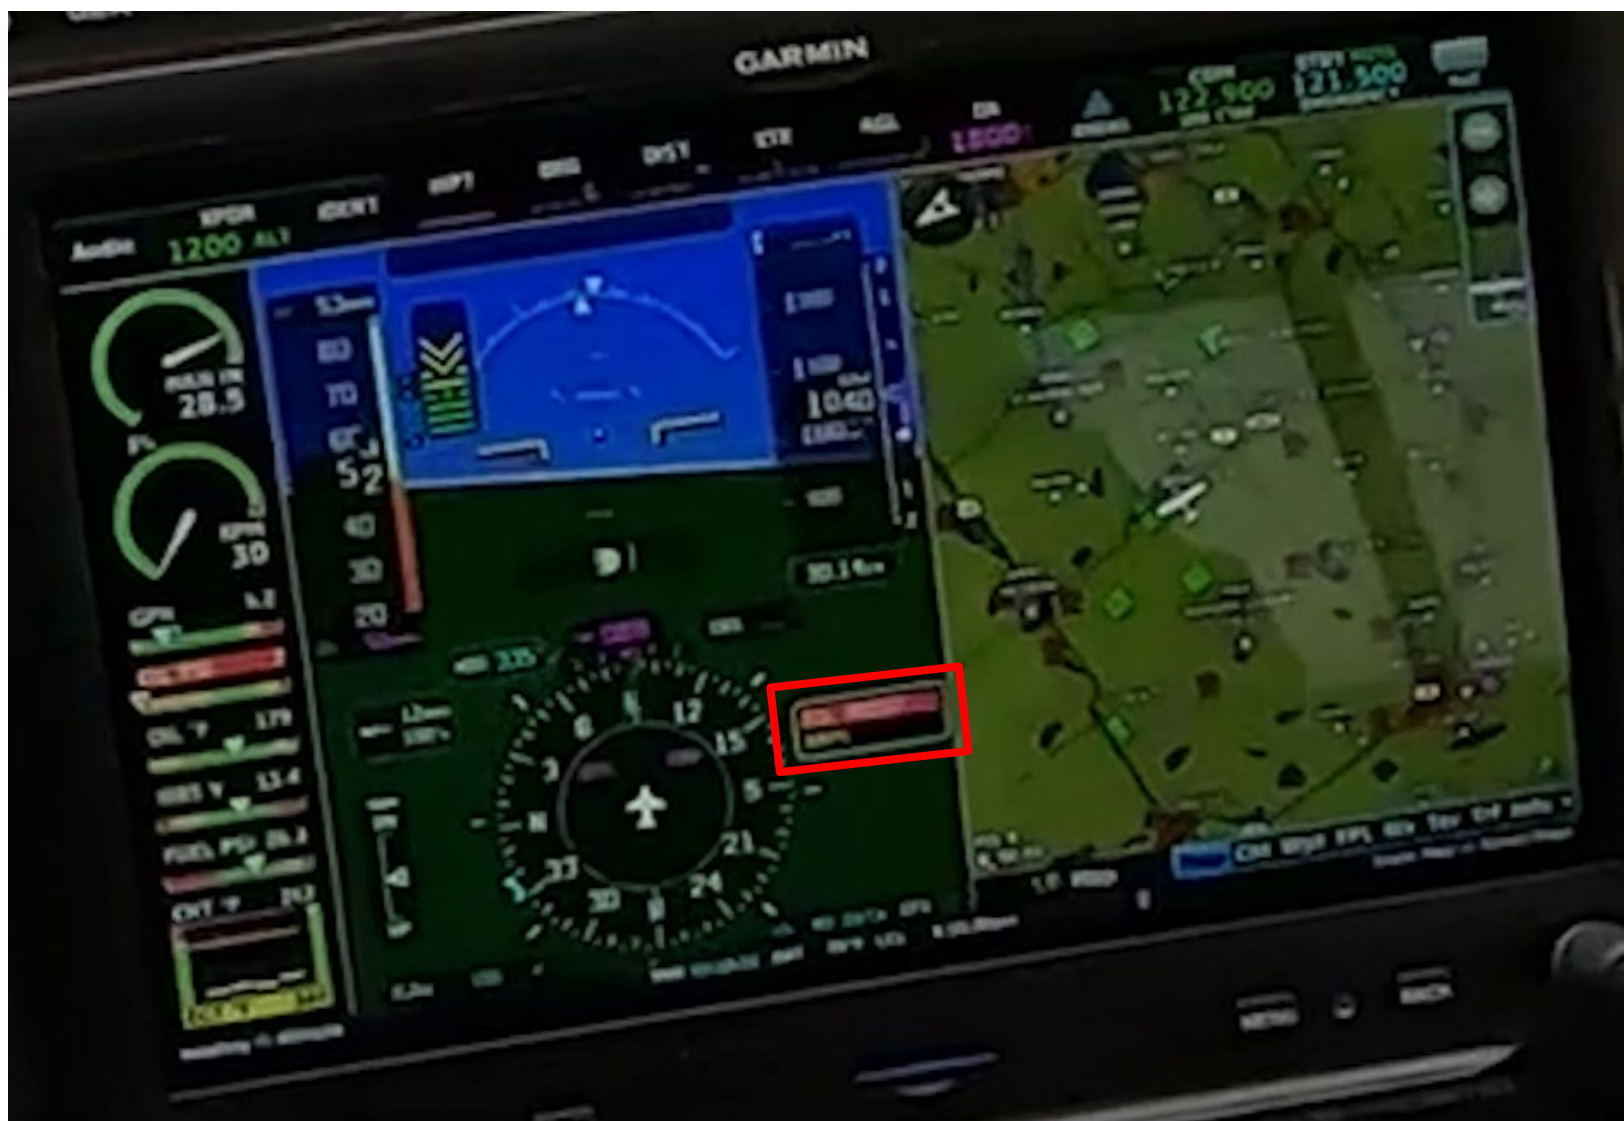
**Figure 9.** Garmin G3X PFD display with CAS OIL PRESS red warning (red rectangle). Screenshot taken at 16:55:31 CDT.

| <b>Time CDT (HH:MM:SS)</b> | <b>Observation</b> |
|---|---|
| <b>16:55:31</b> | One single chime was heard and a CAS "OIL PRESS" red warning illuminated on the Garmin G3X, as shown in figure 9. The airspeed was 52 mph and the altitude was 1040 ft (approximately 25 ft AGL). |
